# Surprising Discoveries From the Analysis of the Exterior Paints of “Bel-Mede” in Williamsburg, Virginia

Front Facade

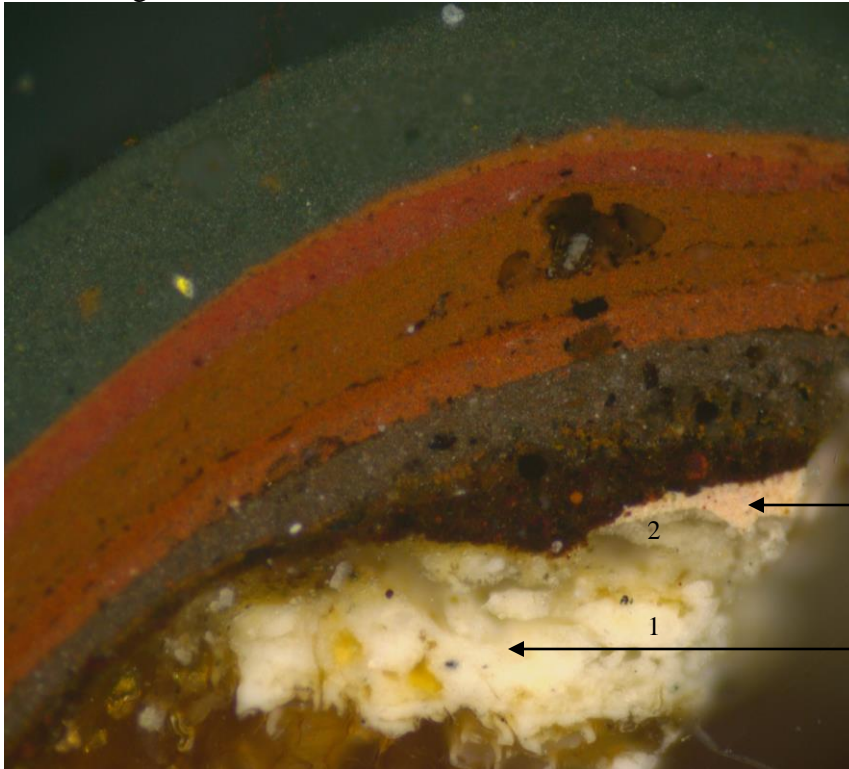
Sample 1. Front façade, top edge of right door leaf.  
Visible Light 200X

The evidence in sample 1 from the door suggests it was first painted off-white in generations 1 and 2, which is surprising for an element that was so exposed to abrasion and wear. The paint evidence on the door is quite fragmentary and uneven, so it is difficult to be confident about the earliest paint sequence as many early paints seem to be missing. The most recent nine layers of paint are dark browns and reddish-browns, followed by the most recent dark green.

Likely a finely ground  
20<sup>th</sup> century coating

First weathered off-  
white paint layer

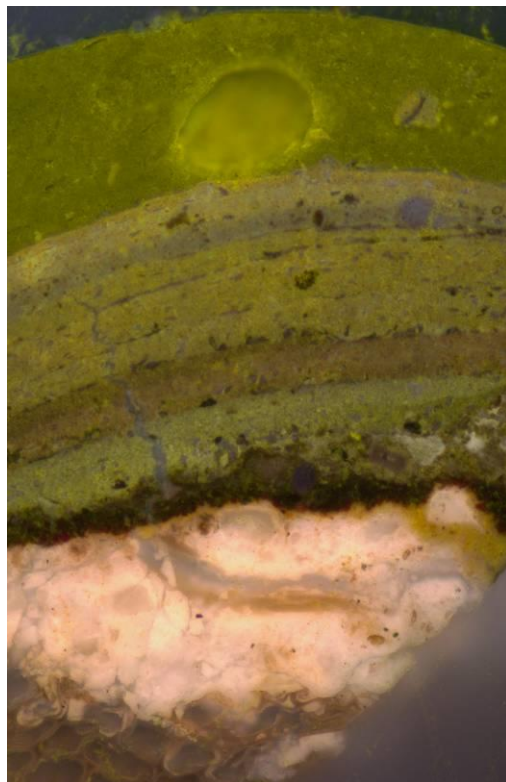
UV Light & DCF for the presence of oils  
All layers reacted positively

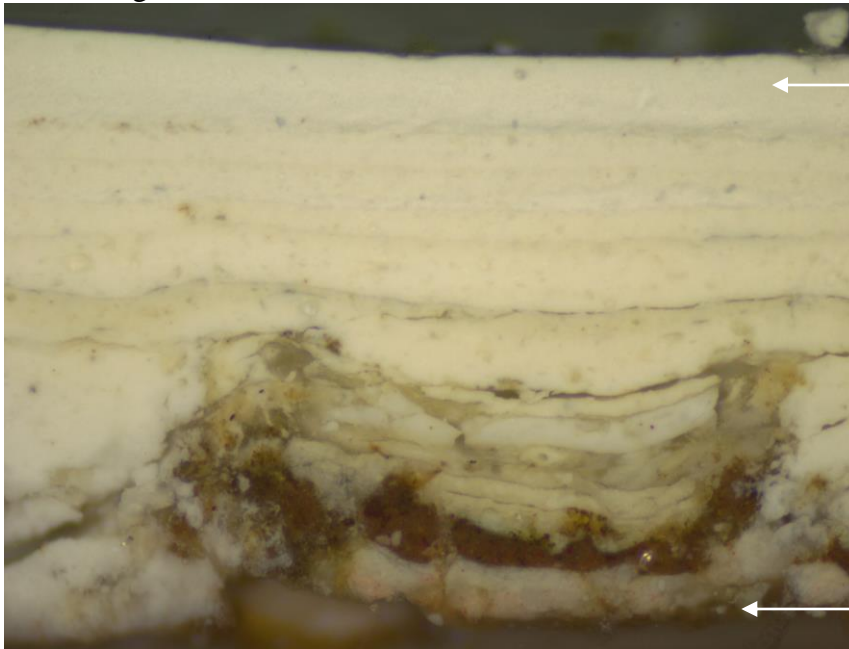
Sample 2. Front façade, door trim, right side at bead molding, about 5-feet up.  
Visible Light 100X

The most remarkable discovery was that the first layer of paint on the weatherboards and door trim was a disrupted, weathered, distinctly pink layer of oil-bound paint. In sample 2 from the door trim this first pink layer was followed by an off-white paint. In sample 3 from a weatherboard the second generation was a slightly darker pink. It was difficult to discretely separate pigments from the first pink layer for pigment identification because

Approximately 16 generations of paint remaining in the area sampled

Original dull pink paint

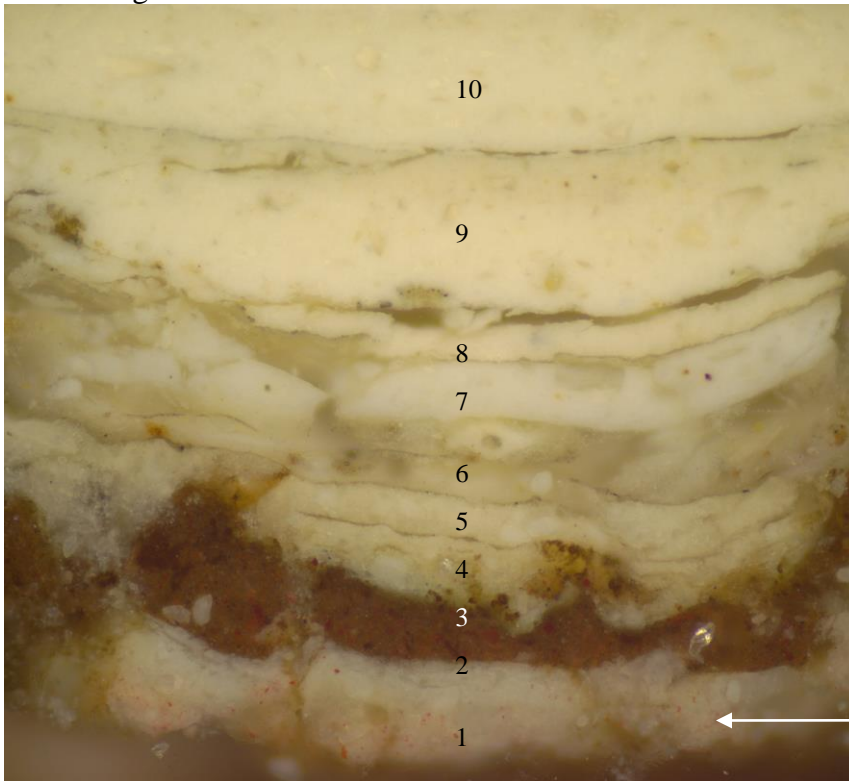
Visible Light 200X

Original dull pink paint

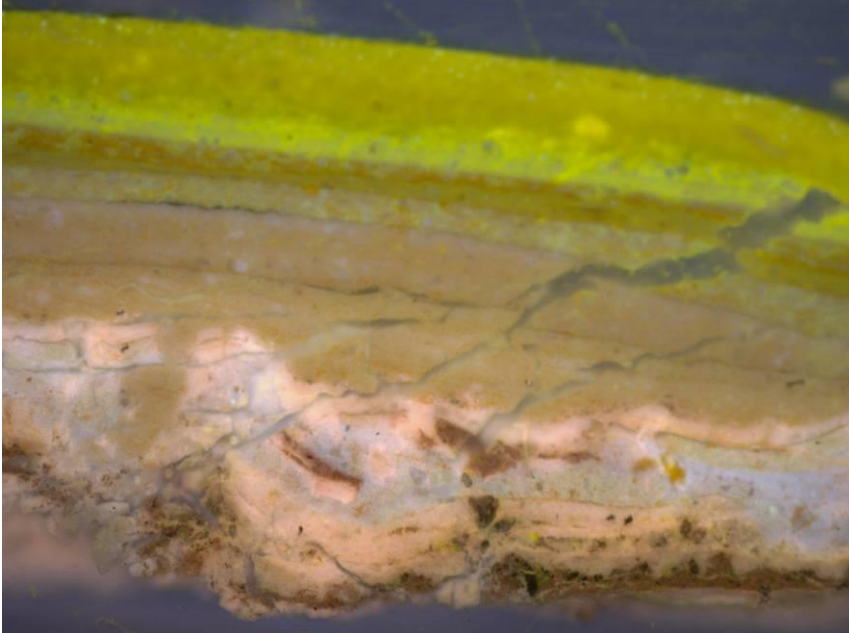
UV Light & DCF for the presence of saturated and unsaturated lipids 100X  
All layers reacted positively, to varying degrees, for saturated (cross-linked) oils

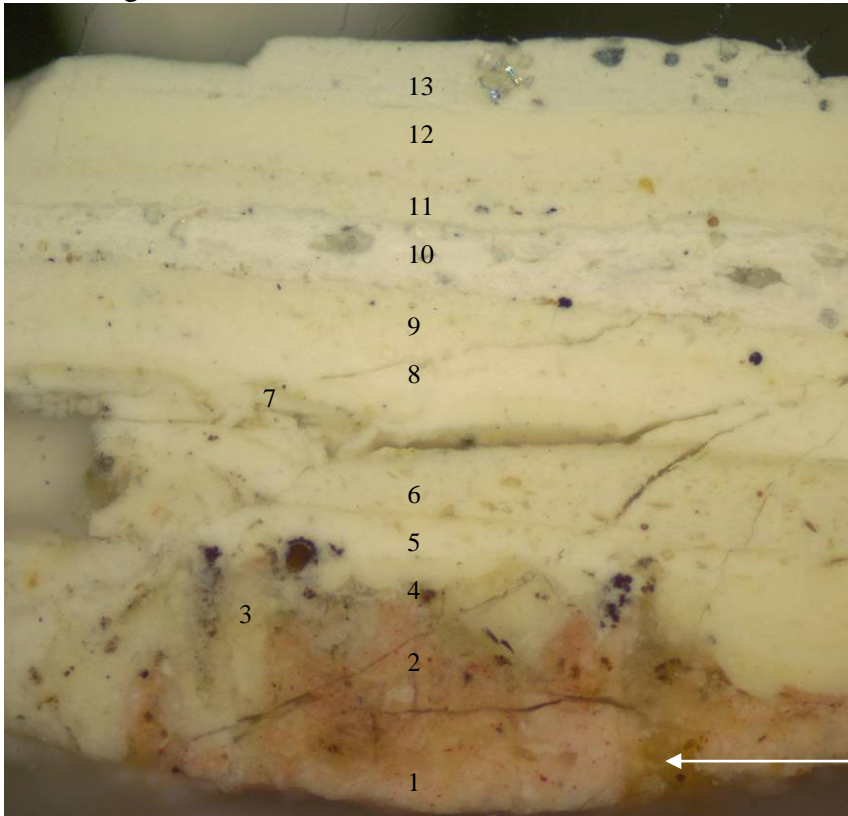
Sample 3. Front façade, weatherboard just left of door, about 5-feet up, under lip of bottom edge.

this paint was so degraded and disturbed, but in cross-section the first and second paint generations in sample 3 appear to be composed of red ochre, white lead, calcium carbonate, and a few red lead particles.

First pinkish paint found on the weatherboards and door trim

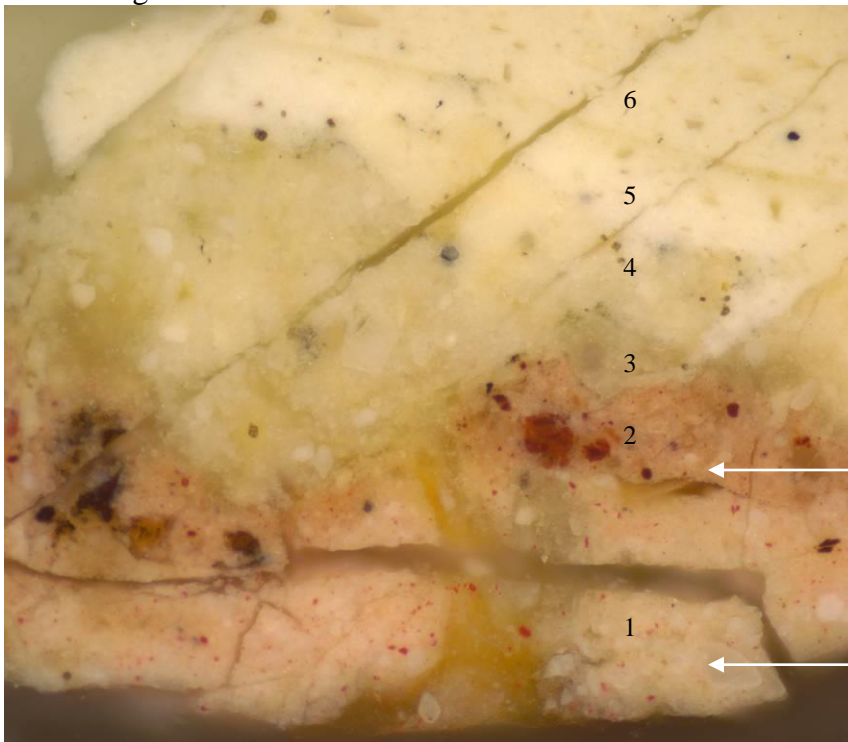
Visible Light 200X

Second generation of darker dull pink paint

First pinkish paint found on the weatherboards and door trim

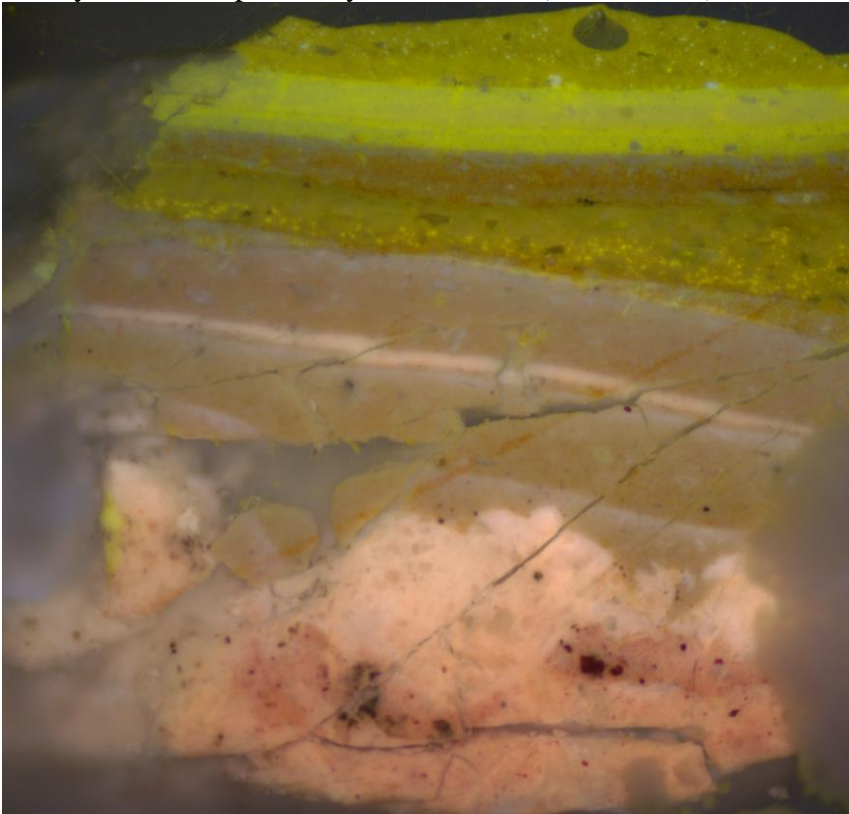
UV Light & DCF for the presence of saturated and unsaturated lipids 100X  
All layers reacted positively for saturated (cross-linked) oils

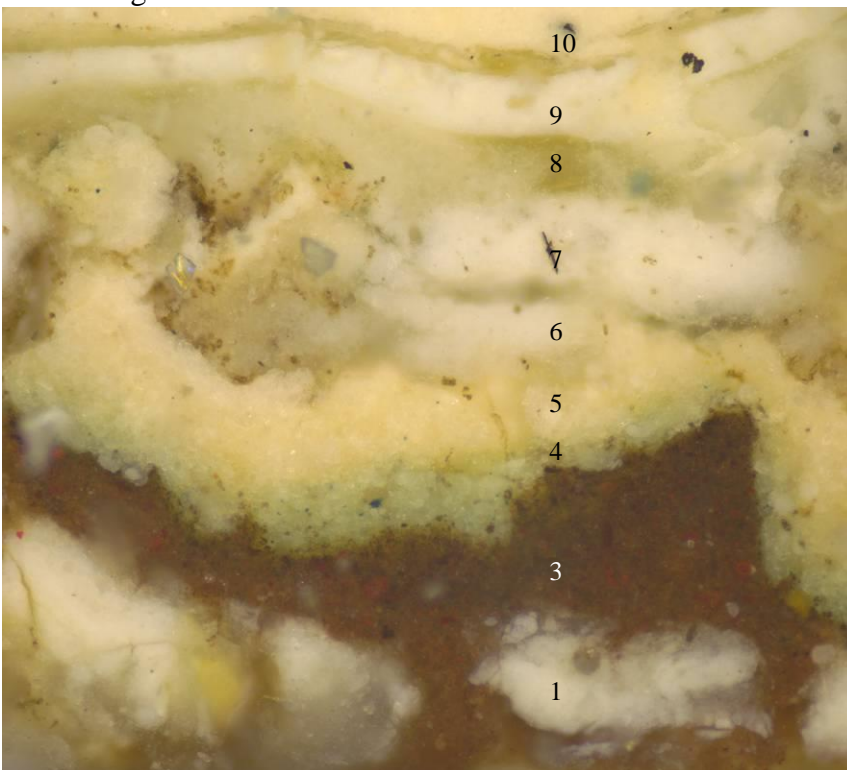
Visible Light 200X

First fragmentary off-white layer resembles the first paint found on the front door in sample 1

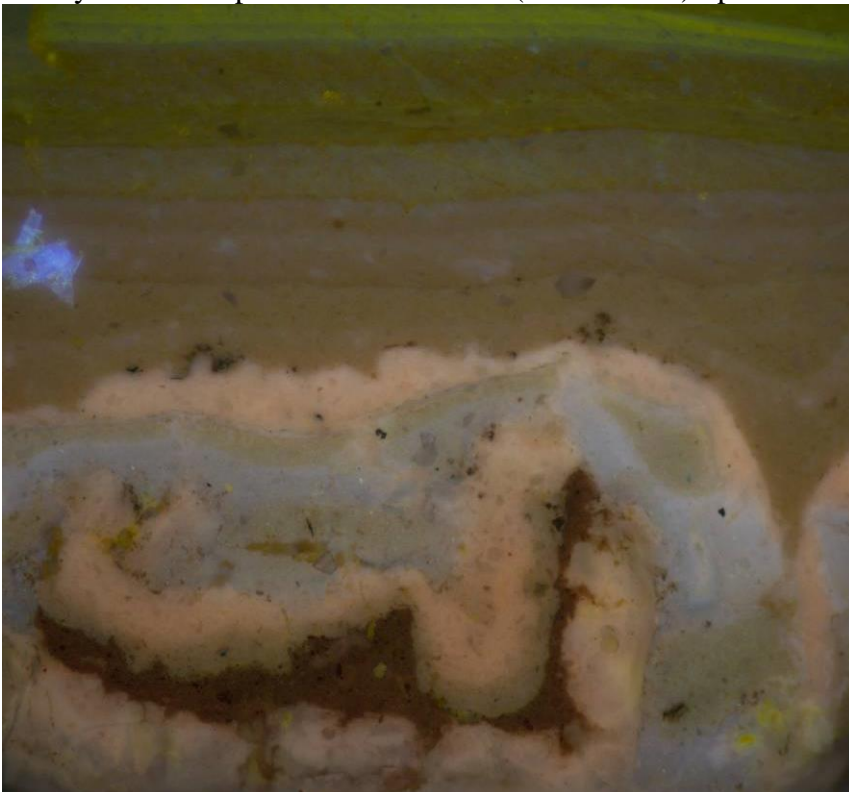
UV Light & DCF for the presence of saturated and unsaturated lipids 100X  
All layers reacted positive for saturated (cross-linked) lipids to varying degrees

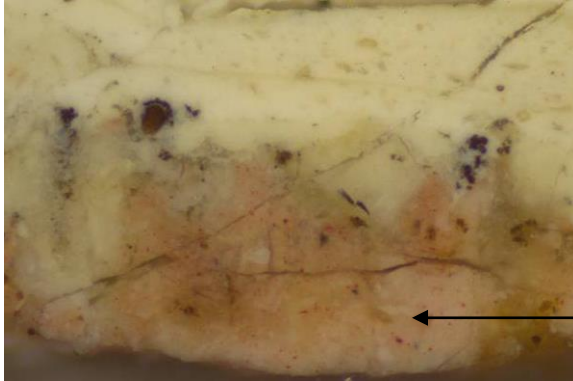
Sample 3. 100X

The first pinkish paint on the weatherboards and door surround was matched by eye at 30X under a color-corrected light source as the earliest layers were too fragmentary and degraded for accurate color matching. The appearance of this unusual pink layer and the binding media reactions suggest it was originally moderately glossy.
