## **Cross-section Paint Microscopy Report Exterior Paints**

### **Cupola House The Cupola House Association Edenton, North Carolina**

Date: October 6, 2018

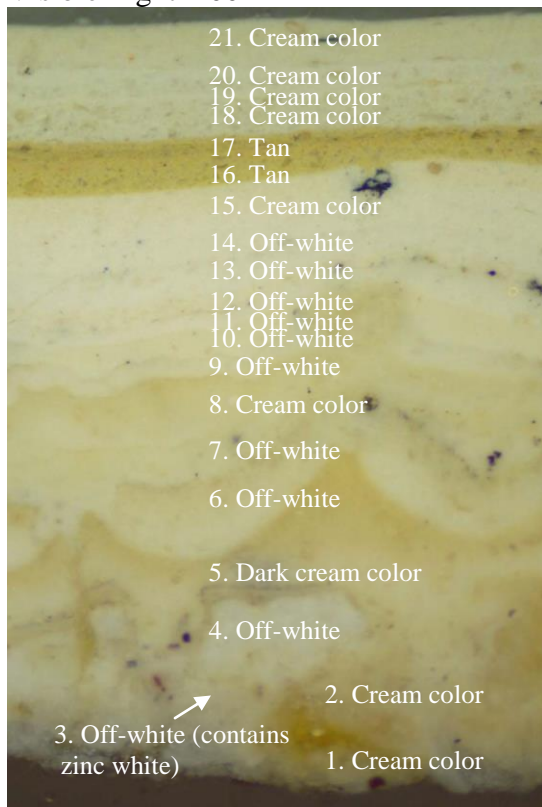
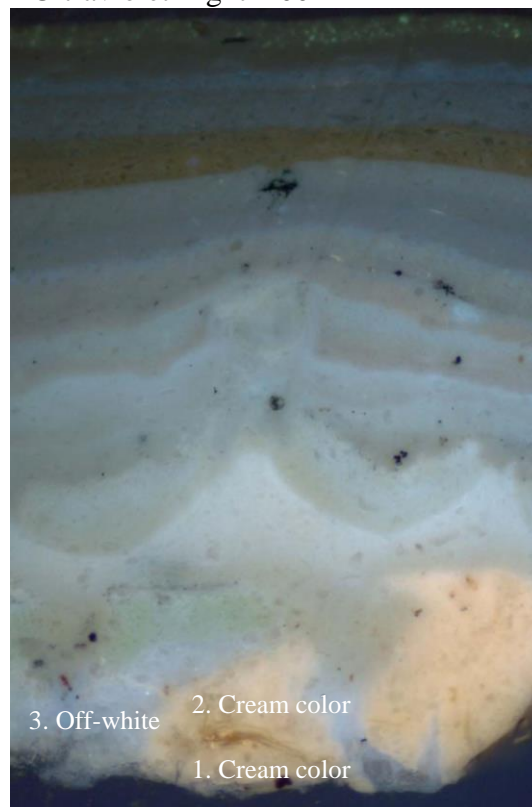
The most complete cross-section is S-5 from one of the brackets on the south. This element is original to the building and 21 generations of paint can be identified in the cross-section. But, only the first two white lead-based, cream-colored paints might date to the eighteenth century. These two paints are fragmentary, consisting of only two discrete lumps, and are surrounded by later paints which flowed into cracks. The third generation of paint is an off-white paint with a sparkly blue autofluorescence that marks the presence of zinc white, dating this paint to not before about 1845 when zinc white became commercially available. Most of the paint colors on this bracket are creams and off-whites, with the exception of more recent tan paints in generations 16 and 17, as shown in the photomicrographs below.

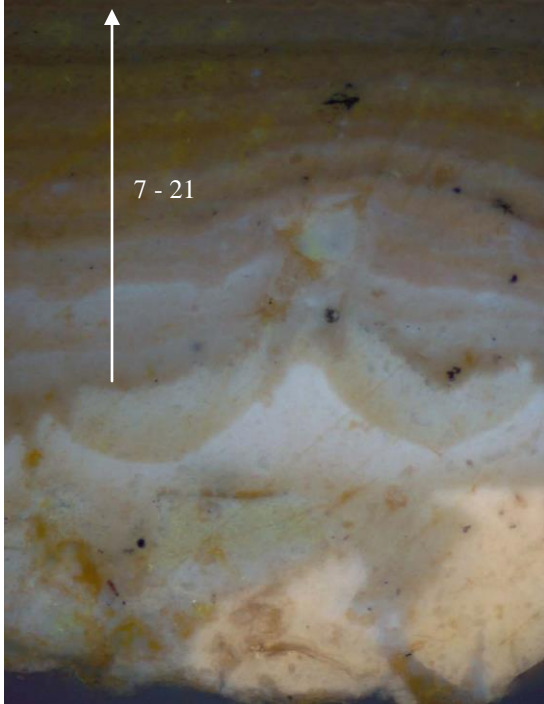
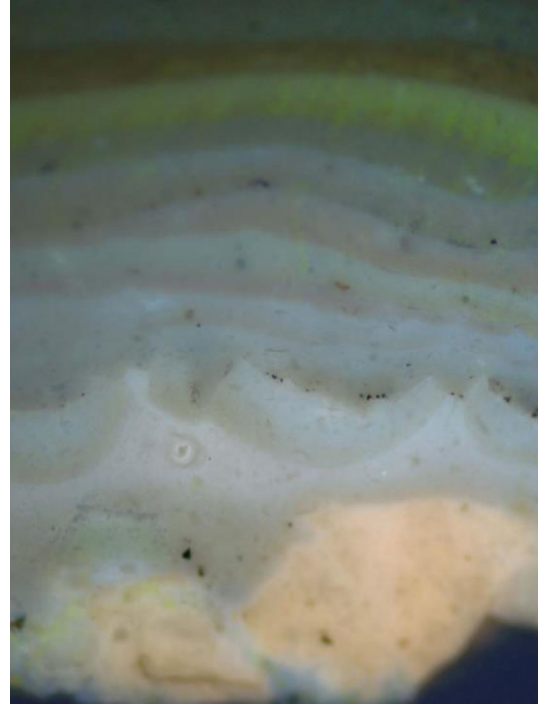
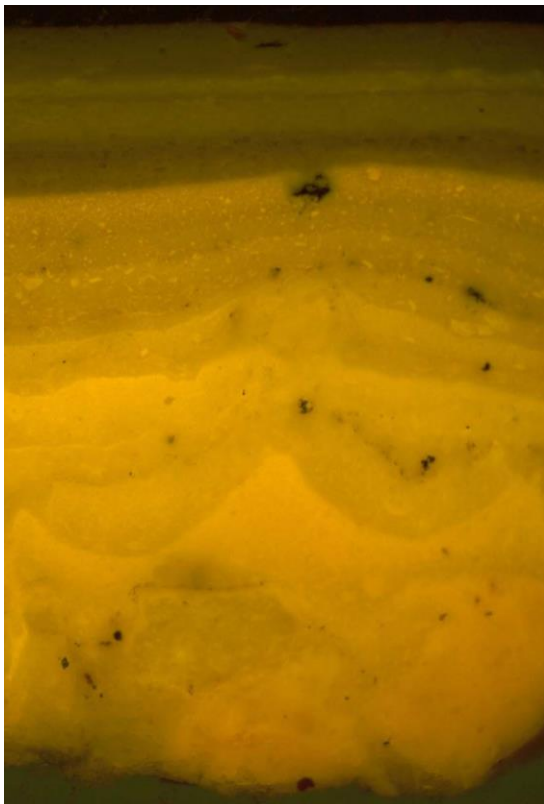
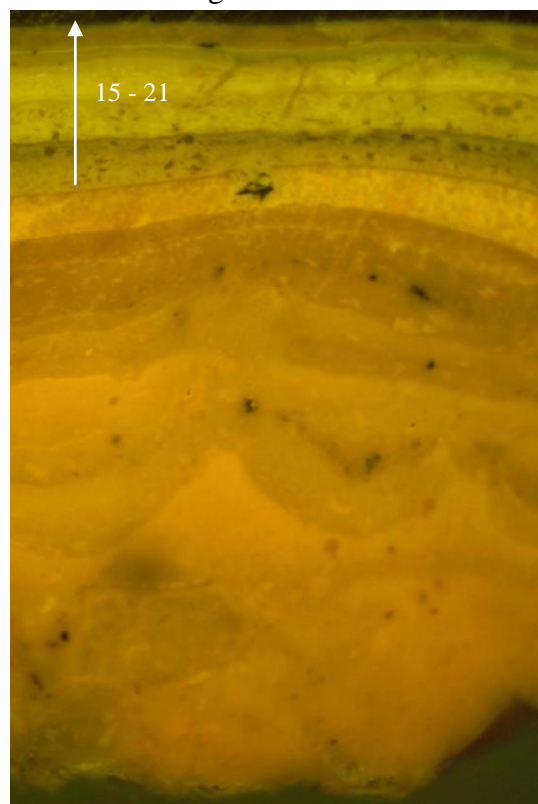
S-5. South elevation, west side, side of bracket.

Binding media analysis of sample S-5 shows that all the paints contain oil components. There are carbohydrate components in generations 7 through 21 which could be organic additives to thicken or toughen the paint (such as natural gums and casein) or cellulosic fillers. The paints in generations 15 through 21 contain protein components, likely surfactants (with amine groups) added to these modern paints to improve their wetting properties. Polarized light microscopy pigment identification of the components in the first cream-colored paint could not be done with confidence because this paint layer is so fragmentary and compromised by penetration of later paints into the cracks in the earliest layer (at the bottom of the cross-section).

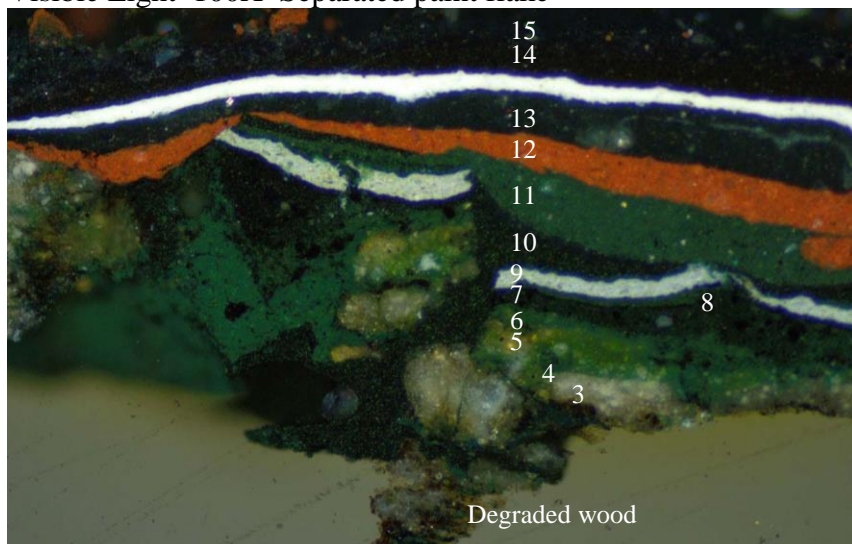
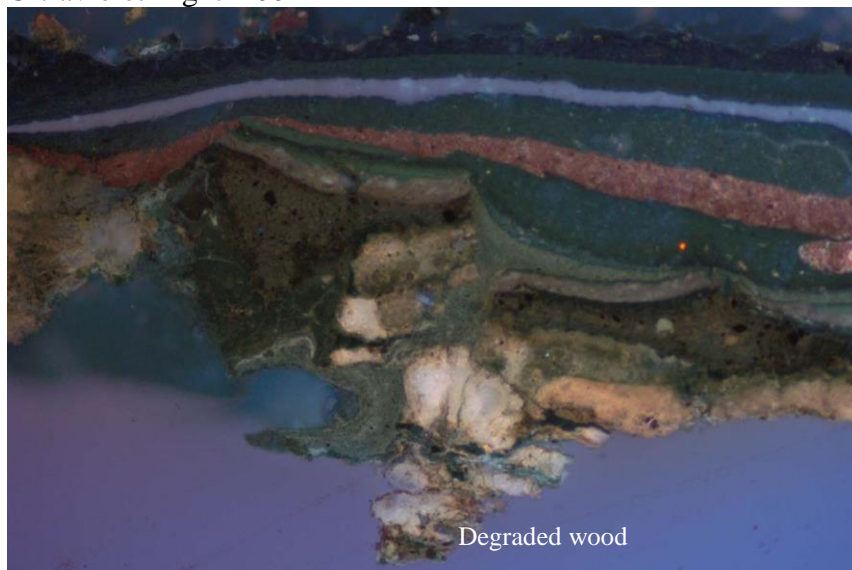
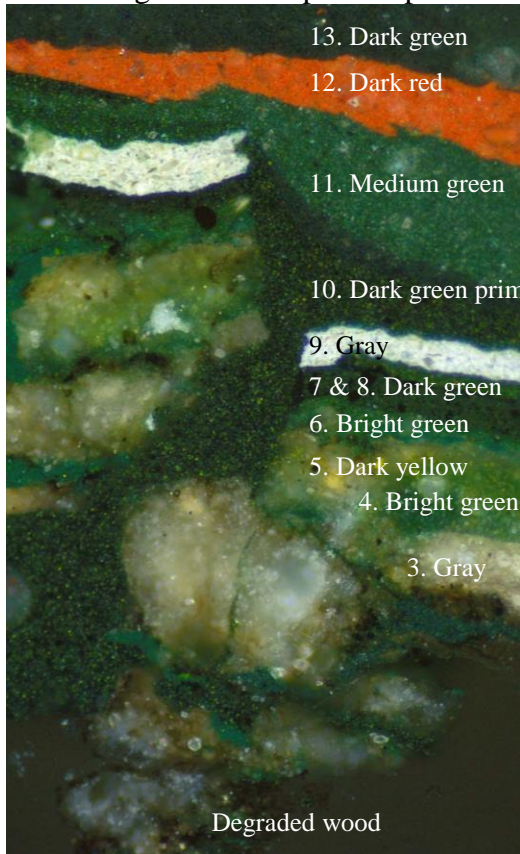
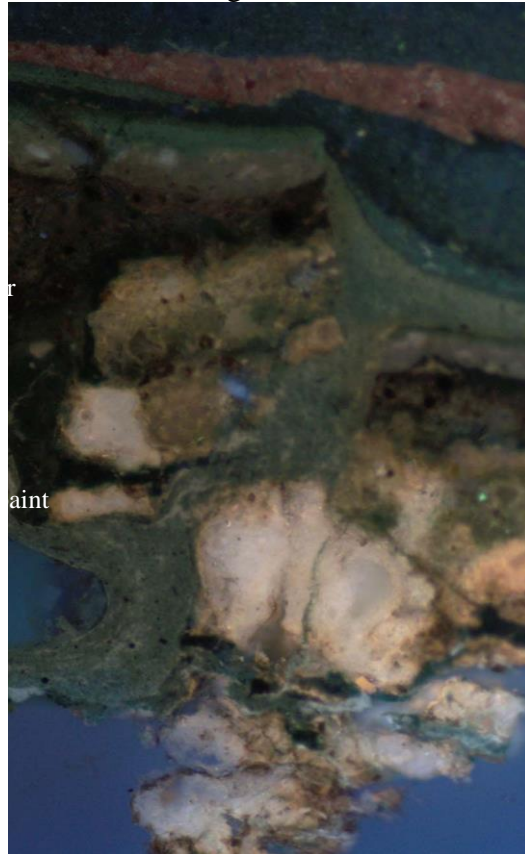
Shutter-8. Detached shutter, right side of panel, at join with right stile.

Shutter 8. Exterior shutter. There are at least fifteen generations of paint remaining on the shutter, but the wood substrate in this cross-section, and in the other uncast portions of the shutter samples, is extremely degraded. This suggests that virtually all the earliest paints completely weathered away before later repainting efforts. In sample “Shutter-8” there is clearly a long history of green paints which range from early bright greens to the most recent blackish green. The shutter was painted gray in generations 3 and 9, and deep red in generation 12. The earliest bright green paint in this cross-section can be aligned with the fourth generation of paint in sample 2 from the iron bar, so it has been labeled as generation 4 in this shutter sample. It is likely that the original paint on this shutter was green, but the earliest paints are too degraded and weathered to be confident about interpreting the original shutter color.

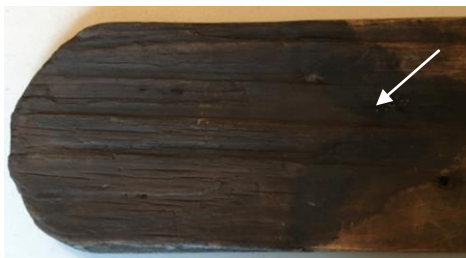
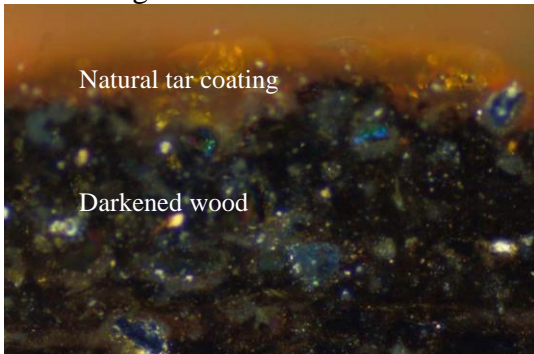
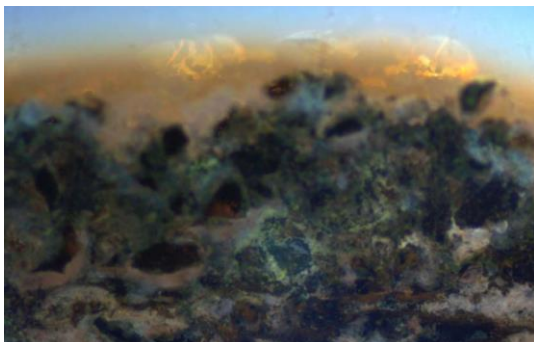
Sample 1. Shingle found trapped in second-floor kneehole attic, at edge of blackened coatings.

**Sample 1. Shingle.** The exposed end of this blackened shingle is fissured, charred and weathered, but there is an accumulation of slightly glossy, dark brownish material where two shingles overlapped at the top of the exposed end. This area was sampled for analysis and in cross-section the wood substrate is blackened and compressed, most likely from extreme heat exposure. There is an amorphous, translucent brownish coating on top of the wood surface which softened on exposure to the mineral spirits applied to the sample before cover slipping. Binding media analysis shows that there is oil in this brownish coating and in the wood. The appearance of the brownish coating in cross-section, and the presence of oils, is typical of an unpigmented, natural pine tar coatings which were traditionally heated with linseed oil or fish oil during preparation. So, optical microscopy analysis indicates that there is a natural tar coating on the shingle, but further organic materials analysis would be needed to confirm the presence of pine tar and other organic components.

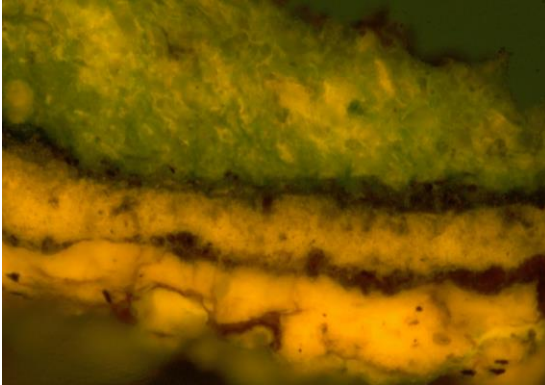
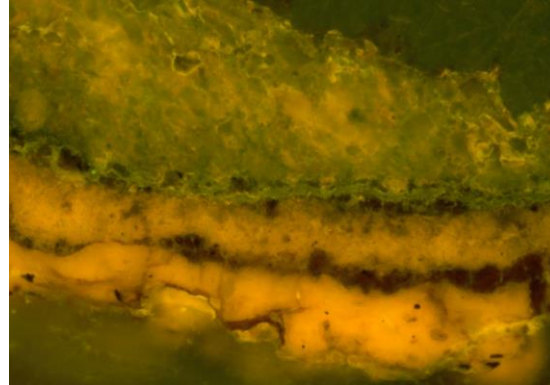
**Sample 2. Iron bracing bar.** The paints on an iron bar that might have been part of the original cupola balcony structure are fragmentary and degraded by rust, but there are still islands of paint clinging to the iron substrate. Cross-section microscopy analysis shows there are four generations of paint remaining on the iron bar, each with films of corrosion and dirt on their surfaces. The earliest surviving paint is a coarsely ground cream color (at the bottom of the cross-section), followed by an off-white paint in the second generation, and then a coarse gray paint in the third generation. There are films of grit and rust between each of these paints. The most recent paint in this cross-section is a thick, coarsely ground, green paint. The bright green paint in this cross-section can be aligned with an early green paint on the shutter, which has been labeled generation 4 in shutter sample 8. The original cream-colored paint is white lead-based, and may relate to the earliest cream-colored paint found on the exterior bracket (sample S-5), but the cream-colored and off-white paints in this sample are too degraded to make a confident connection.

Binding media analysis with biological fluorochrome stains shows that all the paints on the bracing bar are oil-bound, and the fourth generation bright green paint contains protein components as well. The shape, size and morphology of the green pigments in the bright green paint suggest the presence of chrome yellow and chrome green, which dates this green paint to after about 1825 when chrome green became readily available. There is a thick layer of soot and dirt on the top of the third-generation gray paint, which indicates it was exposed for decades before being repainted bright green.

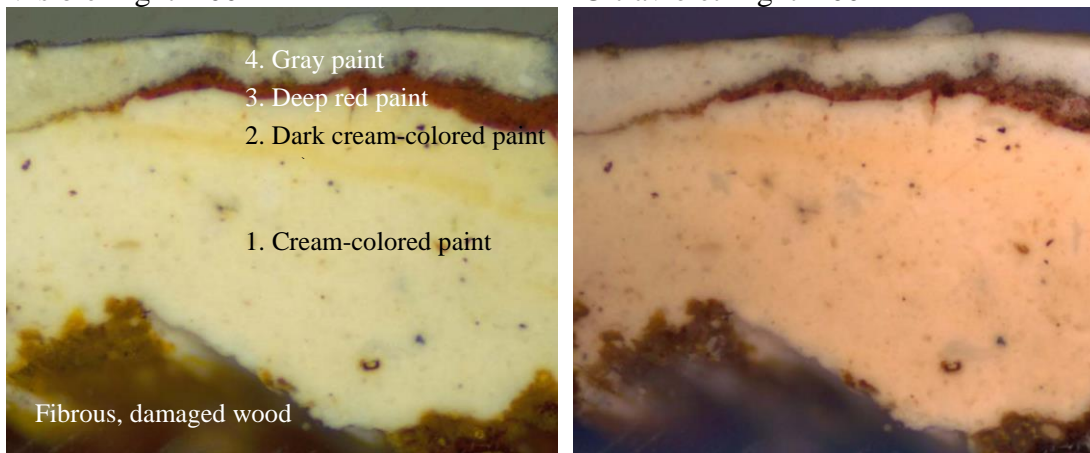
Sample 4. Exterior finial from pediment of cornice, south elevation, on side of carving.  
Visible Light 200X                      Ultraviolet Light 200X

Finial. The front of the original wooden finial for the roof pediment on the south elevation is eroded and stained, but there are small patches of aged paints on the sides of the carved decoration of the finial base. The paint chronology in the sample from one side is promising as there are four paint generations on top of the wood. However, in cross-section sample 4 the wood surface is eroded and fibrous, suggesting that the earliest paints completely weathered away before the first cream-colored paint was applied. This decorative element was repainted cream color in the second generation, and then it was repainted deep red in the third generation. The most recent surviving paint is light gray.

This paint chronology does not directly relate to the paints found on the exterior trim, although the two cream-colored paints are white lead-based, like the earliest exterior paints in sample S-5 from the bracket. A search of early photographs of the house may also provide clues about when the finial was painted a dark color, which could provide a date range for the deep red paint in generation 3.

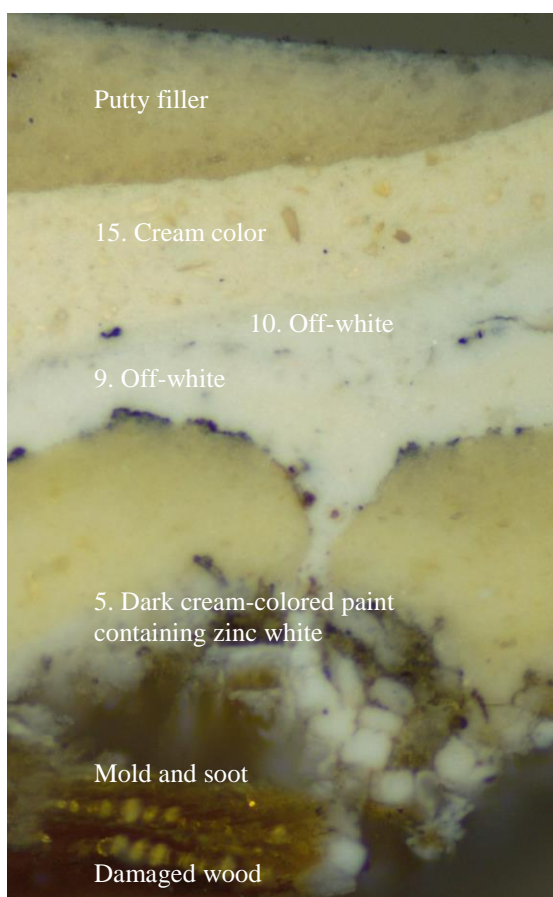
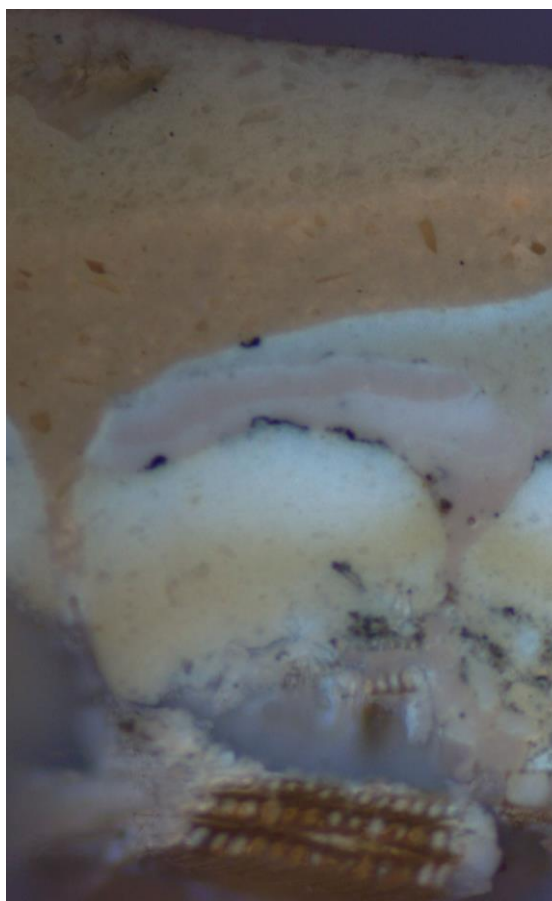
Sample 5. Rusticated siding board from cupola, at edges.

**Sample 5. Rusticated siding.** There are thick accumulations of weathered, discolored paints on the edges of the rusticated siding and bolelection molding which were sampled for cross-section microscopy analysis. At the bottom of the cross-section for sample 5 the wood substrate is disturbed and has blackish mold on its surface. These are clues that the original paint was allowed to weather away completely before the siding was painted dark cream color.

In the reflected ultraviolet light image the first dark cream color has a slightly sparkly bluish appearance, which is characteristic of paints containing the pigment zinc white. This particular pigment was not incorporated into architectural paints until after about 1845, which means that this cross-section does not retain the earliest paints applied to the siding. This dark cream-colored paint may line up with generation 5 in exterior sample S-5 from the bracket, and the later layers can be aligned with generations 9, 10 and 15.

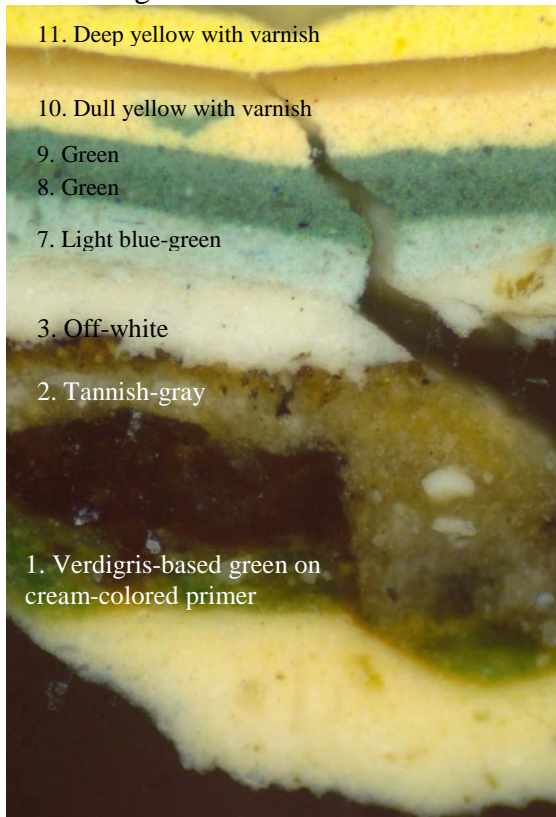
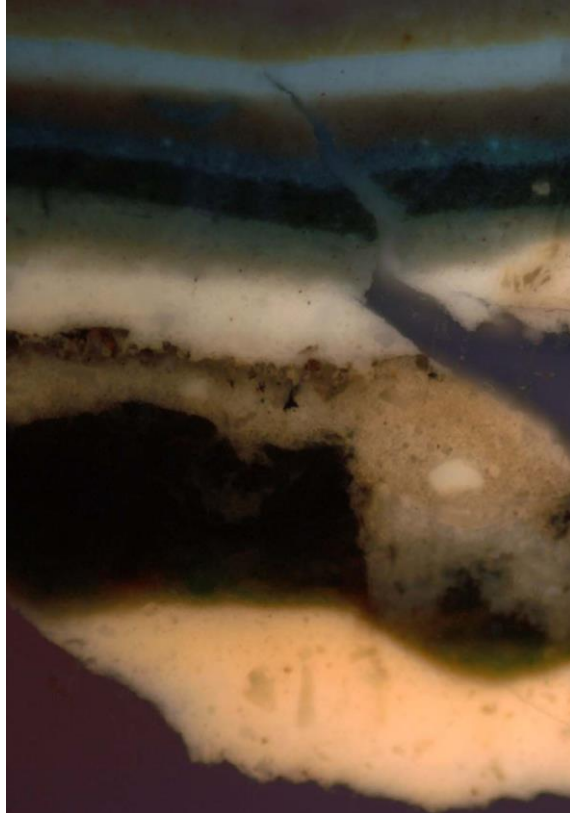
The evidence in samples SE-2 and SE-3 shows that the first layer above the wood is a cream-colored paint, followed by the distinctive, coarsely ground, bright emerald green-colored paint. There is no boundary or definite edge between the cream-colored paint and the bright green paint, indicating that the cream-colored paint was the original primer. This is a traditional craft approach because the copper-based green pigment verdigris is slightly translucent and does not have good covering power. In the cross-section the surface of the green paint is discolored and darkened, which is typical as verdigris is an unstable pigment which tends to darken over time when combined with linseed oil or varnish. However, when freshly applied this grainy green paint must have been brilliant and glossy, likely making this room the most stylish chamber in Edenton, North Carolina at the time.

The second generation of paint is tannish-gray, and it also became dirty and degraded before being painted over with a finely ground off-white paint in the third generation. This off-white paint is smooth and relatively clean, and is more typical of commercially prepared twentieth-century paints. Generation 4 is a medium blue paint, followed by a light blue-green paint that was identified as generation 7 in sample SW-1 from the southwest chamber. Generation 8 is a green paint, also found in the same context in sample SW-1, and in sample CH-2 from the second-floor hall. The full chronology of paints in the southeast chamber is listed in the comparative table on page 32.

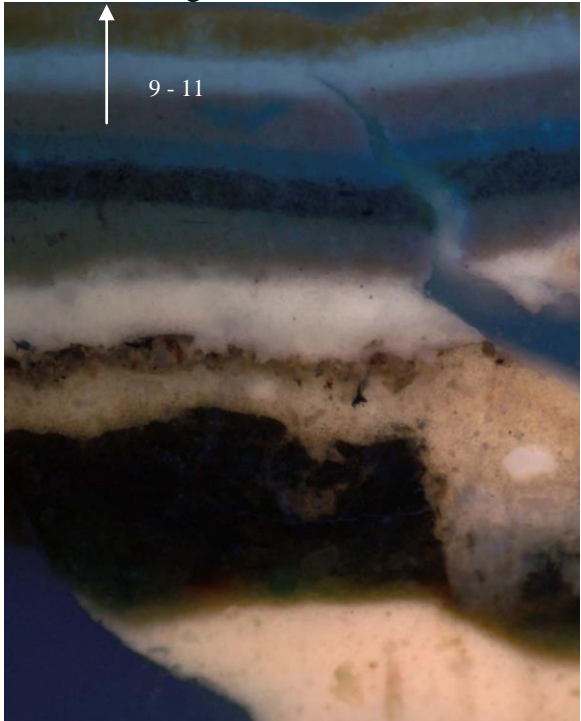
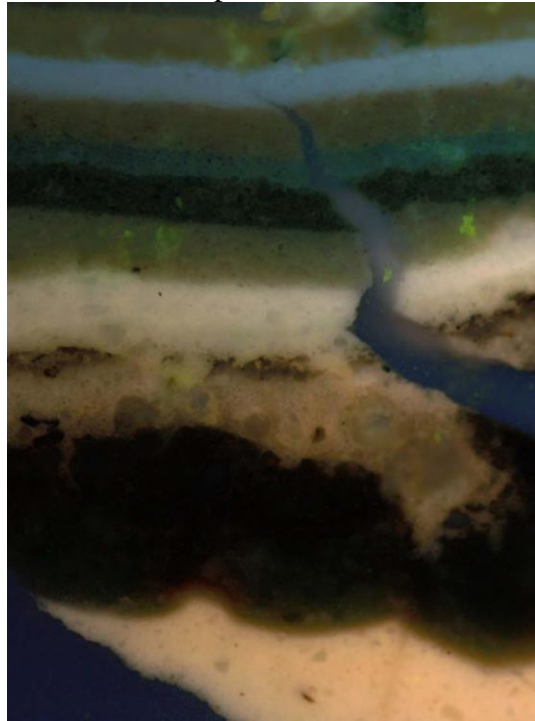
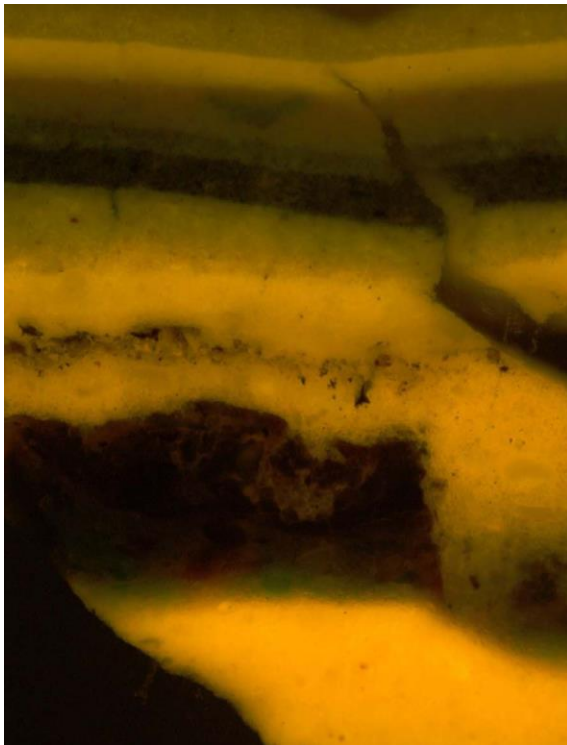
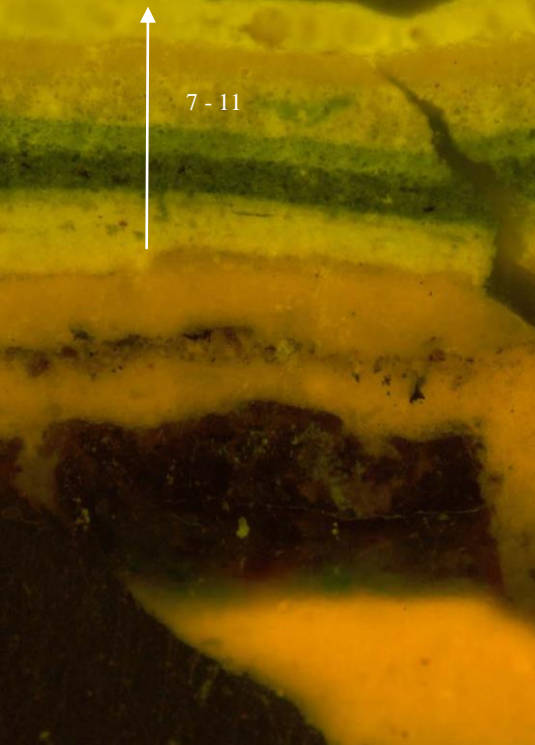
SE-3. East wall, top left corner of wainscot panel just right of fireplace opening.  
UV Light & TTC for carbohydrates 200X    UV Light & DCF for lipids (oils)  
+ reactions in generations 9 to 11                      + reactions in all paints

Binding media analysis with biological fluorochrome stains shows that all the paints contain oil components, and generations 9 through 11 contain carbohydrate components. Generations 7 through 11 contain protein components which are likely modern surfactants added to increase the wetting properties of the paints. Polarized light microscopy analysis confirms that the pigments in the green paint consist of very large verdigris pigments, with yellow ochre, white lead and calcium carbonate (sample SE-3).

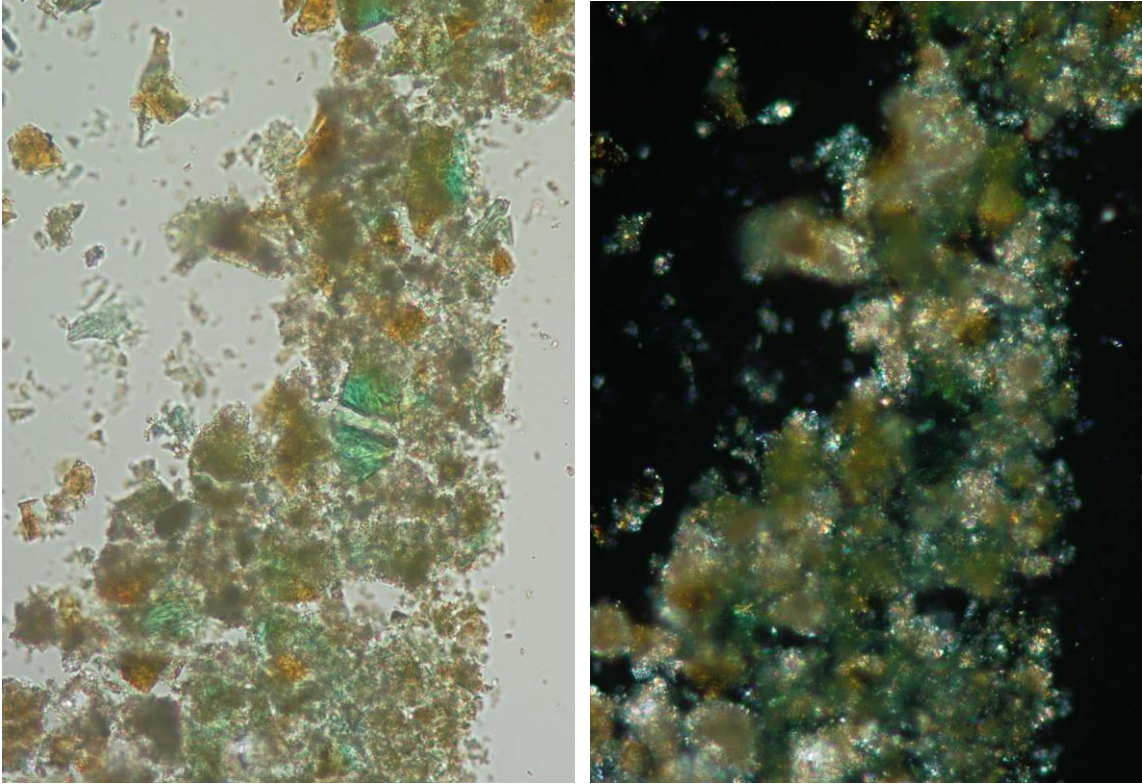
SE-3. East wall, top left corner of wainscot panel just right of fireplace opening.  
Pigments in the original green paint: verdigris, yellow ochre, calcium carbonate.  
Plane polarized transmitted light 400X      Crossed polars (darkfield) 400X

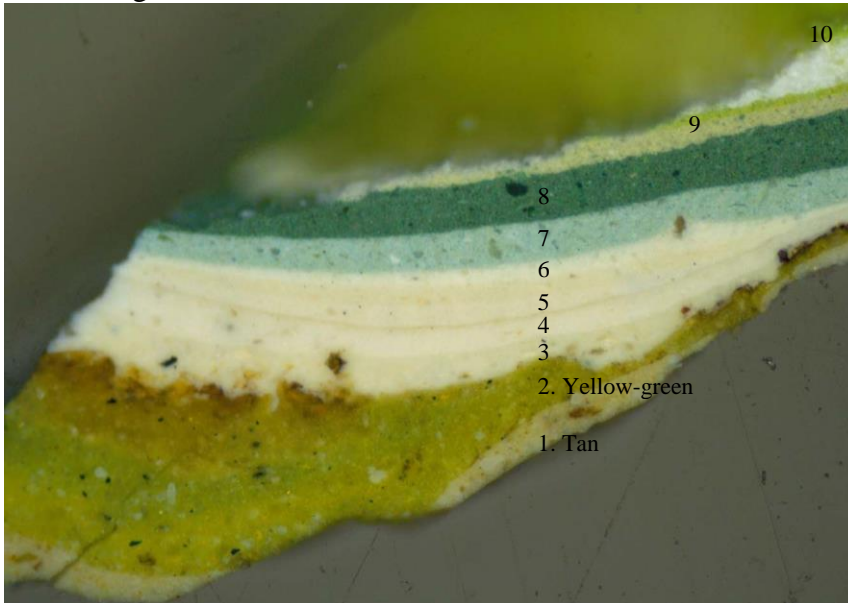
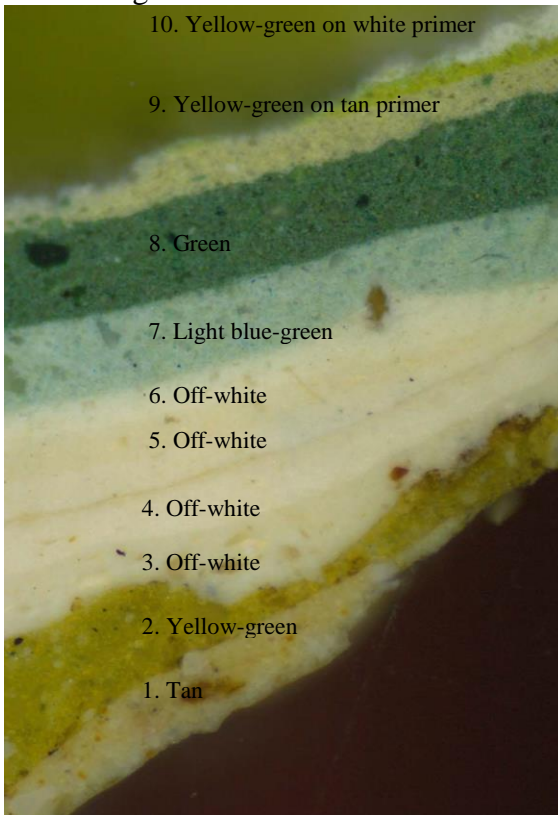
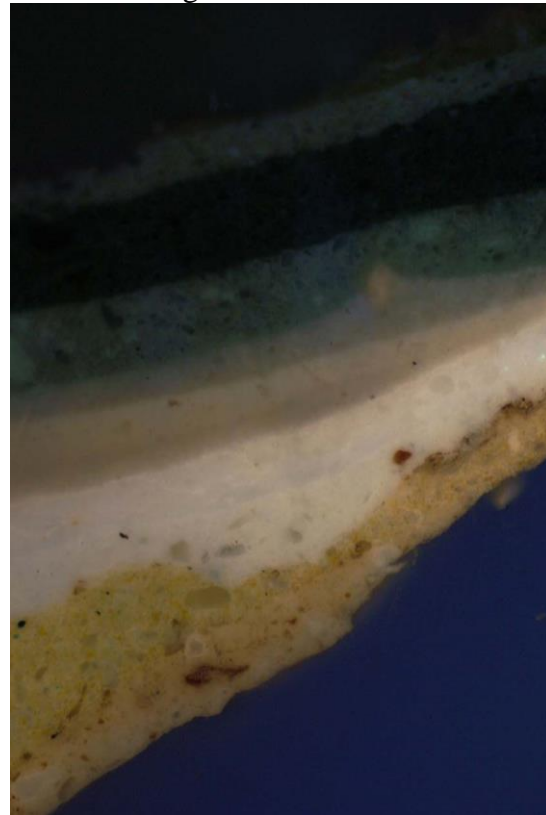
SW-1. West wall, in interstices of leaf carving on right side of overmantel panel.

Samples SW-1 and SW-2 Woodwork Paint. Cross-section microscopy analysis shows that there are ten generations of paint in the most complete sample SW-1 from the overmantel. The evidence in this cross-section reveals that the yellow-green paint is actually the second paint generation. The original paint is a tan layer that collected a distinct layer of grime before it was painted over with the distinctive yellow-green paint. This yellow-green layer also became grimy and discolored before it was repainted in the third generation with a finely ground off-white paint. The same evidence was found in SW-2 from the chair rail, which cleaved apart during sampling.

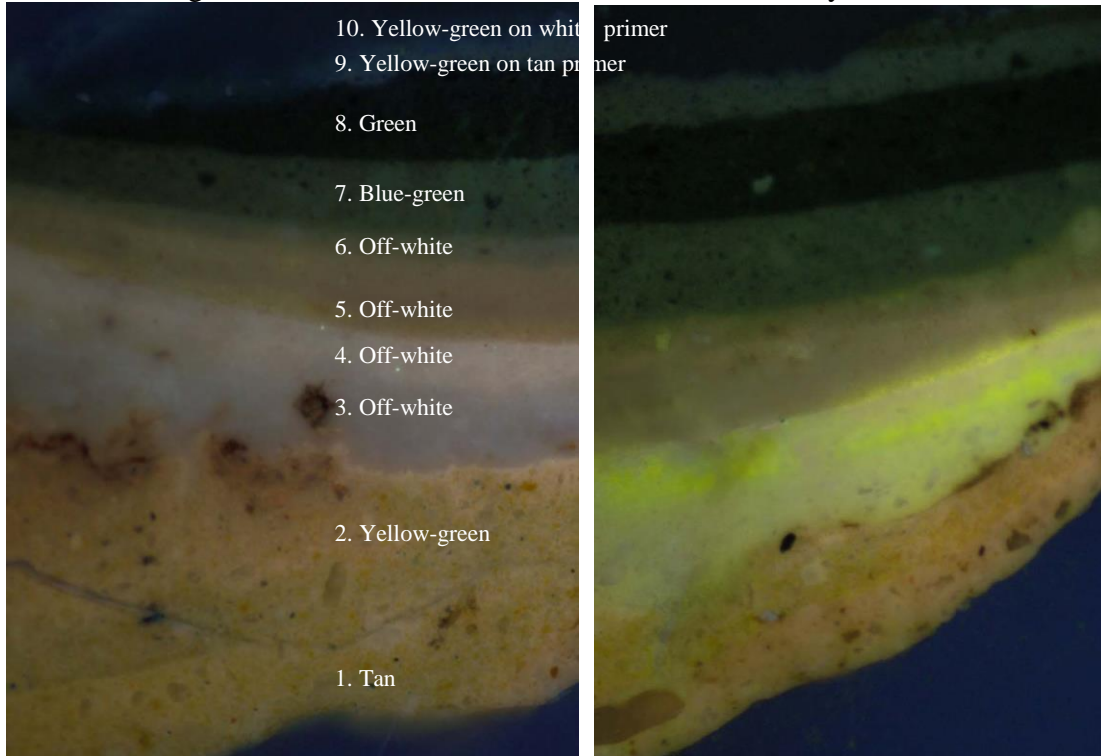
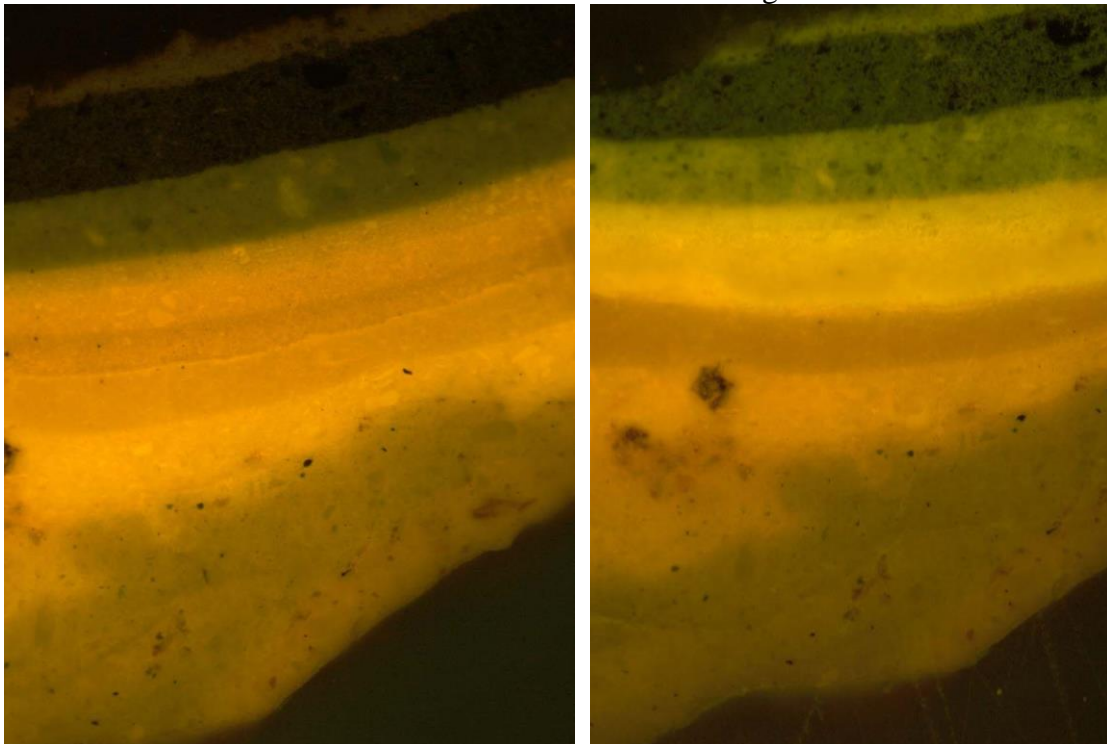
Binding media characterization with biological fluorochrome stains indicates that all the paints contain oil components (with the fluorochrome DCF). Weak positive reactions for carbohydrates were observed in generations 8 through 10 (with TTC), and positive reactions for proteins were observed in generations 7 through 10 (with FITC). The positive reactions for carbohydrates and proteins in the modern paints are typical of complex paints which contain bulking agents and surfactants.
