Fox Hall - *Part 3*, Hall Floor Lift

By Jim Melchor and Tom Newbern

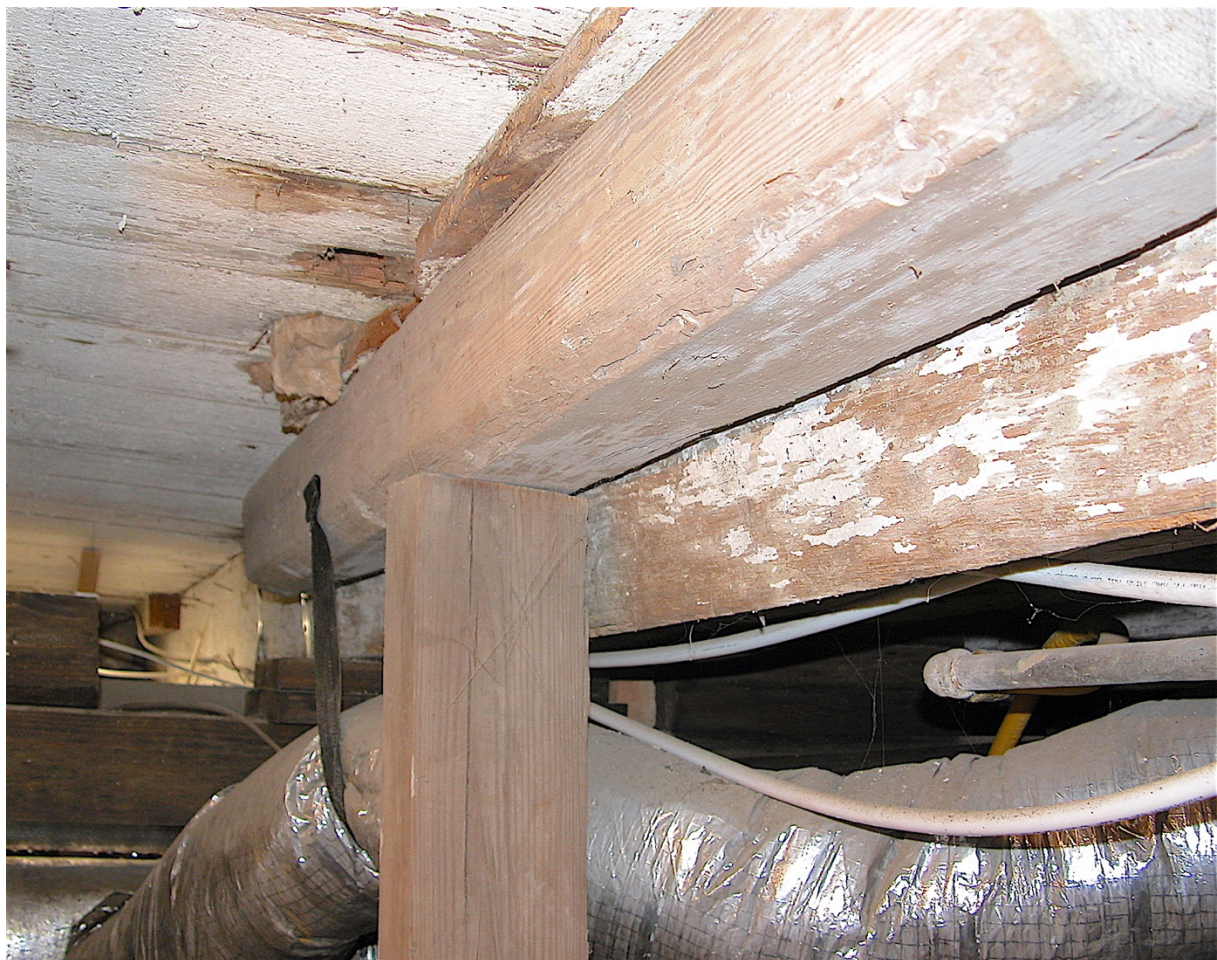
Figure 1

In the middle of nineteenth century, an attempt was made to stabilize a section of flooring beneath the hall, adjacent to the central-passage wall (Fig. 1, Nineteenth-century support T-beam). This likely addressed an immediate concern of a "springy" floor, but it did not solve the problem.

The floor in the hall was checked with a level to determine what sections underneath needed to be lifted. Prior to any lifting, the mid-nineteenth-century T-beam support had to be removed (See Fig. 1). This was done by slowly and carefully lifting the support beam and removing the post, then slowly lowering the jack to make sure removing this T-beam did not cause any catastrophic failures. Fortunately, it did not.

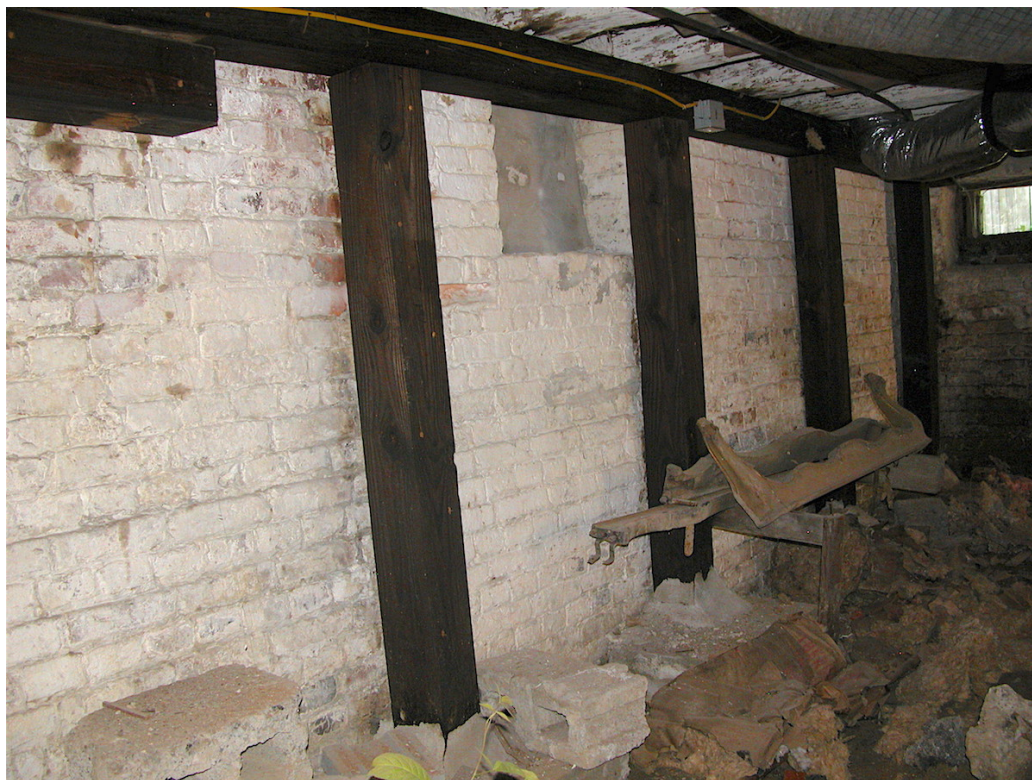
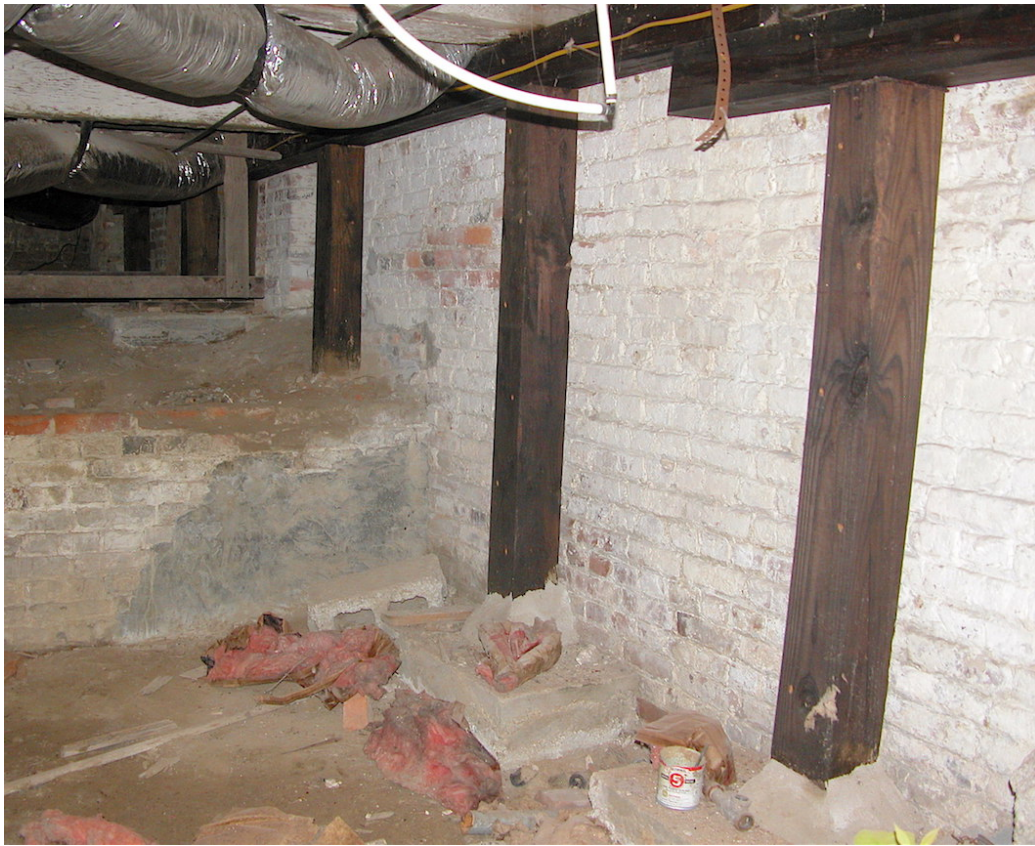
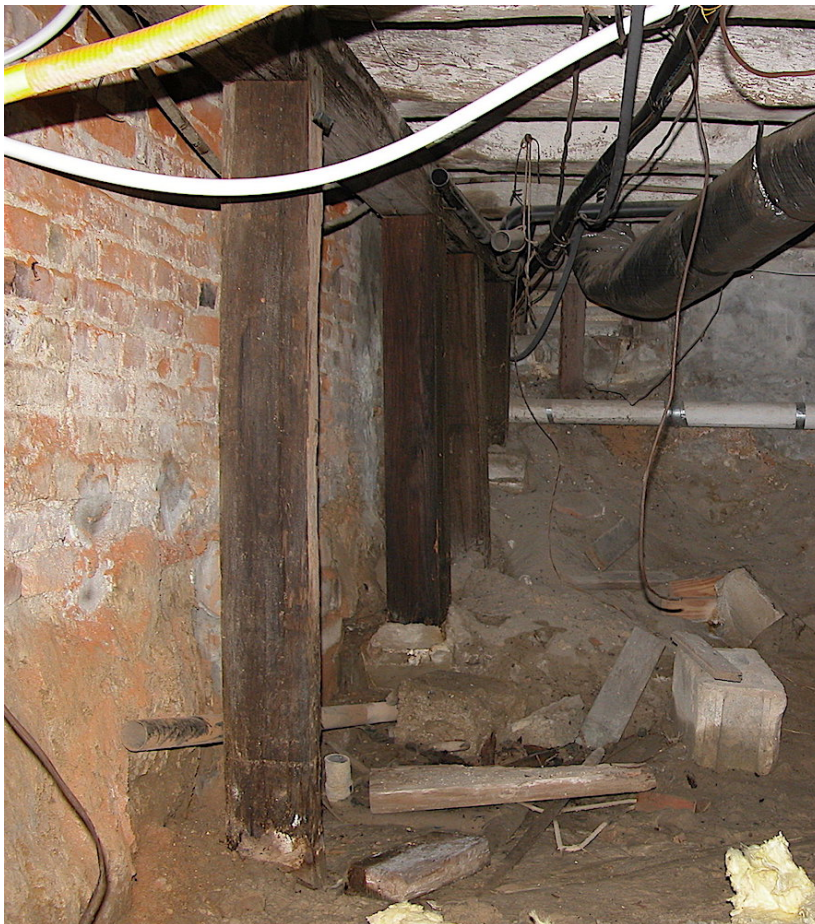
By early in the twentieth century, the condition of the framing under the house, due to damaged joist tails, had become serious enough that corrective action had to be taken. Creosoted support beams and posts were installed along both the front and back basement walls and down most of the centerline of the house (Figs. 2 & 3, Support beams and posts along front wall) (Fig. 4, Support beams and posts along the back wall) (Fig. 5, Centerline support beam and post). The support system along the walls was intended to transfer the framing load from the masonry joist-bearing pockets, to the system, farther in on the joists, bypassing the damaged joist tails.

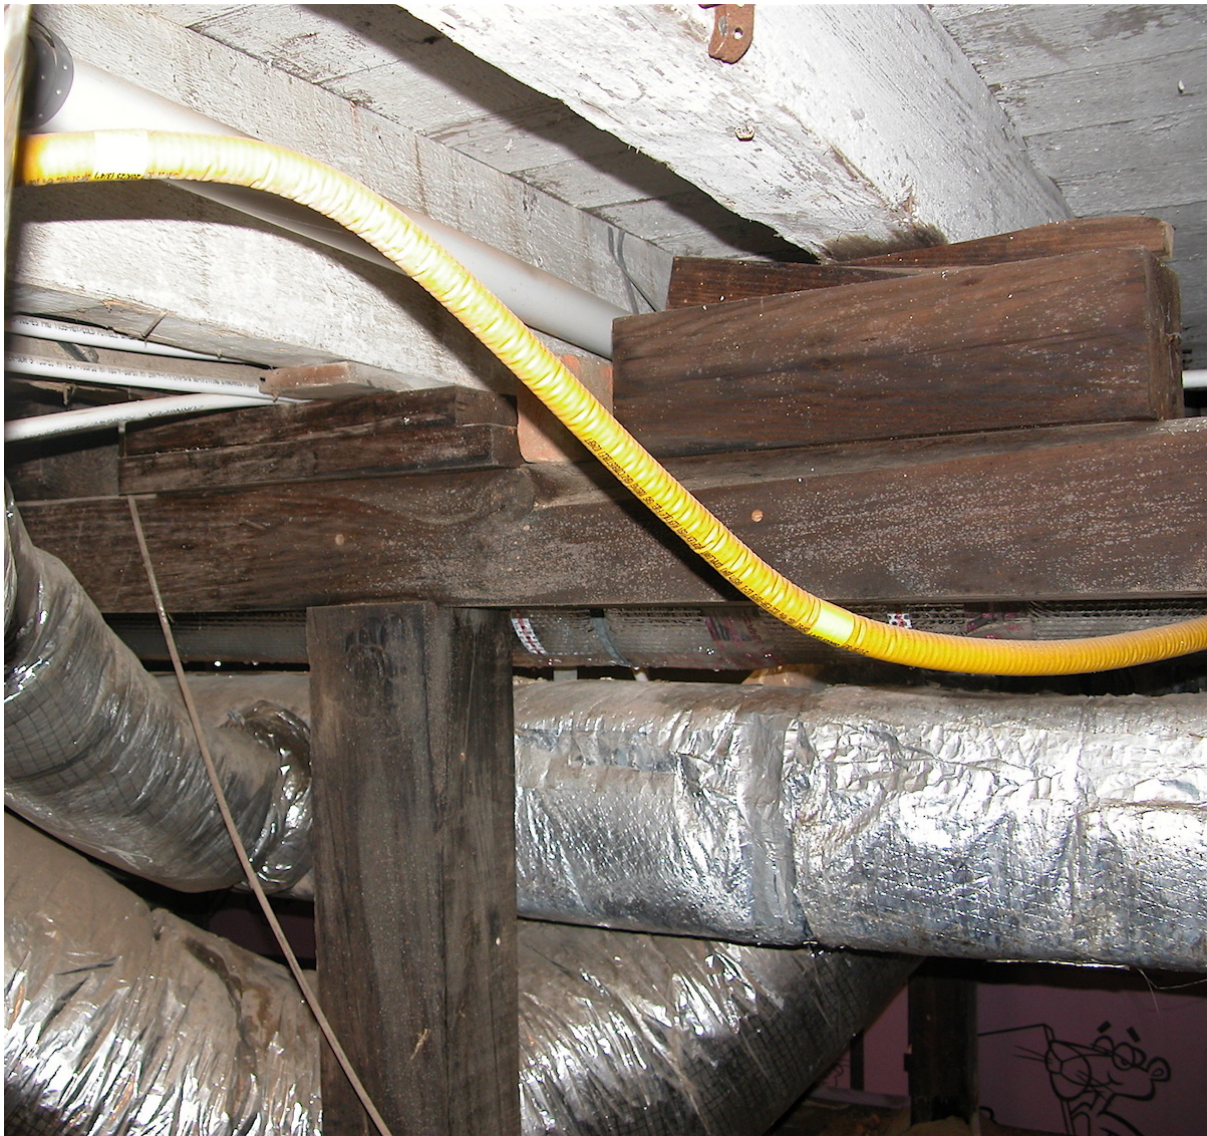
Figure 5

In Fig. 5, note the block and wedges on the centerline support for tightening the support against the floor joist. Here is the only place in the early twentieth-century support system that a means was incorporated to adjust/correct for continuing movement of the framing.

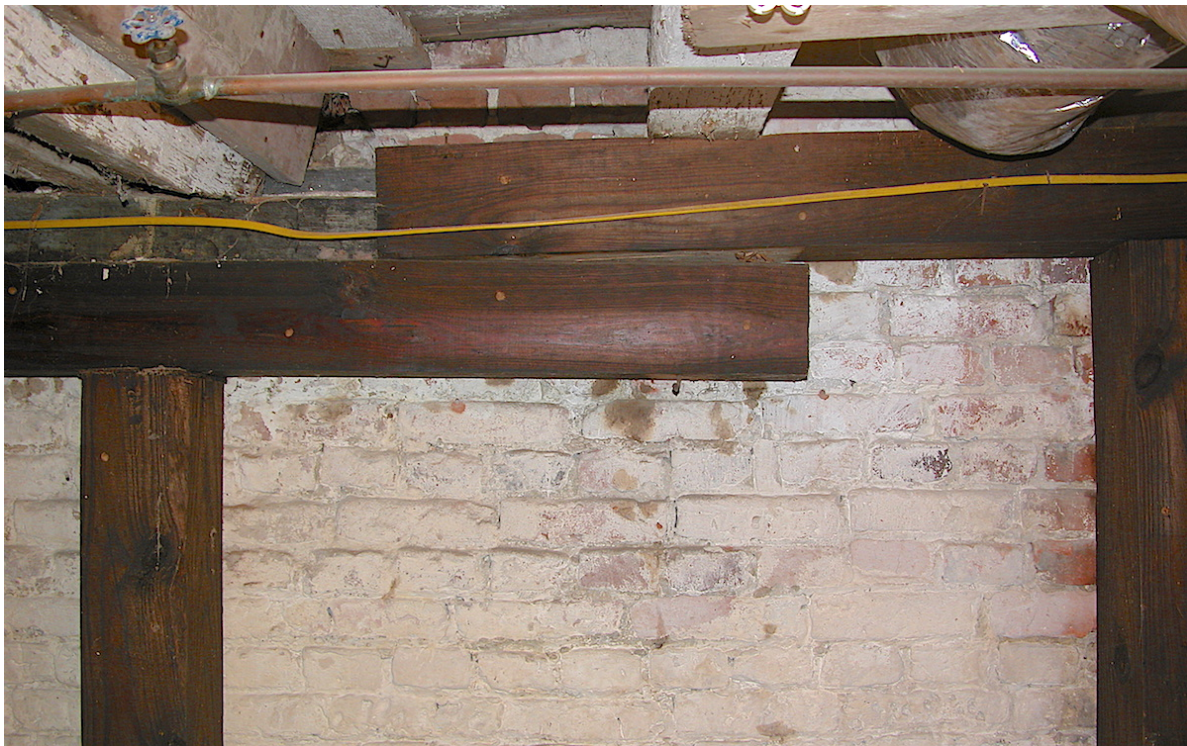
Figure 6

The main deficiency was that there were no provisions in the wall sections for tightening them against the joists to adjust for future movement/settlement. Another major issue with the wall system on the front of the house was where the two beam sections overlapped. Instead of placing a post at this intersection to support the beams, the beams were cantilevered, one over the other. As the supported house framing at this intersection settled further, the support beams warped downward (Fig. 6, Warped support beams).

Lifting of the warped cantilevered beams of the early twentieth-century support system and the original floor joist above them was accomplished with a hydraulic jack and then secured with a column jack (See Figs. 6 & 14). In Fig. 14, note the small slate shim, high right, between the support beam and the original joist.

A problem was encountered in this last lifting effort. A single heavy lift of the cantilevered beams together with the original joist did not straighten the warped beams sufficiently to raise the hall floor high enough to level it. To solve this problem, this lift was done in two stages. First, the original joist was lifted and a slate shim was inserted. Second, the cantilevered beams were then lifted together with the shimmed original joist. This did the trick in the final floor leveling (See Fig. 14).

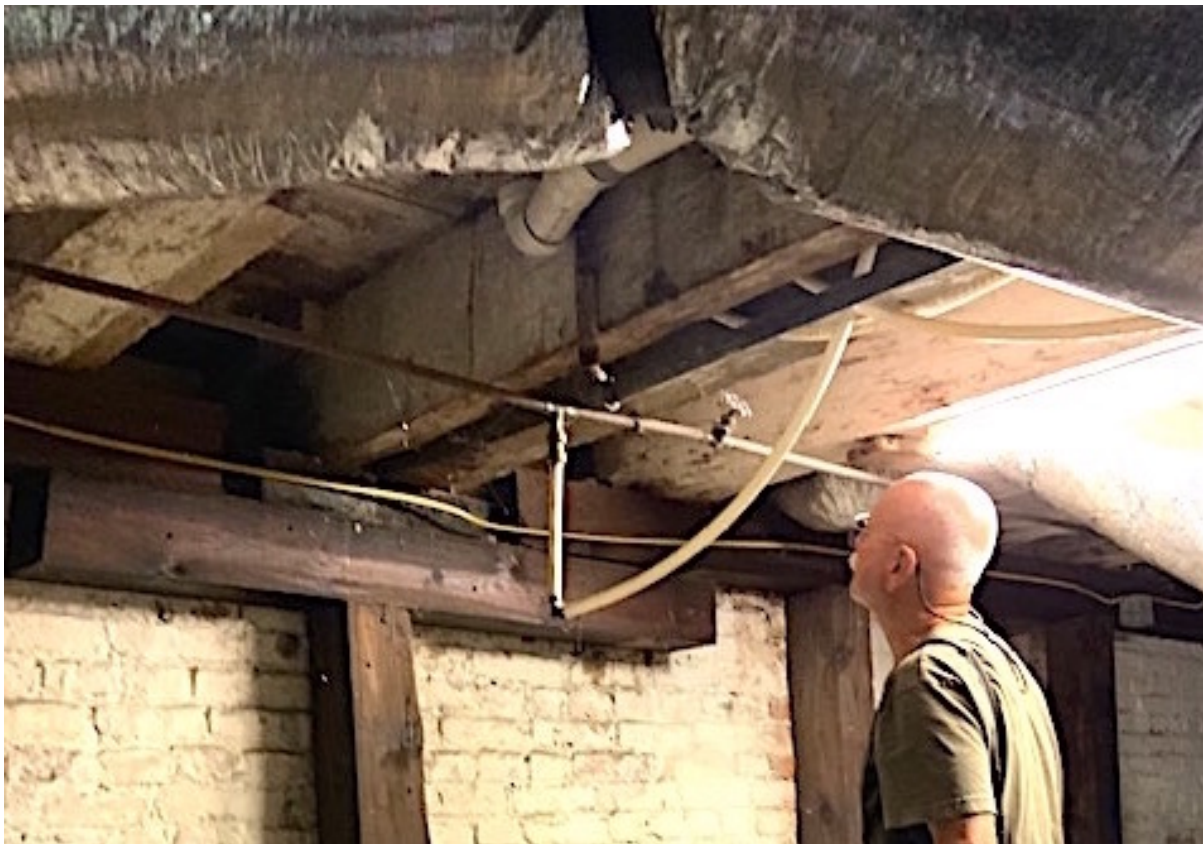
Both the mid-nineteenth-century and early twentieth-century remedies failed to recognize and address a serious problem in the change-order framing joist (See Part 1 of this series, change-order discussion). Figure 7 shows the double joist added in the change order. (Fig. 7, Change-order joist).

Apparently, the two timbers in this double joist were not fully seasoned prior to installation. The last couple feet of the timber on the right warped, rotating several inches to the right. This resulted in the flooring

Once this piece of wood was removed, a hole was drilled through the double joist and a galvanized, three-quarter inch steel bolt with large washers was inserted and tensioned to reduce further warping of the right element of the double joist.

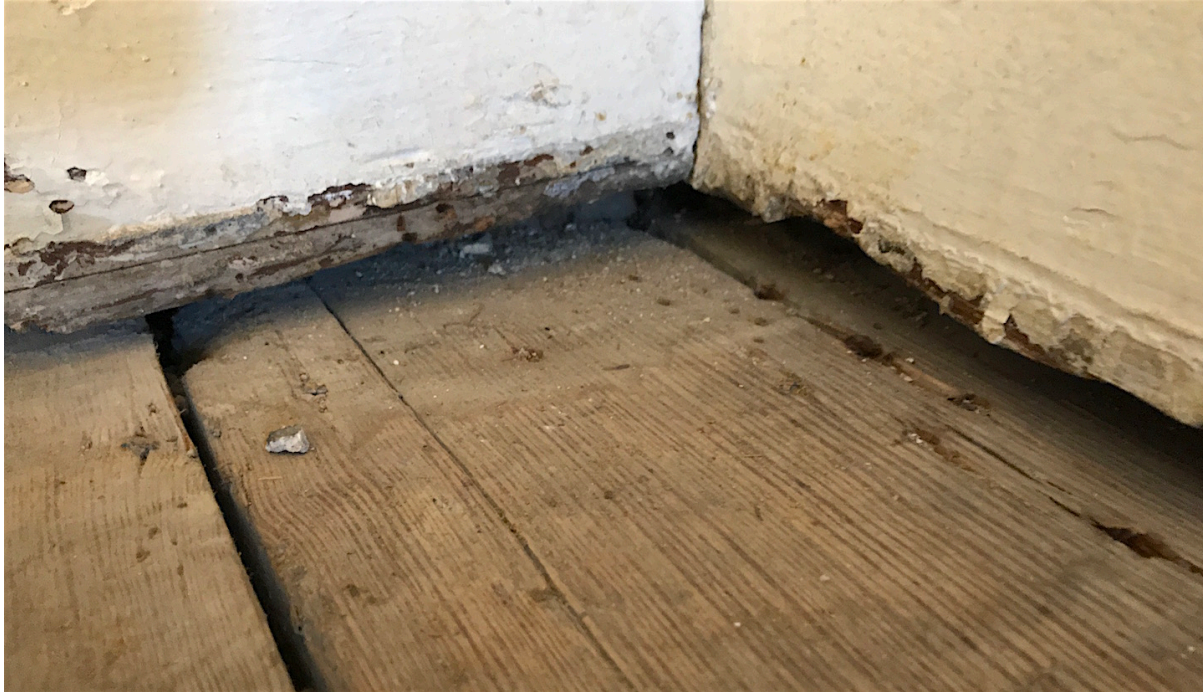
Figure 8

above it in the hall to settle approximately one and three-quarters inches over the years (Fig. 8, Floor settlement in hall).

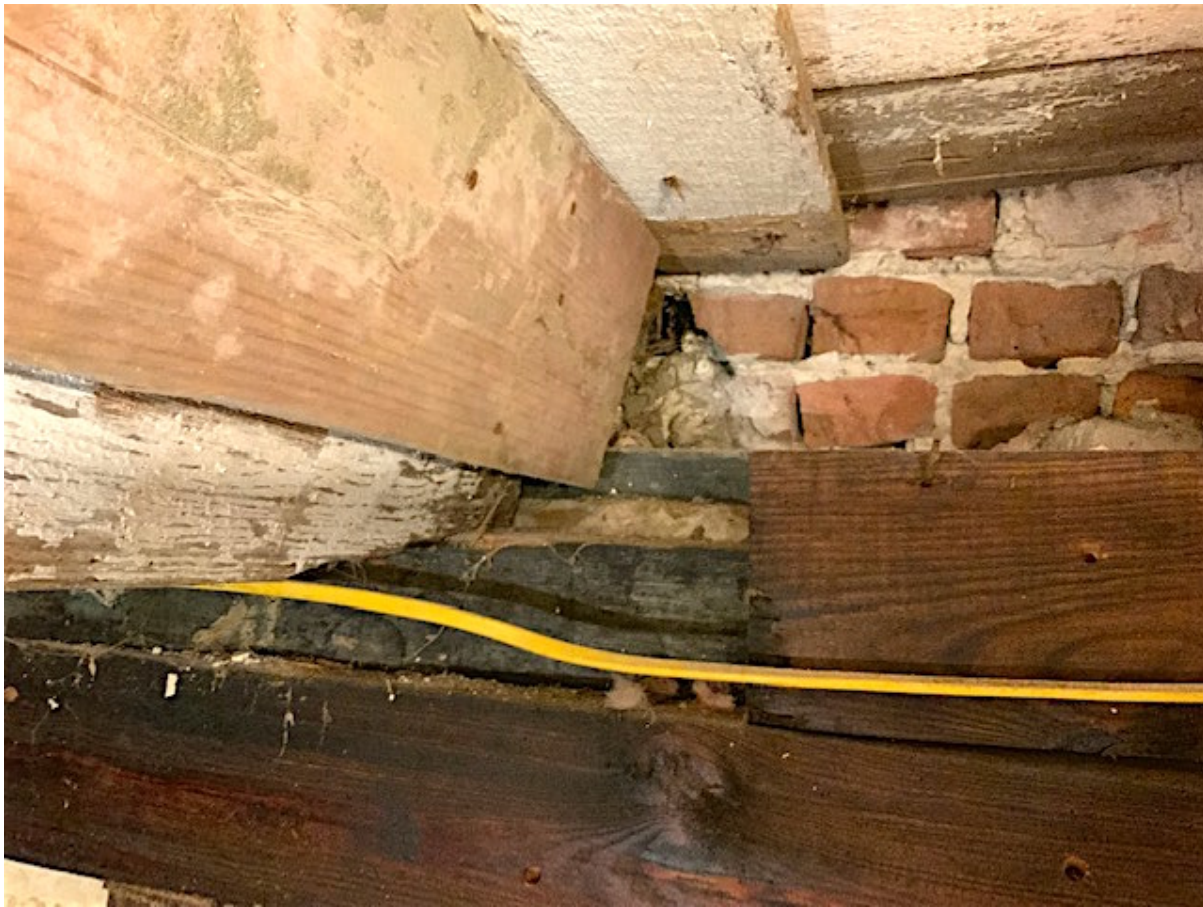
Figure 9

This problem was recognized sometime in the twentieth century, and there was an unsuccessful attempt to fix it. This "solution" was to nail a piece of wood roughly two inches by eight inches by three-feet long to the side of the warped joist. This scabbed-on piece of wood had to be removed prior to the floor lift (Fig. 9, Scabbed-on piece of wood).

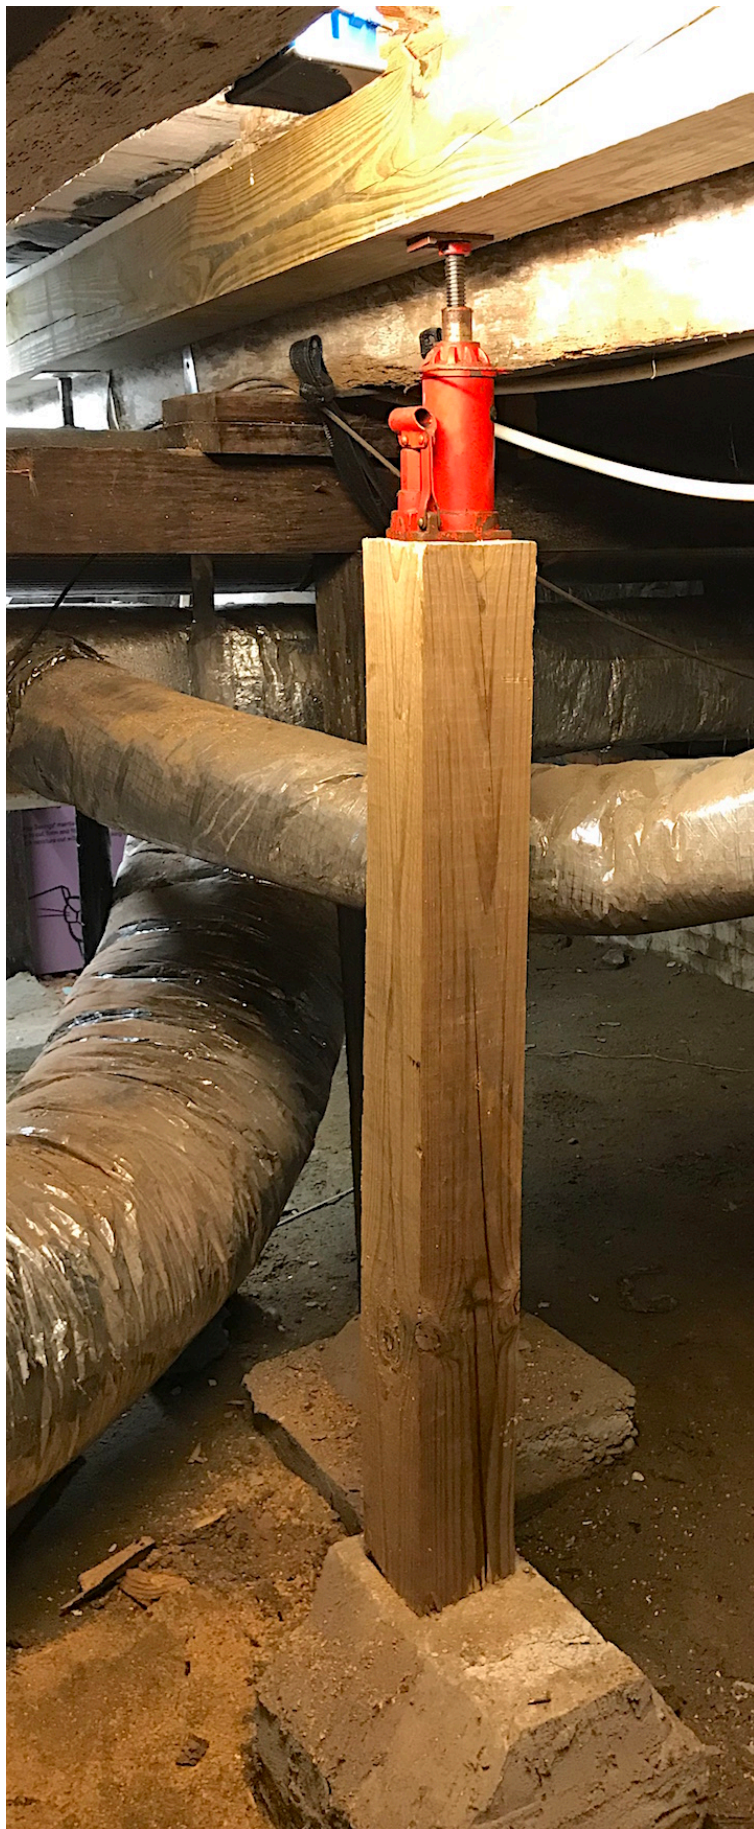
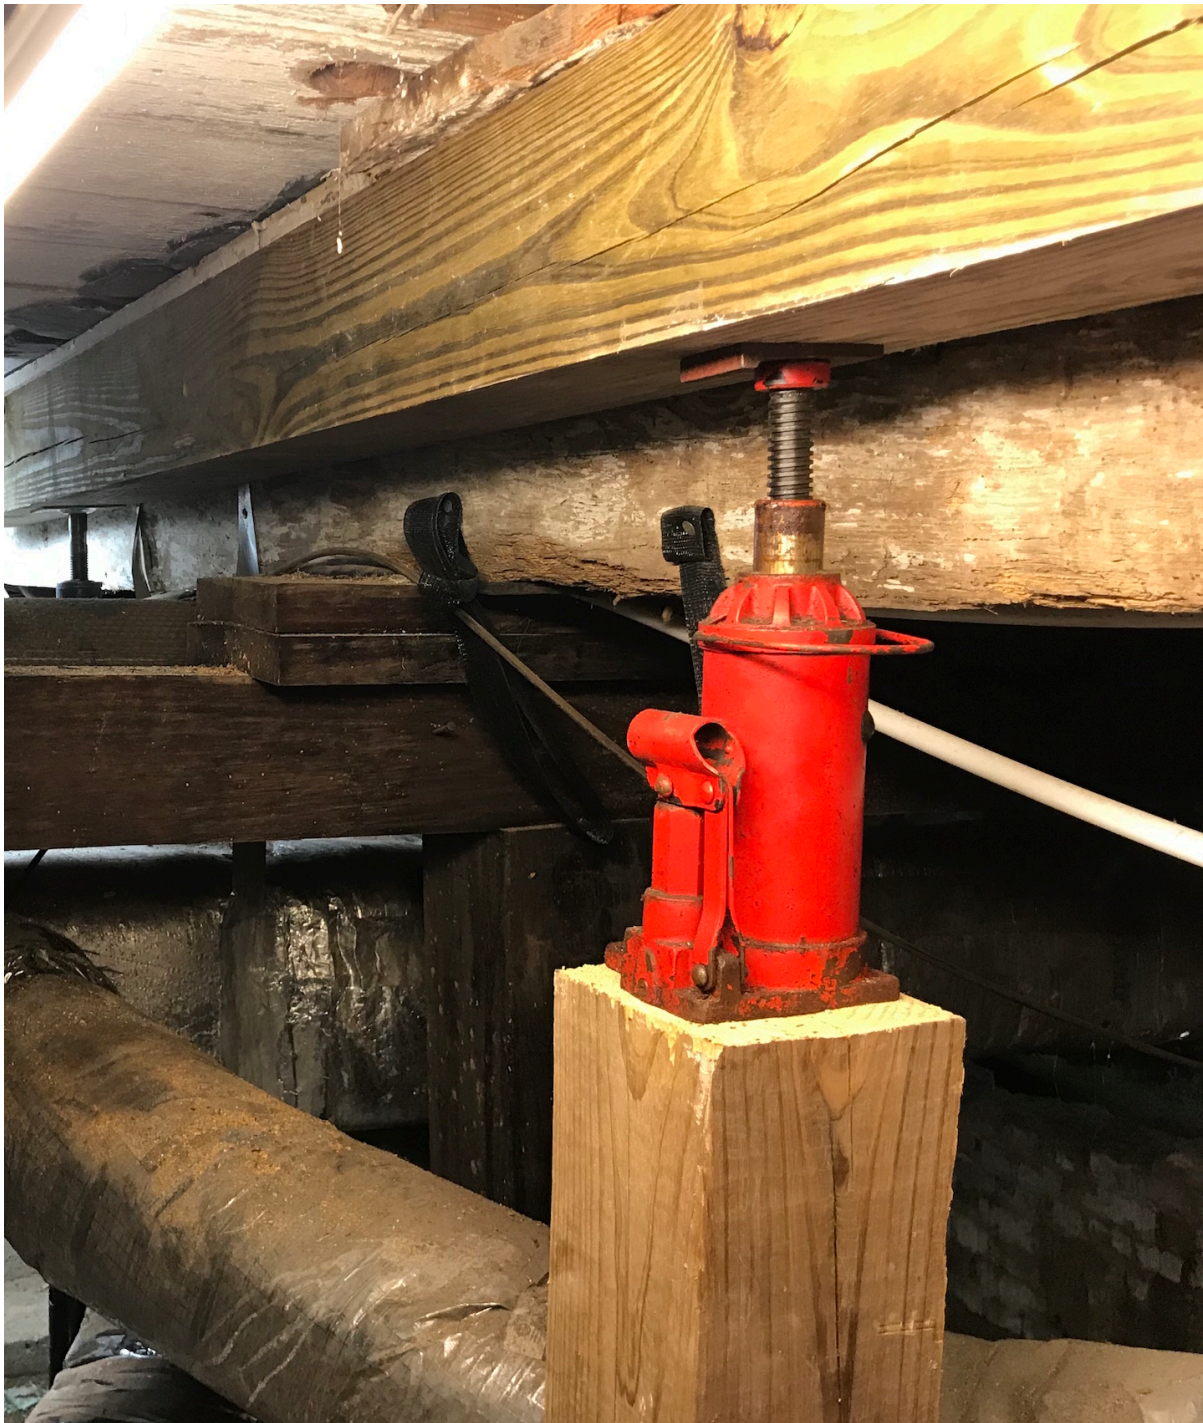
Note the small slate shims between the timber and the above floor. Slate is used as it will not compress.

A 13-foot long, salt-treated timber, six-inches square, was, with considerable difficulty, threaded in along the side of the double joist. It was then lifted with the hydraulic jacks until the settled floor along the double joist was level in the hall (Figs. 10 & 11, Heavy lifts).
