Fox Hall - Part 4, Chimneys and Fireplaces

Jim Melchor and Tom Newbern

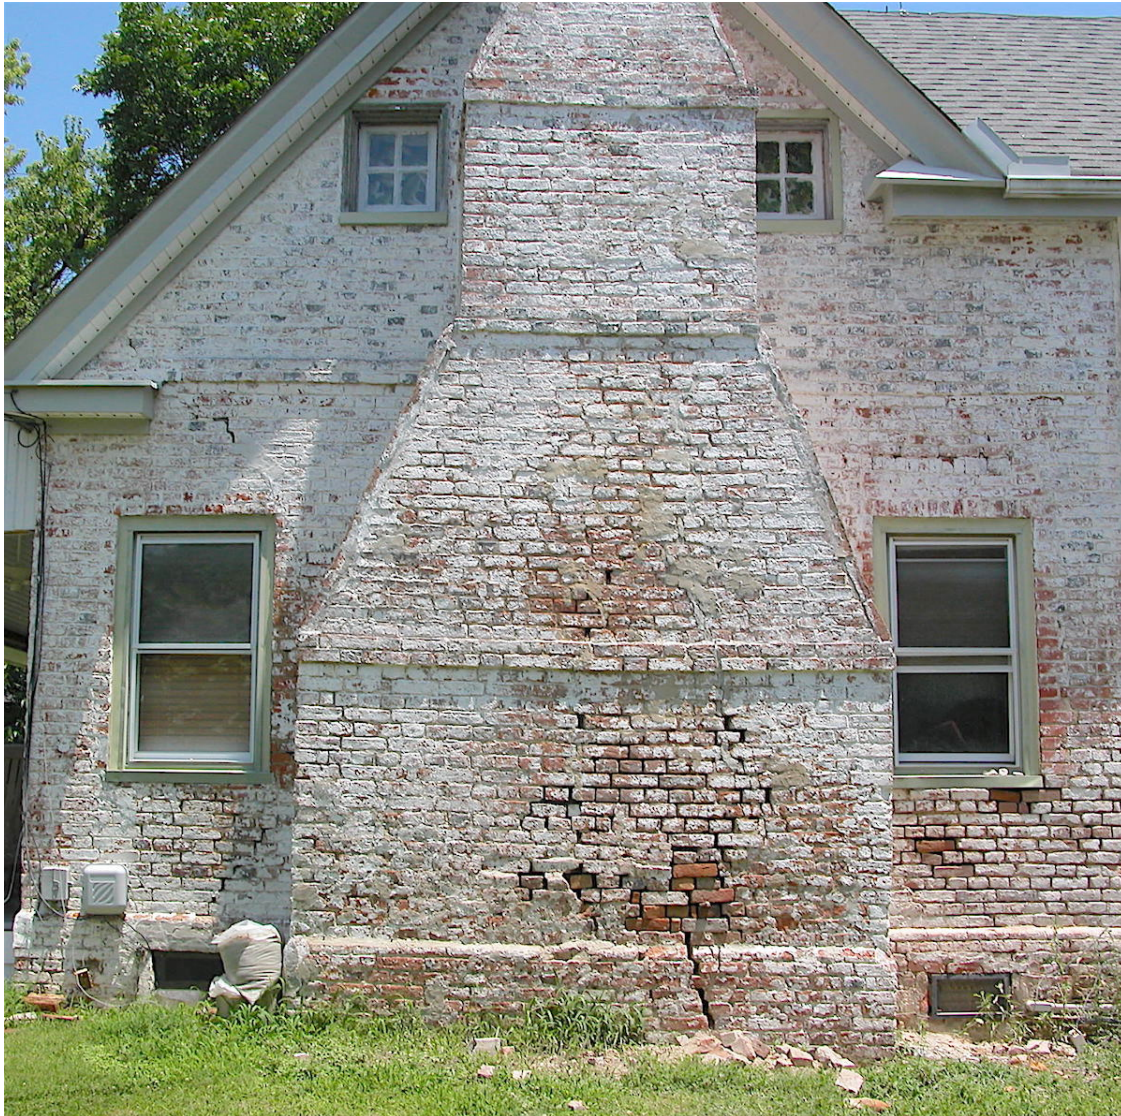
Figure 3

West Chimney We shall begin with the exterior restoration of the west chimney. As can be seen in Fig. 3, this chimney has suffered some minor settlement resulting in a few cracks. In the past, some of these cracks have been "repaired" with Portland cement. This improper mortar

Before discussing further damage to the west chimney, observe in Fig. 3 that the two first-floor windows flanking the chimney are incorrect adaptations. The right window was altered in size in the nineteenth century. The left window is a twentieth-century piercing where

Also, the two foundation vents seen in Fig. 3 are not original and will be closed by the project masons later in the restoration project. The original foundation vents at Fox Hall have already been discussed on this website in *Part 2* of this series by Tony Russell.

The most serious damage to the west chimney was burn-through of the fireplace back in the kitchen. This can be seen in Fig. 3, but it became most apparent when the kitchen fireplace was reopened, and the debris from collapsed sections of the fireplace and infill demolition was removed. Daylight could be seen through the back of the fireplace. Repairing this damage required considerable rebuilding of the chimney outside as well as rebuilding a portion of the fireplace inside (Fig. 4, Repair of west chimney).

has been removed, and the affected joints have been tuck pointed with hydraulic lime mortar (Fig. 3, West chimney before restoration).

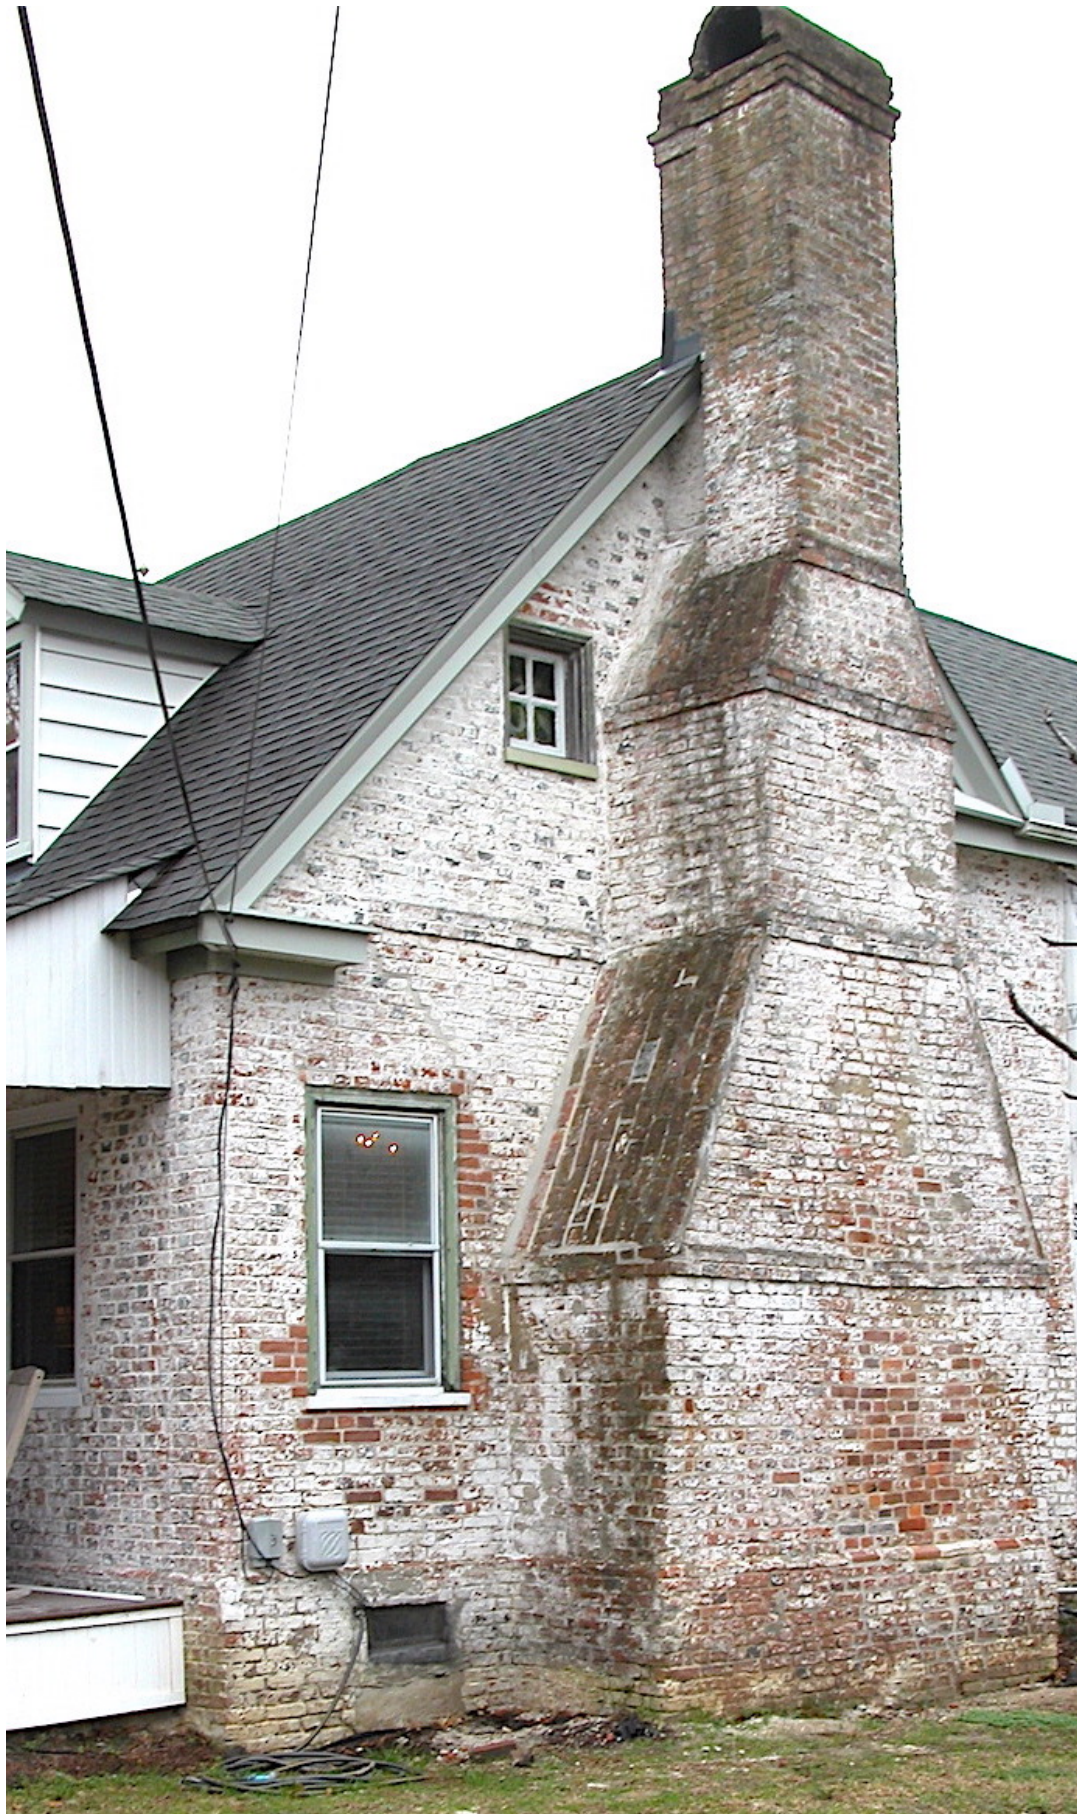
Figure 5

The incorrect arched chimney cap on the west chimney will be removed later in the project (See Fig. 5).

Completed repair of the west chimney and tuck pointing of open mortar joints in the west endwall can be seen in Fig. 5 (Fig. 5, Completed west chimney and endwall masonry repairs).

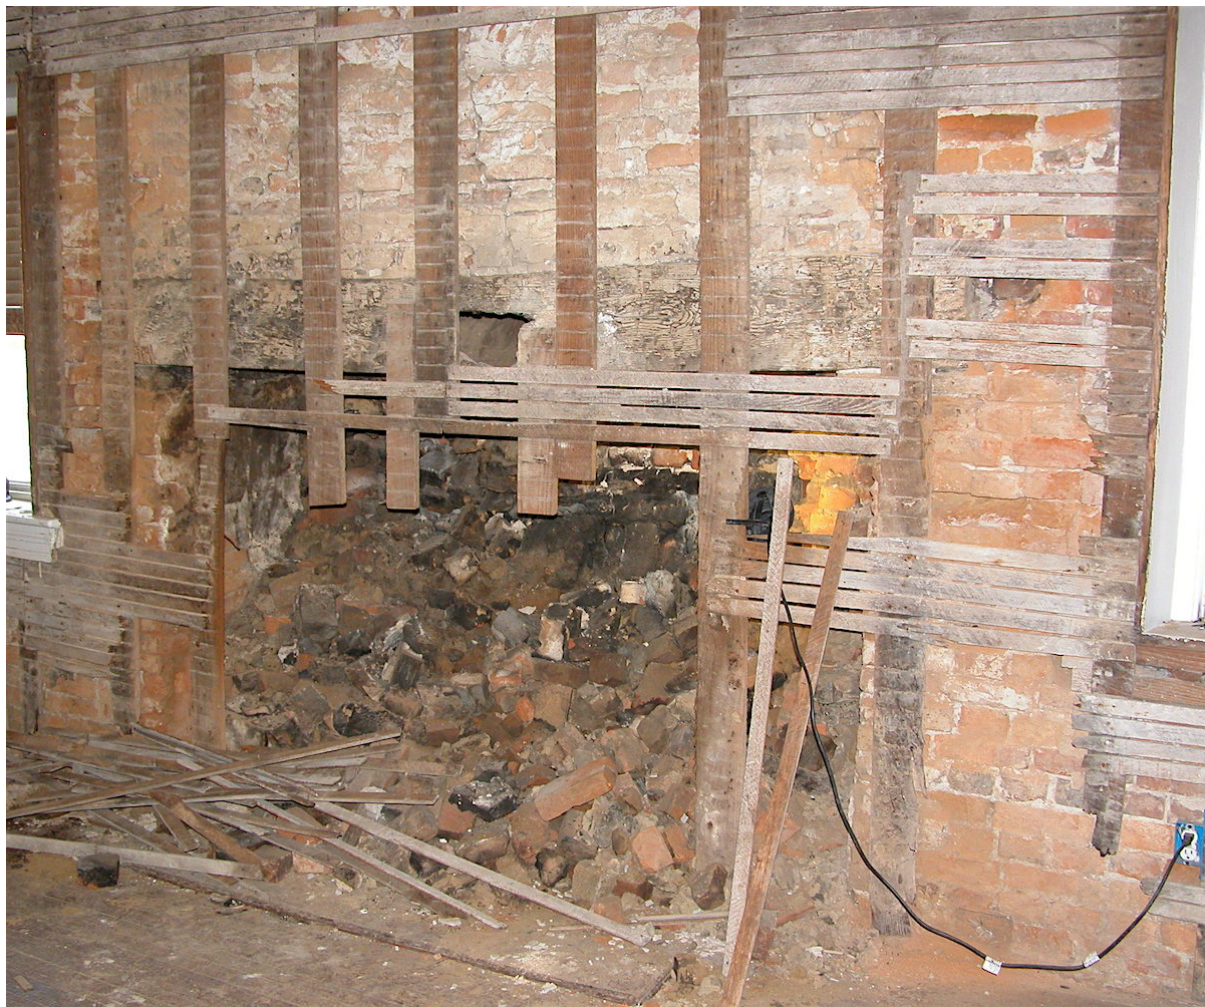
Figure 7

In Fig. 7, note the furring strips and sawn plaster lath from the late nineteenth century.

manteltree resulted in a serious structural problem. Had not the heavy furring strips been nailed to this damaged timber and the fireplace infilled with masonry, the brick mass above the fireplace opening could have collapsed (See Fig.7). Fortunately, it did not.

To restore the original kitchen, this modern living room had to be cleared. The room was stripped to its bare walls, including the wall covering and plaster, and the fireplace infill was dismantled (Fig. 7, Stripped kitchen fireplace with infill rubble).

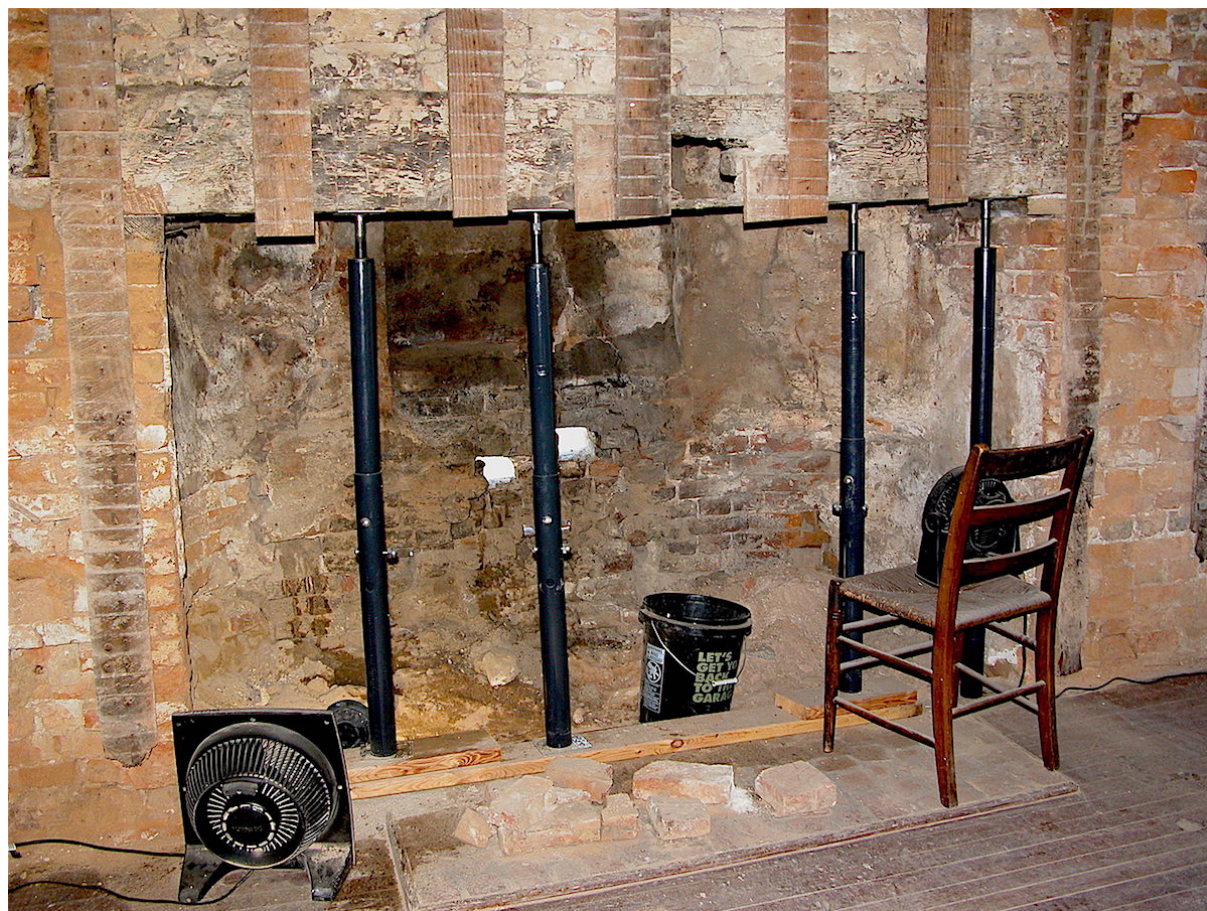
Figure 8

The fireplace has rounded corners in the back, and its sand hearth originally was covered with pavers roughly five and one-half inches square, one of which can be seen, lower-center right, in Fig. 8. The back of the fireplace had suffered fire damage as noted in the west chimney discussion. The masons rebuilt this damaged area in conjunction with the repairs made to the exterior of the west chimney.

Once the rubble from the infills was removed and the damaged manteltree was stabilized, the shape and condition of the fireplace and its hearth could be ascertained (Fig. 8, Cleared fireplace).

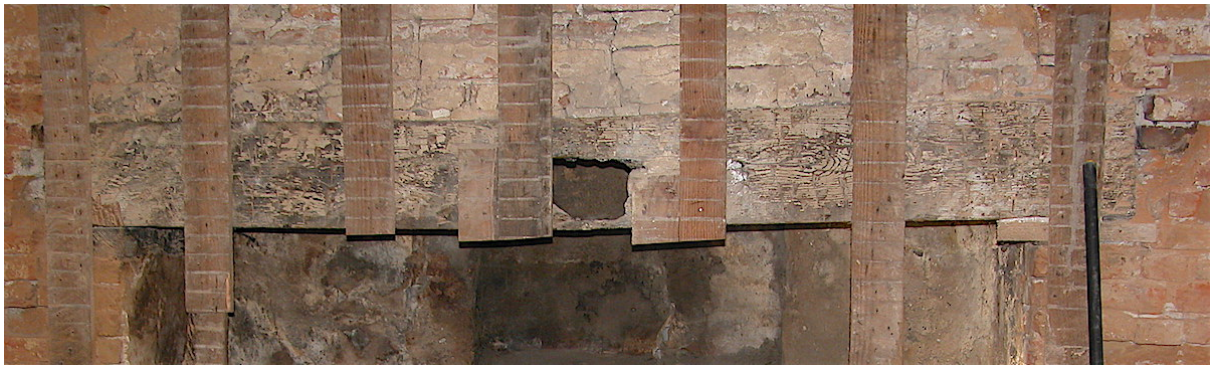
Figure 10

A hole can be seen in the center of the manteltree (Fig. 10, Hole in manteltree). On the right side of this hole there is a brick header and on both sides a wood plank, an attempt by someone to repair/fill the hole. Obviously, based on the plaster lines, this attempted repair predates the plaster and lath (Fig. 11, Attempted repair to hole in manteltree).

Sometime in the past, prior to infilling the fireplace after it was no longer used for cooking, someone saw this large fireplace and thought it should accommodate a large fire. In fact, it was not designed for large fires. It was built to allow for access on three sides of a normal cooking fire. By building a large fire or multiple fires, the manteltree burned through. The purpose of a manteltree is to support the heavy brick load above a fireplace opening. This damage to the Fox Hall kitchen

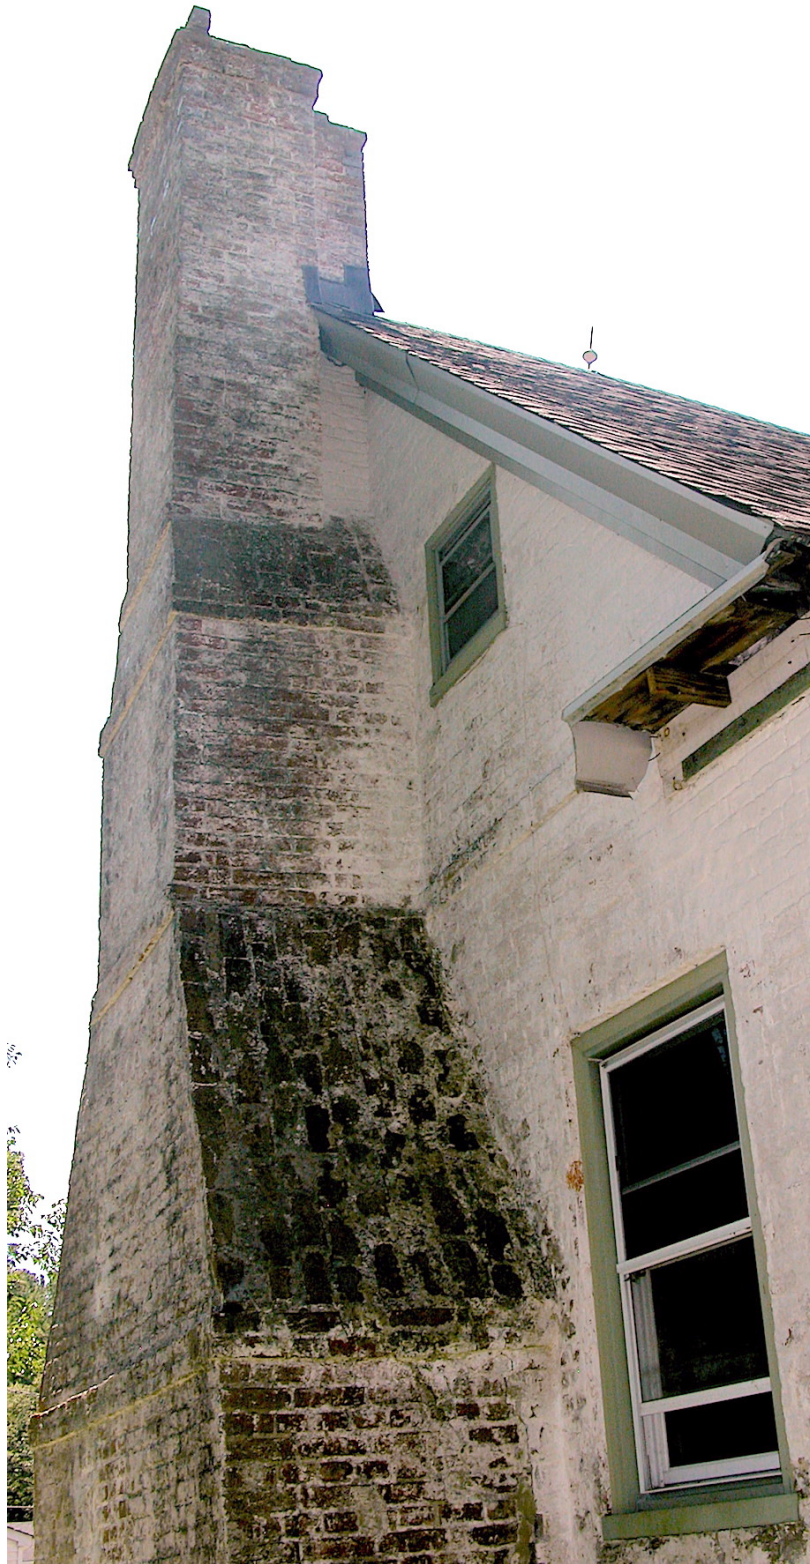
Figure 14

problem areas (Fig. 14, Weathered bricks on shoulder and tree damage to chimney cap).

As seen in Fig. 14 and mentioned in its caption, the chimney cap of the east chimney suffered tree damage. The cap has been restored to its original configuration (Fig. 25, Restored east chimney cap). The cap of the west chimney will also be similarly restored in this project (See Fig. 5).

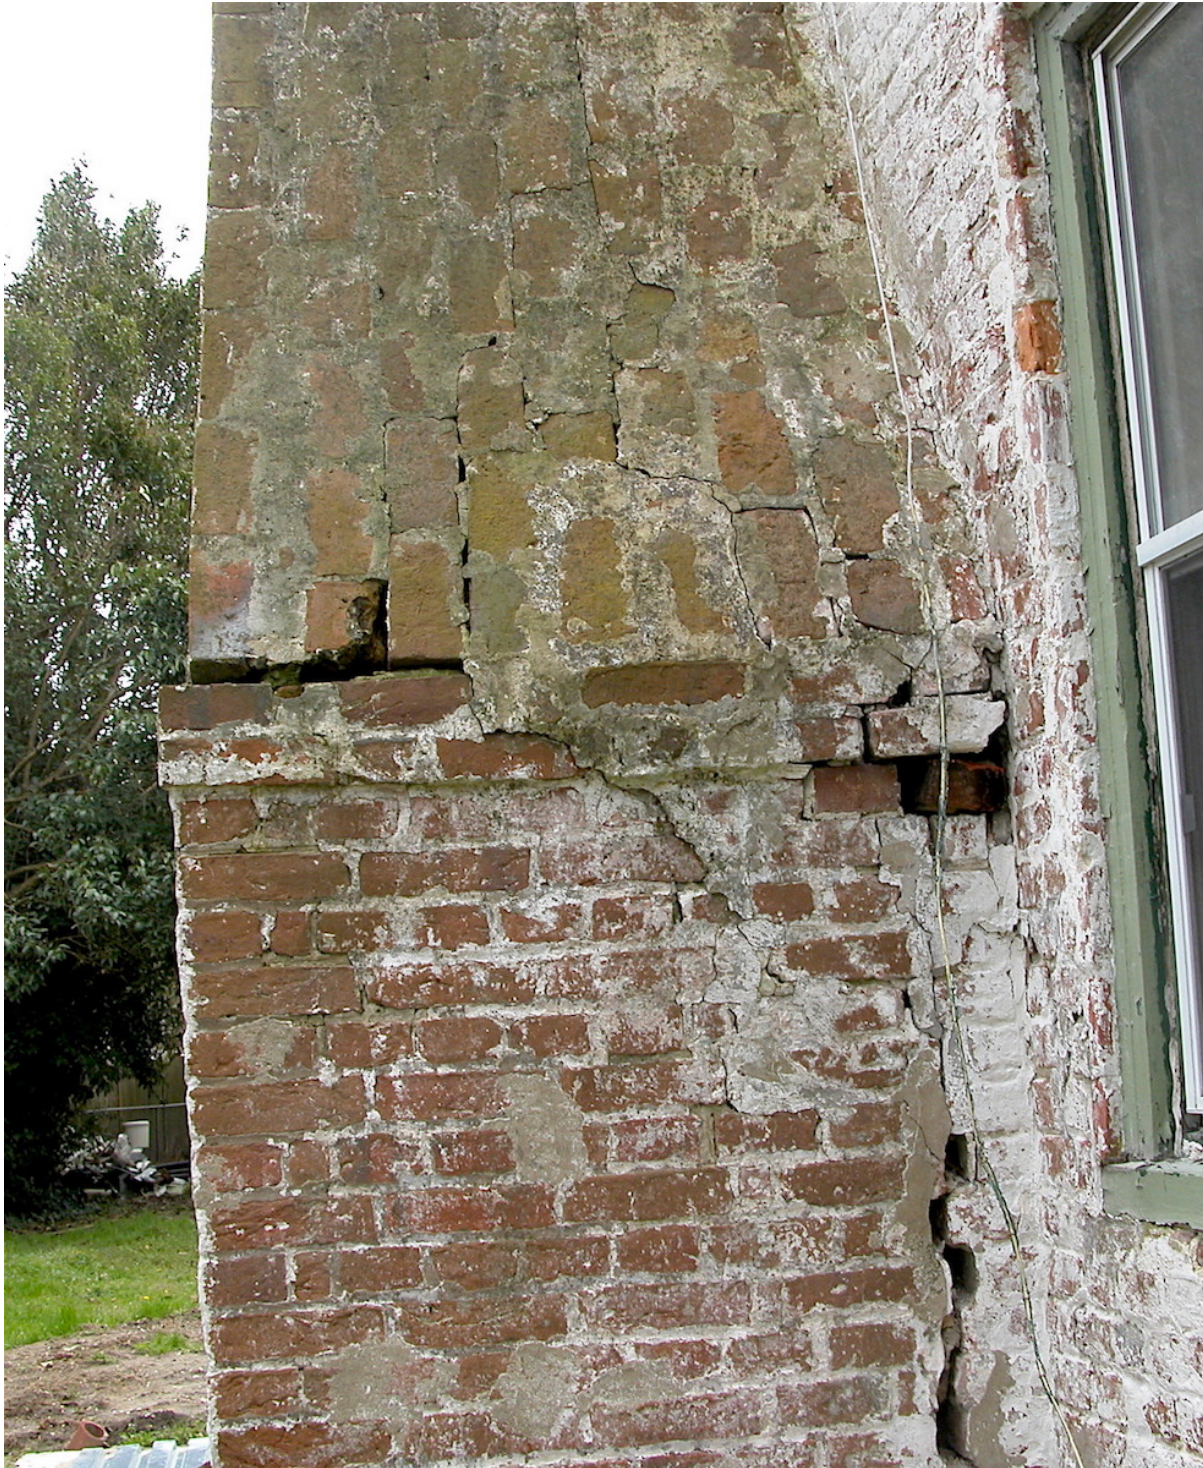
Figure 15

The photo in Fig. 15 shows the extent of the deterioration of the shoulder brickwork and the separation of the chimney from the house (Fig. 15, Damage on north side of east chimney).

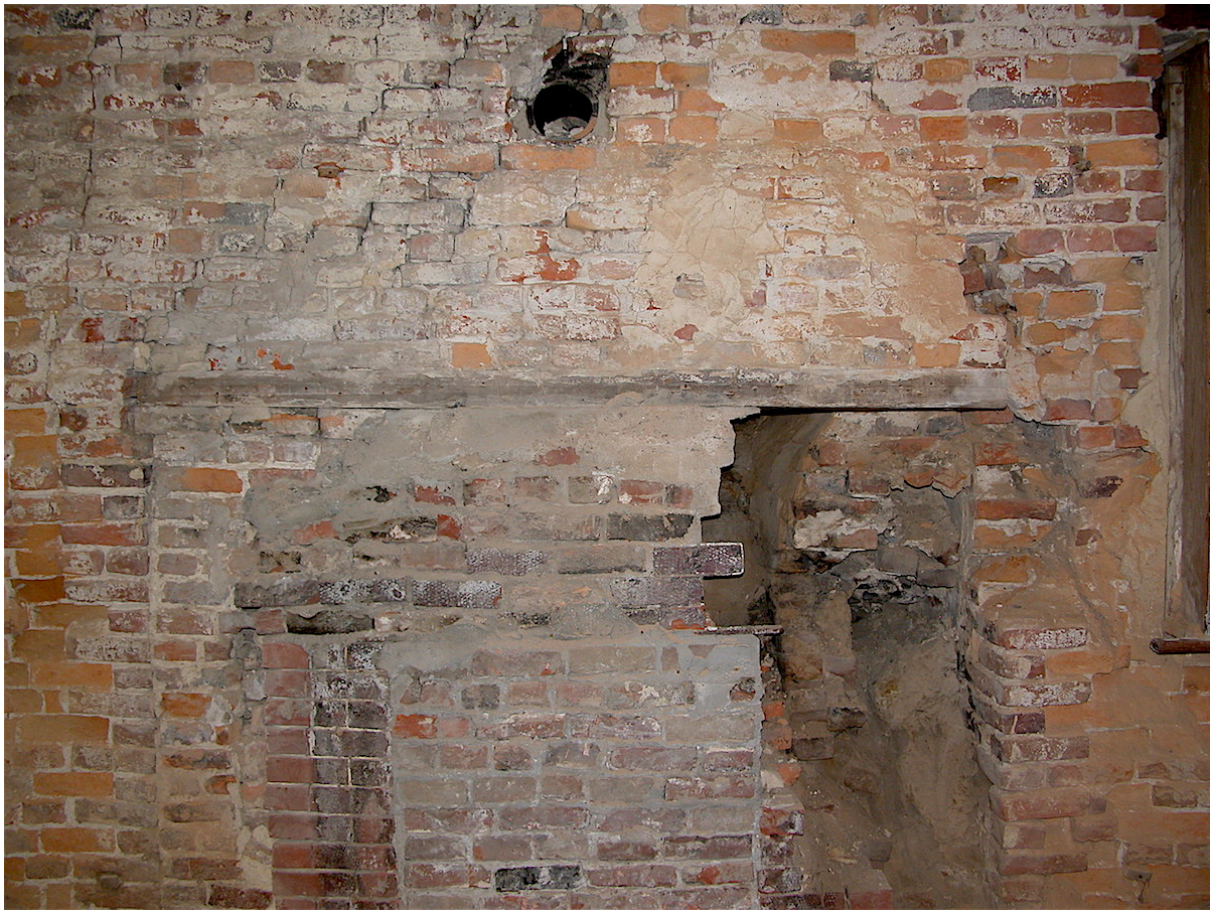
Figure 26

plaster on the endwall and in front of the fireplace had to be removed, exposing the brickwork and fireplace infill (Fig. 26, Hall fireplace wall stripped of plaster). The wall above and to the right of the fireplace was irregular and bulging due to chimney settlement.

As can be seen in Fig. 26, the apparent sequence of events closing the hall fireplace was:

- 1) The original manteltree was removed resulting in collapse of the brickwork immediately above it. Alternatively, the brickwork above the

manteltree collapsed as a result of chimney settlement as did parts of the fireplace walls, and the manteltree was removed.

- 3) The fireplace was infilled approximately one foot above and on each side.
- 4) Collapsed brickwork above the fireplace opening was grossly repaired.
- 5) Another infill, using redder bricks, further reduced the size of the fireplace opening about a foot across the top and along each side.
- 6) A final infill closed the fireplace completely. It was at this time the chimney above the closed fireplace was pierced for a stovepipe.

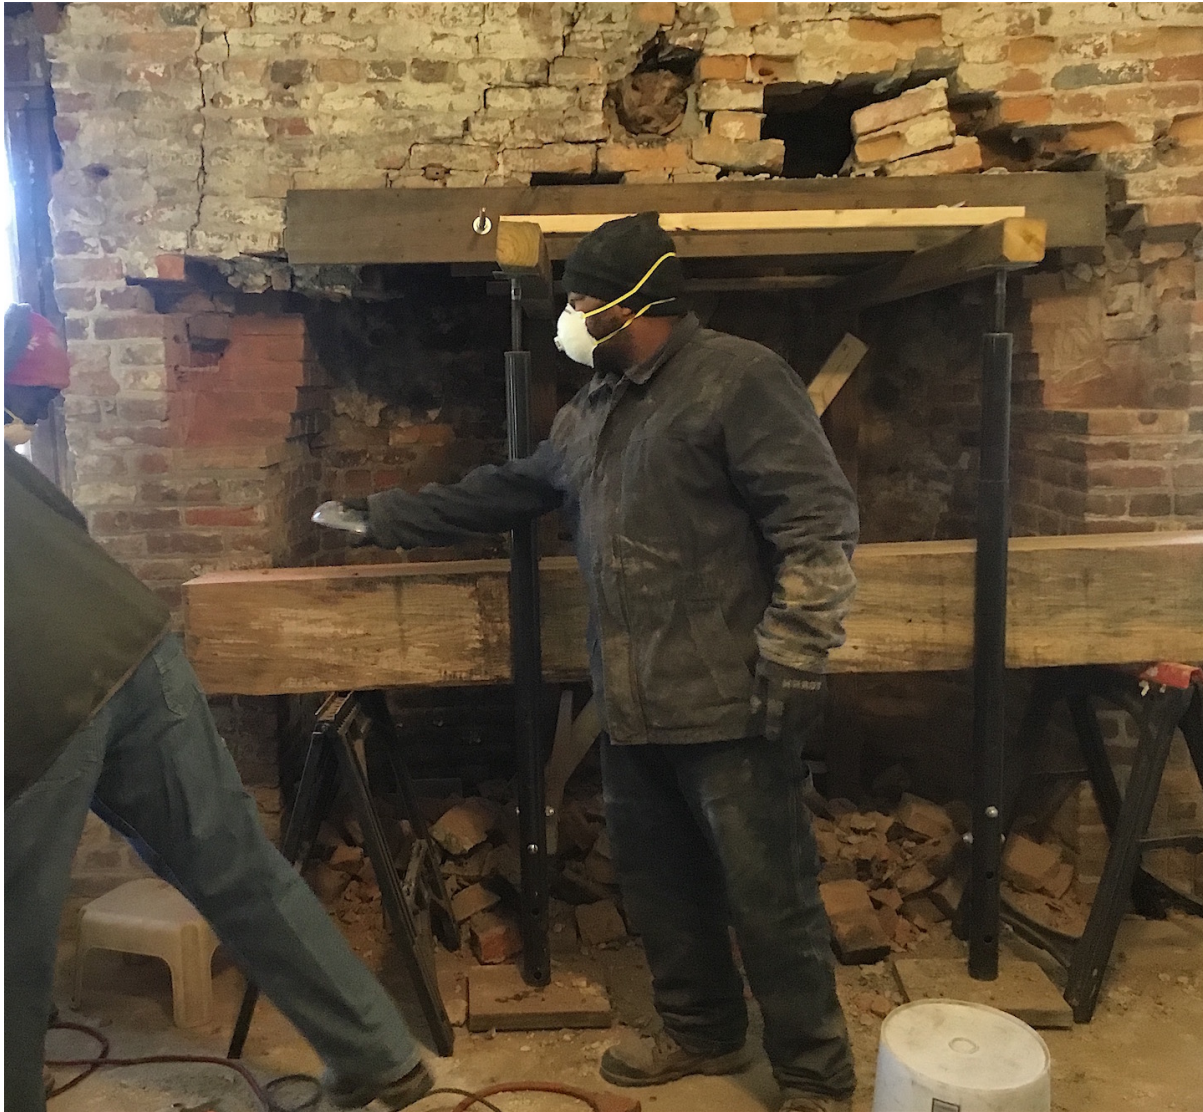
Figure 32

4) Figure 32, Masons preparing to set new manteltree in place in the hall fireplace. Note the failing brickwork.
