Fox Hall - *Part 5*, Cellar Entrance

By Dick Gresham and Tony Russell

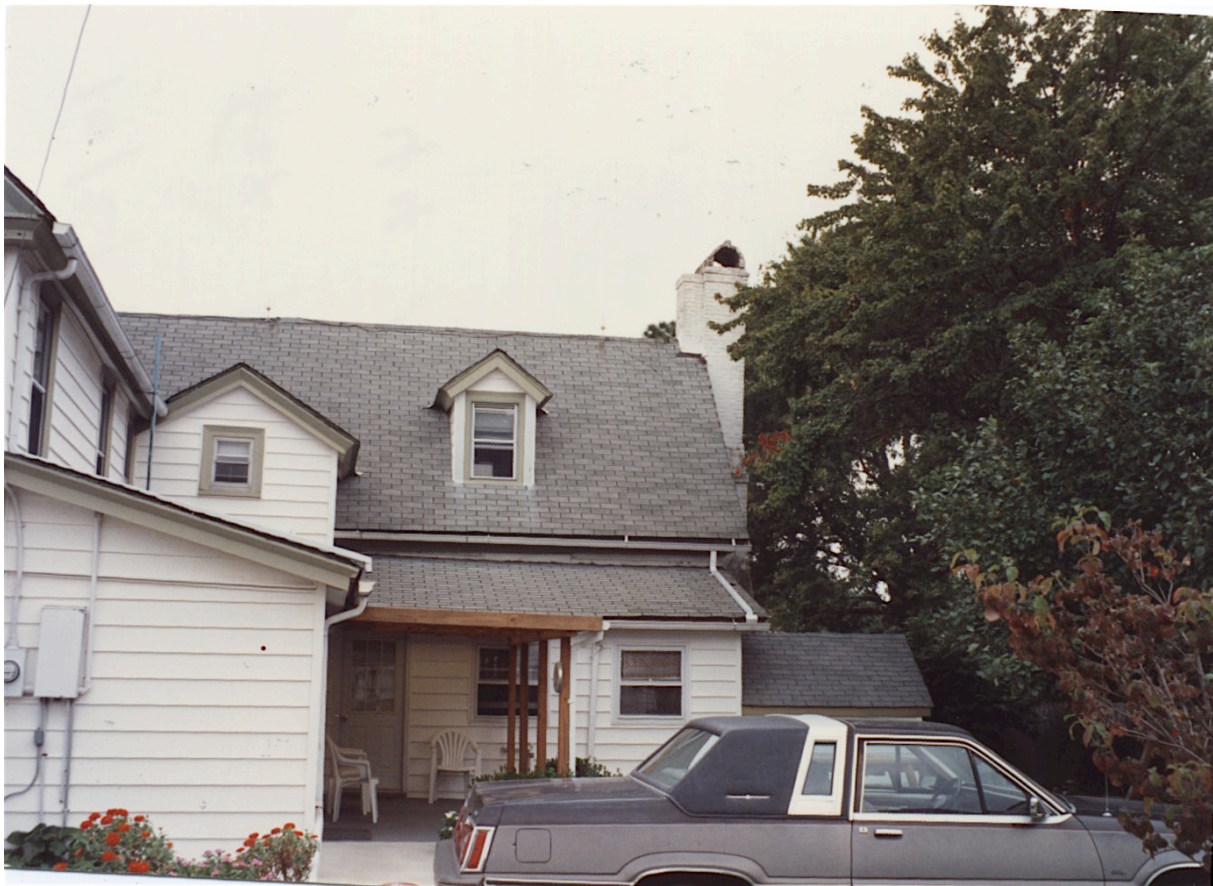
Figure 1

In *Fox Hall - Norfolk's Oldest House, Part 1*, the first article of this series, numerous changes to the house were discussed. Several of these changes were additions to the back or south side of the house. Of particular importance to this discussion was a frame addition and porch that extended eastward across the back of the house along the hall wall. This addition was built by the current owner's great aunt around the middle of the twentieth century. It contained a bathroom and a kitchen to convert the hall into an apartment. To provide access to this addition from the hall, a doorway was cut into the hall-passage wall in the southwest corner of the hall. This doorway has been closed in the current restoration (Fig. 1, Bathroom and Kitchen addition) (Fig. 2, Doorway cut into hall wall).

Originally Fox Hall's cellar was entered via an exterior south-facing stairwell enclosed in a gabled annex near the southeast corner of the house. Apparently, this was removed when the addition was added, and a new east-facing cellar entrance with a gable roof was incorporated into the addition (See Fig. 1 right side above car roof) (Fig. 3, 1960s photo showing new cellar entrance, left side of photo).

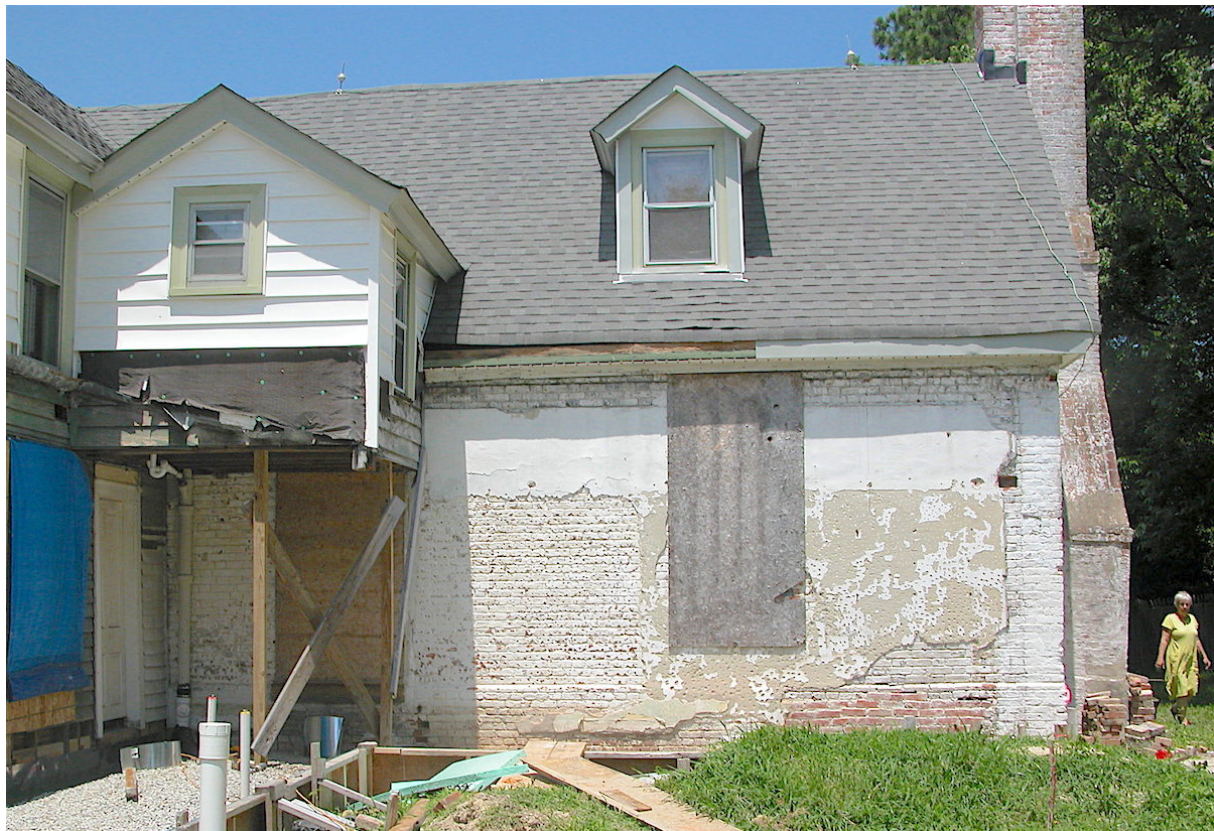
Figure 4

The current owner removed her great aunt's addition and the stucco finish covering the south exterior wall of the hall (Fig. 4, South wall of hall after demolition, owner is lower right).

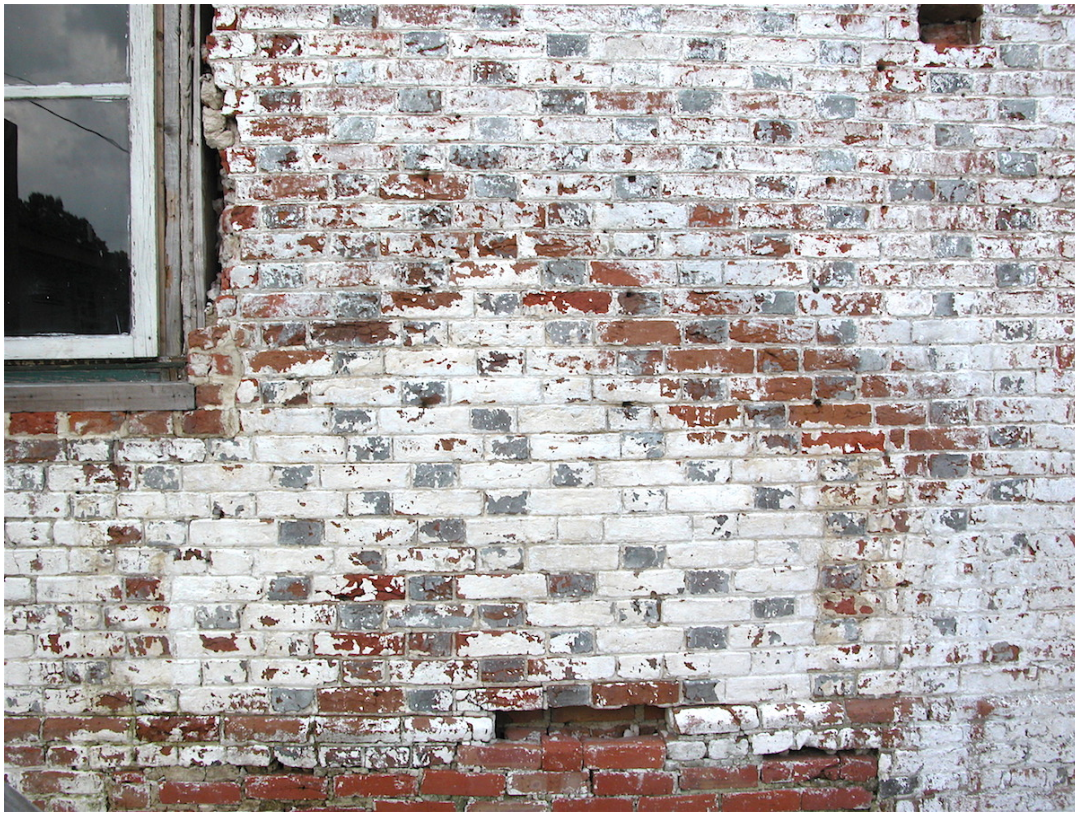
Figure 5

There is ample evidence of the original cellar entrance in the form of a "ghost" left in the exterior whitewash. The whitewash was applied early on, most likely because of structural issues that troubled the house from its beginnings (Fig. 5, Ghost of original cellar entrance) (Fig. 6, Ghost of original cellar entrance, outlined for clarity).

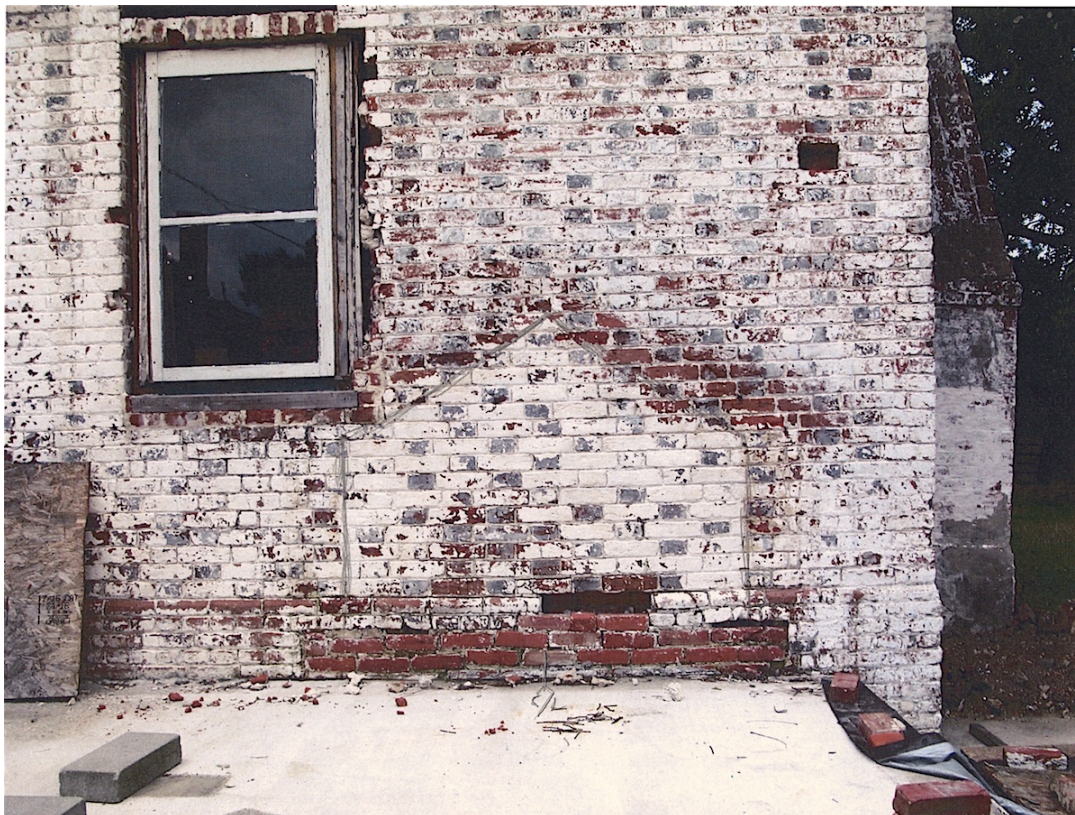
Figure 6

At the bottom of Fig. 6, note the patch in the brickwork. This patch covered the original timber header over the stairwell opening into the cellar. This header was exposed by the masons when the patch was removed and replaced with proper brickwork (Fig. 7, Cellar stairwell header).

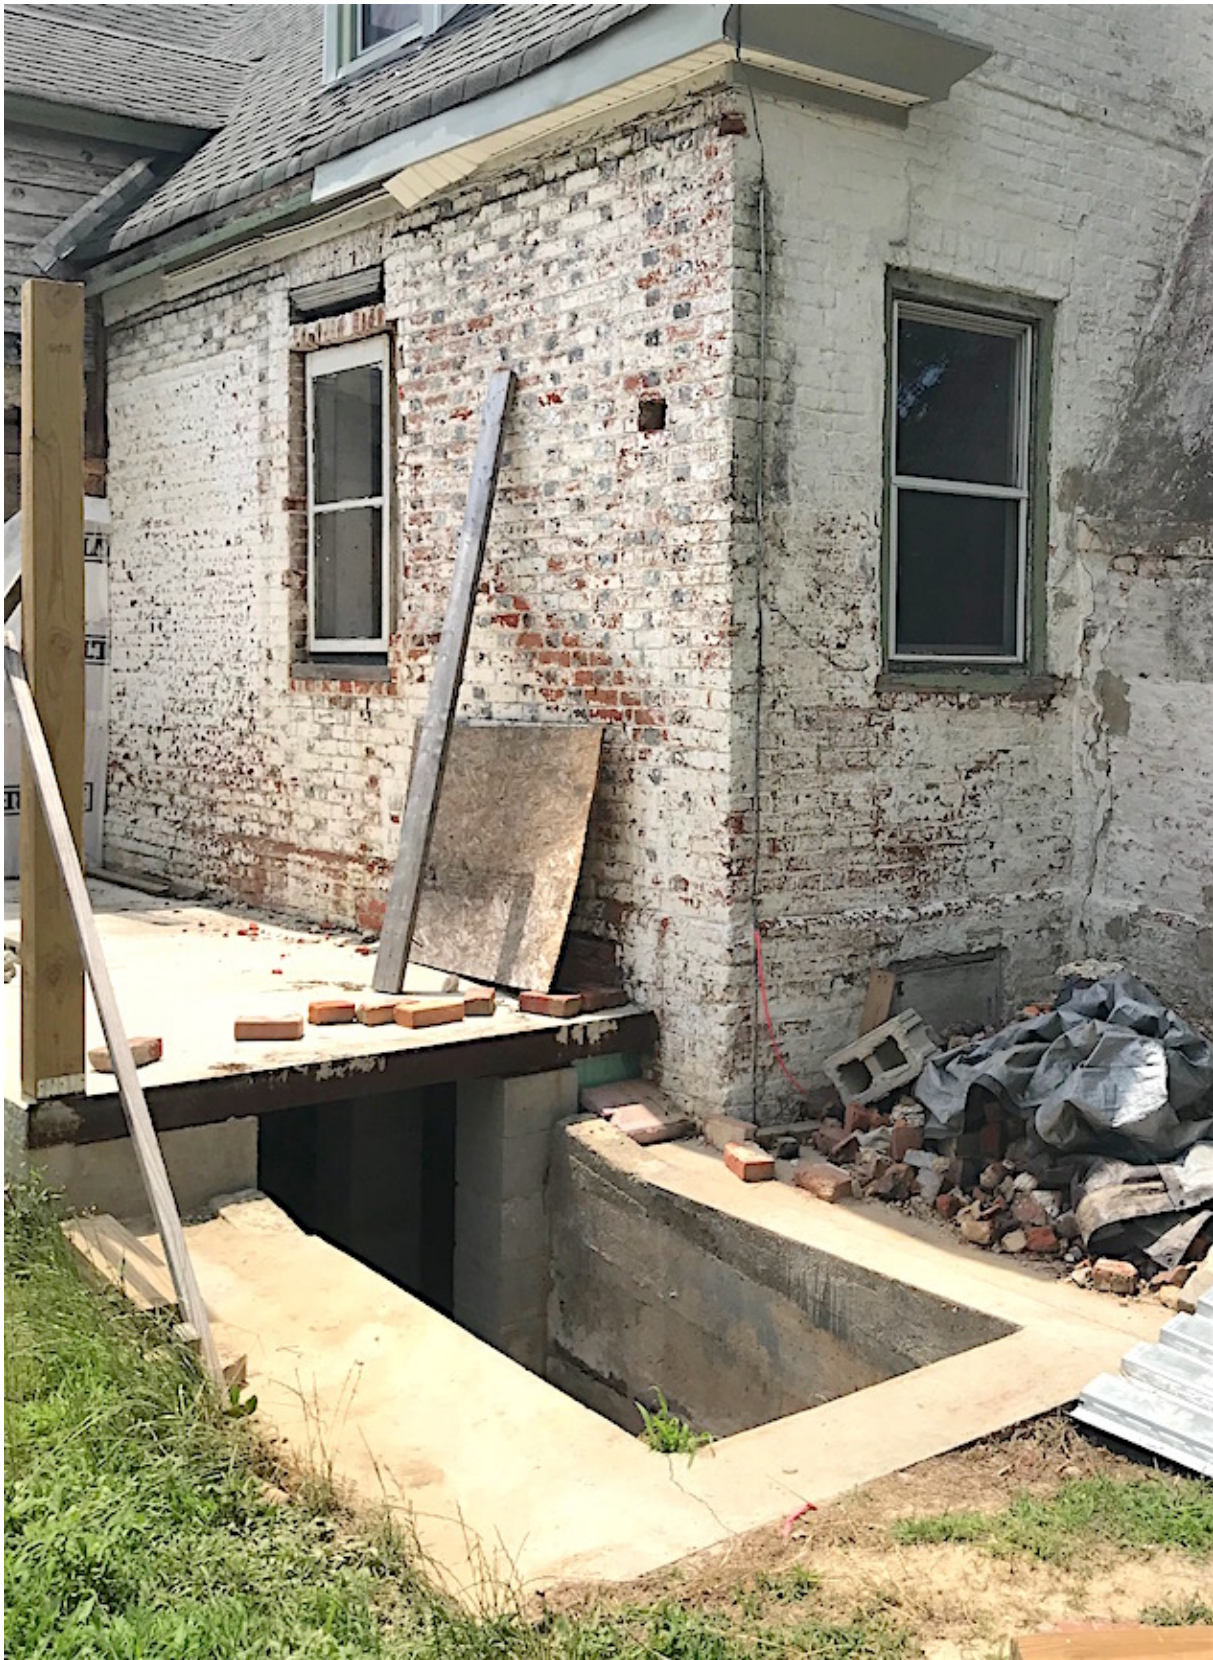
Figure 8

The stairwell in the original cellar entrance was replaced with a crudely constructed, east-facing, concrete and cinder block stairwell that projected out beyond the house's building line (Fig. 8, Replacement cellar stairwell).

With the stairwell being open to weather (See Fig 8), rain, snow, and sleet provided floodwaters, mildew, and humidity into an already damp cellar. Also, the open stairwell was a convenient pathway for rodents.

Since the stairwell was not historic and not abutting the original house, an opportunity developed for an appropriate accessory structure to cover the stair. The design was drawn and revised for a gabled rectangular structure with proportions that would mimic Fox Hall. The design of the structure was further tweaked so that the ridge of the roof was at the exact elevation of the roofline of the original cellar entrance.

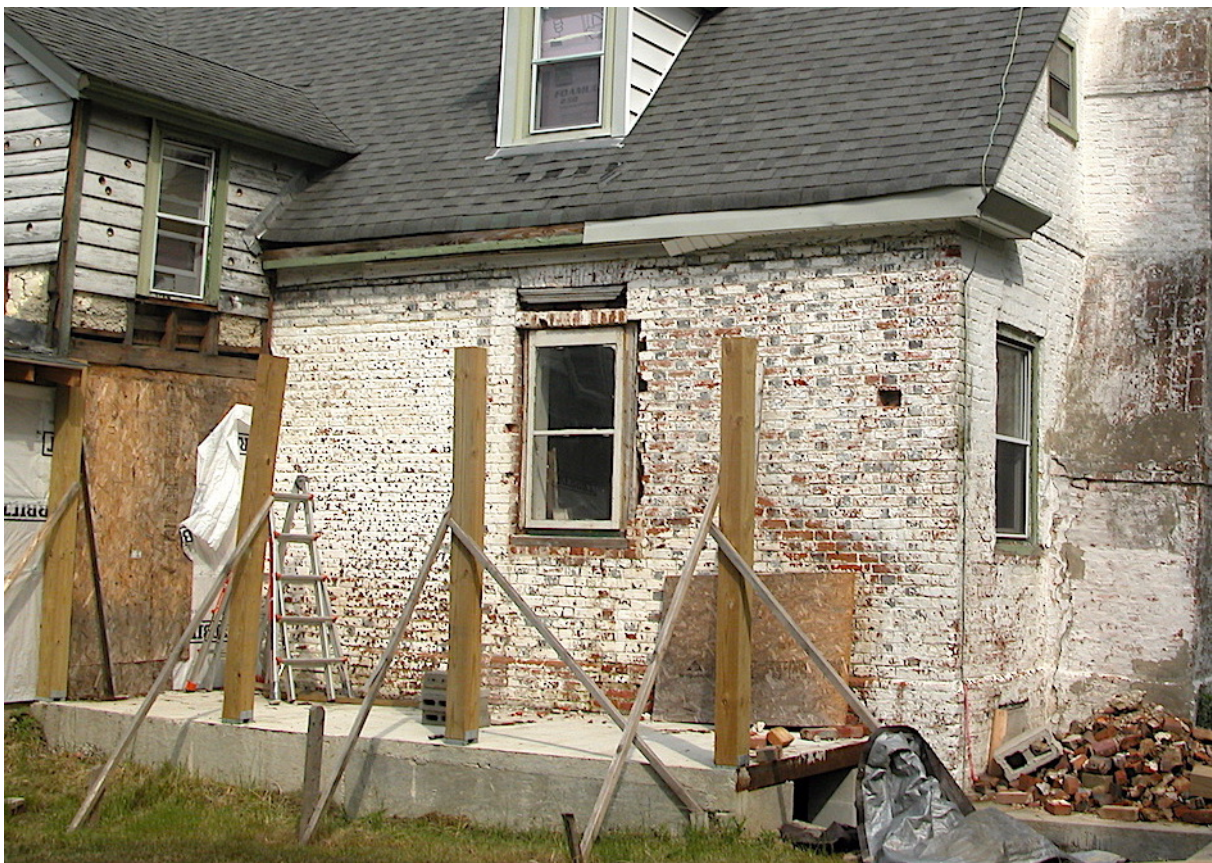
Figure 9

Recently, a raised concrete deck, the first phase of a proposed covered porch, was constructed along the open south face of the original house (Fig. 9, Recent concrete slab). This new construction was never completed as the restoration manager sought cessation of the work and dismissal of the contractor. Despite our best efforts and those of the restoration manager and masons to convince the owner to remove this slab, she opted to keep it as an open patio.

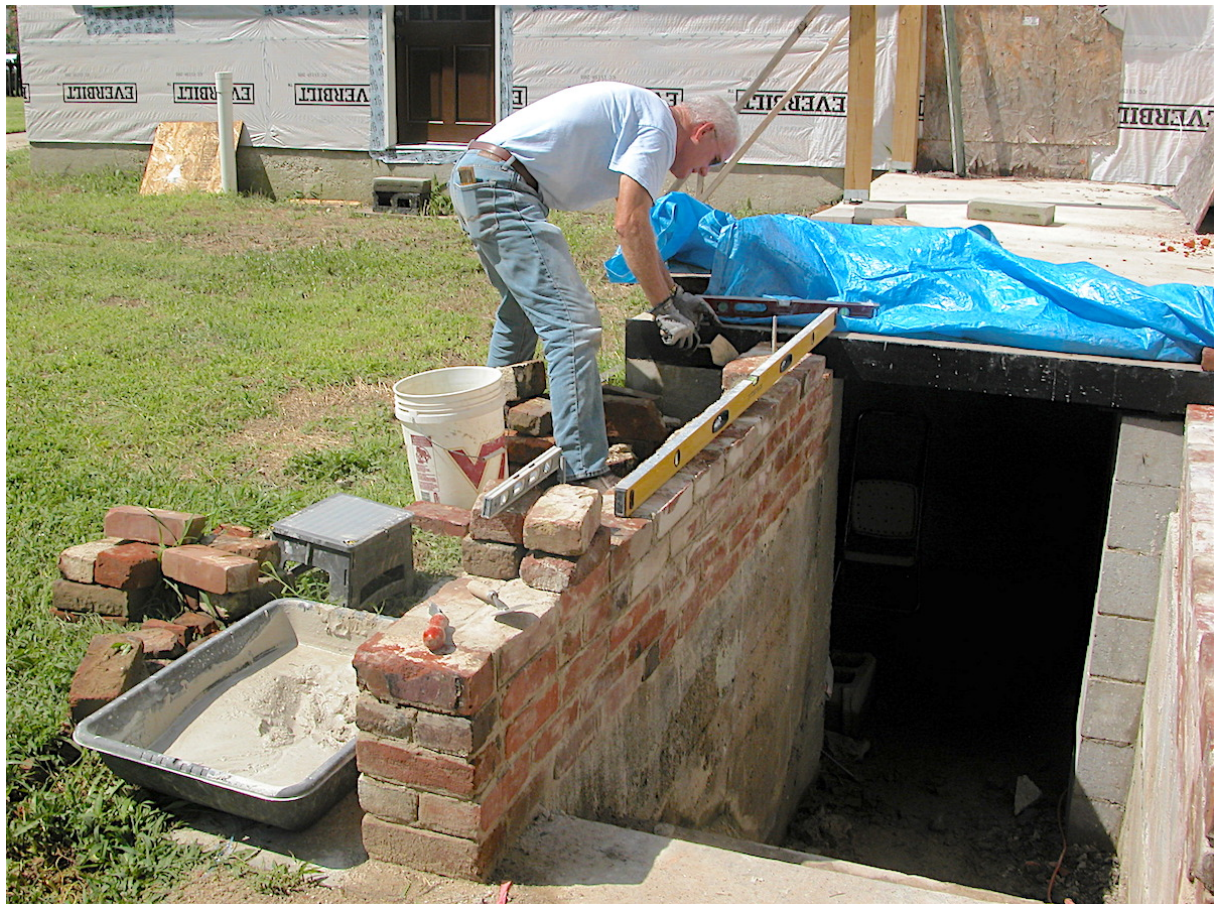
Figure 10, Brickwork base

The design called for six courses of English-bond brickwork as a base to a frame structure with shiplap siding. Bricks culled from the fireplace demolition piles (See *Part 4* of this series of articles) were used as face brick and laid in the restoration mortar. The joints were struck using a jointer custom made in the style of an early eighteenth-century one (See *What Is It?* article under Historic Trades on this website). With the exception of the bricks and door hardware, all other materials were modern. These included: Hardie Plank cementitious siding, Azek PVC trim, PVC eave gutter, plastic faux cedar-shake roofing, pressure treated wood, and modern sheathing and house wrap.

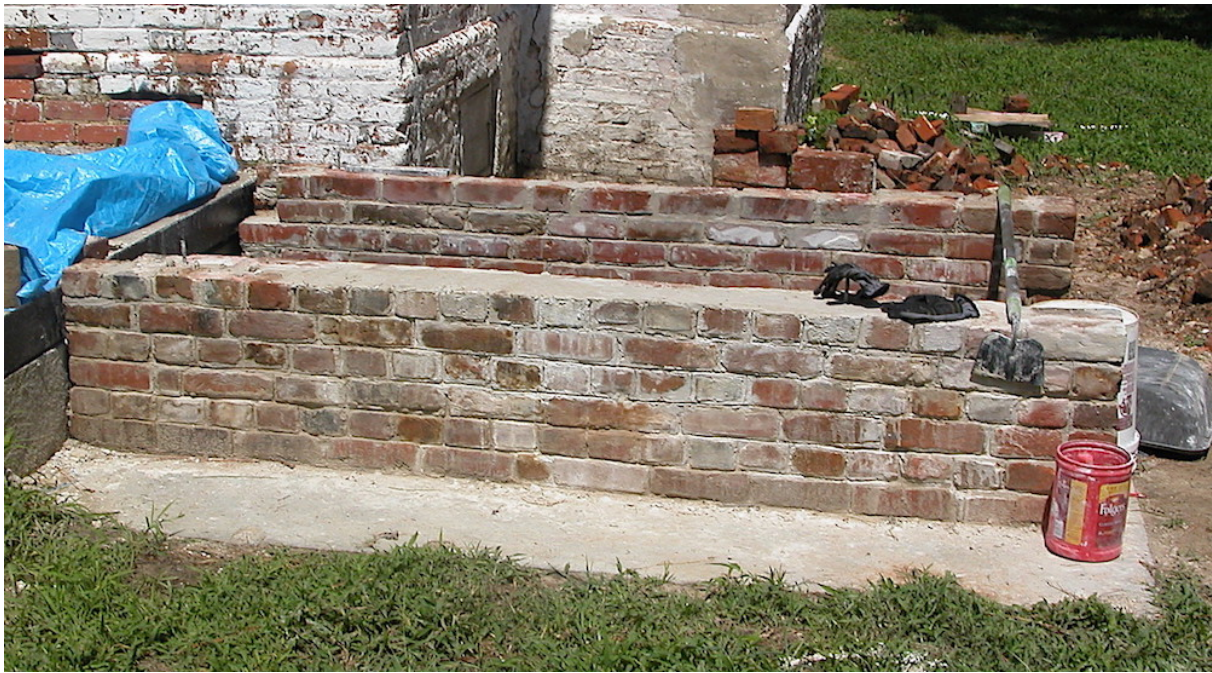
Figure 11, Completed base

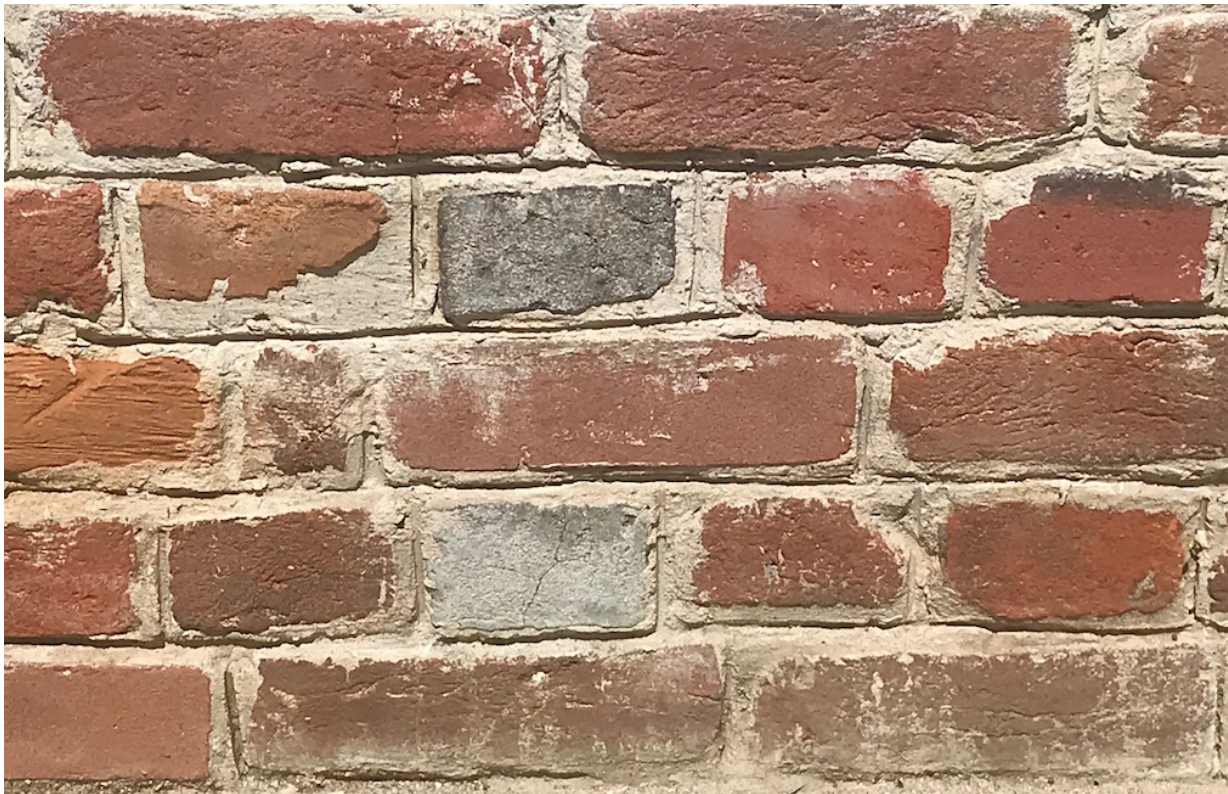
Figure 12, Cleaned brickwork

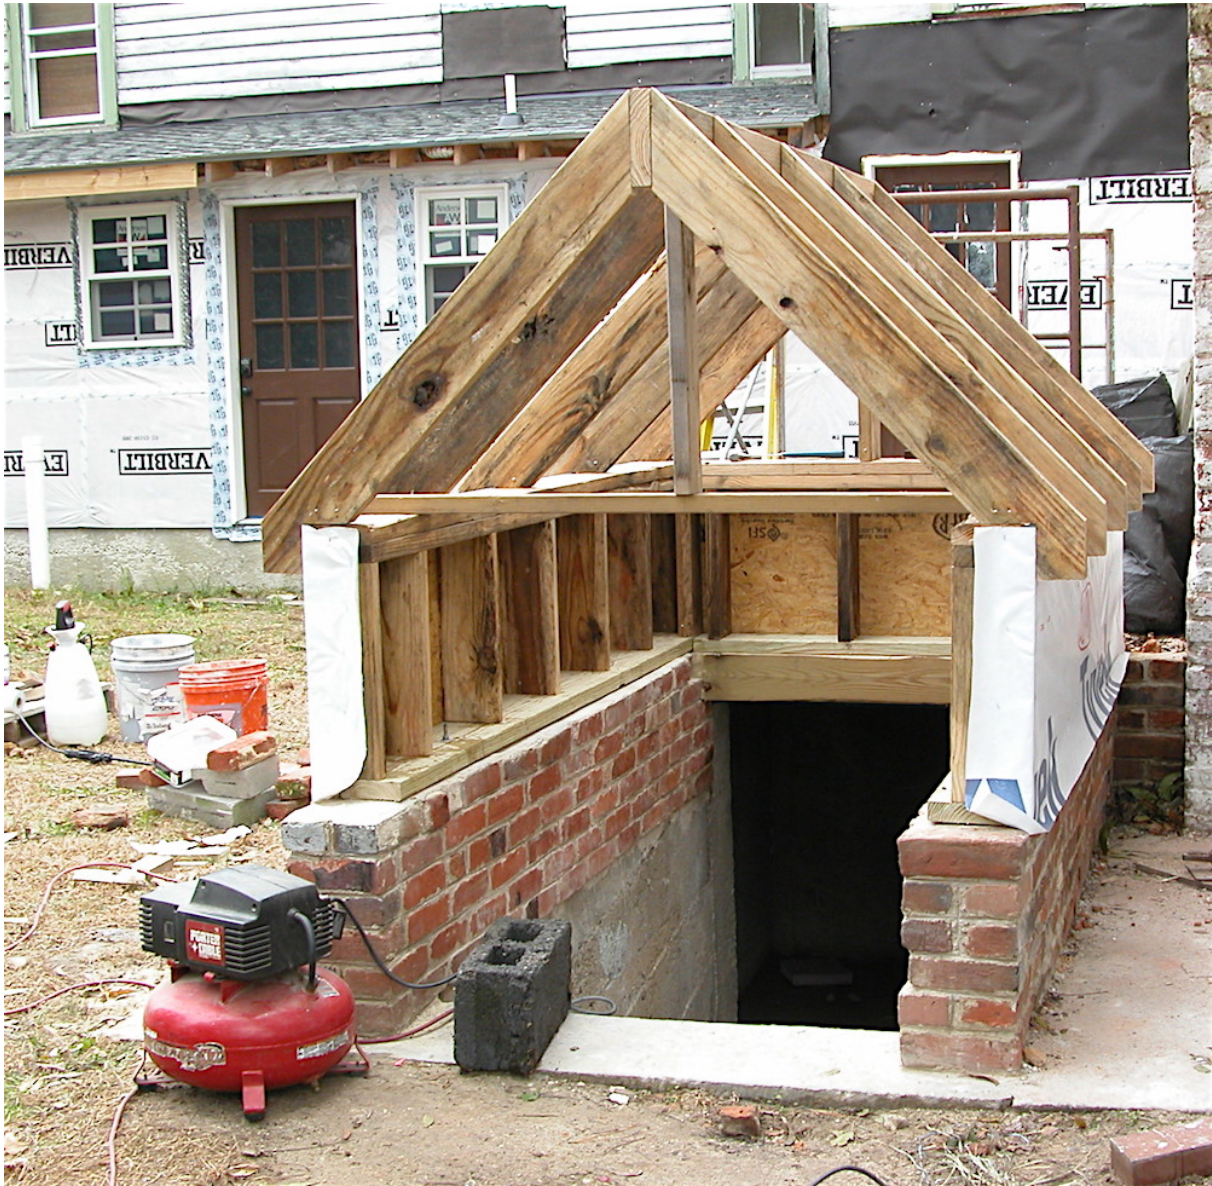
Figure 13, Initial framing

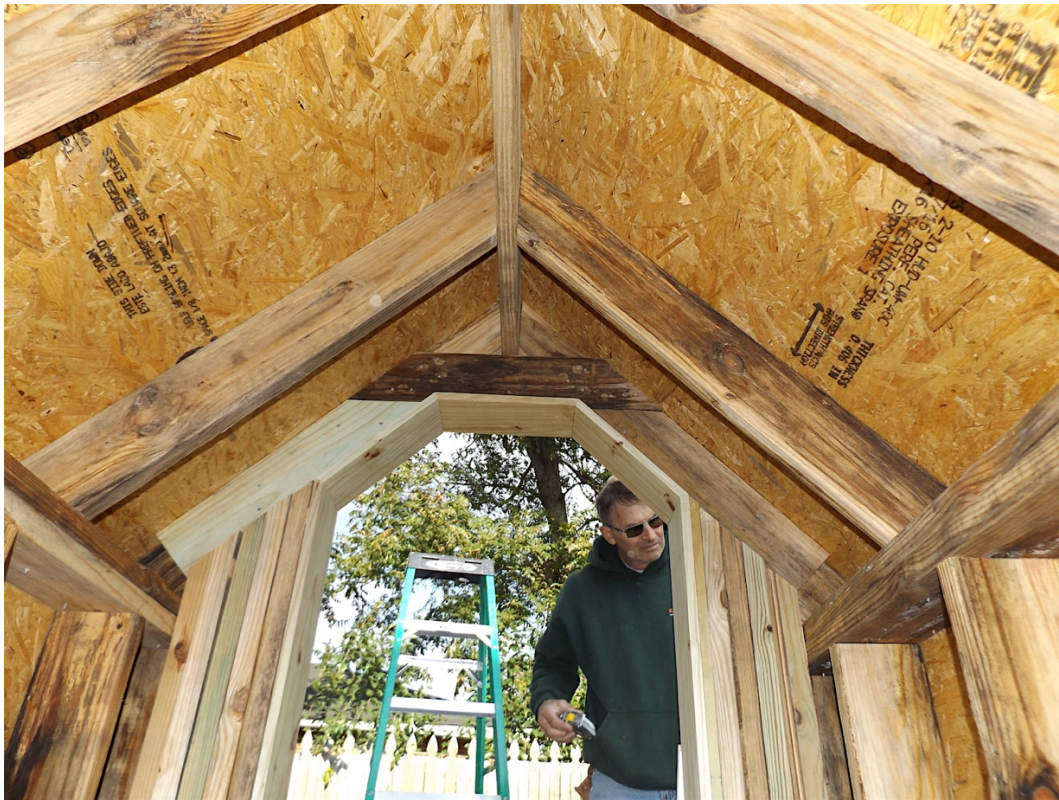
Figure 14, Doorway framing

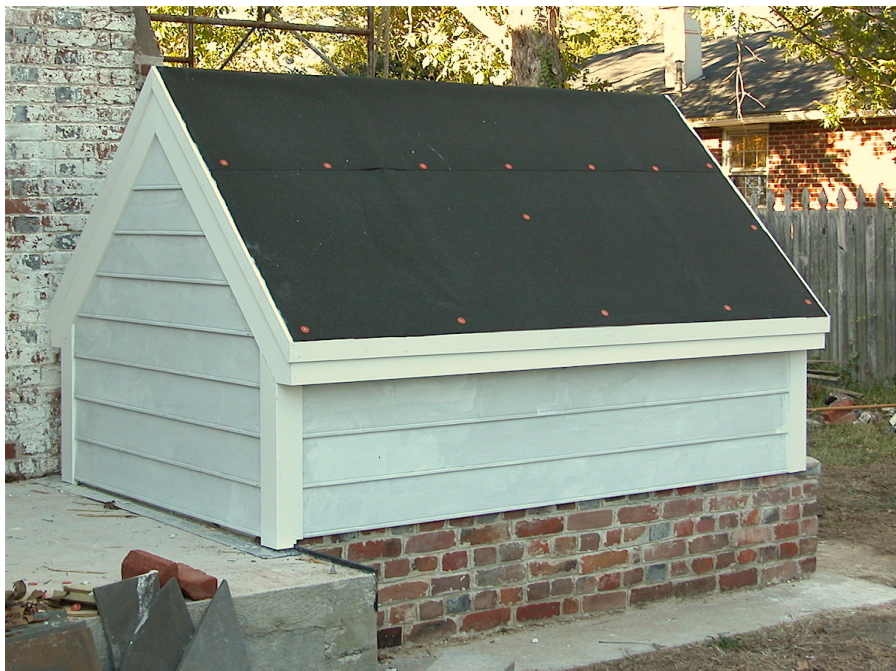
Figure 15, Siding and trim complete

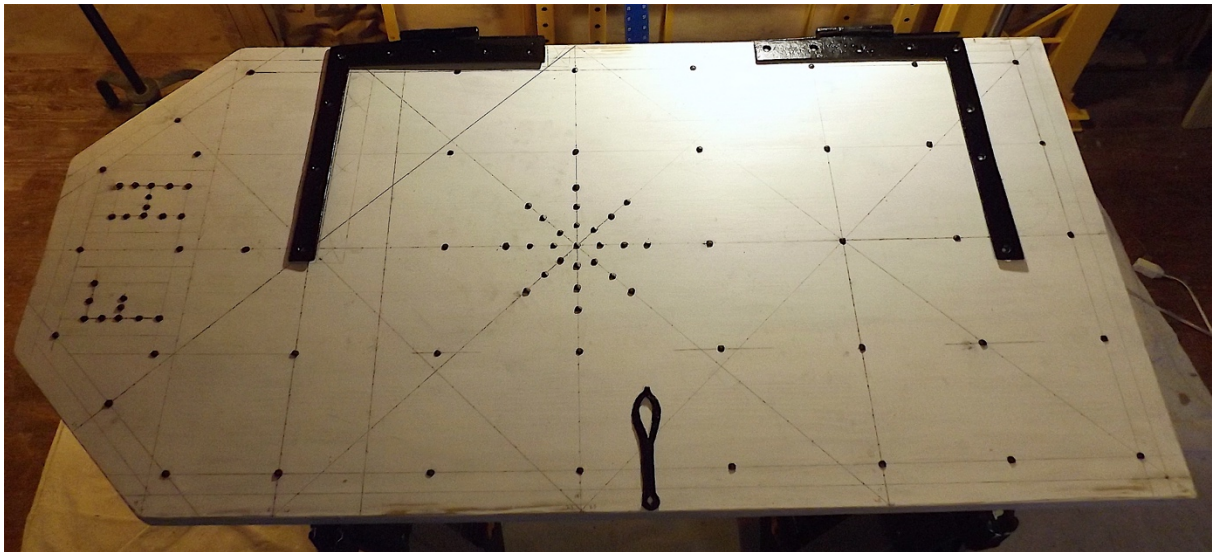
Figure 16, Wrought-nail studding on door

A key element in the design was an era-appropriate batten door with wrought-nail studding. The restoration manager laid out the studding pattern, installed the studs, provided and installed period door hardware,

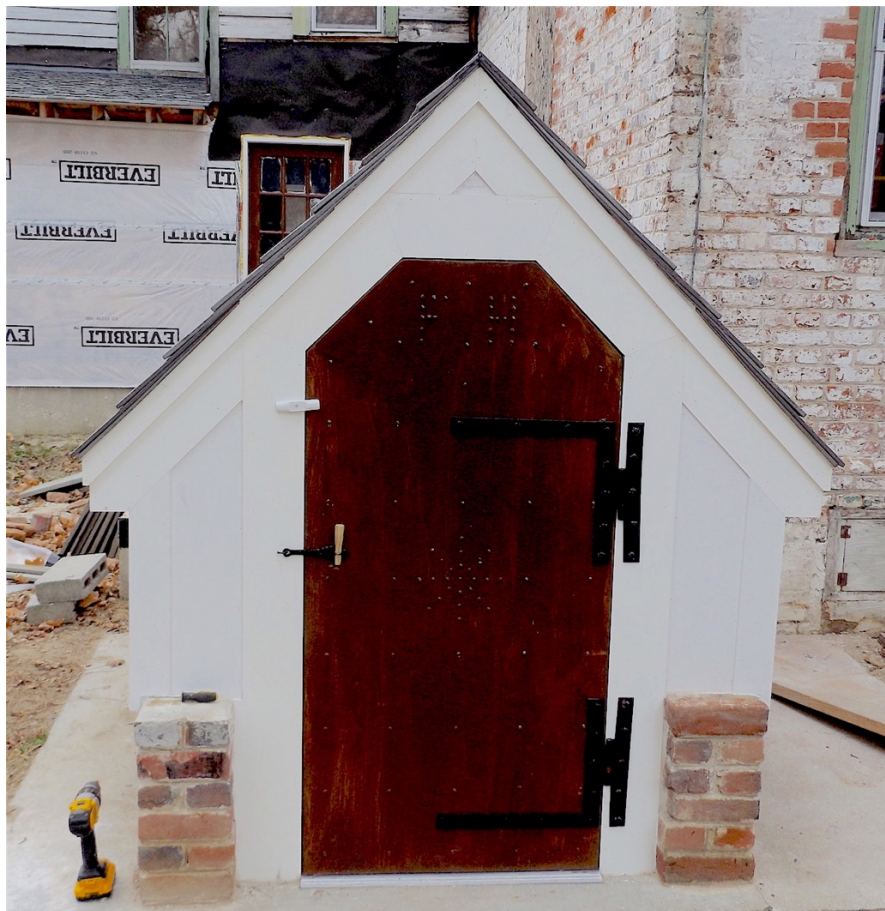
Figure 17, East elevation of cellar entrance

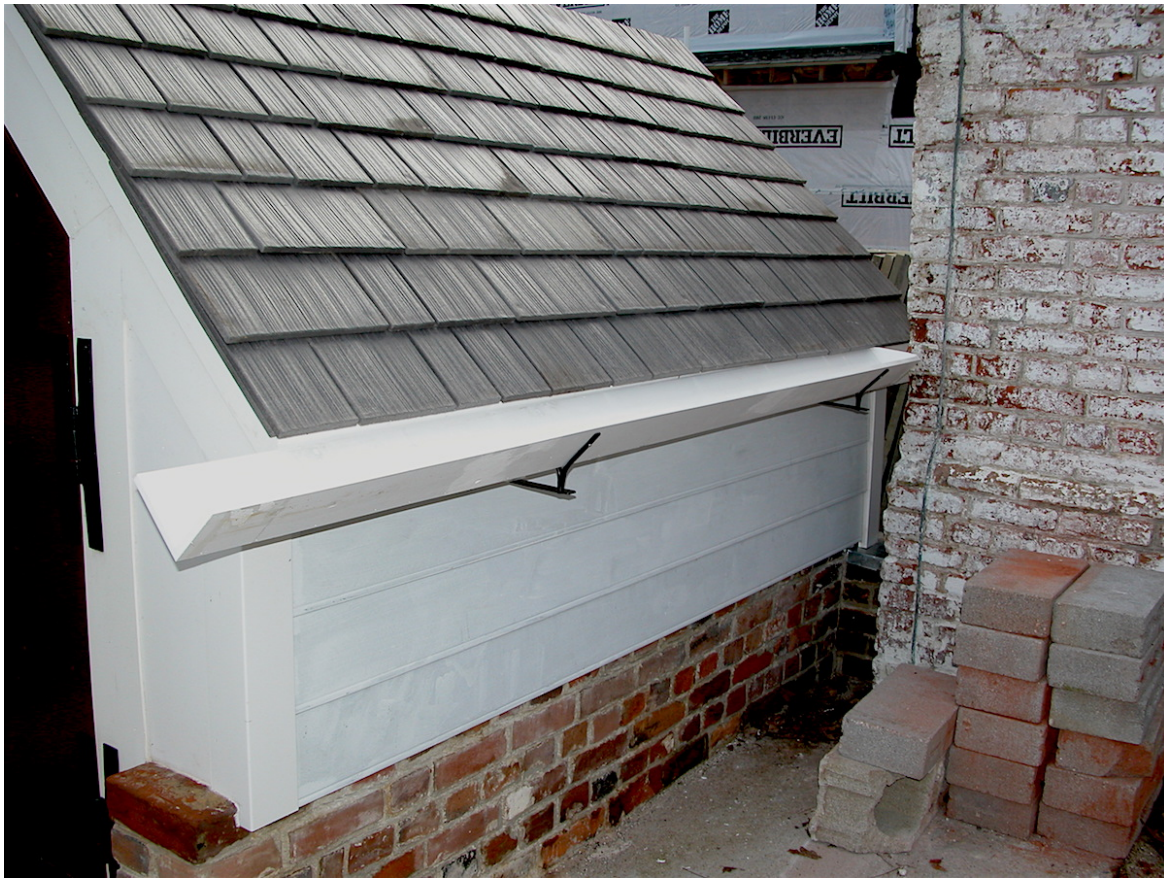
Figure 18, Roofing, eave gutter, and wrought-iron gutter brackets

and hand forged and installed the period-appropriate, eave-mounted gutter brackets.

The eave gutter, designed to capture rain from the roof of the cellar entrance and transport it away from the main house, was fashioned after eighteenth-century wooden gutters occasionally found on vernacular buildings.

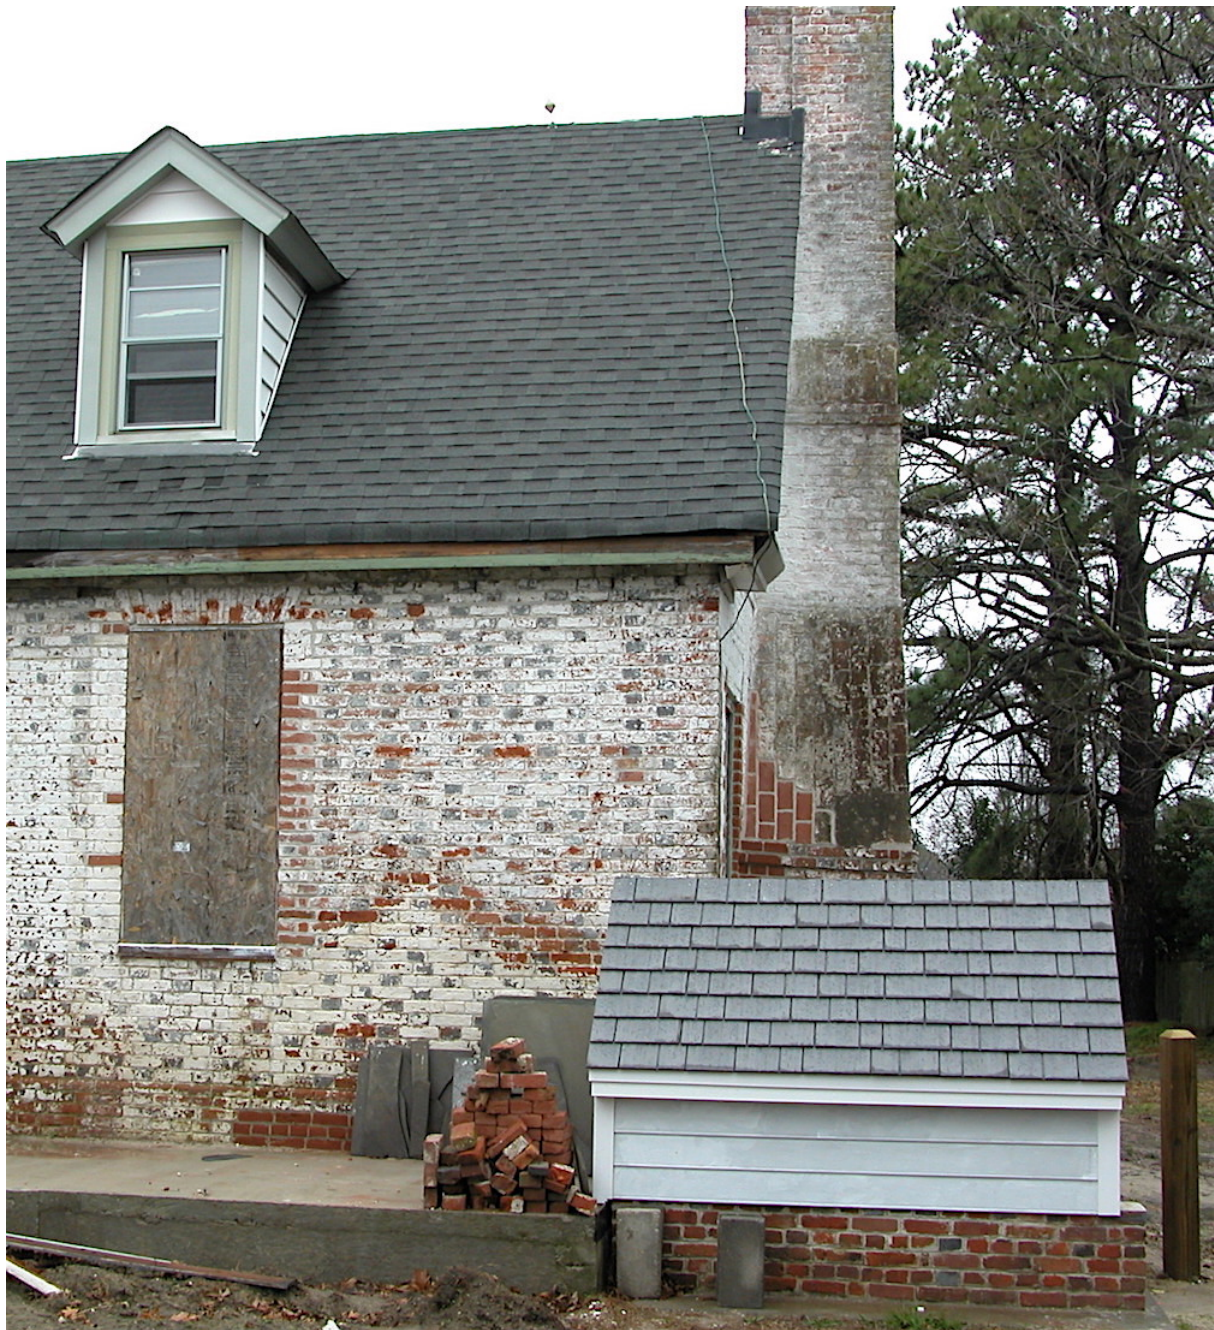
Figure 19, "Dick's Dog House" completed
