Fox Hall - *Part 8*, Windows

By Jim Melchor, Tom Newbern, "Cheetah" Waller, and Dick Gresham

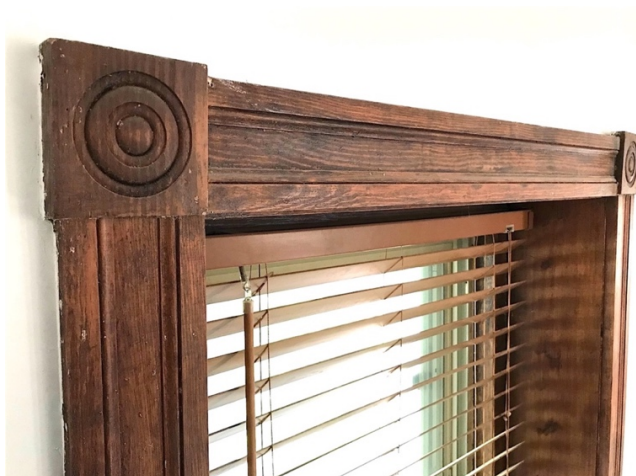
Figure 1

The five windows in the hall and three of the four in the kitchen are located essentially in their original positions. However, these window openings were altered to their present, post-1870 sizes to accommodate new windows. This date is based on the bullseye style, construction, and finish of the interior trim around these windows (Fig. 1, Post-1870 window trim).

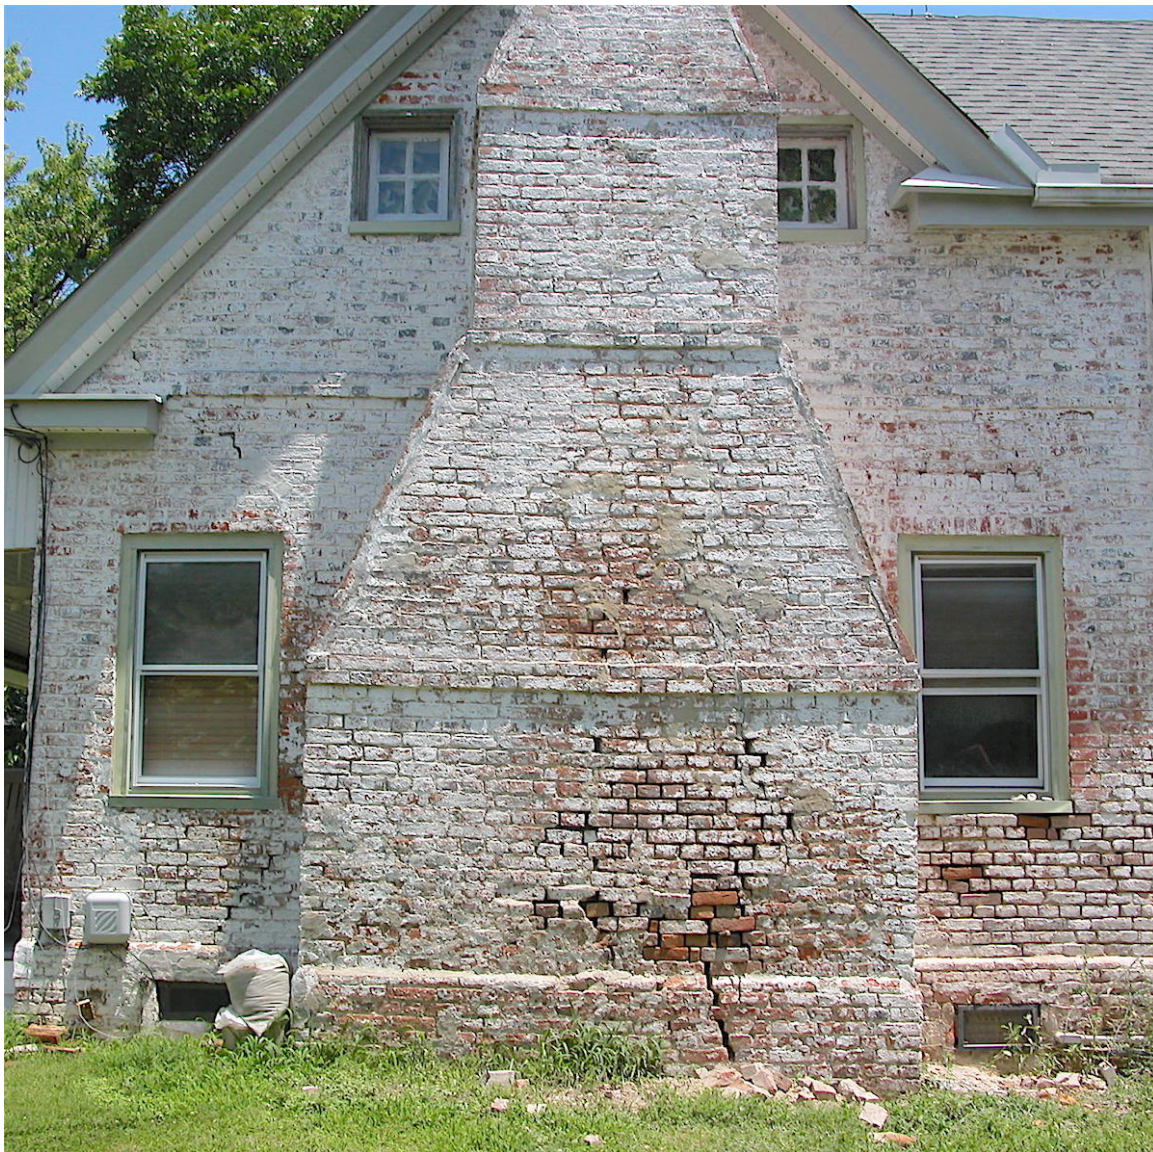
Figure 2

Fox Hall faces north with the kitchen on the west end and the hall on the east. The north window on the endwall of the kitchen, the one to the left of the chimney in Fig. 2, is a twentieth-century addition to the house (Fig. 2, Kitchen endwall). Originally, there was no window opening in this area. The window opening on the right side of the chimney is in its original location, though it has been considerably altered to accommodate the new post-1870 window now installed.

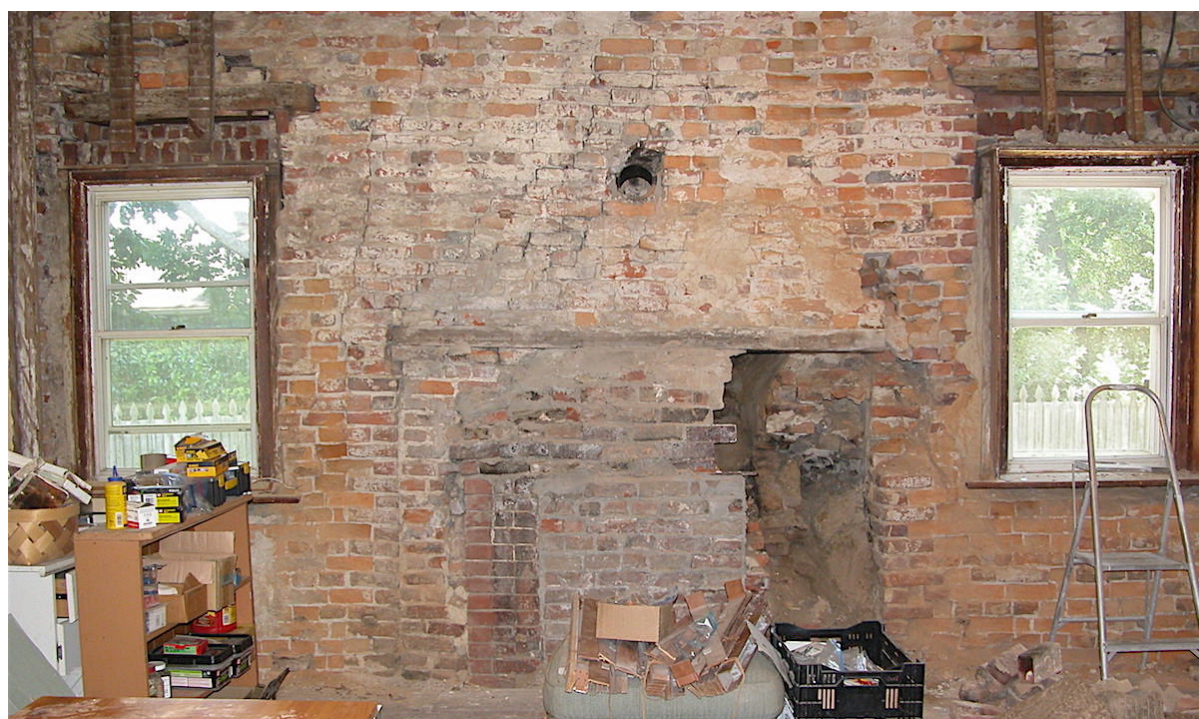
Figure 3

Similar to the kitchen, the hall has two windows in its endwall. Both of these window openings are original, but they also have been altered to accommodate the new post-1870 windows (Fig. 3, Endwall windows in hall).

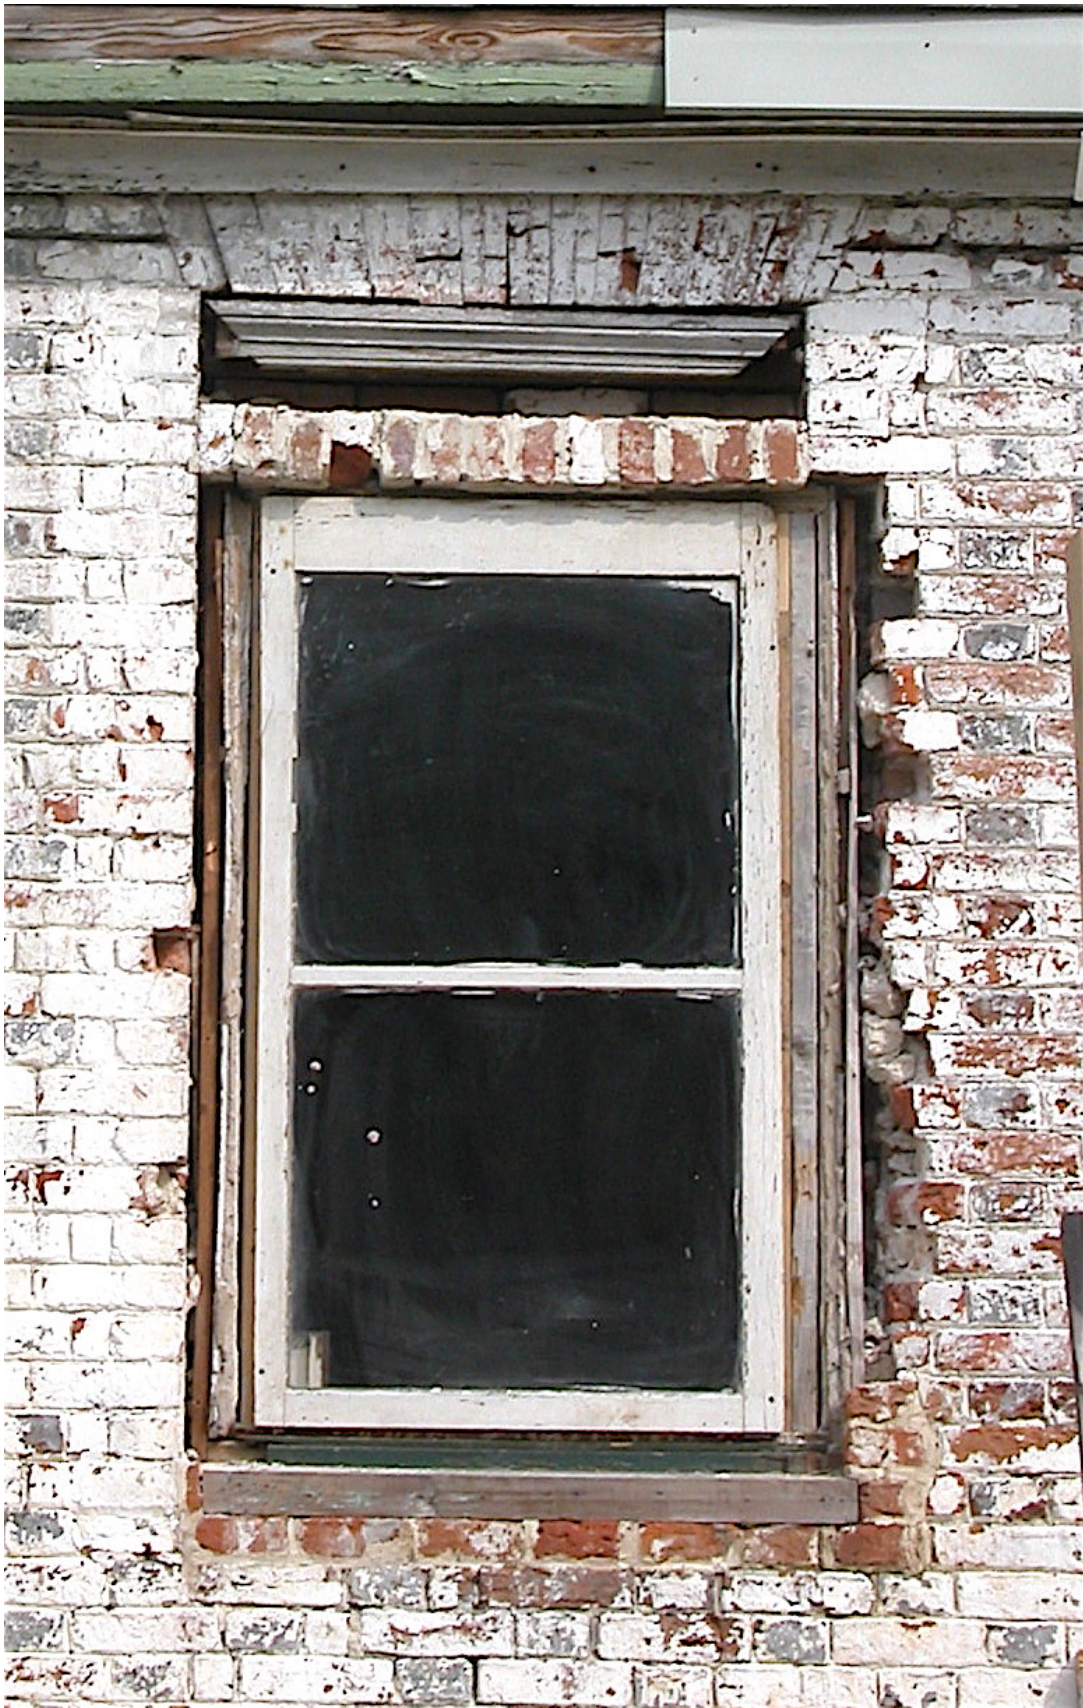
Figure 4

The two front windows in the kitchen and the two front windows and one back window in the hall provide ample evidence of how these window openings changed to accept the new post-1870 windows. At the top of all five window openings, the brick jack arches were left in place during the alterations. The most interpretative of the five openings was the one on the back of the hall. Here, not only was the jack arch left intact, but also the top element or header of the original wood window frame (Fig. 4, Back hall window with wood frame header).

In studying Fig. 4, the details of the original window opening become clear. The left side of the opening from the jack arch downward is original. The post-1870 window sill is set one course of obvious infill brick above the original opening. The right side of the original opening can be precisely determined as it is still partially intact at the top next to the header and below the jack arch. The rough opening of the original window was seventy-five and one-half inches high by thirty-seven inches wide. The right-side brickwork was chopped open to accommodate the new window then infilled with brick and mortar. The frame stock is four and seven-eighths inches by two and seven-eighths inches in cross-section.

There is a trim molding nailed on the face of the header (See Fig. 4). The profile of this molding looked to be later. When this molding was removed for examination, it was found to be attached with cut nails. It likely was added to dress up the original window frame late in the eighteenth or early in the nineteenth century, prior to installation of the

new window. A bead was cut across the inside edge of the header. This bead is original. The decorative trim was applied outside of this bead. With this plethora of information about the original window opening and its frame, the restoration manager decided to restore this window to its original appearance inside and out. The masons restored the rough opening (Fig. 5, Rough opening of hall back window). The manager then hand constructed the frame, and he and the team architect installed it (Fig. 6, frame under construction) (Fig. 7, Copper cap on top of frame) (Fig. 8, Copper flashing below sill) (Fig. 9, Completed frame installed).

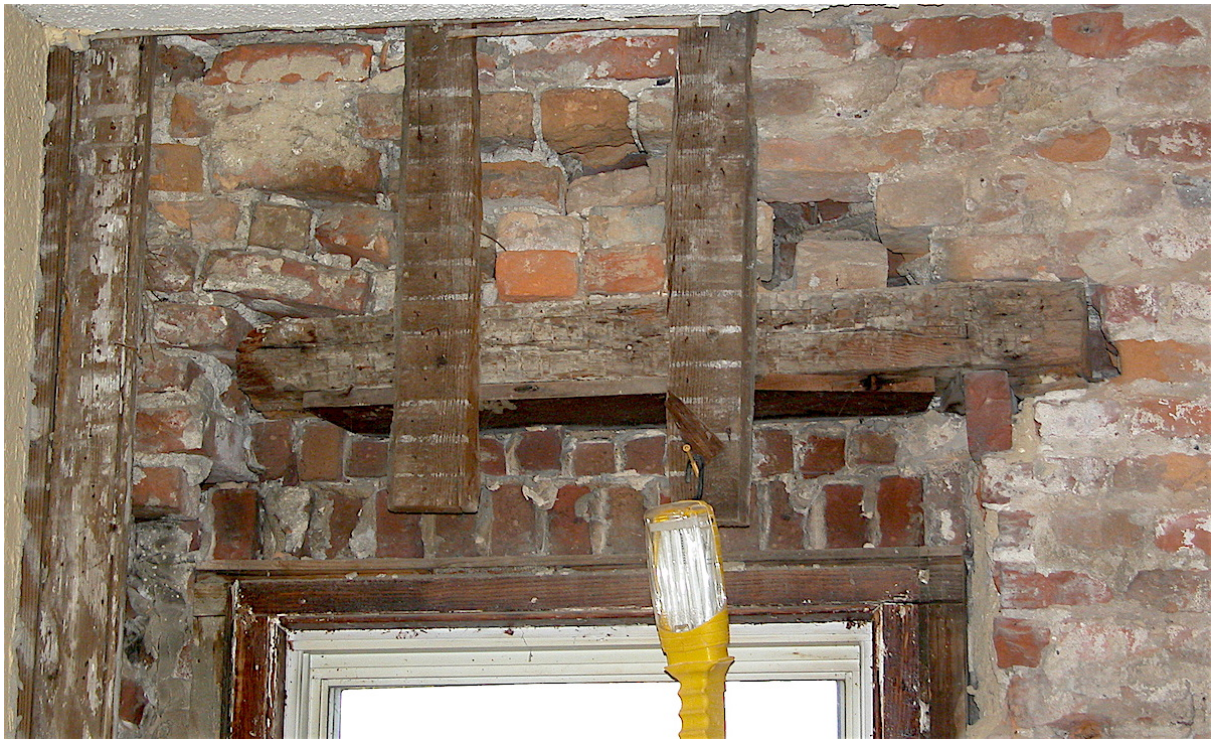
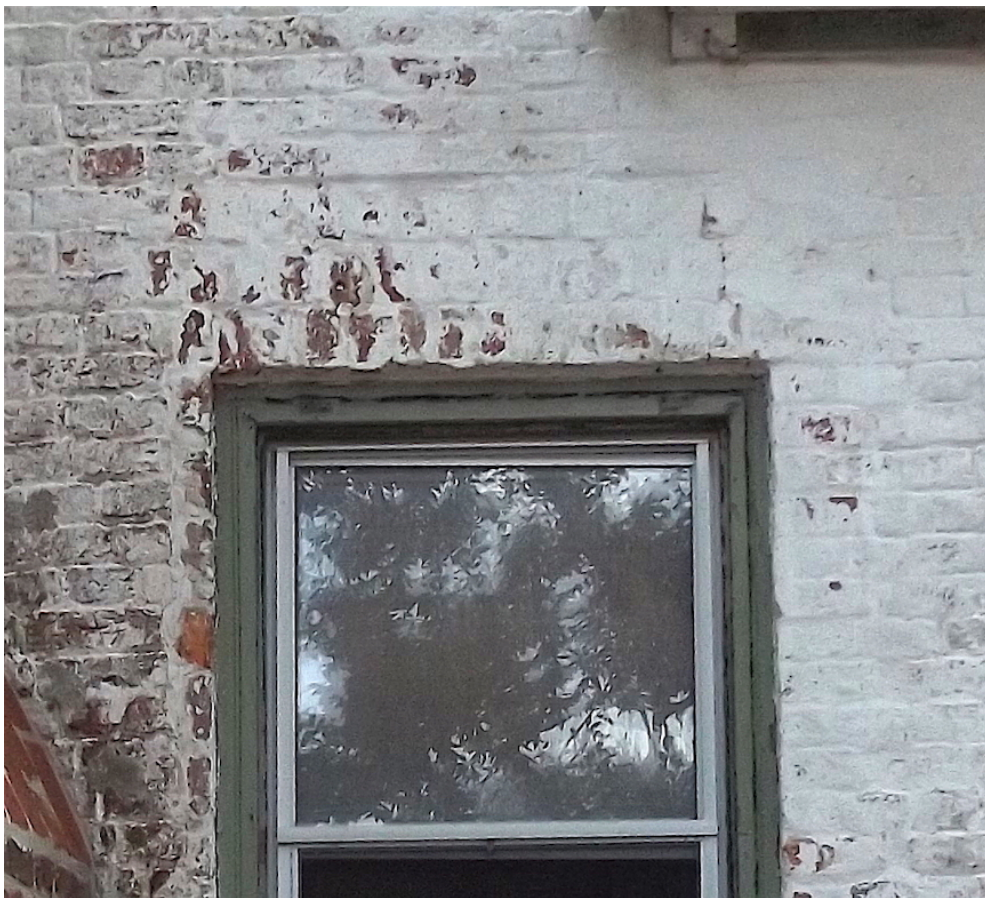
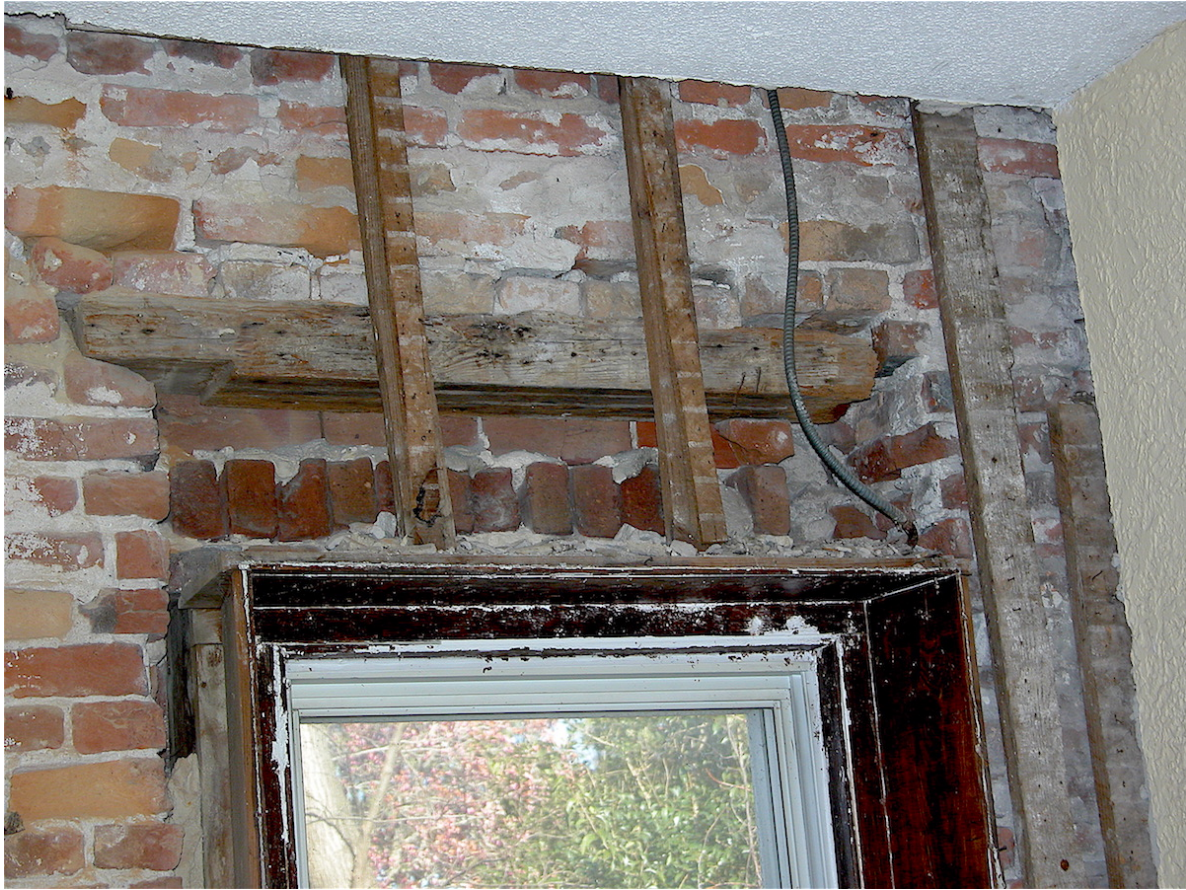
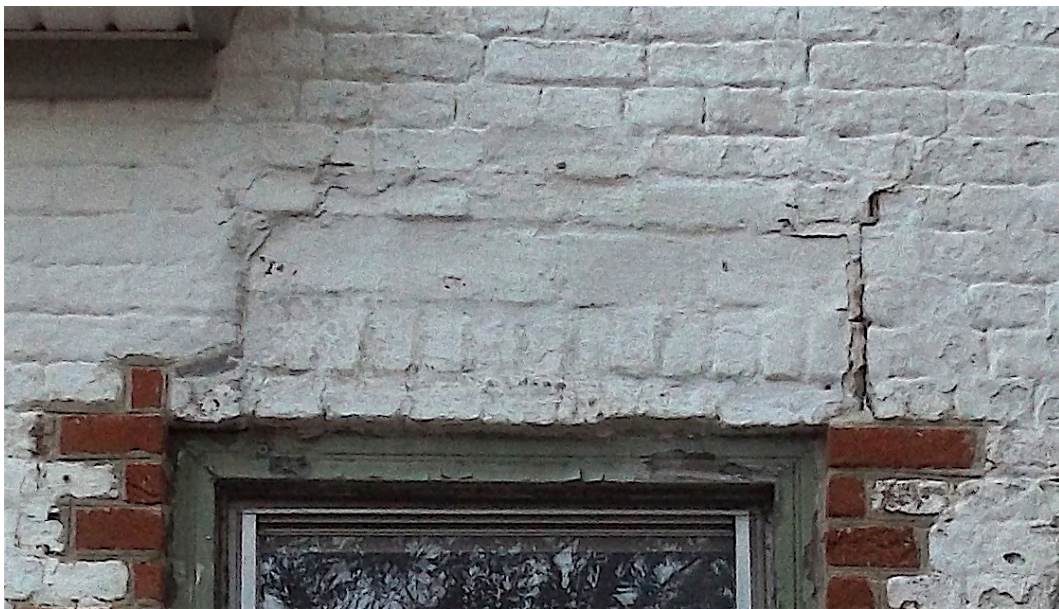
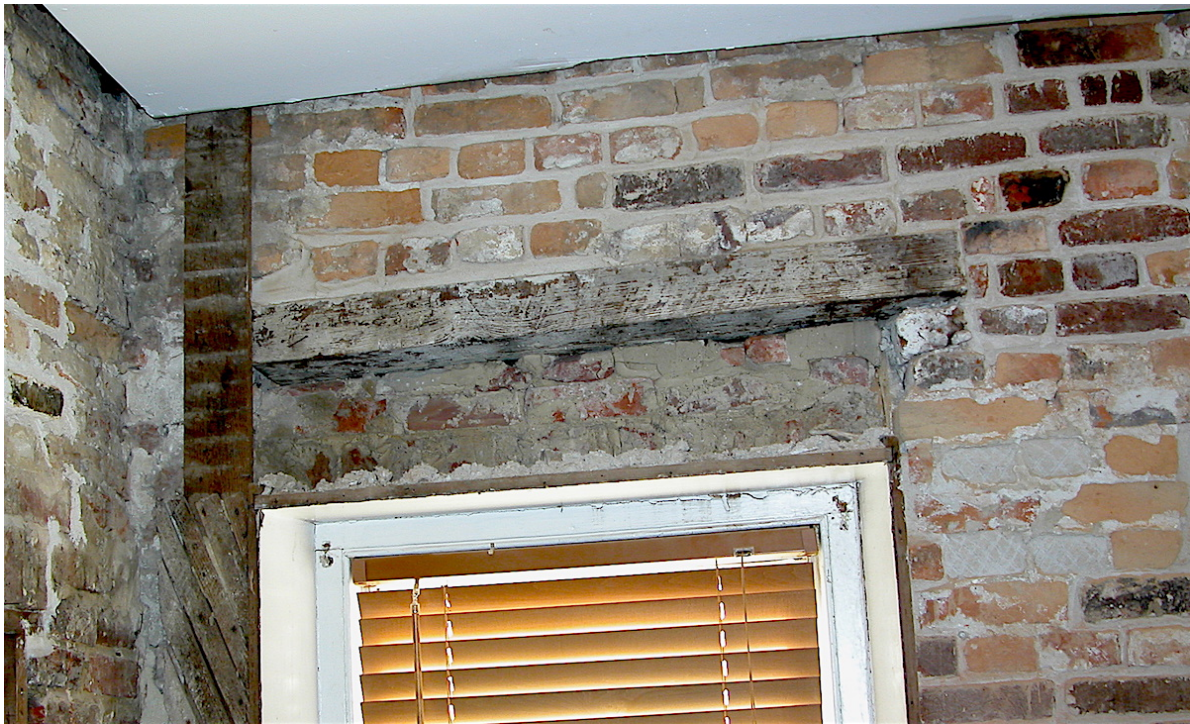
By studying the brickwork around the post-1870 windows occupying the locations of the original three windows, a close estimate of the rough window openings for these three could be made. In Figs. 17 through 22, notice the lintels and infilling (Fig. 17, East endwall, north window, inside) (Fig. 18, East endwall, north window, outside) (Fig. 19, East

endwall, south window, inside) (Fig. 20, East endwall, south window, outside) (Fig. 21, West endwall, south window, inside) (Fig. 22, West endwall, south window, outside).

The three endwall windows were located roughly ten inches higher than the post-1870 windows. Based on the length of the lentils and partial evidence of the openings, the original rough openings for these three windows were approximately forty inches high by twenty-eight inches wide. Using these dimensions, the bottoms of the rough openings land about five inches above the bottoms of the chimney shoulders, keeping the sills above rainwater running off the shoulders. This is important in preventing rot in and around the window sills. The original Fox Hall masons understood this, and our team mason knows this and mentioned it. Those who replaced the original windows apparently did not get its importance, and their sills have experienced rot. With the same frame and sash stock and light size as in the larger windows, the small windows worked out to be two lights wide and three high.

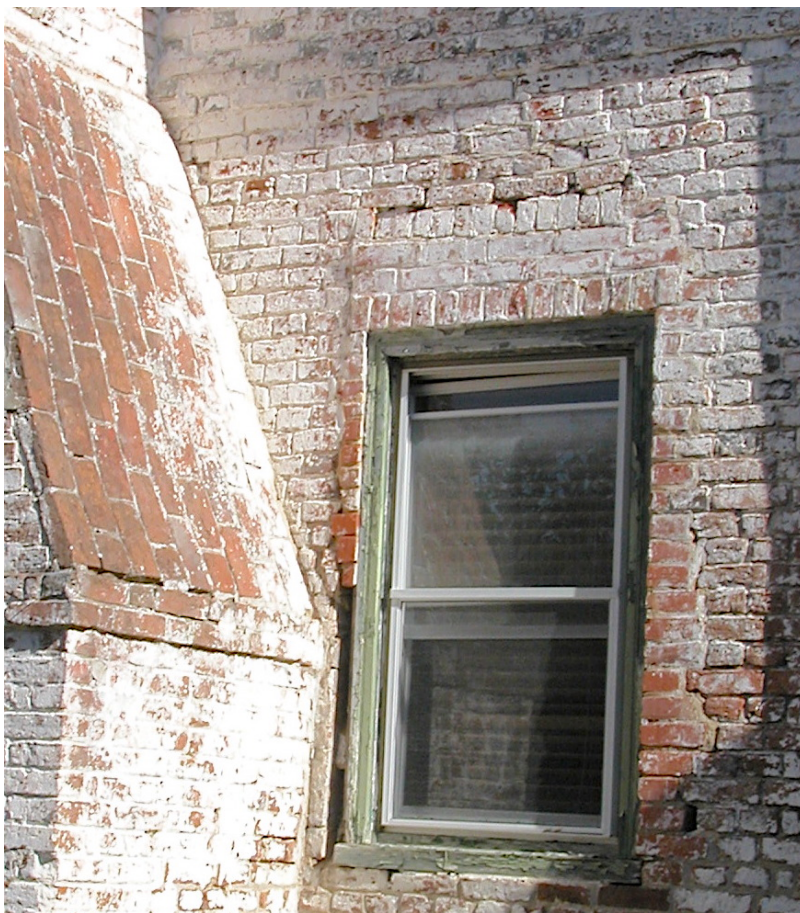
Figure 22

The installers also depended upon the header of their new window frame to support their brick infill above their window as well as the original masonry above their infill. This, of course did not work (See Fig. 22, Original brickwork above infill rowlock bricks). Our team masons had to re-establish the interior support for the lintel, repair the brickwork above the lintel, and repair the settled original exterior brickwork before they could create the proper rough opening for our restoration window (Fig. 34, Repair in progress of settled original brickwork).

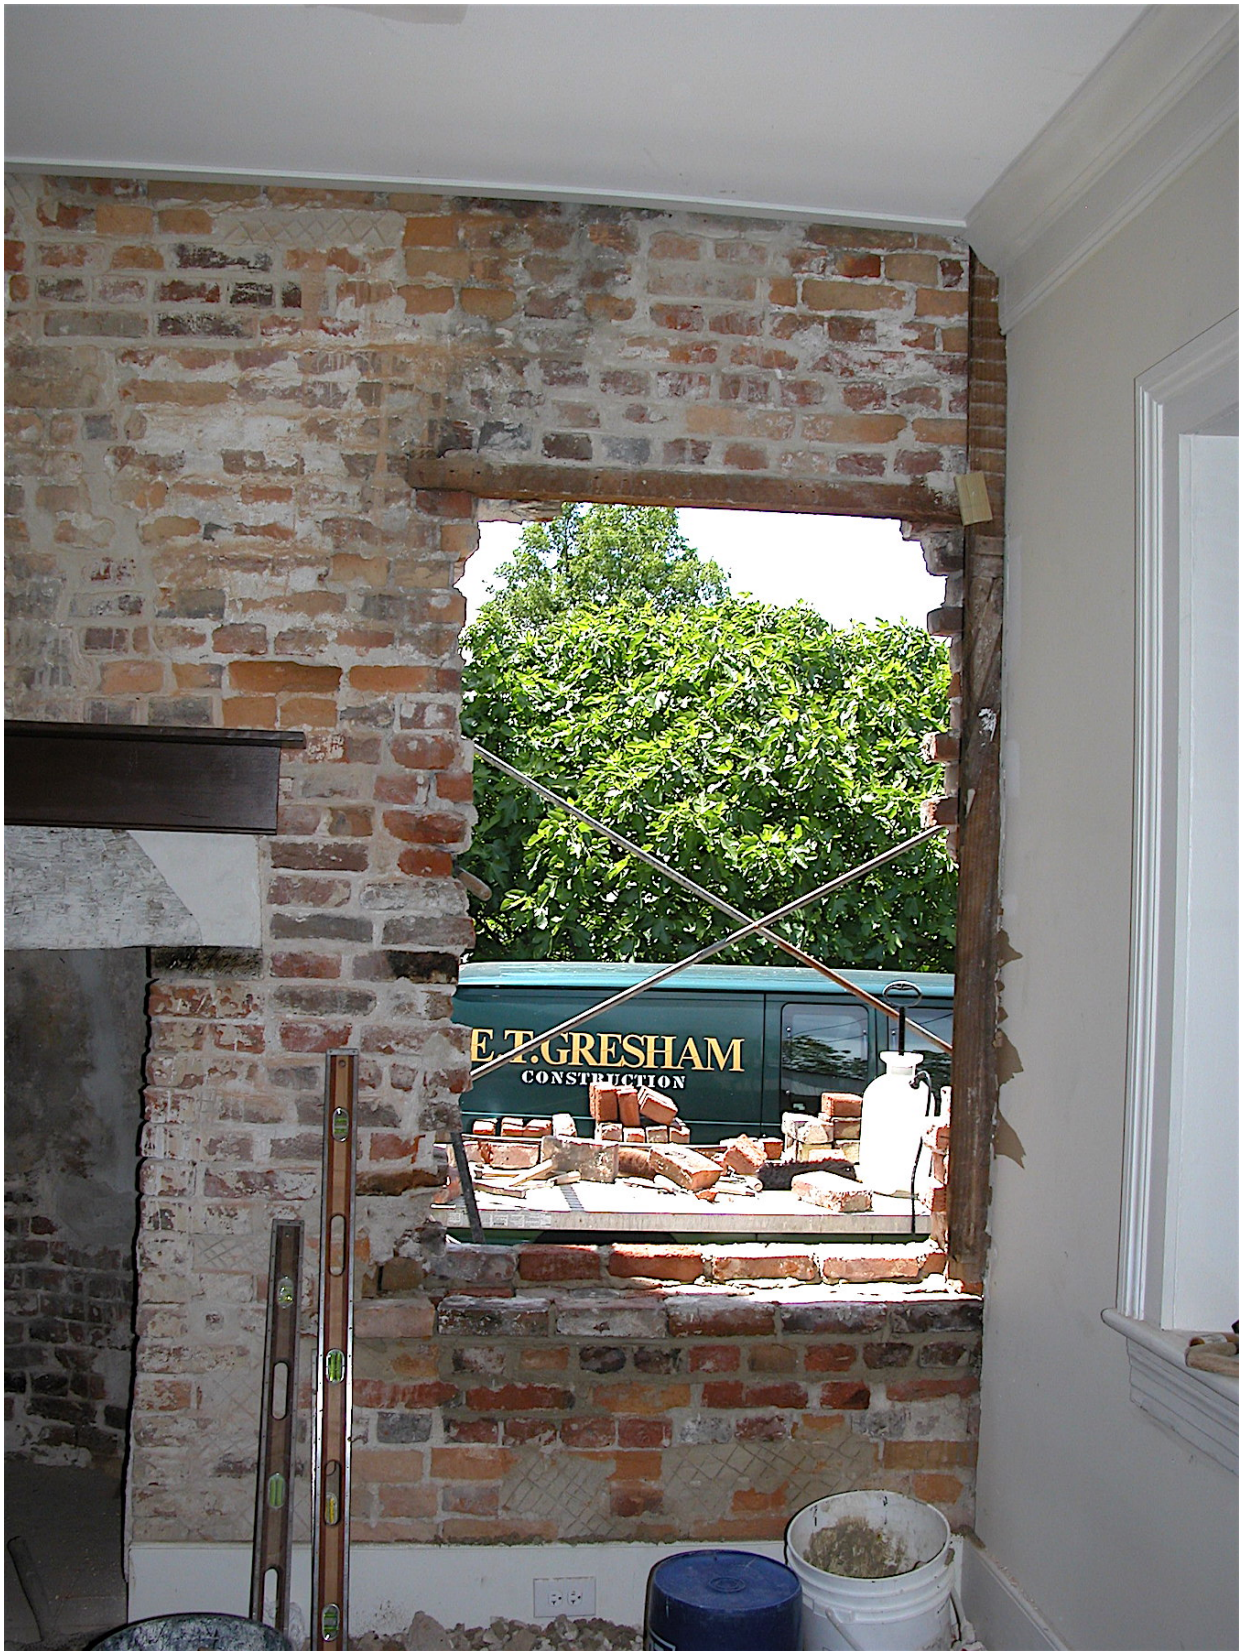
Figure 25

Prior to installation of these seven restoration windows, the masons had to restore the rough openings. As part of this step, they also removed the improper modern window in the west endwall and restored the brickwork. There was no evidence of an original window in this location north of the chimney (Fig. 25, Window removed, note twentieth-century, rough-cut two-inch by four-inch lintel, now removed) (Fig. 26, West endwall restored). As noted in *Part 4*, the mortar used in restoration here is hydraulic lime and local sand, no Portland cement added.

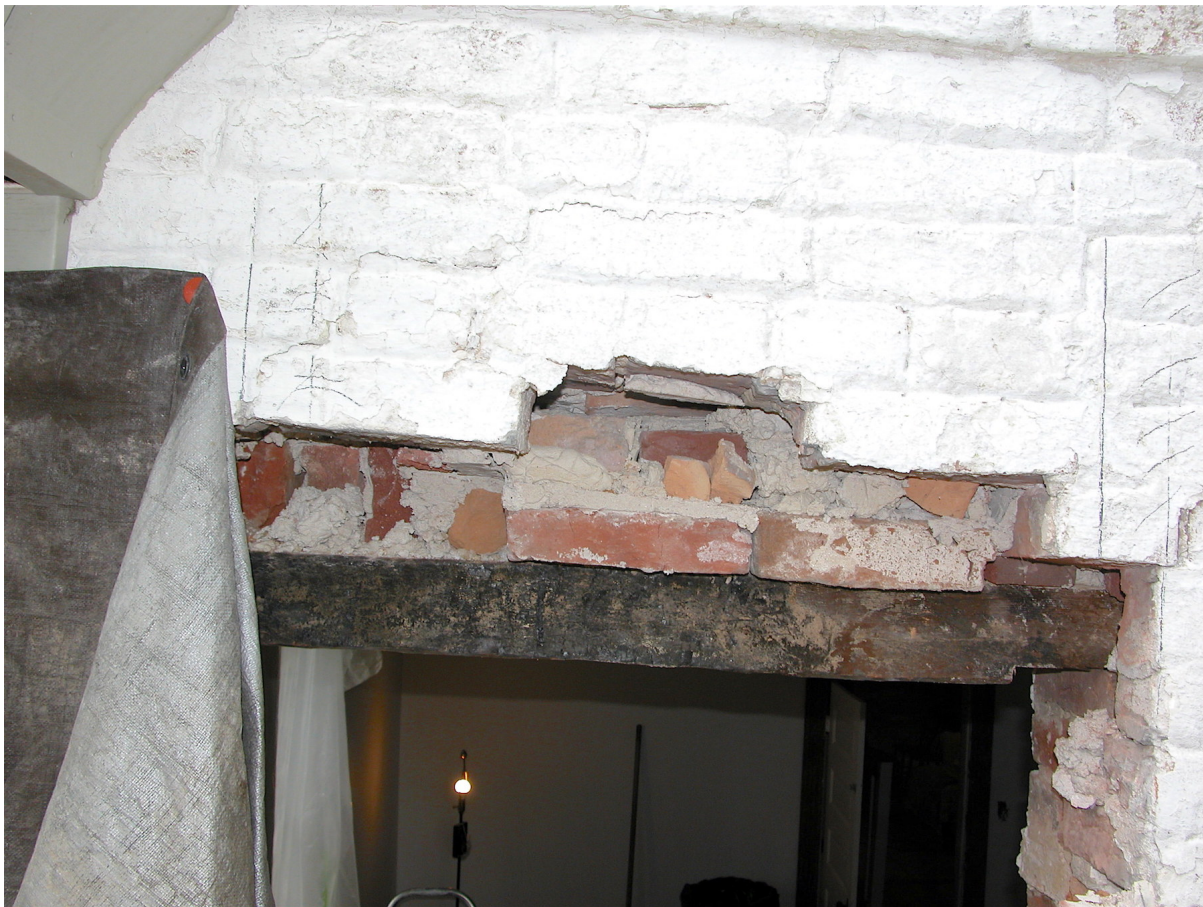
Figure 27

Based on the settlement of the south side of the east chimney and the endwall surrounding the post-1870 window (See *Part 4* of this series), we knew that restoring the south window in the east endwall would be a challenge. It did not disappoint. In Fig. 27, note how the lintel and original coursework dip to the right (Fig. 27, Settlement problems with south window in east endwall). The later infill bricks have been removed.

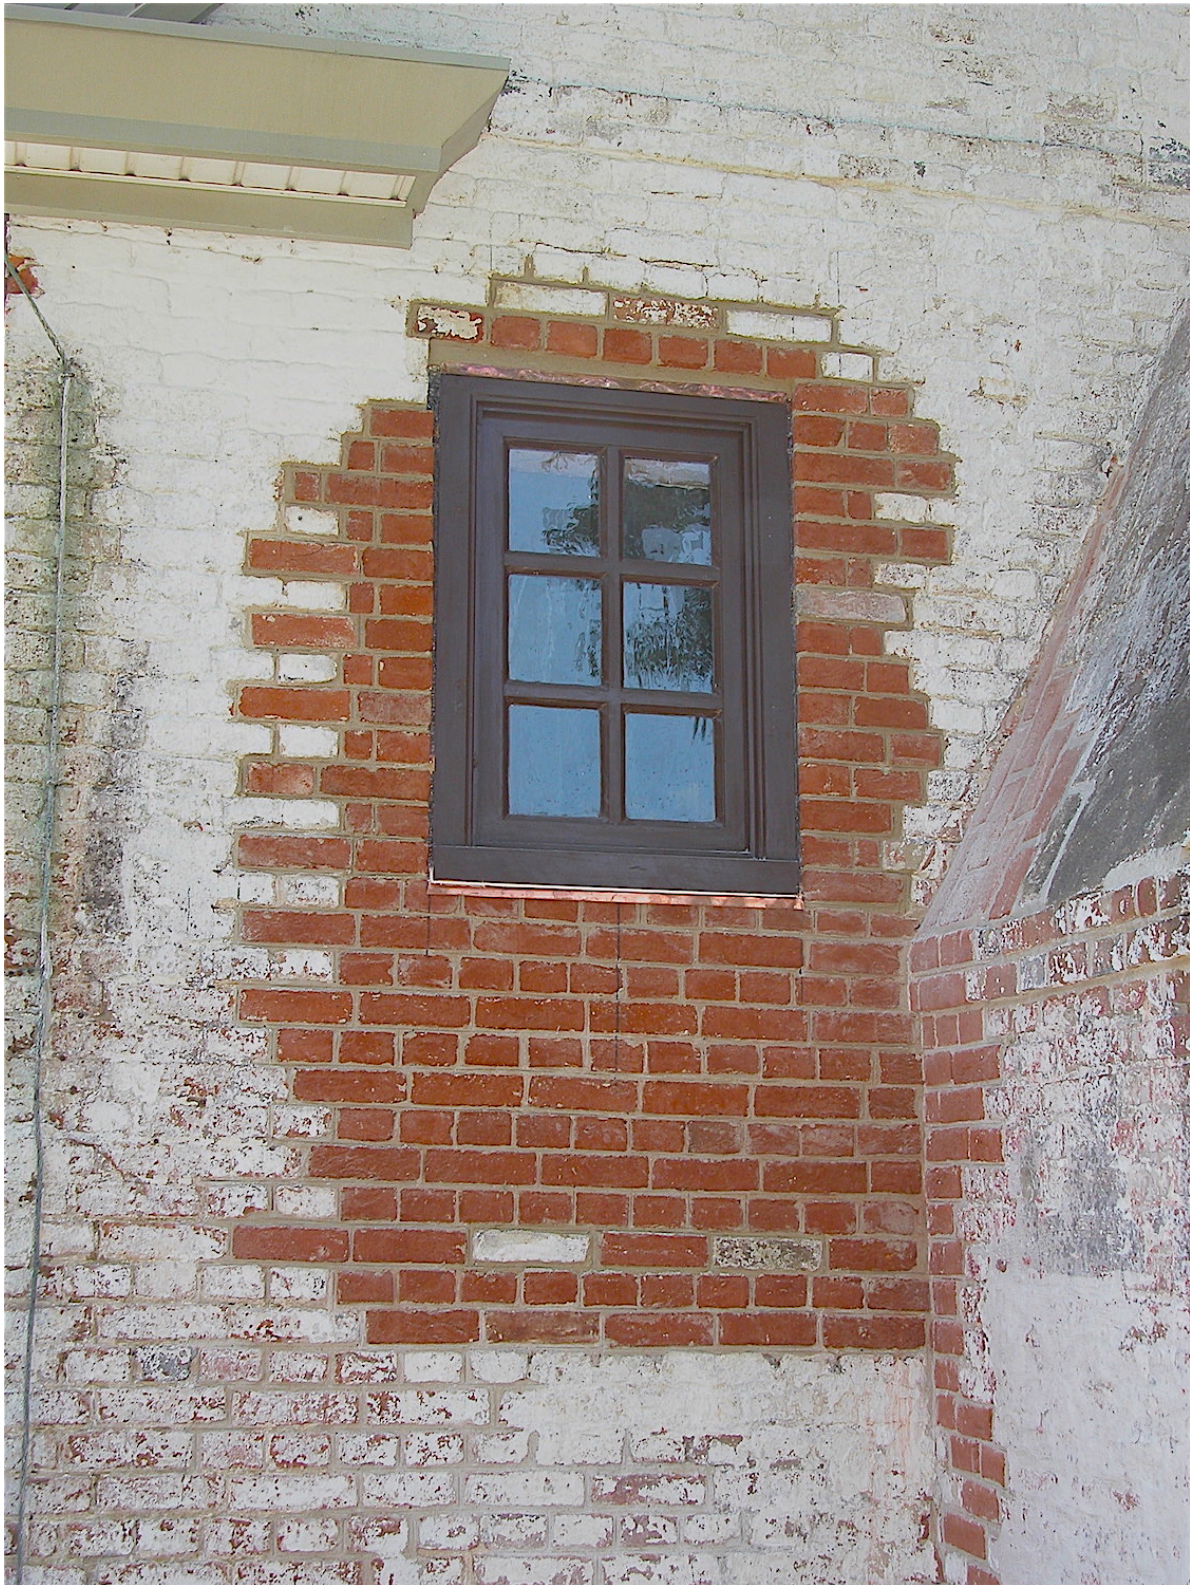
Figure 29 shows the restored south window in the east endwall (Fig. 29, Exterior view of restored window).

Note the tapered top mortar joint over the window. The bottom of the rough opening is level and both sides are plumb. The window frame is square and is set plumb and level in the opening. This mortar joint was the concession to the settled endwall without removing and resetting more original brick above. Figure 30 is the interior view of the set window before installation of trim.

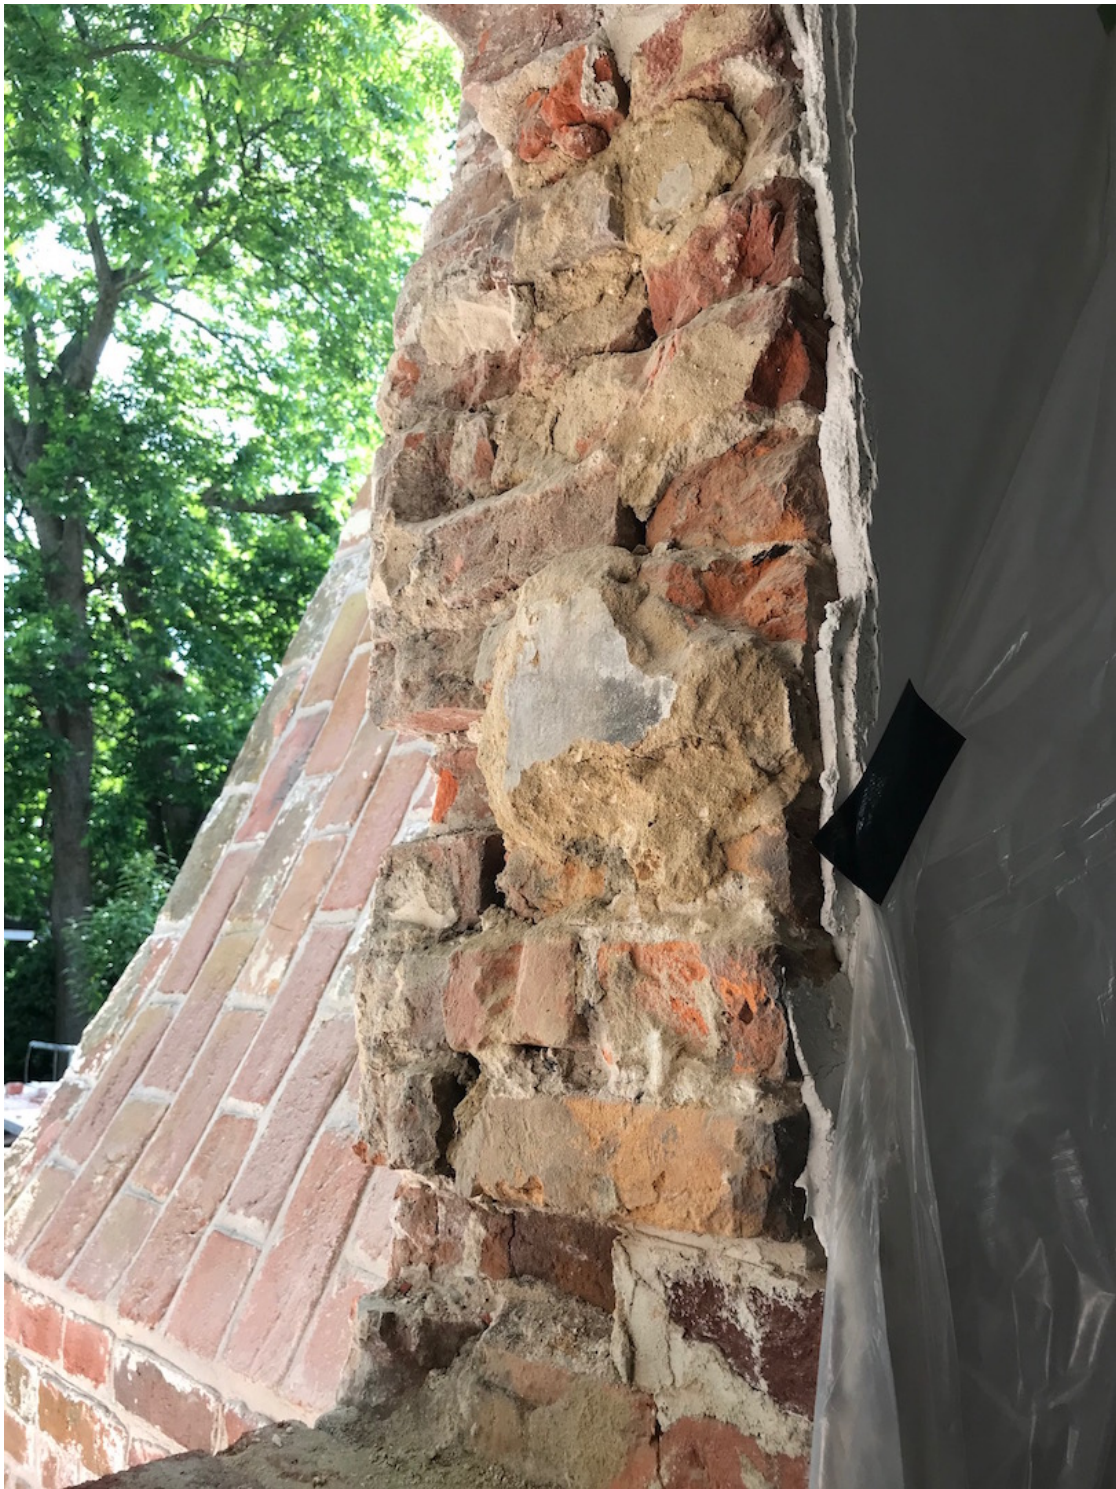
Figure 32

When the post-1870 window was removed to install the proper north window, an interesting artifact of the first-period window was found, a section of original cheek plaster (Fig. 32, Remnant of original cheek plaster).

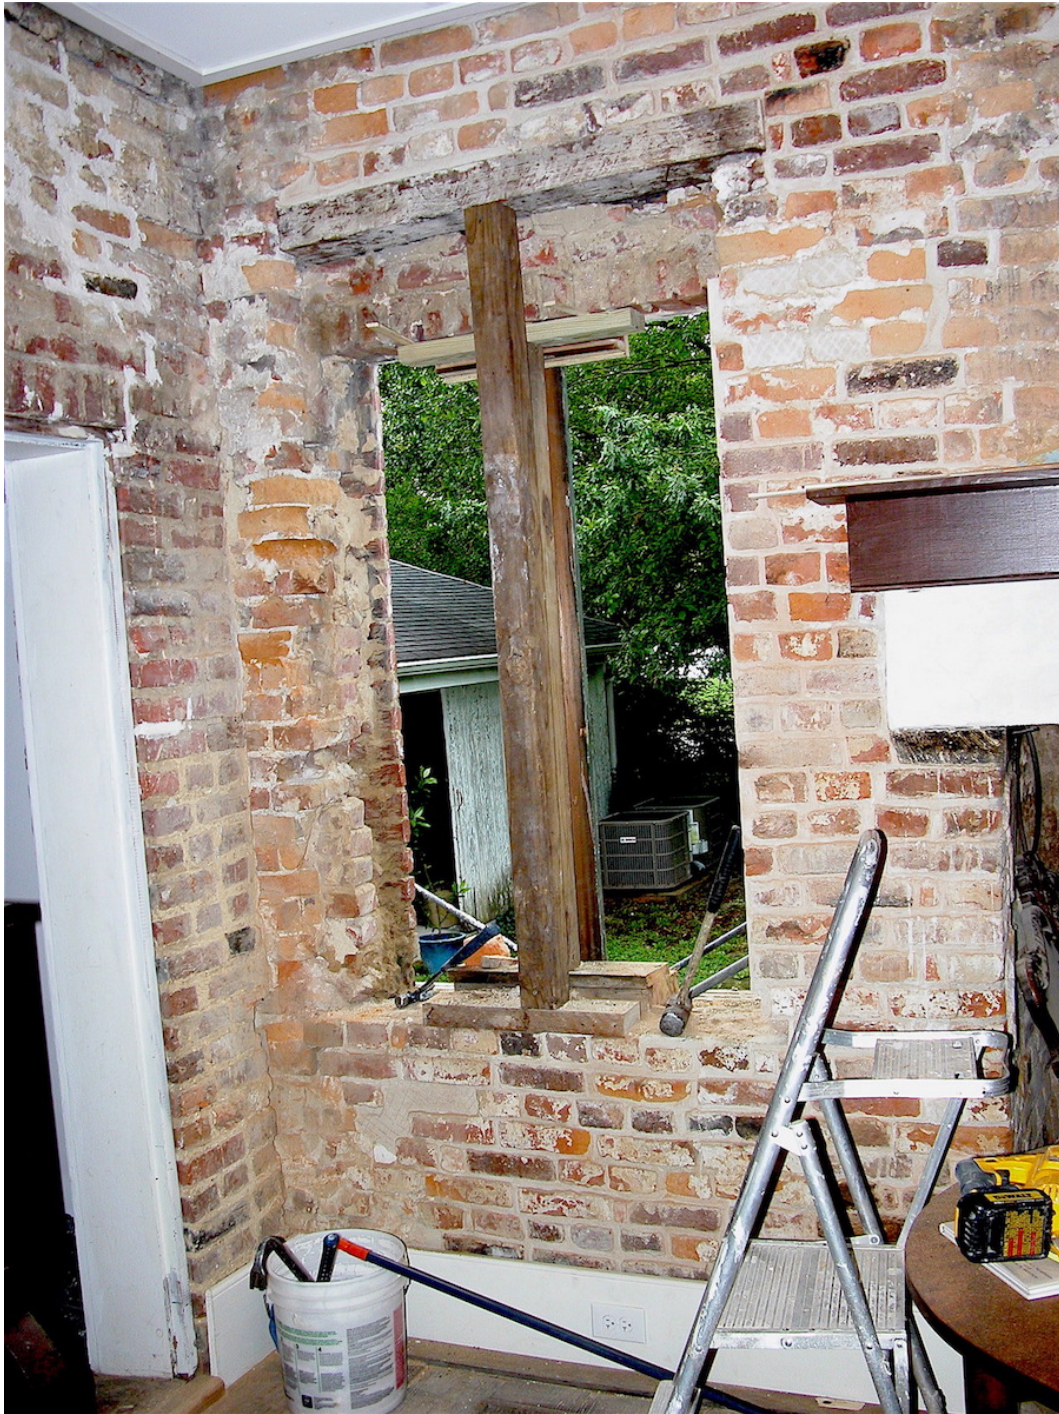
Figure 33

The south window in the west endwall was fraught with its own problems. When the original small window was replaced with the post-

1870 window, the installers removed the interior brick wall support for the left end of the lintel. This resulted in the lintel and the above brickwork sagging (Fig. 33, Unsupported left end of lintel).

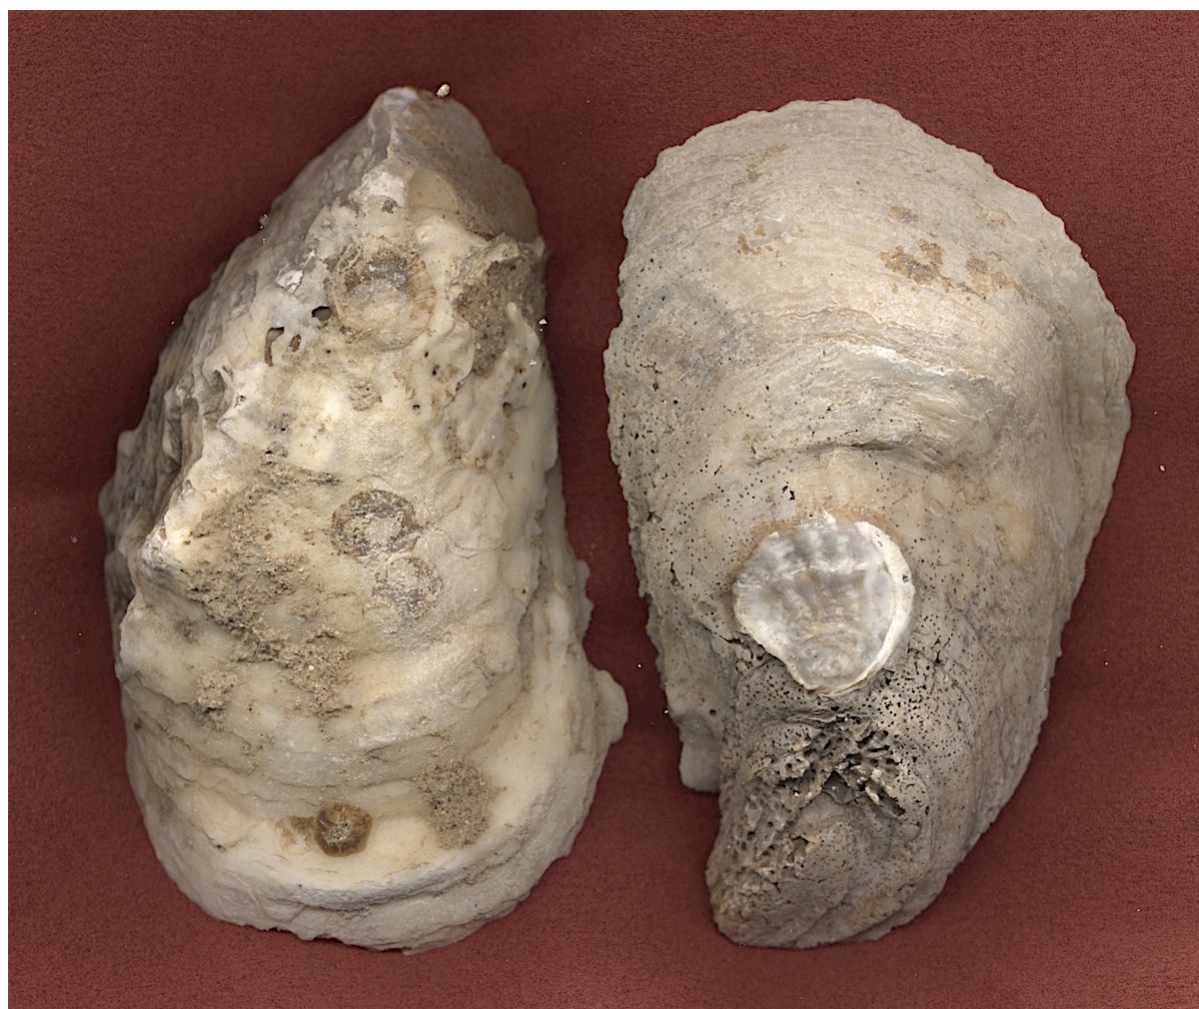
Figure 35

While our team masons were removing a large infill mortar joint above the lintel, they discovered several whole oyster shells imbedded in the mortar. These shells were used as shims in the sloppy mortar joint by the installers of the post-1870 window, **not** by the original Fox Hall masons (Fig. 35, Oyster shells used as shims in mortar joint).

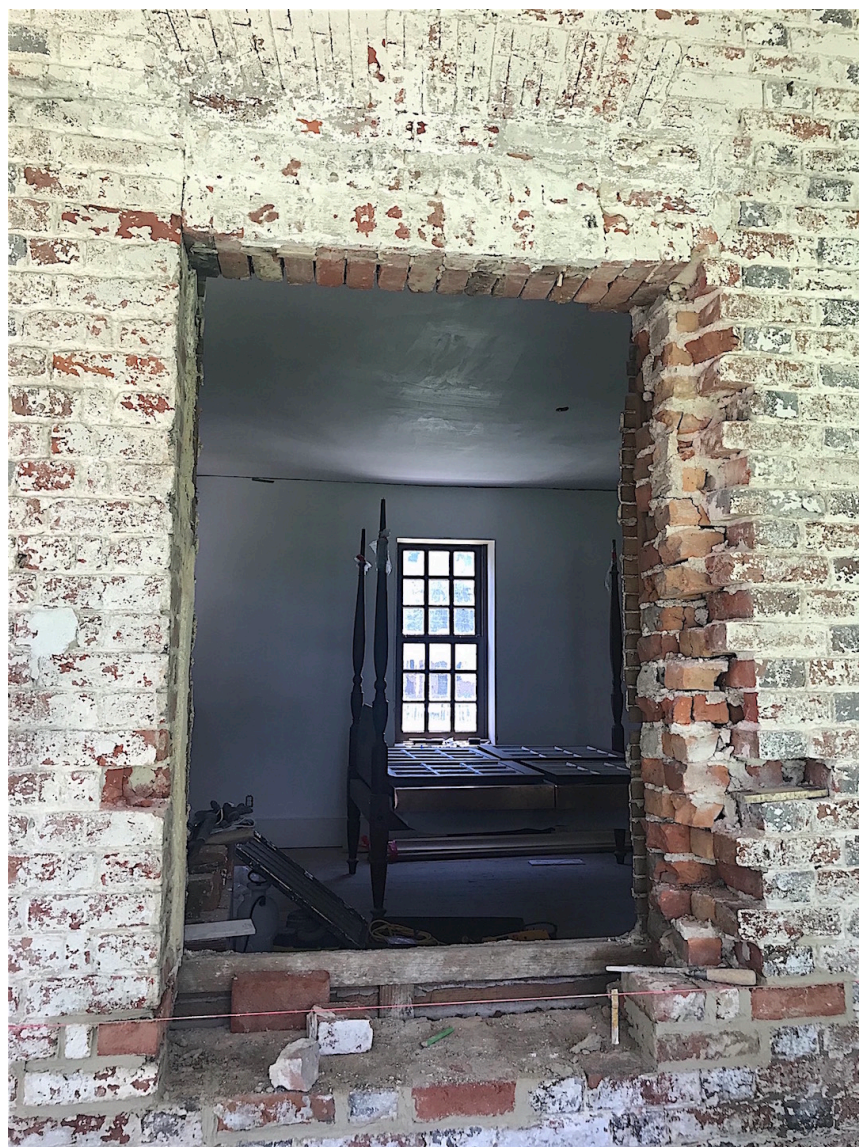
Figure 37

As previously discussed, the four large windows across the front of Fox Hall match the window in the south wall of the hall (See Figs. 5, 13, & 14). While the front windows did not retain the header of the original window frame as did the south hall window, their jack arches are intact, as are one jamb of each rough opening and the bottom course of the openings. In these windows, our masons had to remove the infill brick above the post-1870 windows and restore the jambs the installers of these windows chopped out or damaged during placement of the post-1870 windows (Fig. 37, Restoration of the damaged rough opening).

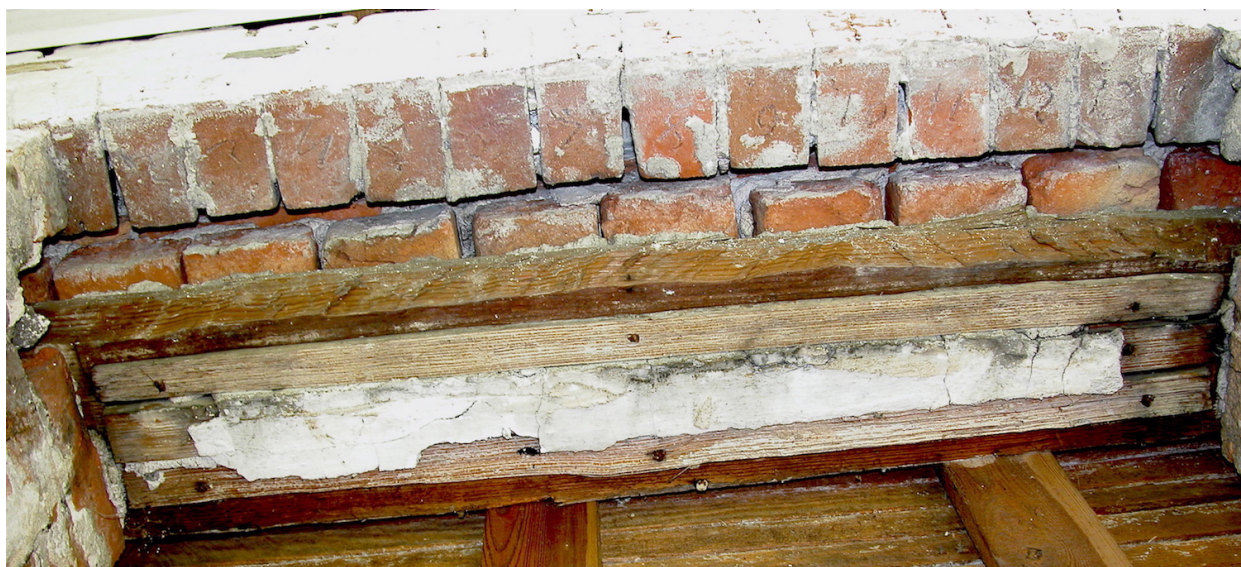
Figure 38

To the amazement and delight of the restoration team, Fox Hall continues to reveal its secrets. After the team masons removed the post-1870, northwest, front window and the brick infill above it, the bottoms of the bricks in the jack arch were exposed. The bricks are numbered 1 through 14 in Arabic numerals. These numbers were scratched into the bricks before they were fired. In addition, there are three pieces of first-period lath with remains of original plaster intact, nailed with wrought nails to the bottom of the hewn lintel (Fig. 38, Numbered jack arch bricks and lath with plaster [zoom in to see better]). Original lath also was encountered on the lintel in the back window in the hall (See Fig. 10).
