Fox Hall - *Part 8*, Windows

By Jim Melchor, Tom Newbern, "Cheetah" Waller, and Dick Gresham

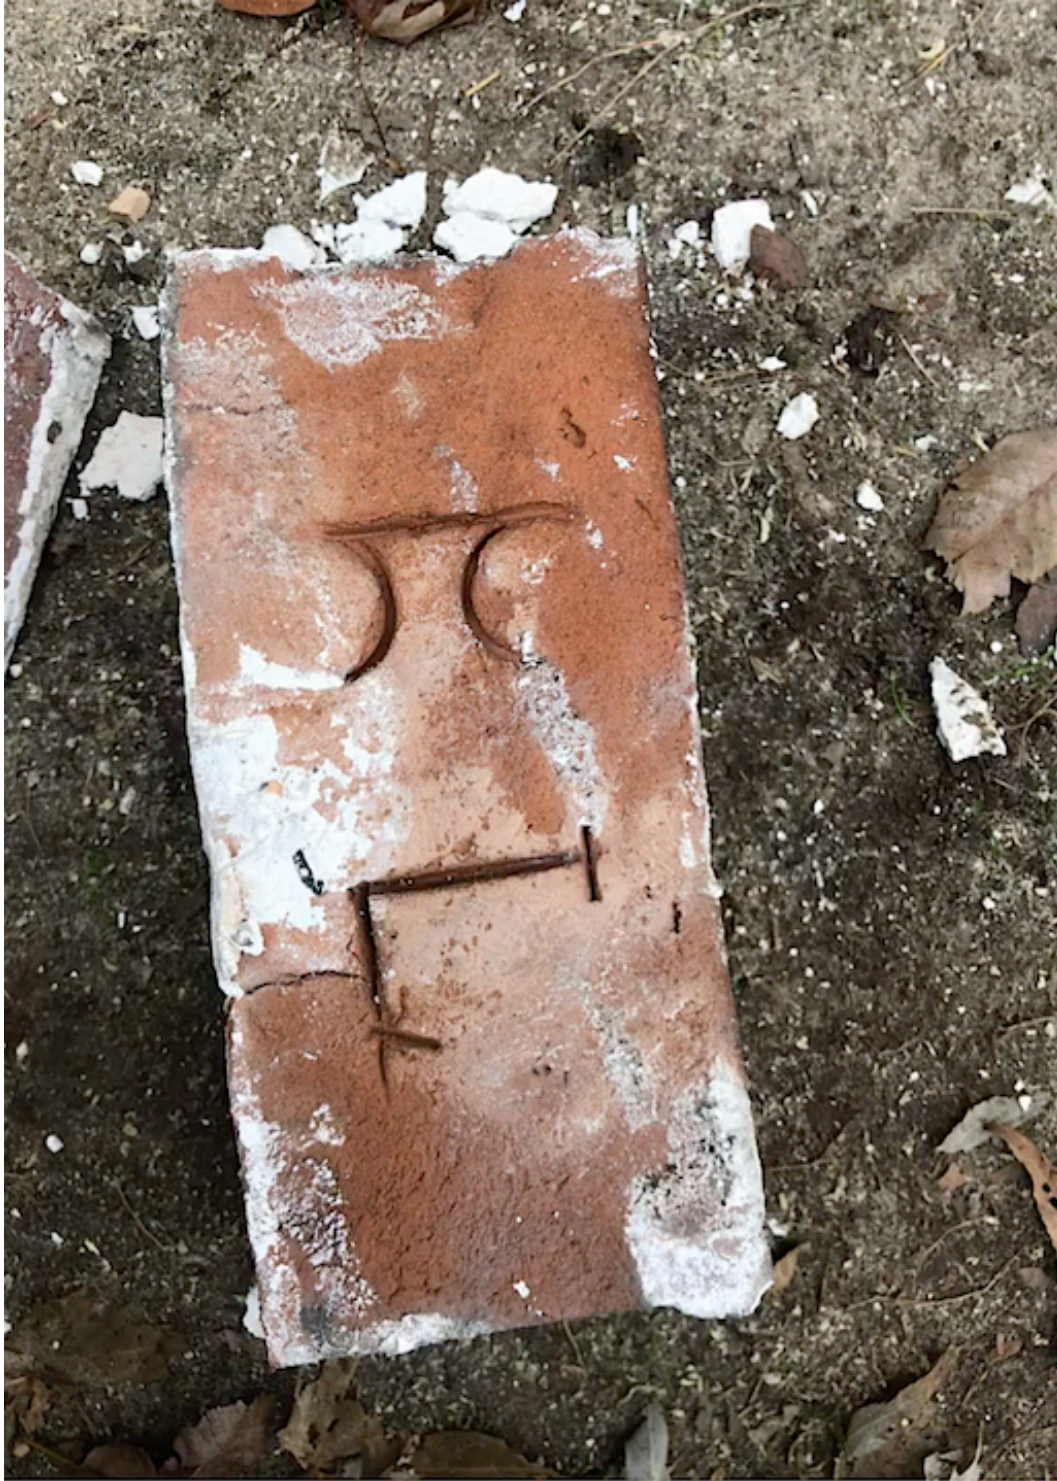
Figure 39

Earlier in the restoration project during repair to the jack arch over the front door, several marked bricks in the jack arch were encountered. These bricks, too, were marked prior to firing (Fig. 39, Marked brick in

jack arch over front door). These marks are symbols rather than numbers.
