Fox Hall - *Part 10*, Jack Arch Segment "8L"

By Dick Gresham, Jim Melchor, and Tom Newbern

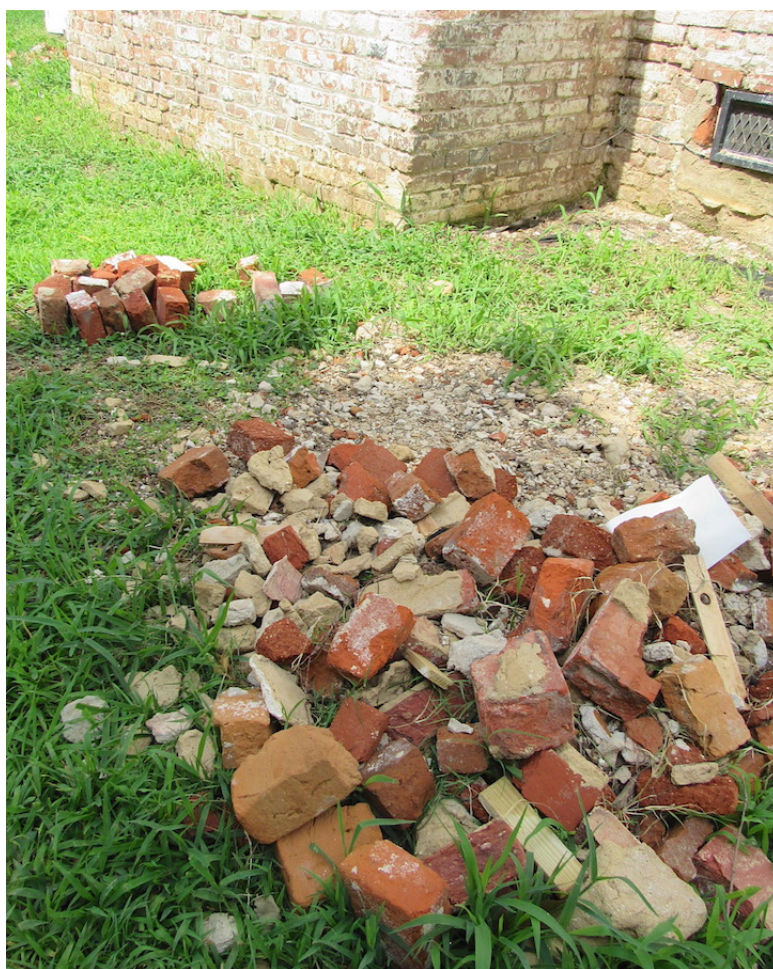
Figure 1

A secondary product of the masonry restoration portion of the overall Fox Hall project is numerous piles of brick and mortar debris surrounding the house (Fig. 1, Brick debris piles).

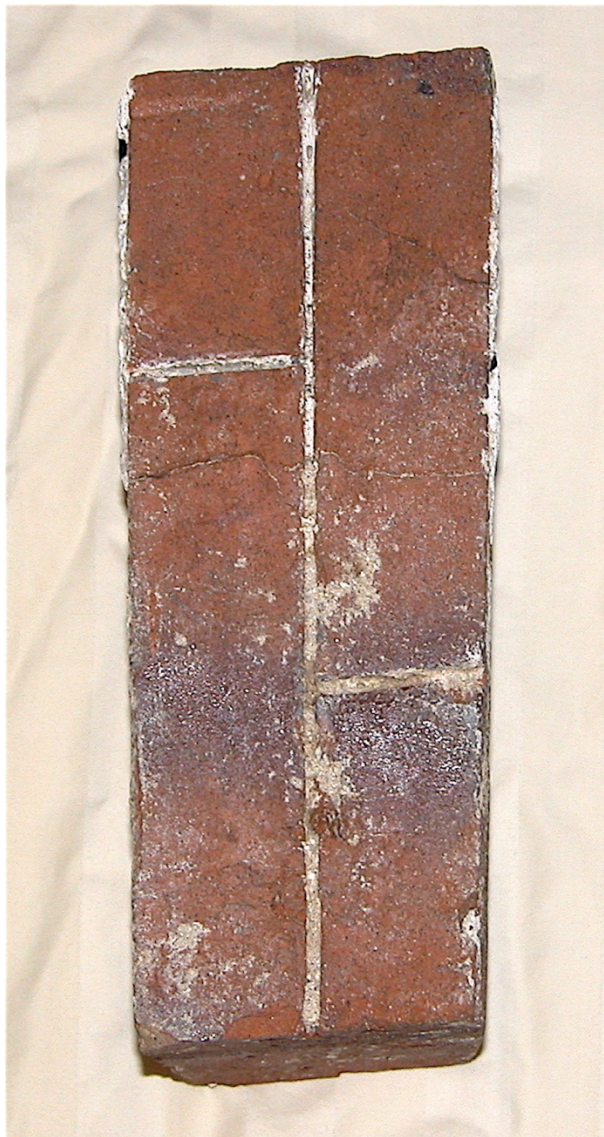
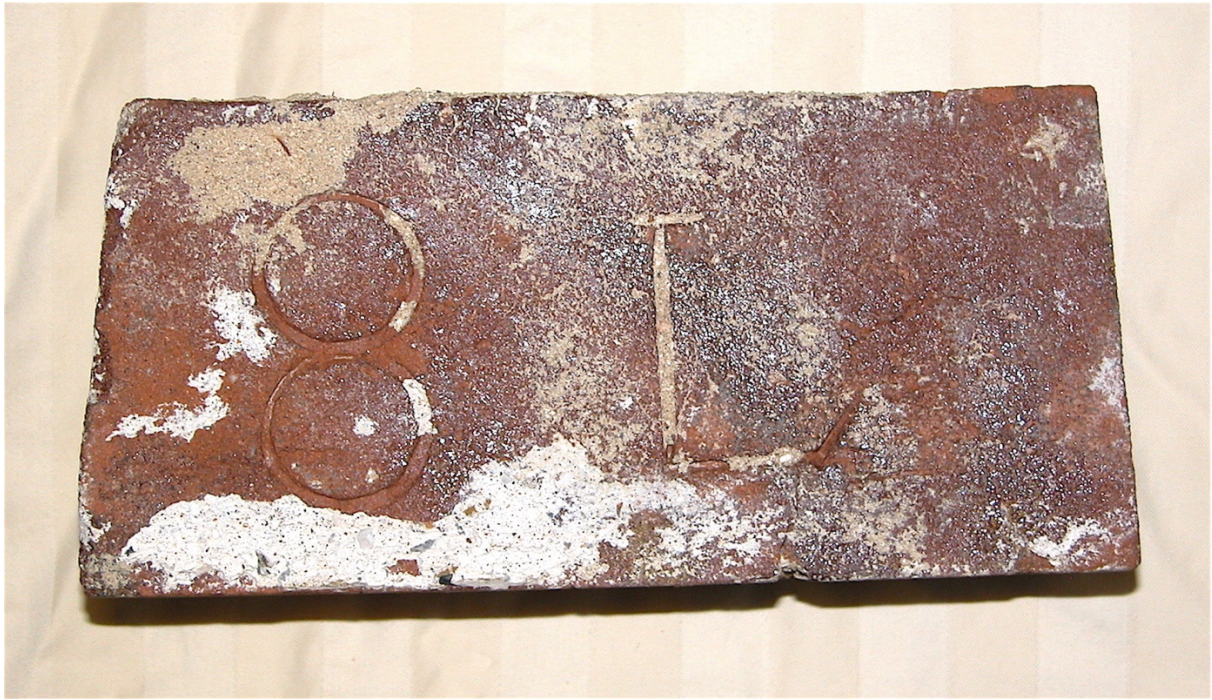
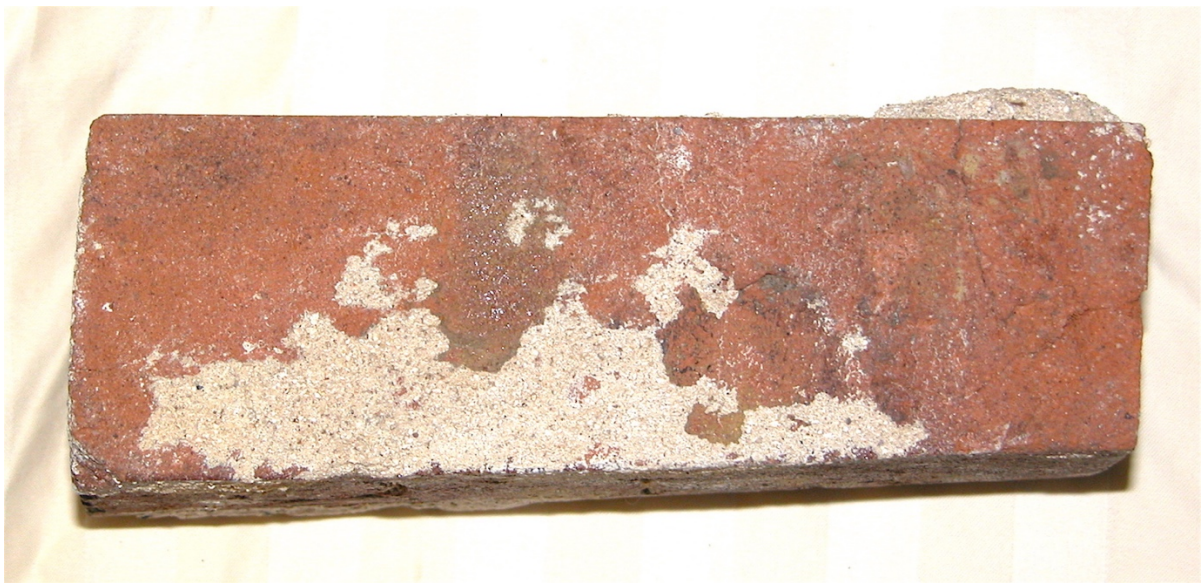
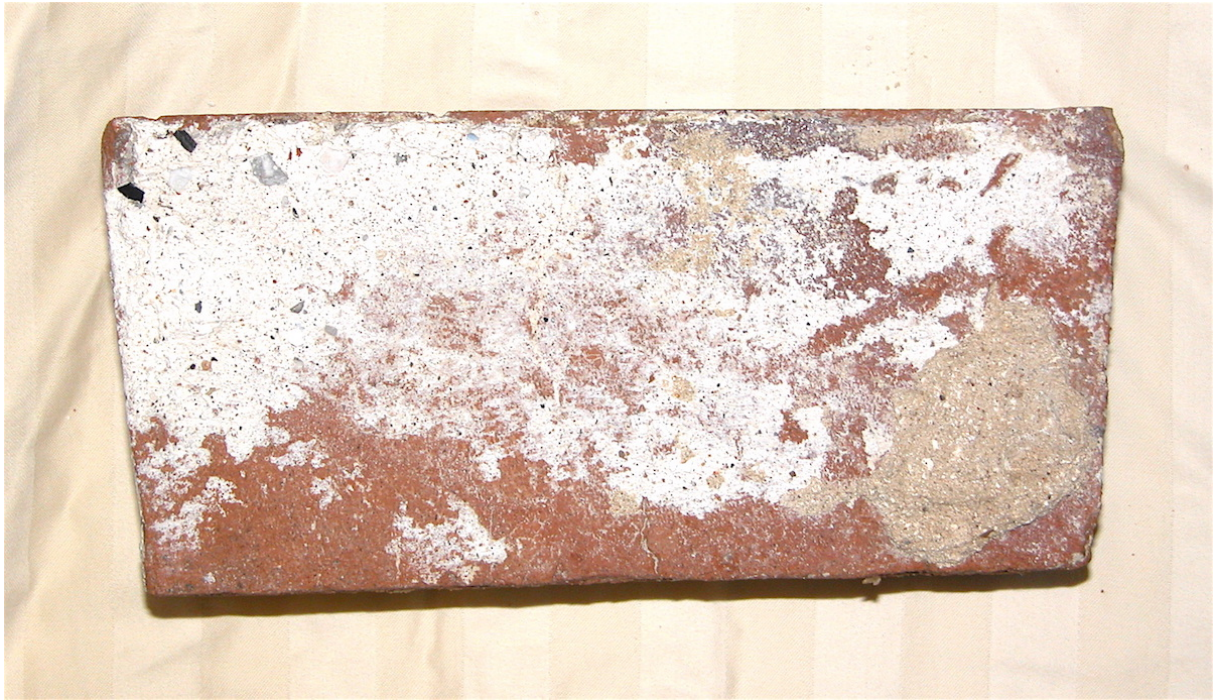
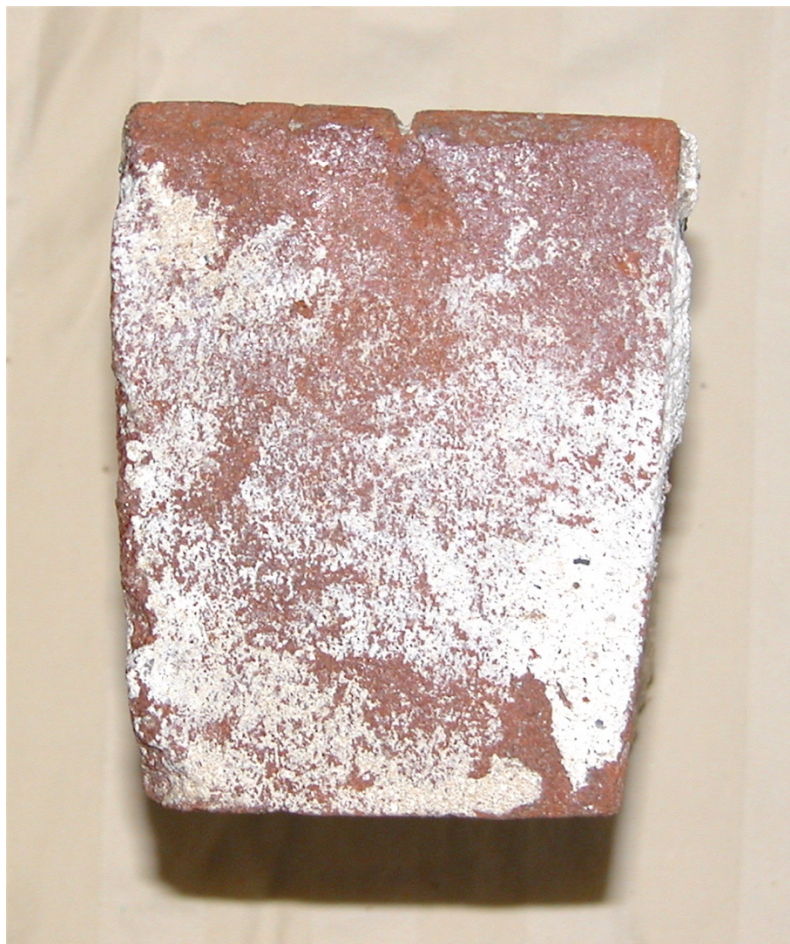
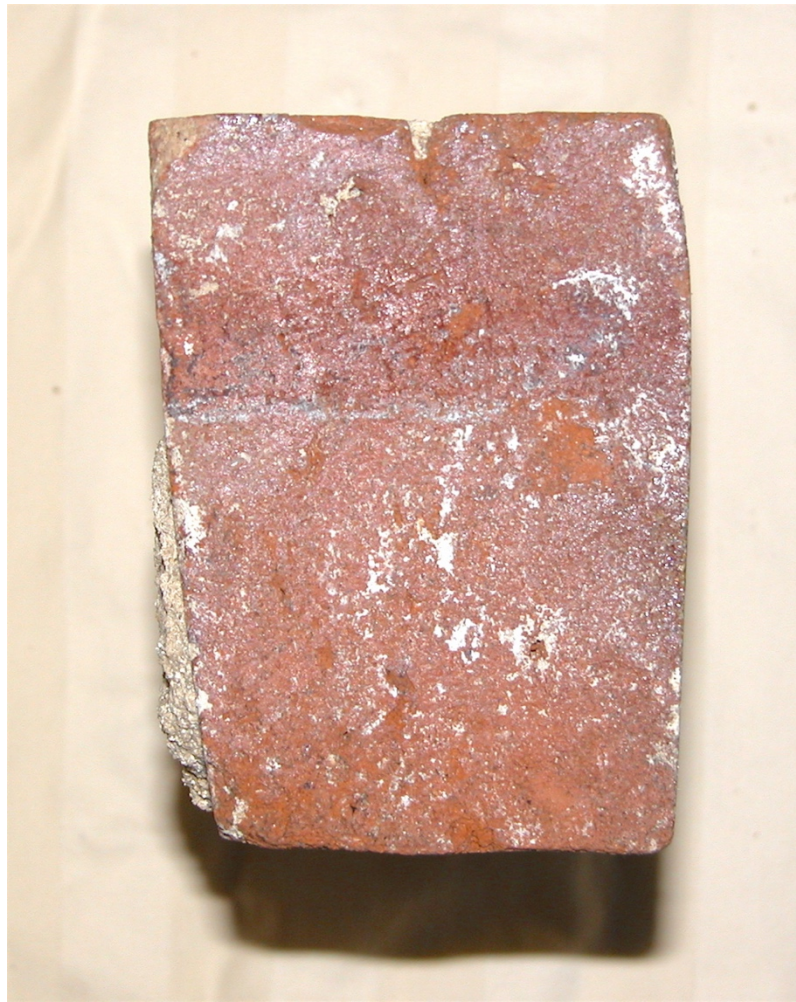
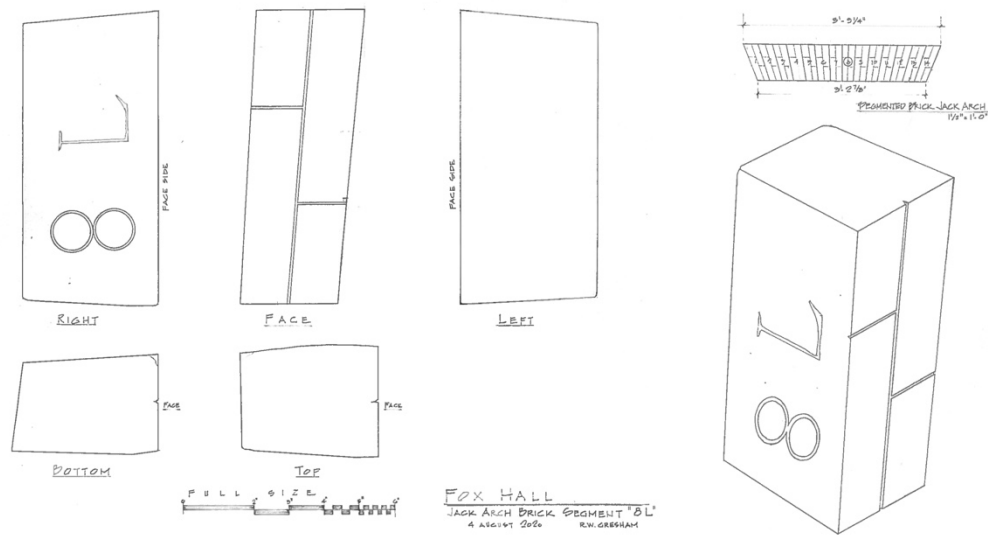
brick emerged from the debris. However, on second look, it became clear that it was an unexpected and interesting find, an original jack arch segment. Inscribed into the side of the brick is “8 L” denoting the segment is from mold set eight and was for position "L" of a jack arch. (Fig. 3, Face) (Fig. 4, Marked proper right side) (Fig. 5, Back) (Fig. 6, Proper left side) (Fig.7, Top) (Fig. 8, Bottom) (Fig. 9, Measured drawings of jack arch segment).

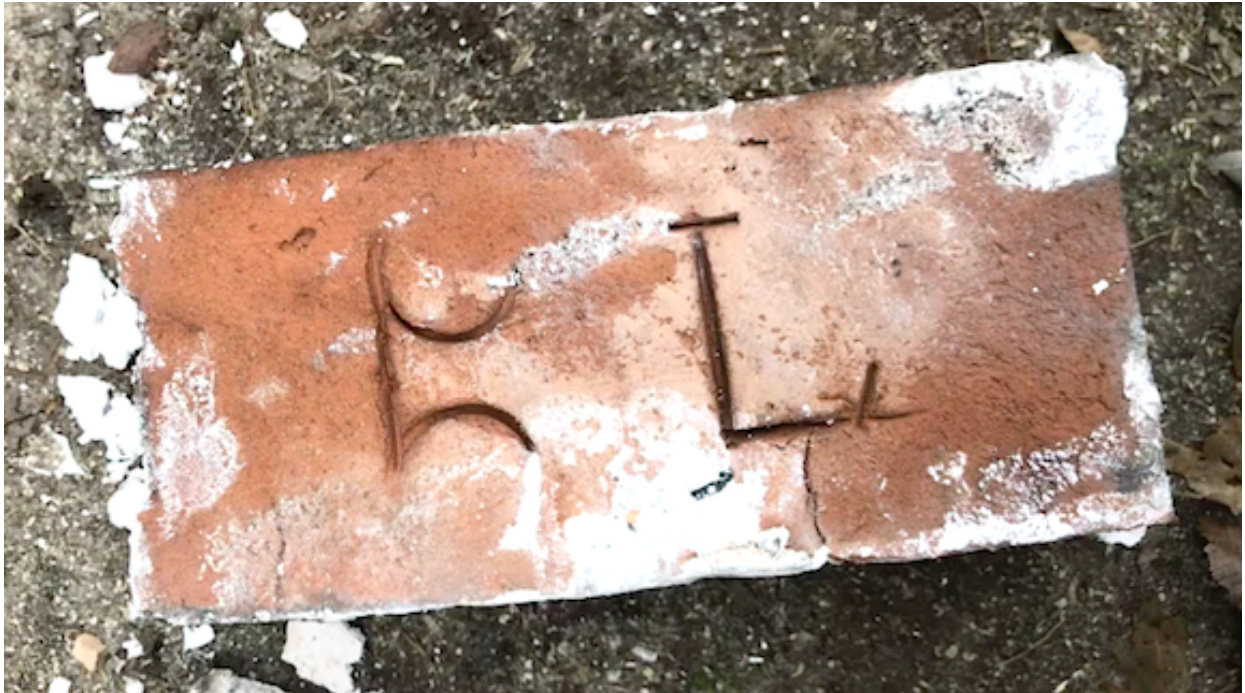
Figure 10

A similarly inscribed segment from the front-door jack arch was photographed prior to the restoration team coming on site (Fig. 10, Front-door jack arch segment) (See **Update** at the end of this article for a discussion of this segment and others from the front-door jack arch at Fox Hall).

On this particular segment, the first mark is a "5" indicating mold set number five. The "L" denotes it fit only in that particular slot in the jack arch over the front door of Fox Hall. Important to notice is that the "L" appears to be by the same hand as the "L" in the newly discovered jack arch segment (See Fig. 4). These marks were incised and/or impressed into the bricks before they were fired.

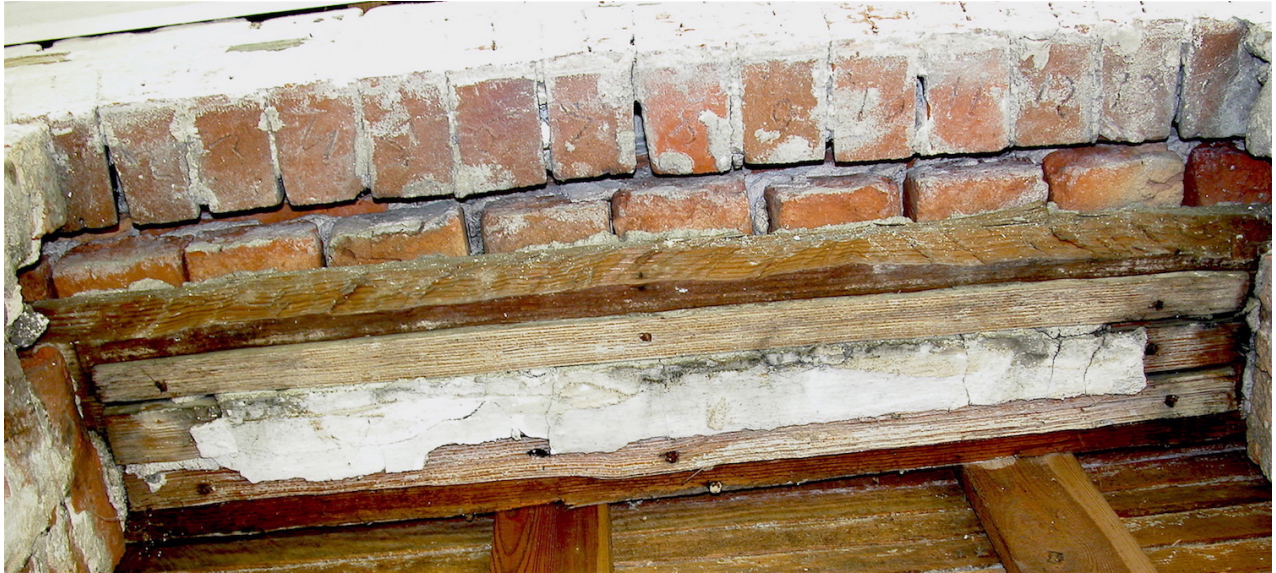
Figure 11 (Zoom in to enlarge for better view.)

There are complete jack arches over the five large first-floor windows and the front door at Fox Hall. As noted in Fox Hall - *Part 8, Windows*, the jack arch of the northwest front window has its segments numbered across their bottoms in Arabic numerals, 1 through 14 (Fig. 11, Jack arch segment numbers of northwest front window). These numbers were incised into the bricks prior to firing.

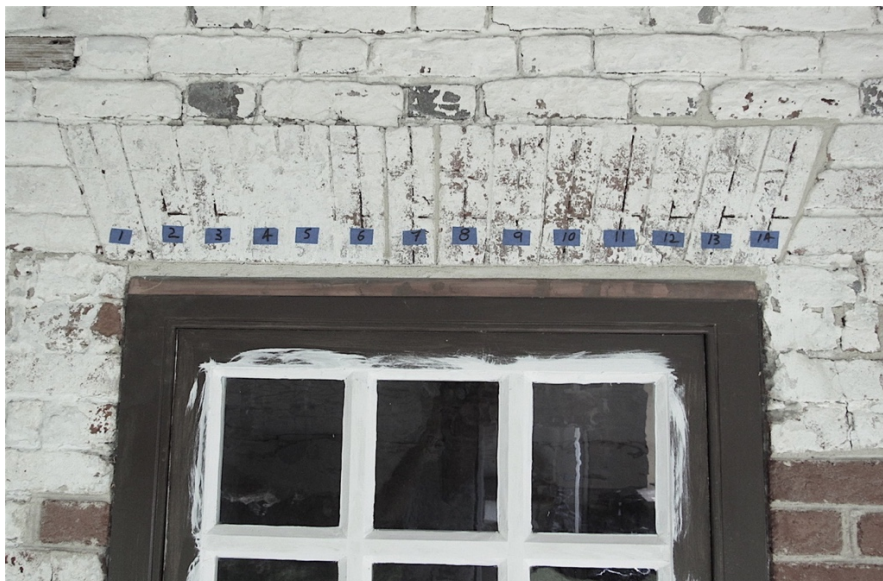
Figure 12

In Fig. 12, these numbers are transferred to the faces of the jack arch segments (Zoom in to enlarge for better view.).

The “8 L” segment initially perplexed the team manager, as all the known Fox Hall jack arches had their "L" segment intact. Based on the section numbers in the jack arch in Fig. 12, the "L" position is the corresponding "12" slot. The manager compared this newly found segment to the "L" or "12" segment in the arches above the five large window openings. It matched them precisely. The jack arch above the front door is considerably wider with more segments, and there was no match. This confirmed that segment "8L" was from a jack arch at Fox Hall, the same size and containing fourteen segments, as those above the large windows. So, where was it located originally?

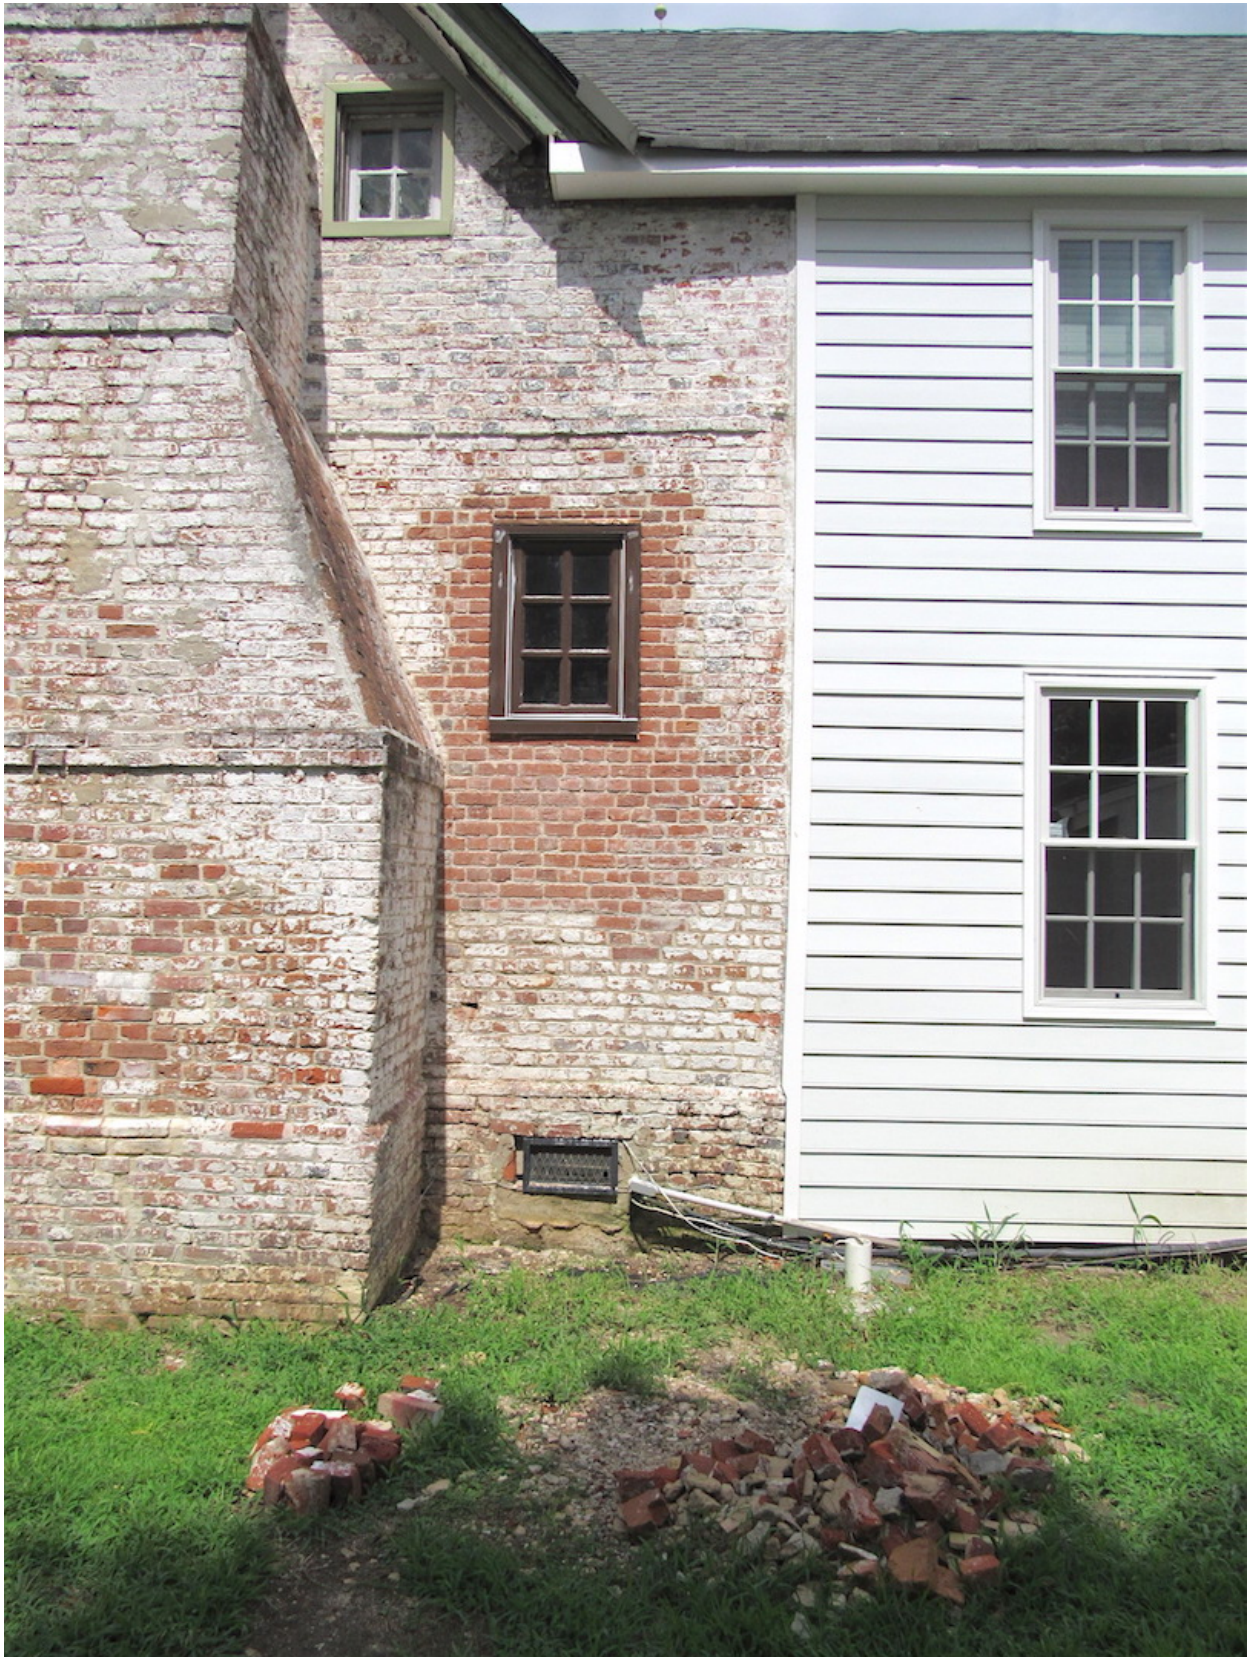
Figure 13

It was during the annex's construction that the masonry corner of Fox Hall was poorly rebuilt using mostly common brick, salvaged old brick, and Portland cement mortar. It is likely that the "8L" segment was incorporated in this corner rebuild and was recently removed unnoticed and discarded by our team masons during the restoration of the small window (Fig. 13, Southwest house corner, annex, and debris pile).

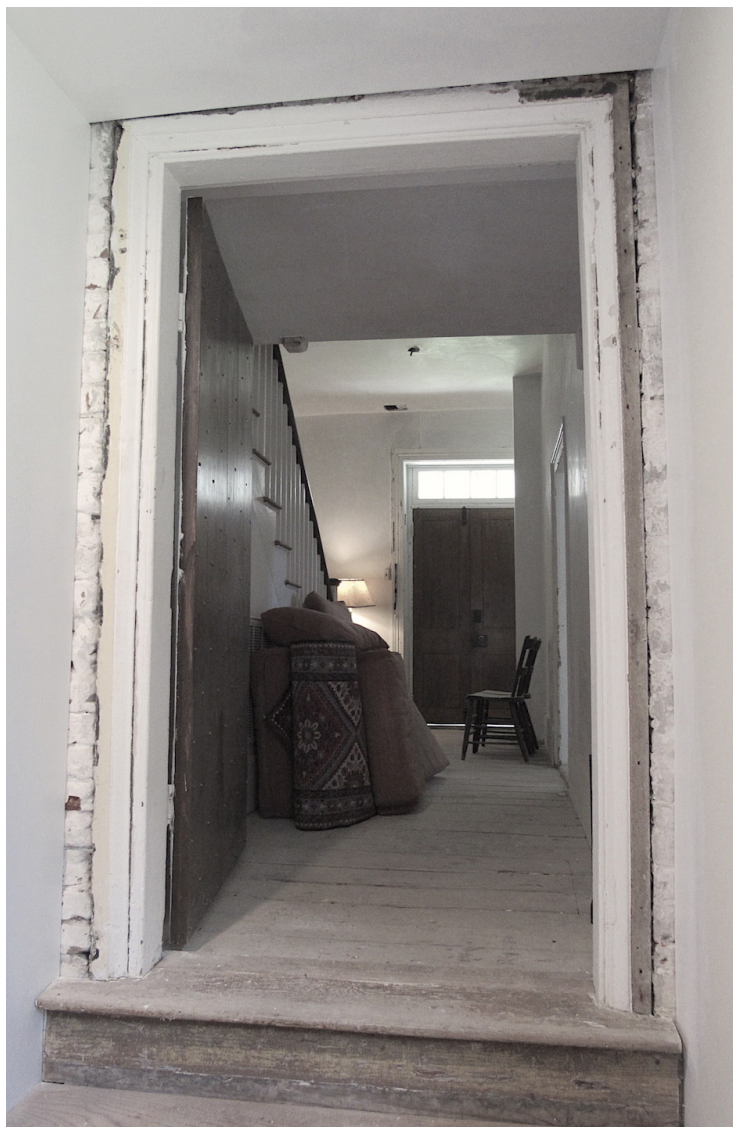
Figure 14

The south exterior door of the passage retains its original frame; however, the bathroom annex's ceiling structure abutting the exterior side of this frame obscures the brick above the frame's head (Fig. 14, Exterior of passage back door).

Further, the width of the rough opening for this door is forty-five inches, substantially wider than the other masonry openings in Fox Hall accommodating fourteen-segment jack arches.

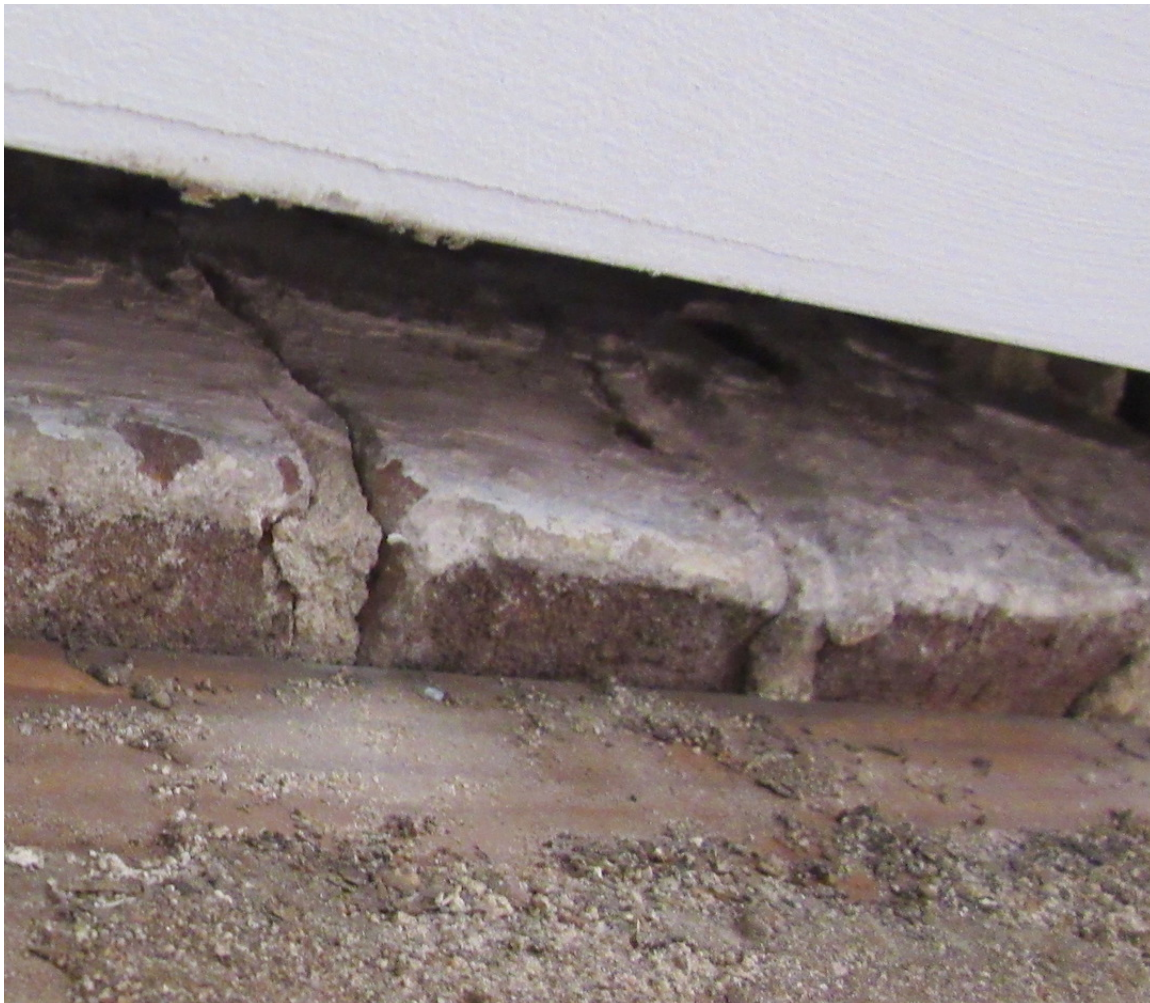
Figure 15

The minimal view of the masonry above the door frame head obscured by the bathroom annex framing provides what appears to be the bottoms of several possible jack arch segments (Fig. 15, Possible jack arch segments over passage south door).

In an attempt to verify possible jack arch segments above the passage door frame, flooring was removed at the stair landing/bathroom doorway above the passage door. However, this was not successful. As best as could be discerned, any jack arch would have been a course or two below the masonry seen in this opening. It is also possible that all the brickwork above the door frame was disturbed and rebuilt with the wall penetration during construction of the bathroom annex. In any case, the width of the south exterior door of the passage would preclude a jack arch containing the "8L" segment. That conclusion left the kitchen chamber opening as the possible original location of the "8L" segment.

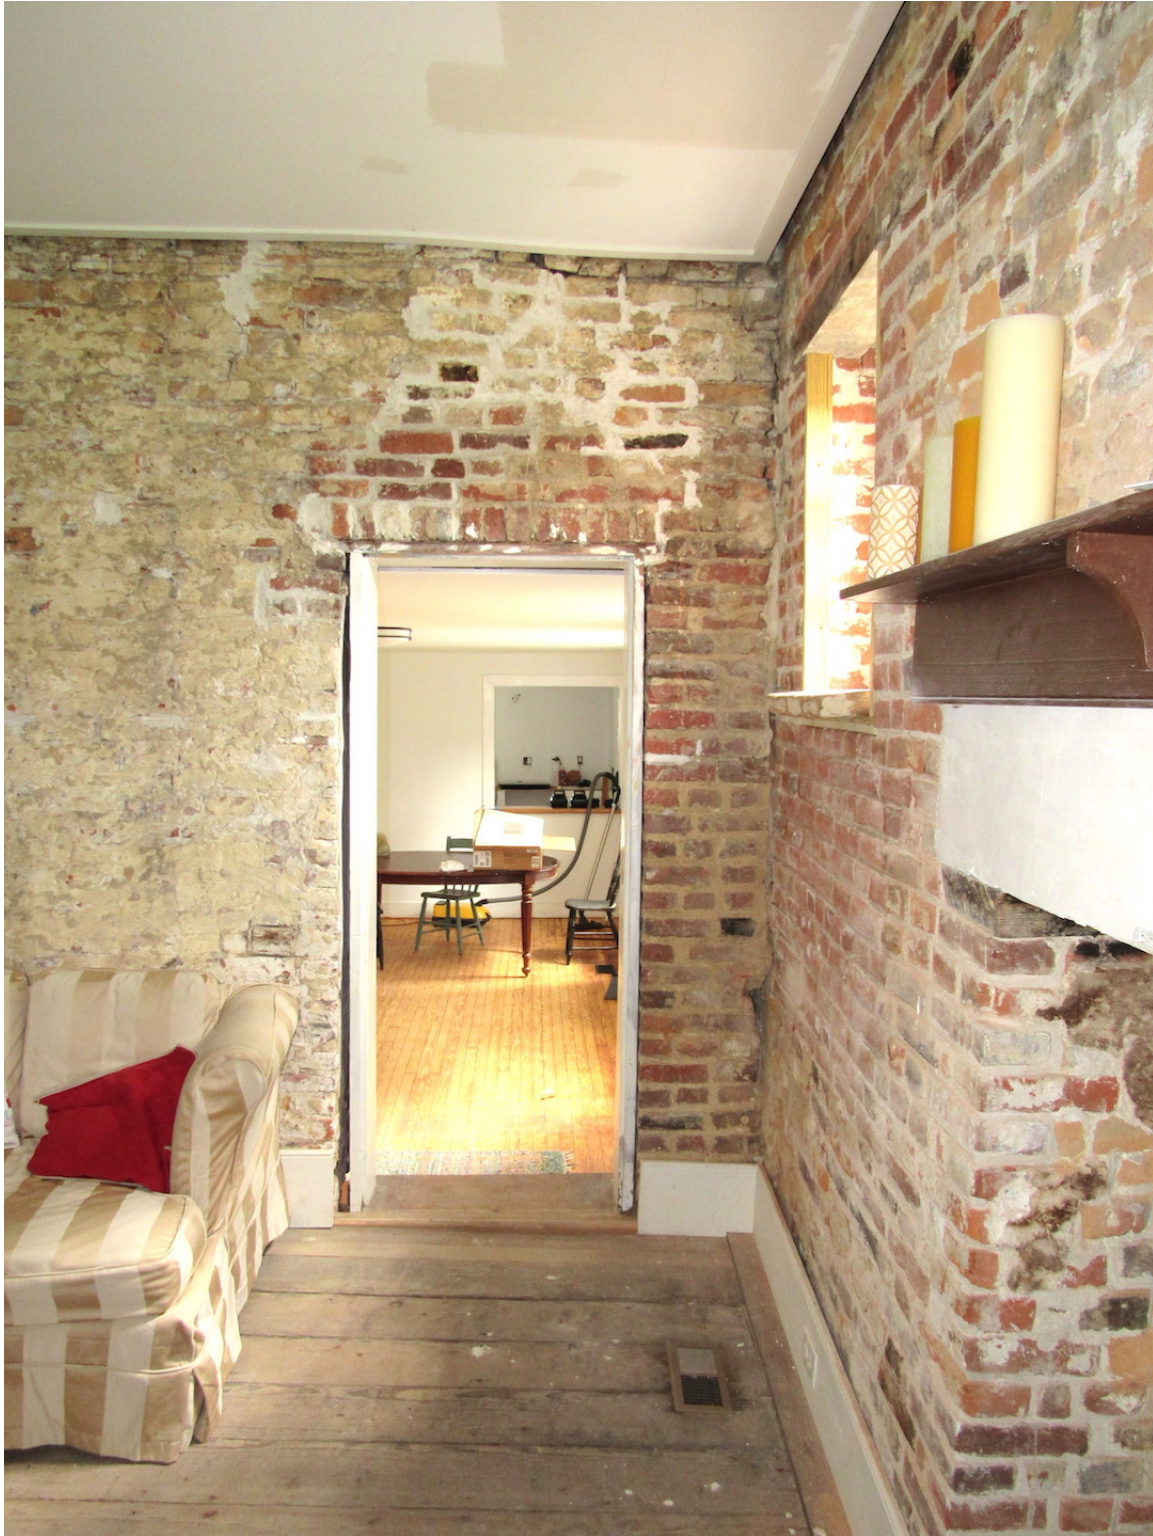
Figure 16

The kitchen chamber opening is rife with problems. The head, one jamb, and the sill had been rebuilt, most likely in the circa 1900-1915 era. While the present opening is approximately the correct width, thirty-seven inches, a classic triangular stress zone in the masonry above the opening is visible and shows a number of attempts at tuck pointing and parging. This distress was caused by the head being poorly rebuilt without a proper bridging arch or lintel (Fig. 16, Damaged brickwork above kitchen chamber doorway, viewed from kitchen) (Fig. 17, Doorway to now-removed kitchen chamber, viewed from annex). Because of this rebuild no original brickwork or hints of an original arch were perceived.

There is some remaining evidence in the brickwork on the kitchen side that there was a five-inch high timber lintel spanning this rough opening about where there are now rowlock bricks in the repaired masonry (See Fig. 16 & blue tape on the right side of Fig. 19).

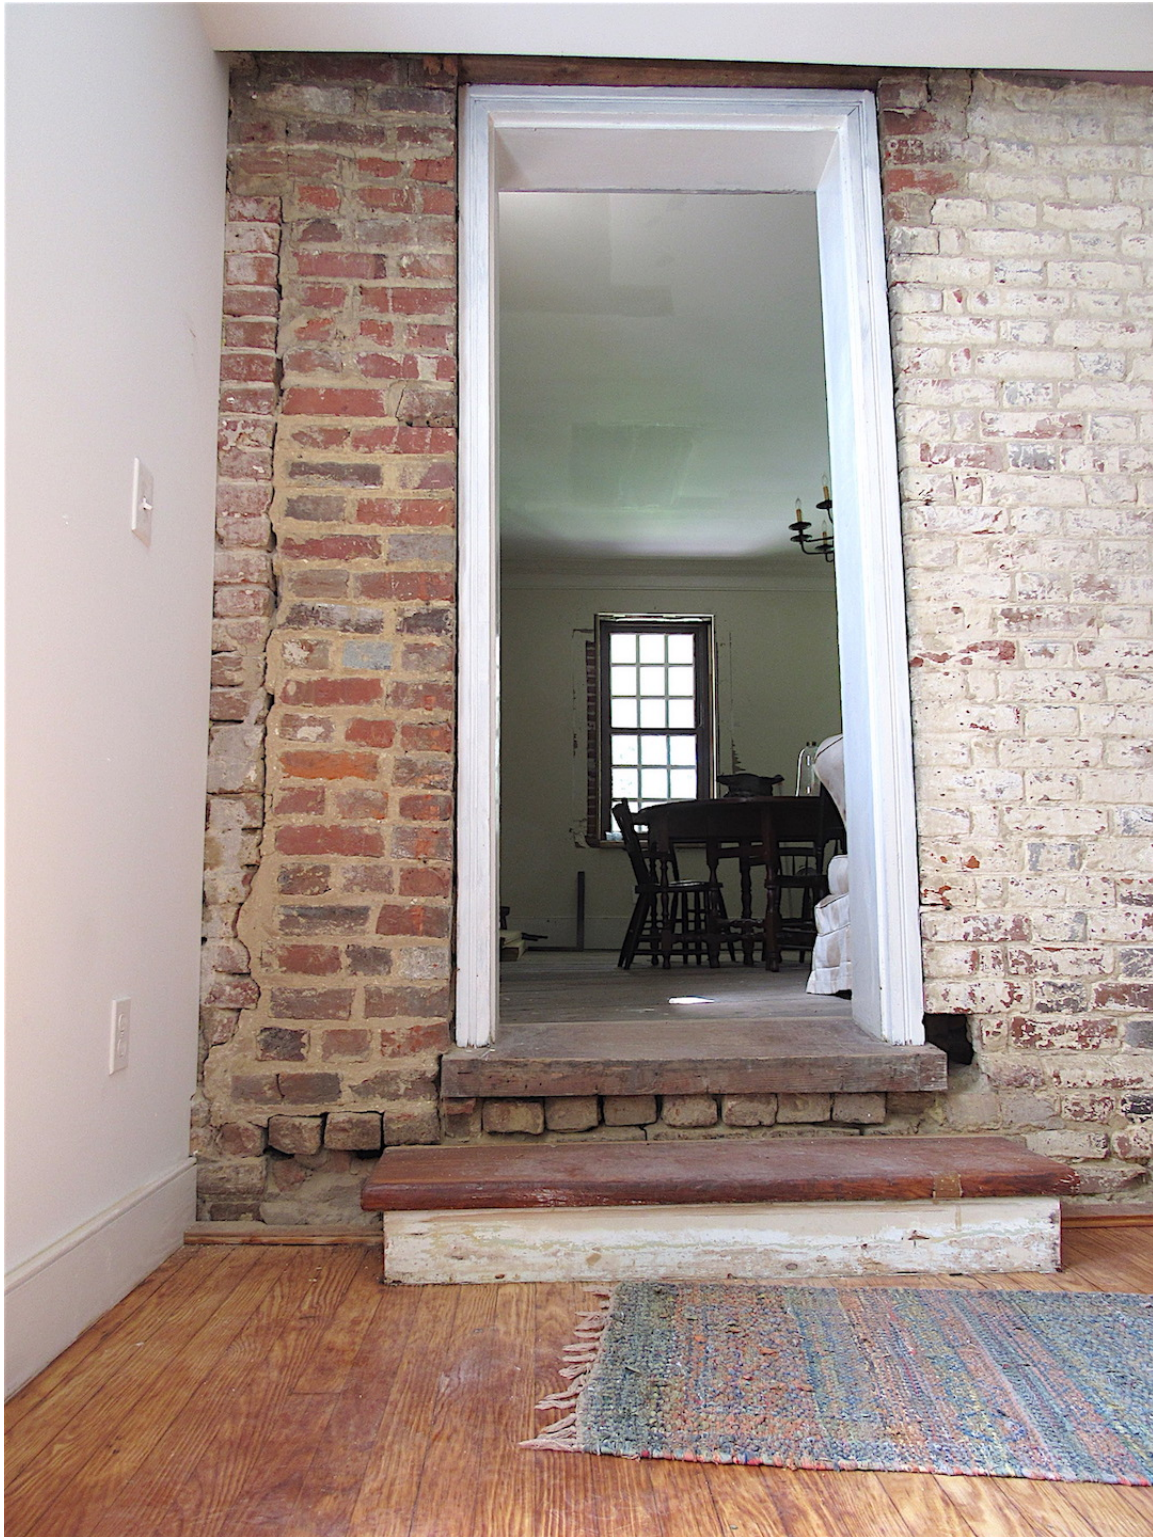
Figure 17

with original or early plaster and good square and plum corners. The plaster on the left jamb extends about nine inches of the thirteen and three-quarter-inch wall depth, just enough for a four and seven-eighth-inch deep door frame. This matches nicely with the original window frames and other two exterior doors frames at four and seven-eighth inches deep. The plaster stops just before six feet, eight inches. Also, slightly below and right of the proper left jamb, there is a joist pocket believed to be associated with the now-removed kitchen chamber (See Fig. 17).

The sill block (15"x 39" x 3"), while old, does not demonstrate the surface wear and tear one would expect after nearly three centuries (See Fig. 17). It probably is a second-generation sill block added with the circa 1900-1915 annex.

endwall at the corner, leaving a fifteen-inch-wide column floating between the house's corner and the former kitchen chamber's masonry opening (See Fig. 17). Existing bricks were re-used as filler in the new wall construction. The existing plaster and the delineation of original and repaired masonry convincingly indicate that a passageway approximately thirty-seven inches wide and six feet, eight inches tall existed with a jack arch bridging the opening.

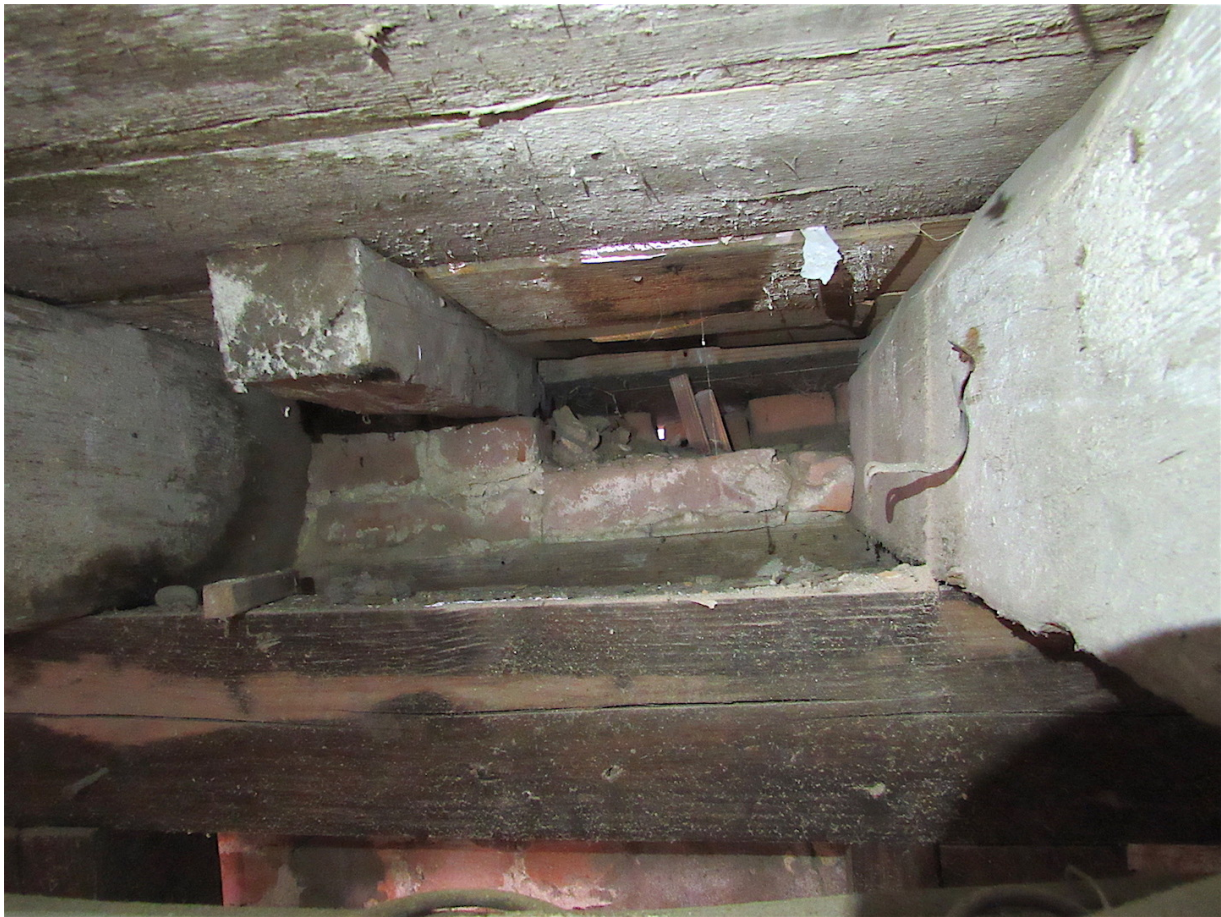
Figure 18

In the cellar, below the southwest corner of the kitchen, there is a forest of wires, ductwork, and structural repair beams, posts, and masonry work obscuring much of the view under the kitchen chamber opening. While investigating this area, a fascinating discovery was made. A hewn support strut, approximately four-inches square, is inserted mid-span between two joists partially under the left jamb of the doorway to the kitchen chamber (Fig. 18, Strut under left jamb). It was intended to add additional support below the left jamb and likely extended under the kitchen chamber.

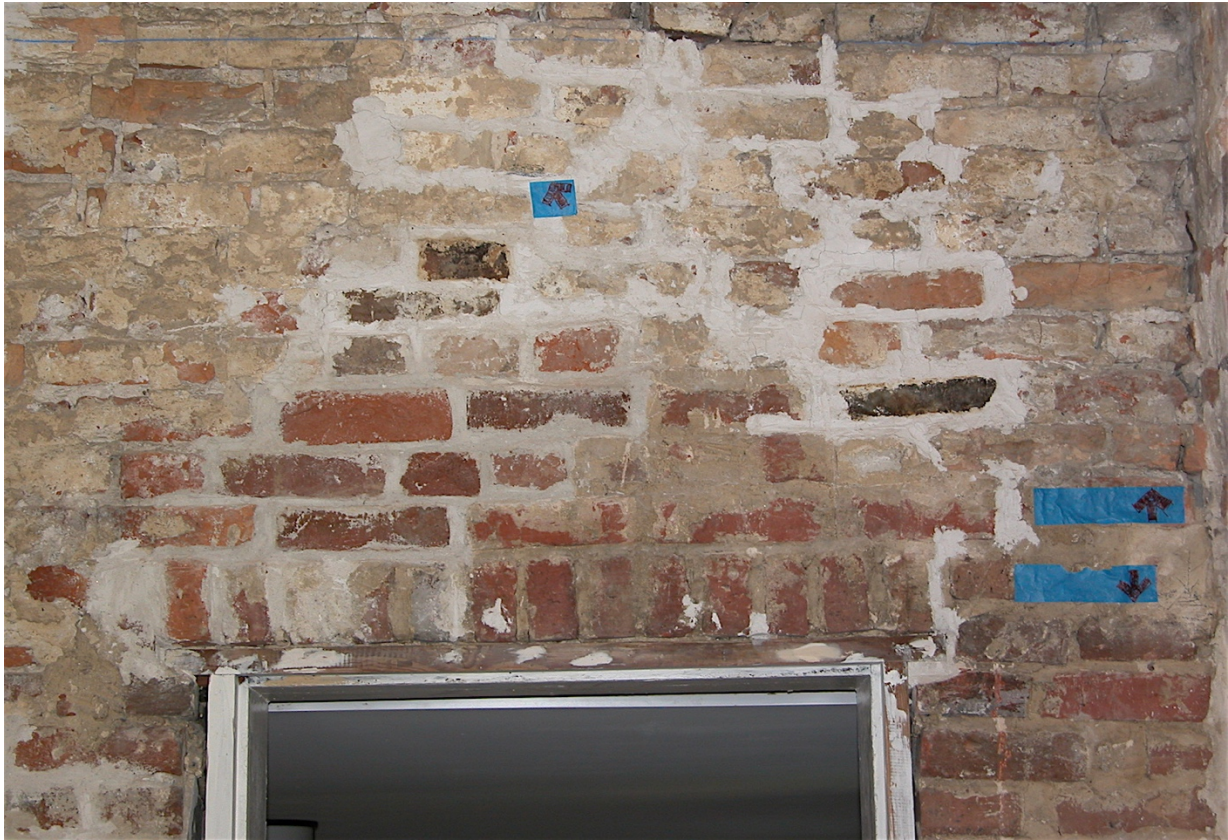
Figure 19 (Zoom in to enlarge for better view.)

Another question concerning this doorway must be addressed. Since the width of the rough opening of the doorway is the same as for the large first-floor windows, the frame depth is the same, and the jack arch containing segment "8L" would be the same as those of the windows, was this opening originally a similar window that was later converted into a doorway? This is a reasonable question, but the answer is no. In looking at the fill brick in the triangular failure area above the doorway, notice there is a small arrow on blue tape, centered over the doorway four courses of brick down from the top. If this had originally been a window, there would have been a timber lintel spanning the rough opening here, the bottom of which being at arrowhead level. Three courses of obvious original brick extend from the left at least as far as the arrow, precluding a lintel. Consequently, a window did not occupy this location. The opening was purpose built as a doorway (Fig. 19, Study area above kitchen chamber doorway).

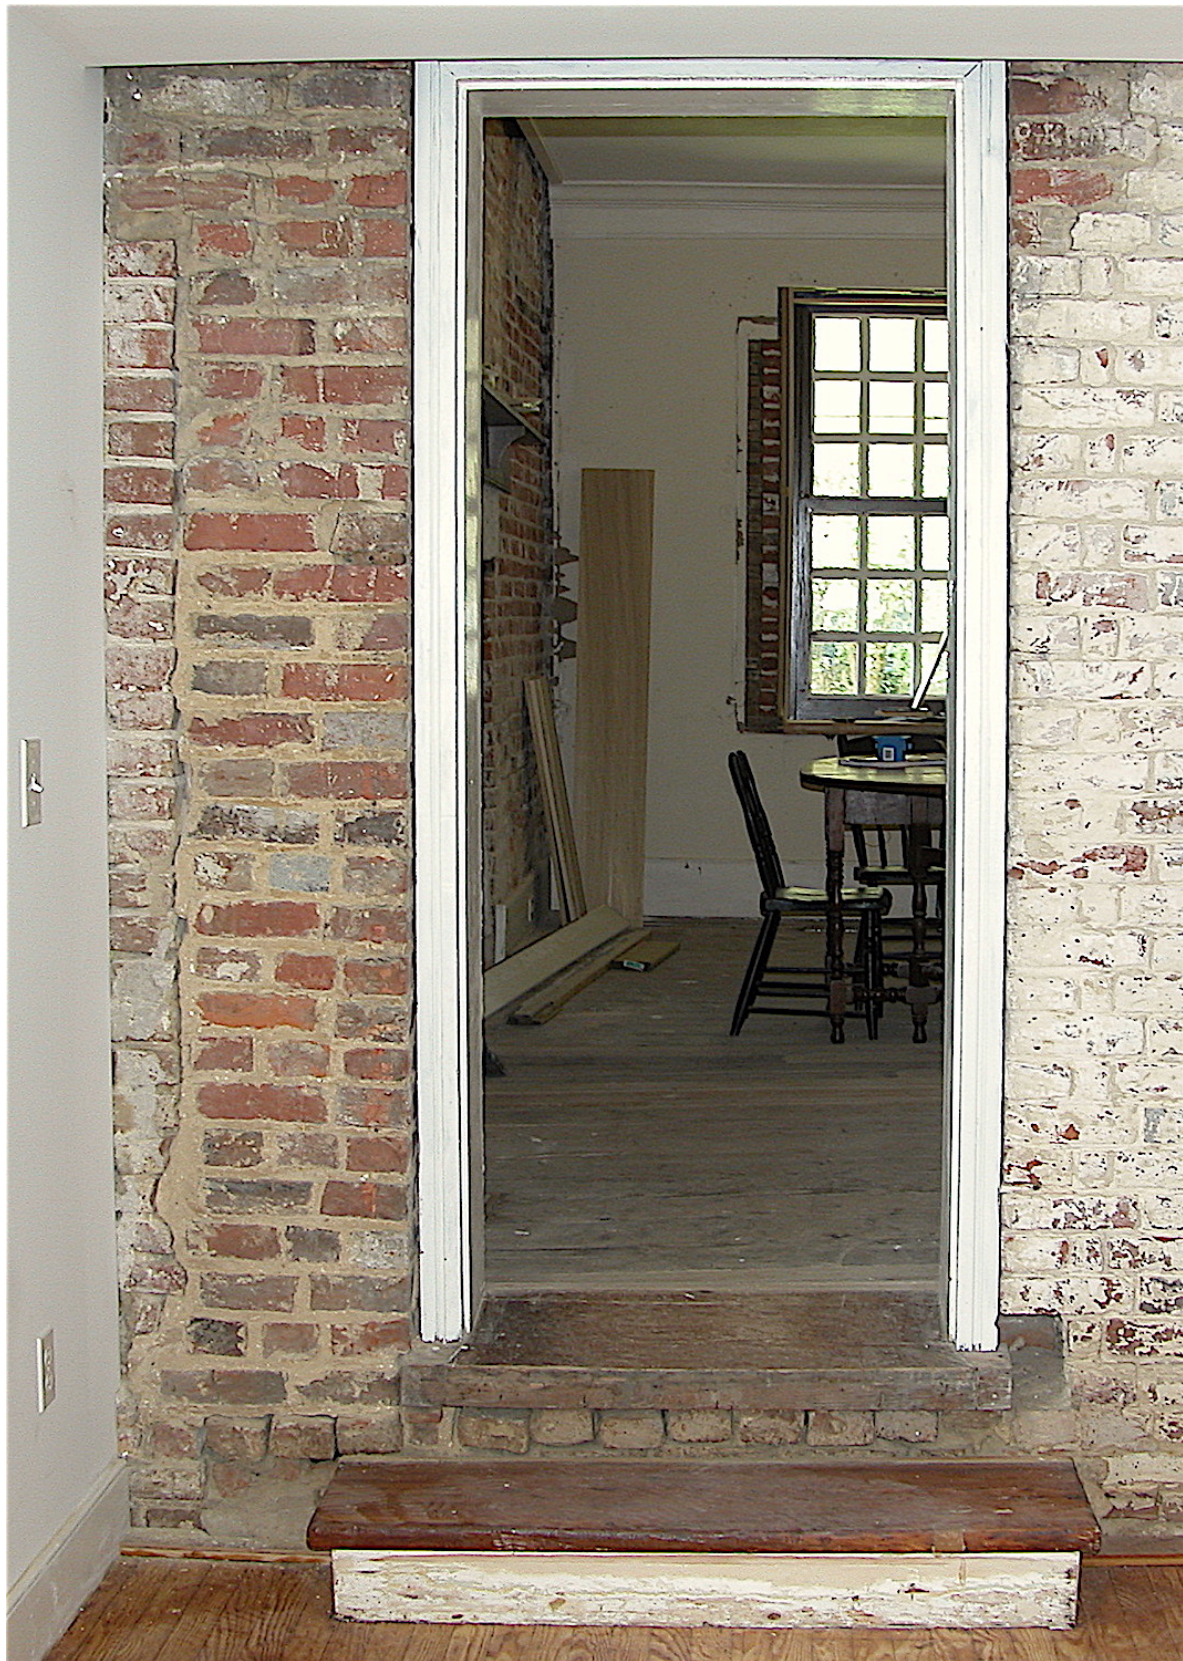
Figure 20

Looking to the left of the doorway, there is a vertical joint between the house endwall and the infilled brick repair (Fig. 20, Joint in brickwork).

Upon careful examination, it becomes obvious that most of the brickwork to the left of this joint is the south end of the west endwall.
