Fox Hall - *Part 10*, Jack Arch Segment "8L"

By Dick Gresham, Jim Melchor, and Tom Newbern

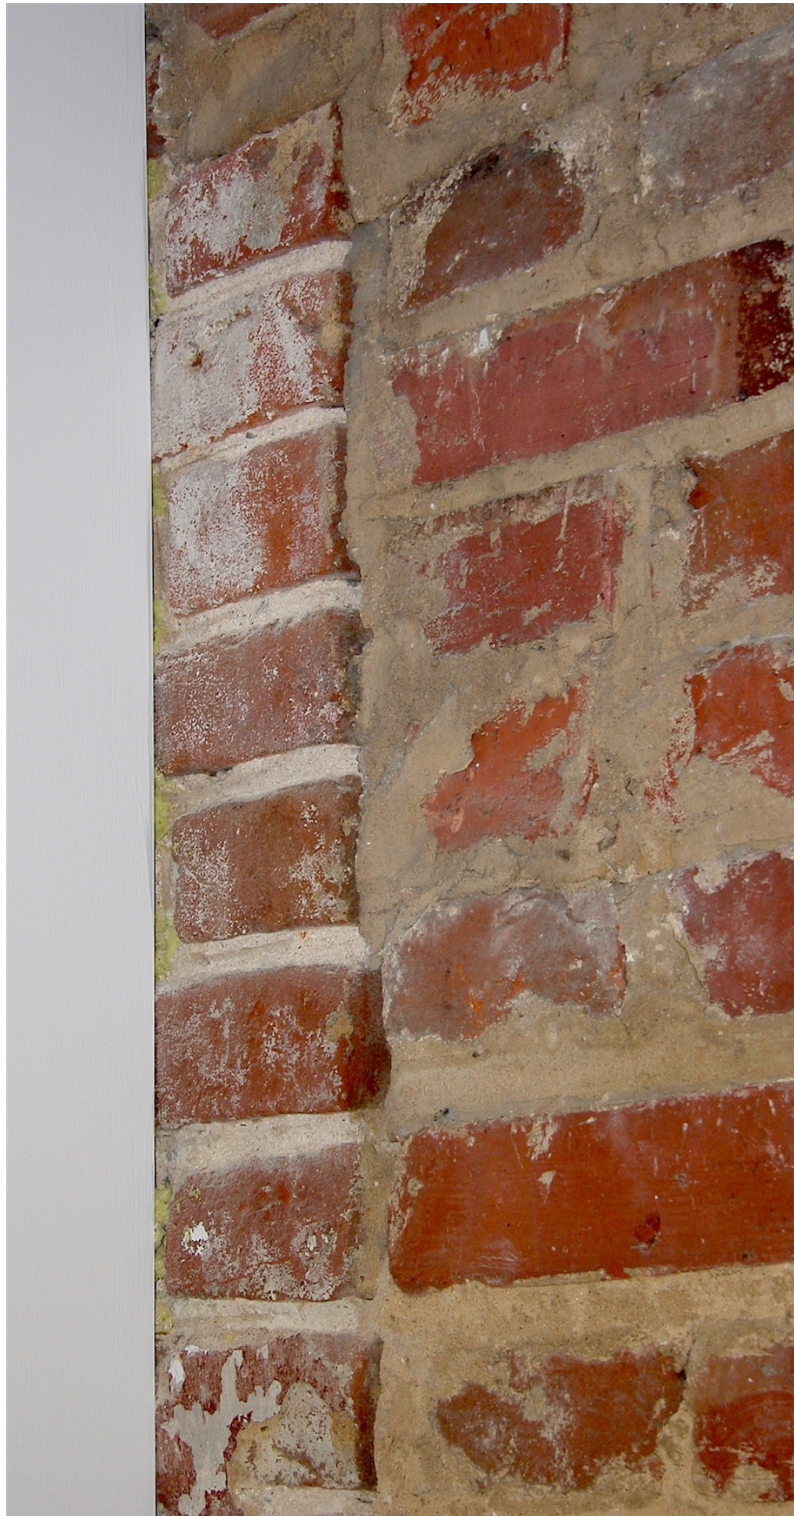
Figure 21

These original bricks, extending from the door sill to about one foot shy of the top of the door, are clean, relatively intact, and have struck mortar joints (See Fig. 20) (Fig. 21, Original bricks with struck mortar joints).

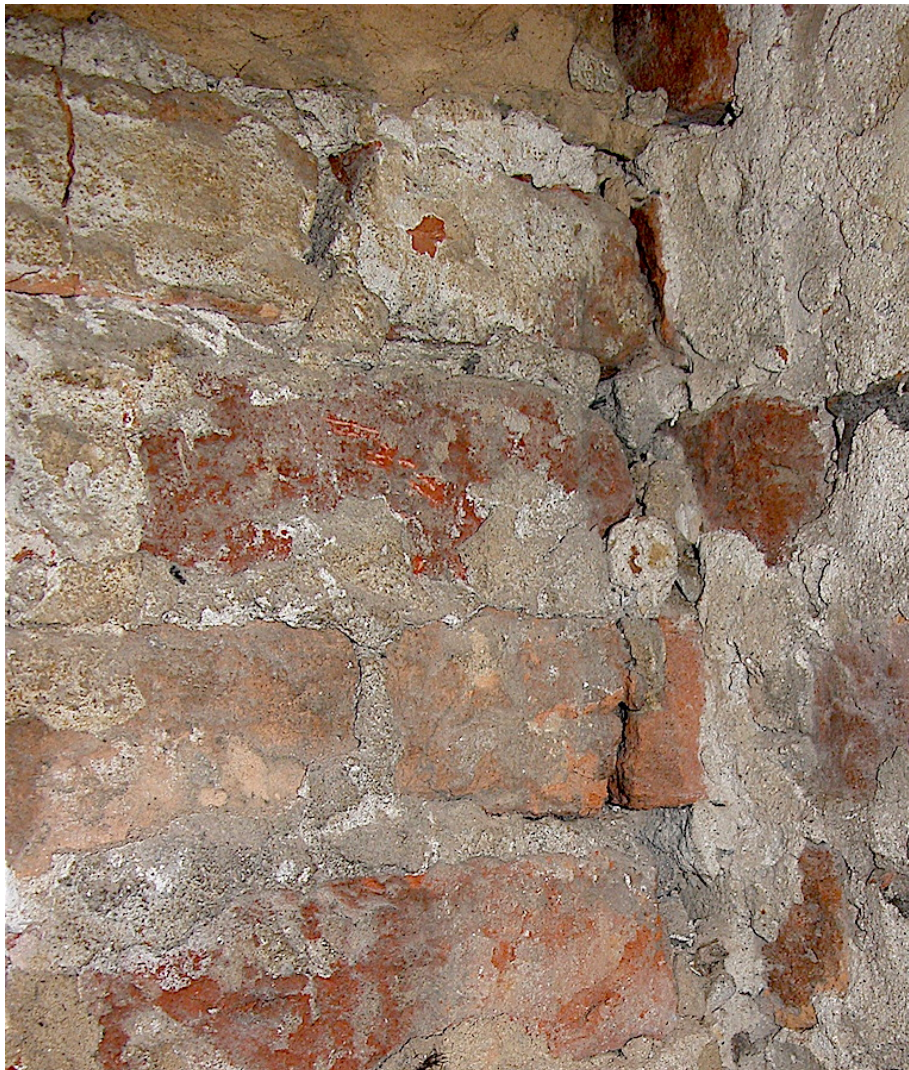
Figure 22

Interestingly, there is no stitched corner in this area turning this endwall into the south wall of the house. Just finished bricks. This is the proper right jamb of the doorway to the kitchen chamber as initially constructed. It matches the brickwork of the proper left jamb, and the courses of brick and mortar joints are perfectly level across this rough opening. There is infilled repair brickwork above this line of original bricks as well as the framing of the annex; therefore, we could not determine if there was corner stitching of the bricks. Fortunately, the corresponding area in the kitchen is open. The bricks of the south wall above the doorway definitely are stitched into the endwall, forming a proper corner (Fig. 22, Corner stitching of bricks).
