Fox Hall - *Part 14*, East-Chamber Fireplace

Jim Melchor, Tom Newbern, and Dick Gresham

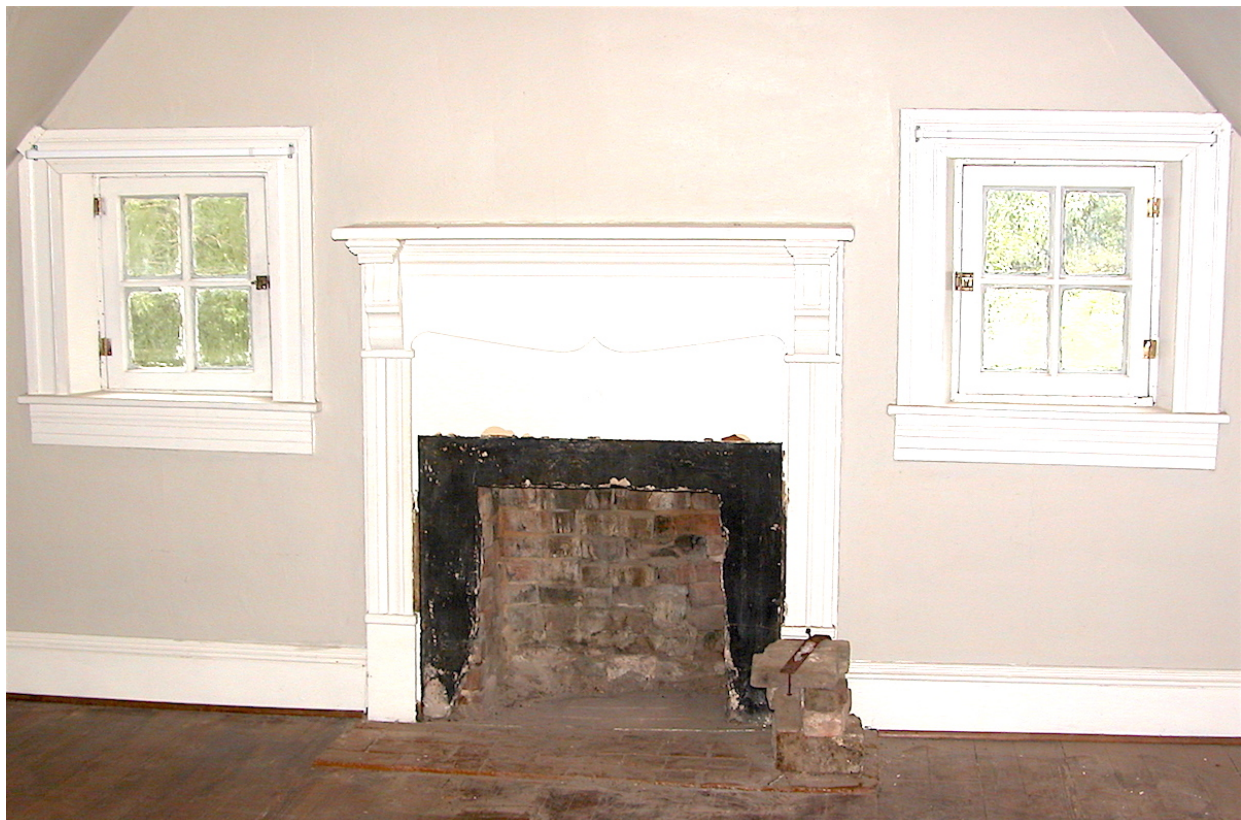
Figure 1

Fortunately, this fireplace was simply boarded over but essentially intact (Fig. 1, West-chamber fireplace) (Fig. 2, Masonry repairs needed in west-chamber fireplace) (Fig. 3, Tuck pointing complete in west-chamber fireplace).

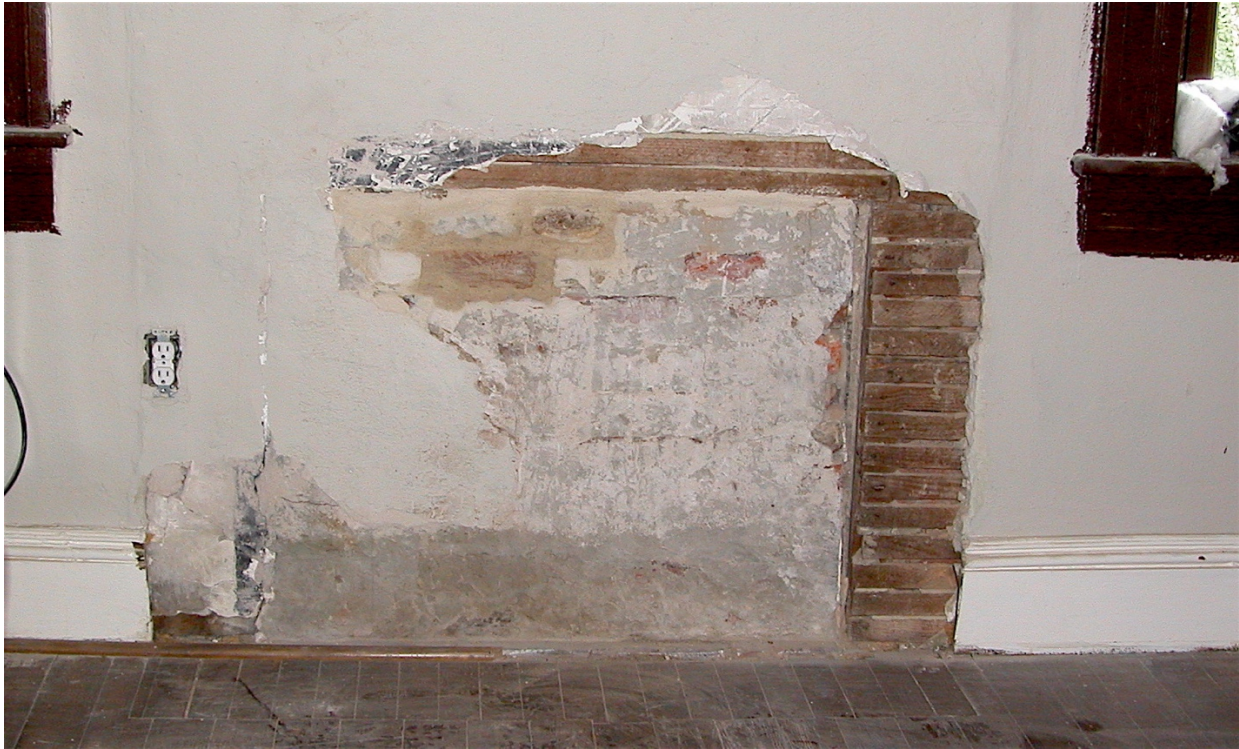
Figure 4

A similar fireplace in the east chamber, however, is bricked in and plastered over (Fig. 4, East-chamber fireplace).

The owner considered reopening this fireplace and restoring it to its circa 1725-30 appearance. Prior to reopening, the restoration manager removed several bricks in the infill, hopefully to assess the condition of the firebox and flue (See top left of infill in Fig. 4 for location of viewing port).

This investigation has come to the same conclusion that repair of the web, closure of the hole, repair of the chamber firebox, and restoration of the fireplace to its circa 1725-30 appearance would cost thousands of dollars and is not practical at this time. Consequently, the owner has decided not to undertake this work and expense. The east-chamber fireplace will remain closed for now.

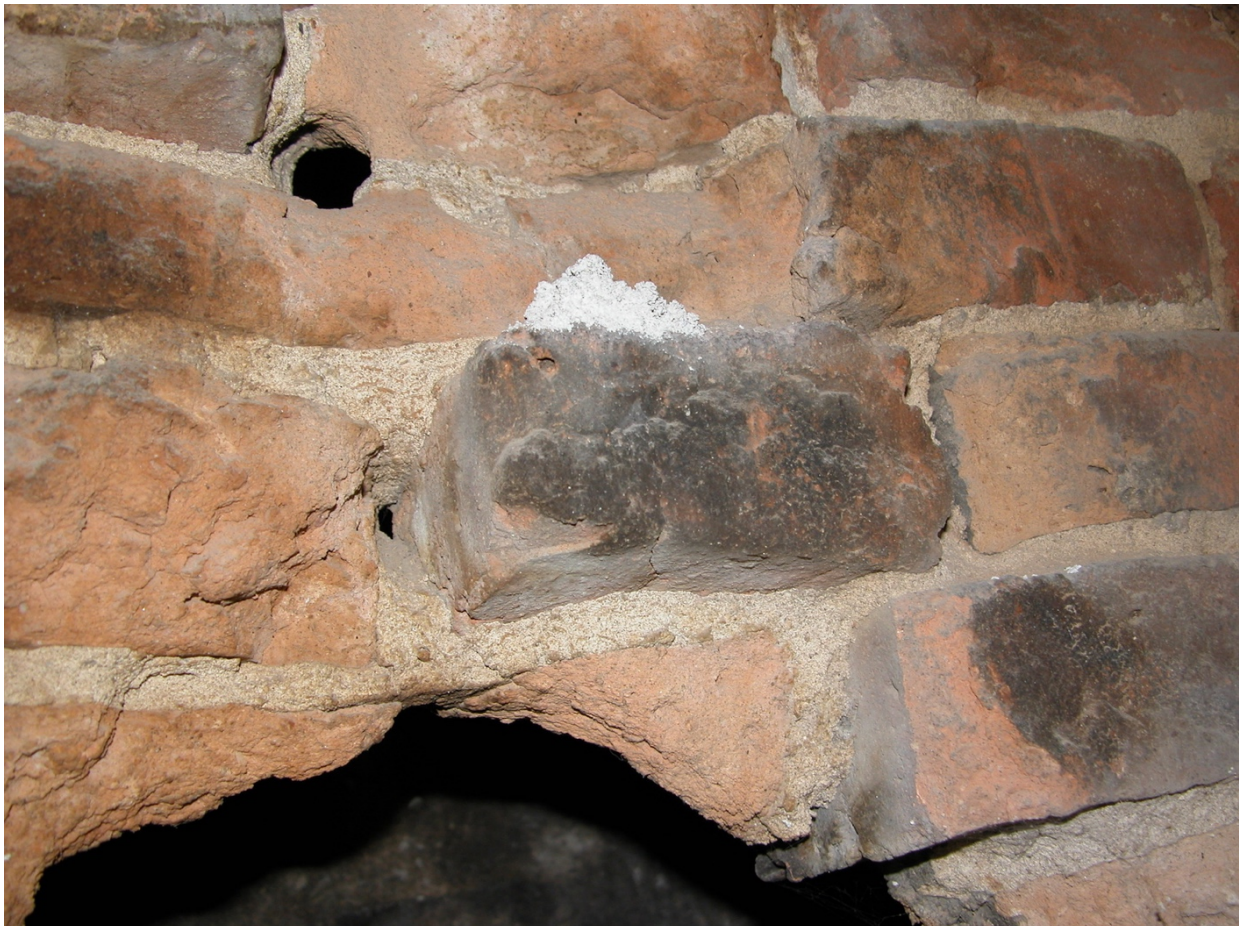
Figure 5

Once viewing access was gained into the chamber firebox through the infill, several observations were made. The firebox is essentially filled with brick bats, other masonry debris, and sand. The top-back portion of the firebox is missing, exposing the web between the two flues, the hole in the web between the two flues, and the flue of the chamber fireplace above the firebox (Fig. 5, Large and small holes in web between flues) (Fig. 6, Open flue above east-chamber fireplace; bottom of photo is the web between the two flues above the holes; both flues are capped at their tops).

The circular shape of the top of the large hole in the web (See Fig. 5) initially led the restoration team to think that there had been a stovepipe inserted from the east-chamber fireplace, through the web, and into the main flue, bypassing the chamber flue. This would be to accommodate a late nineteenth or early twentieth-century coal, wood, or kerosene stove. A suggested reason for this could be damage to the chamber flue obstructing its use. In light of the observed evidence, however, this scenario does not make sense. The hole in the web is too low for a stovepipe from the chamber fireplace, and there is no penetration in the

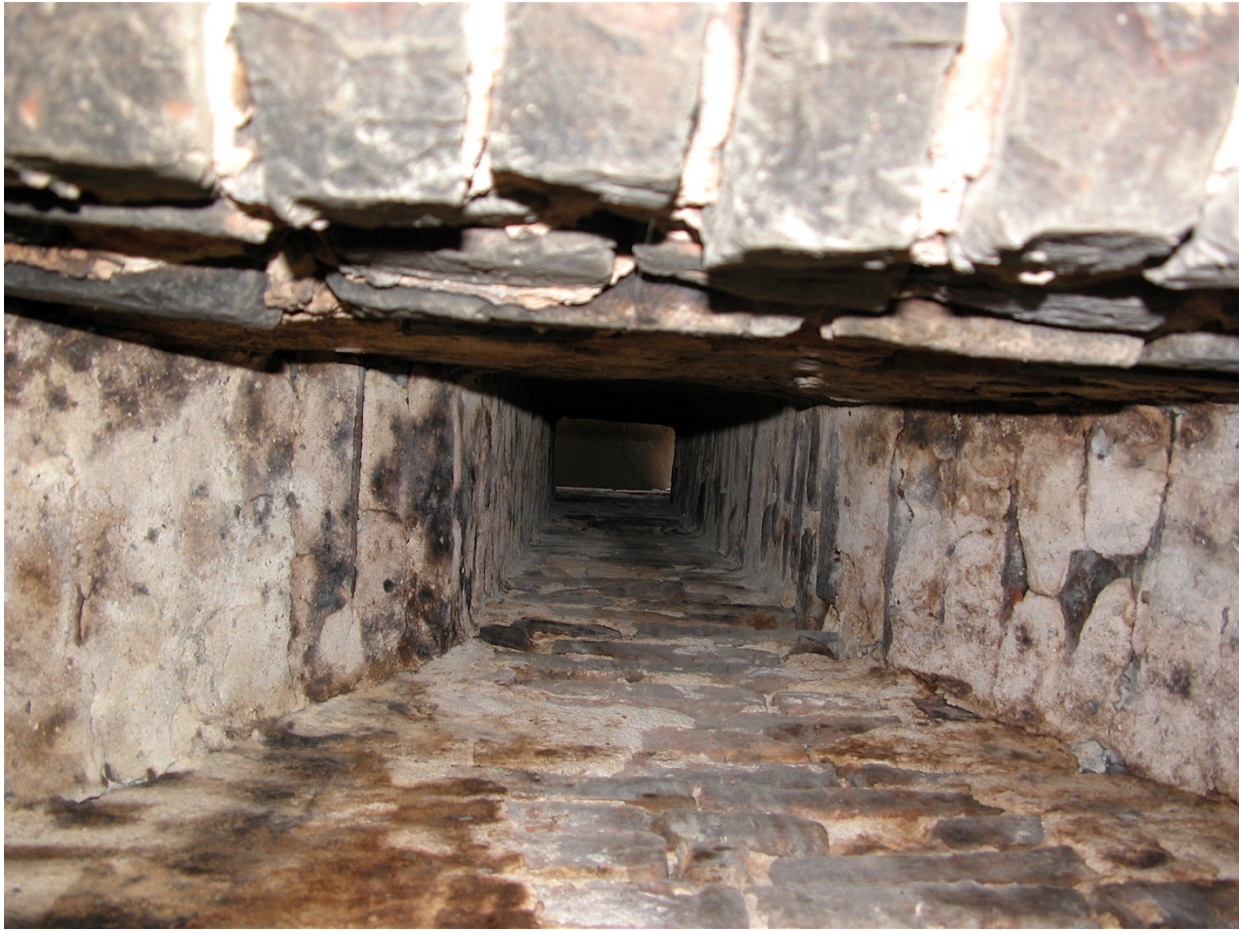
Figure 6

back of the firebox aligned with the hole in the web. Furthermore, the chamber flue is clear (See Fig. 6).

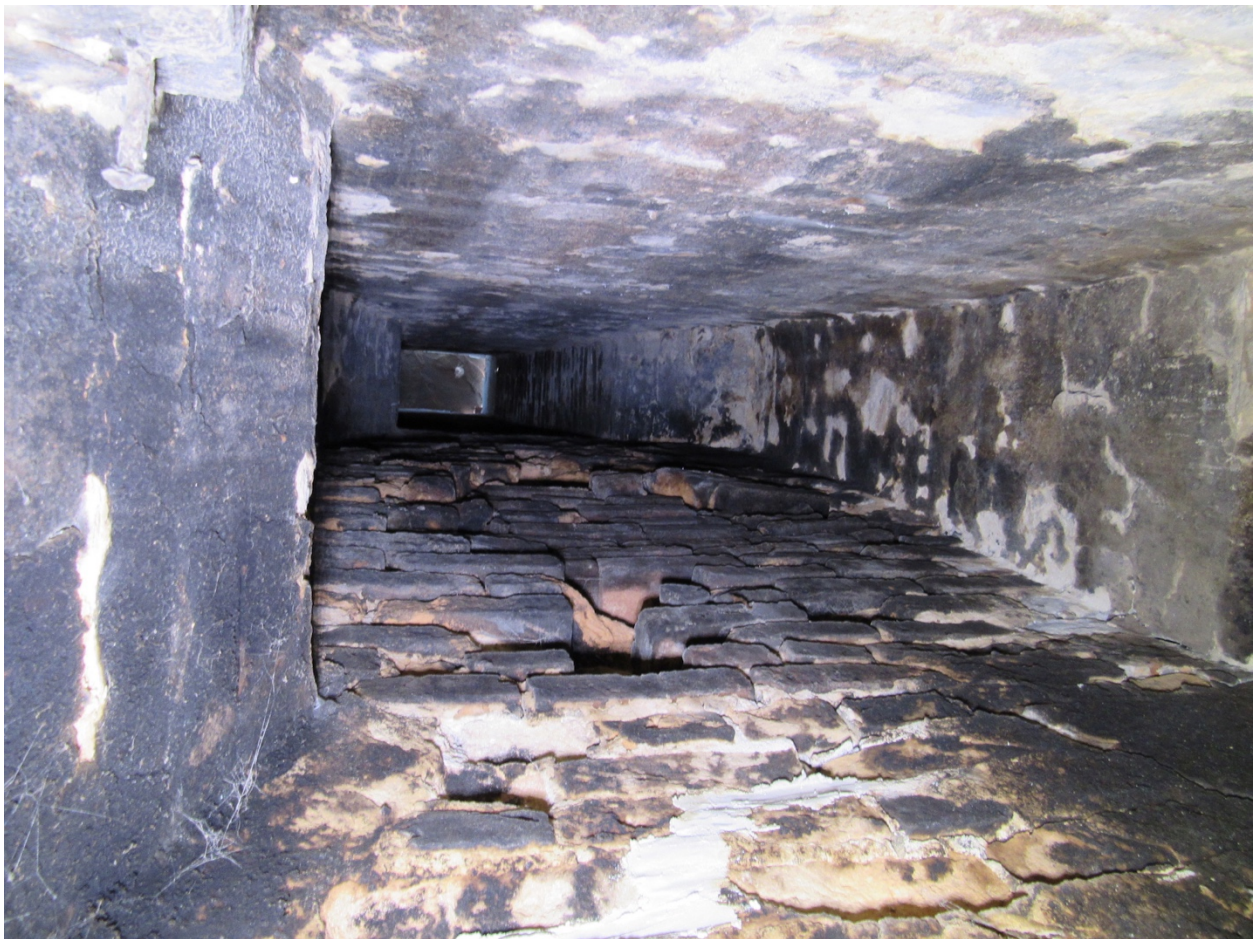
Figure 7

To answer the question about the hole in the web between the two flues, we realized that physically ascending the hall flue to the level of the hole was necessary. Observations in and photos of the hall flue indicate that the web between the two flues from just above the hole down to the restored hall fireplace is in tenuous condition with numerous open mortar joints and some brick loss. Considering that the chimney brickwork is nearly 300-years old, this condition was no surprise (Fig. 7, Hall fireplace flue; bottom of photo is the web).

What appears to be the hole in the center foreground of Fig. 7 is brick loss just above the hall fireplace. The actual hole between the flues can be seen higher up in the flue. Other areas of brick loss and open mortar joints are apparent in Fig. 7.

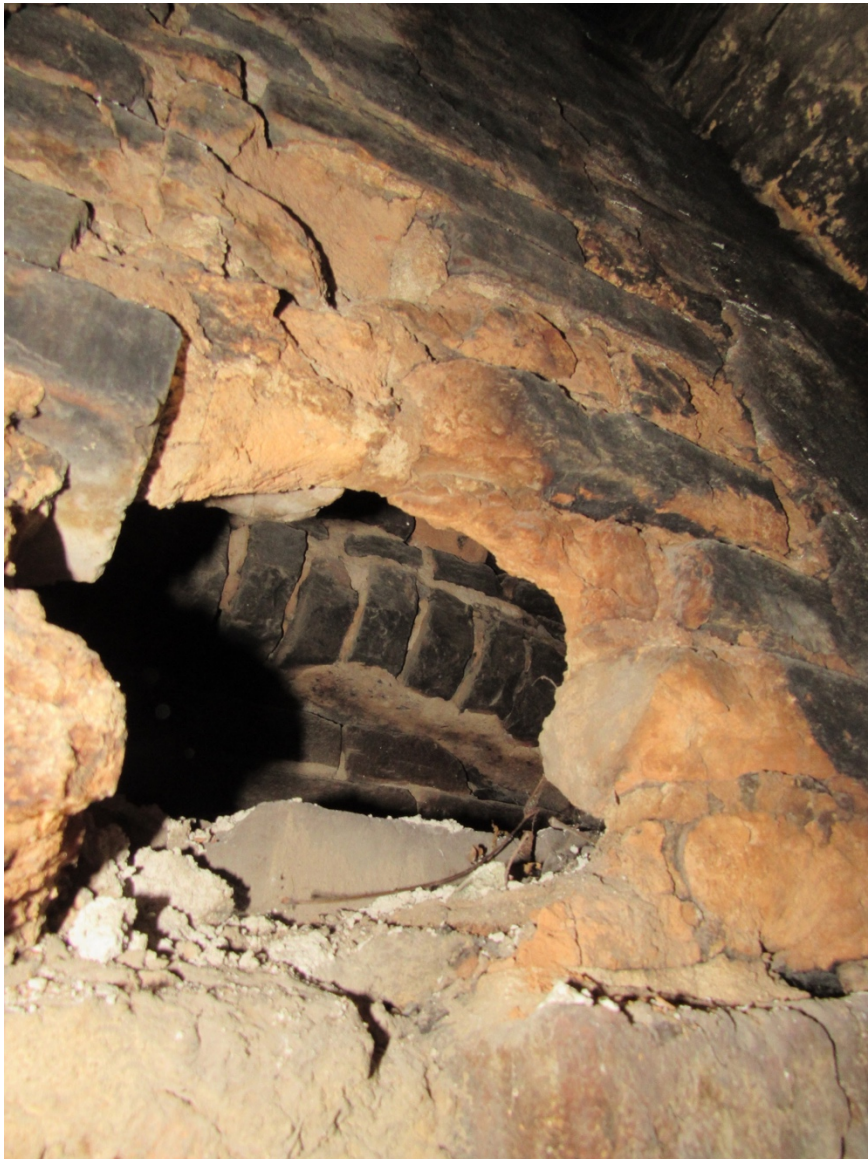
Figure 8

Climbing higher in the flue, reaching the hole in the web, it became obvious that the hole was not punched to accommodate a stovepipe. In fact, it is simply another area of brick deterioration and loss (Fig. 8, View of hole in web from the main flue into chamber firebox).

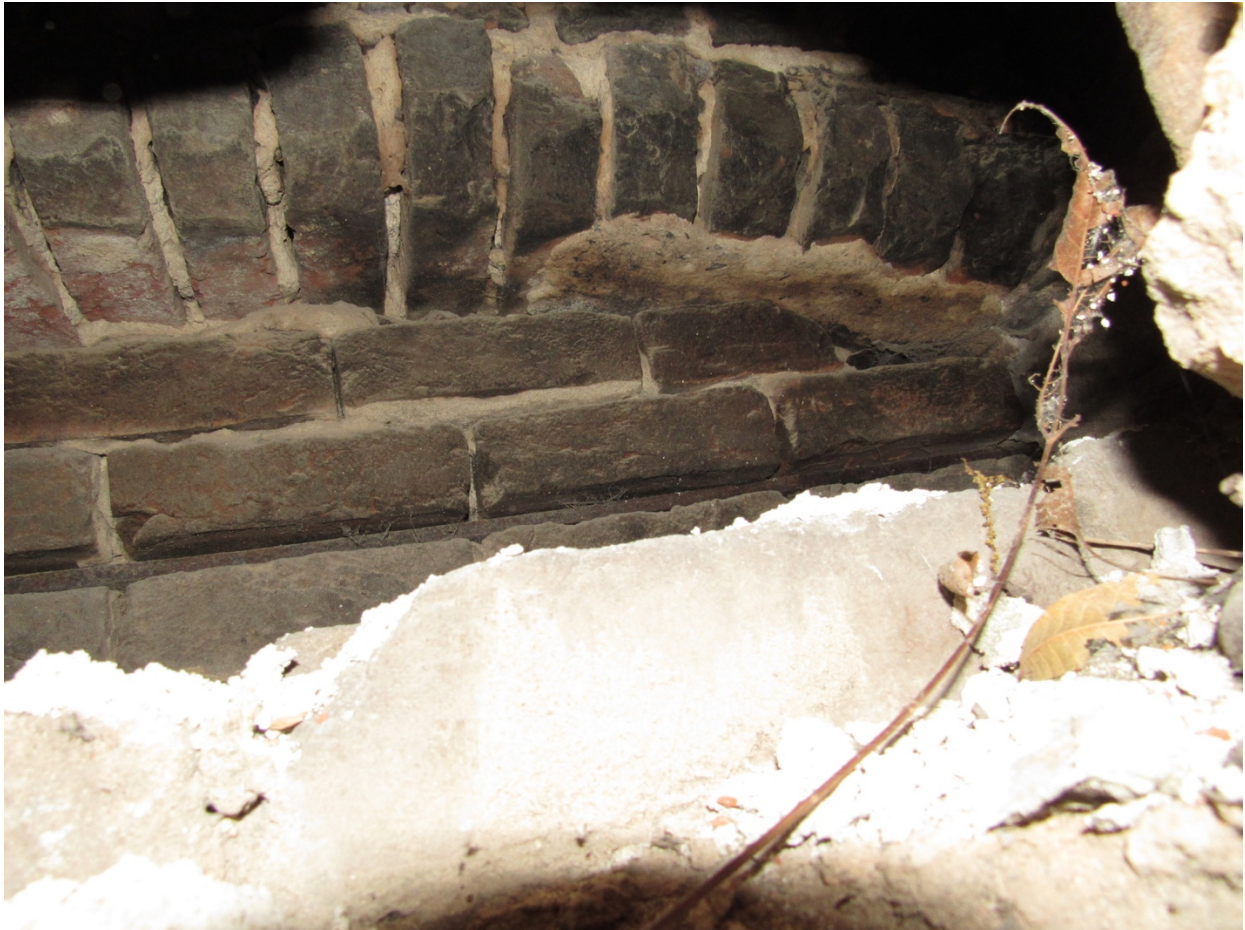
Figure 9

This opening provides a clear view of the intact top-front brickwork of the east-chamber firebox (See Fig. 8) (Fig. 9, Top-front brickwork of east-chamber firebox). The white material in the forefront of Fig. 9 is the debris fill in the firebox.

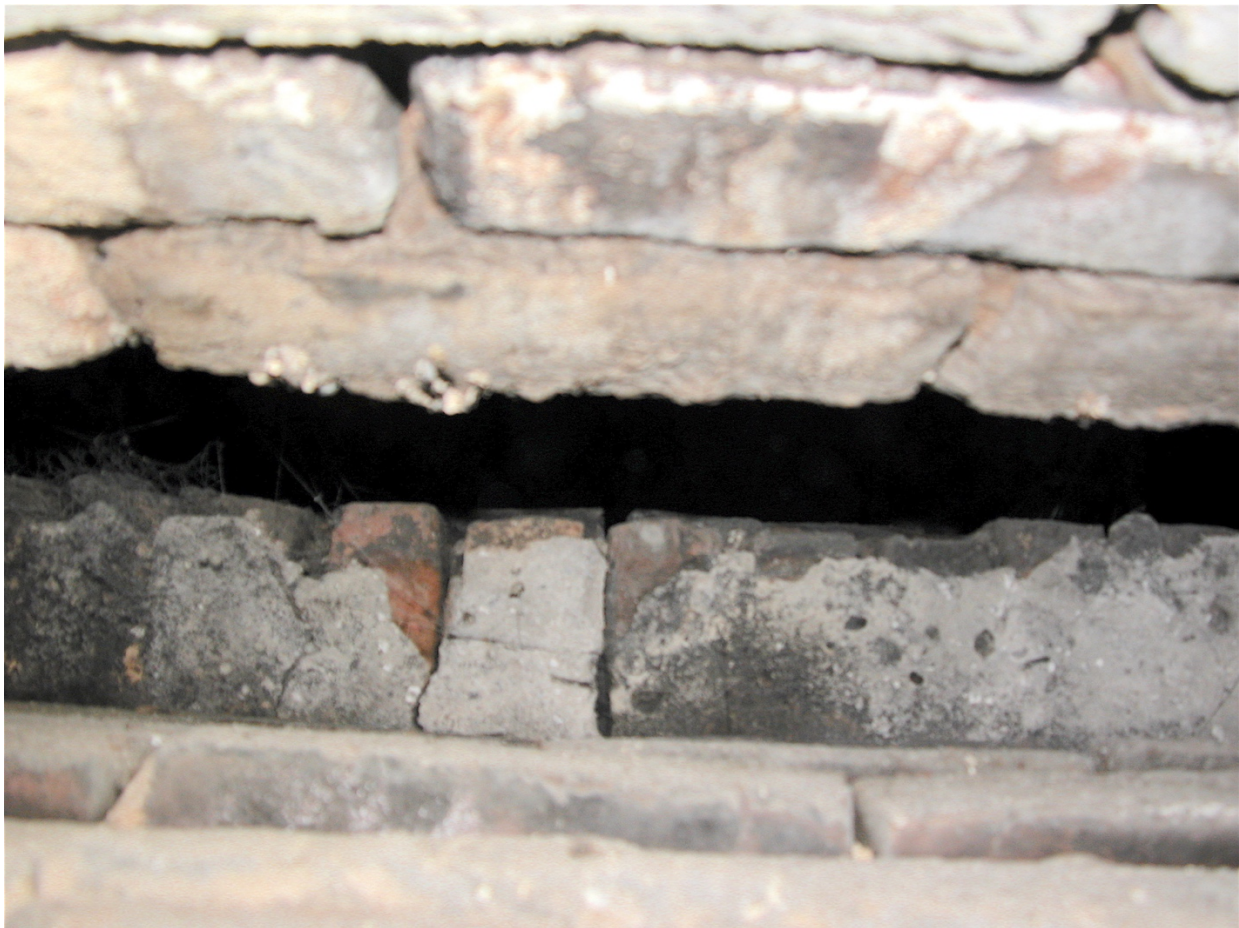
Figure 10

Originally, the top-back and top-front brickwork partially closed the top of the firebox to a narrow slit-type opening or throat, as can be seen in the intact firebox in the west-chamber fireplace (Fig. 10, Top of firebox in west chamber).
