# **Fox Hall - *Part 17*, Circa 1725-30 View**

By Dick Gresham

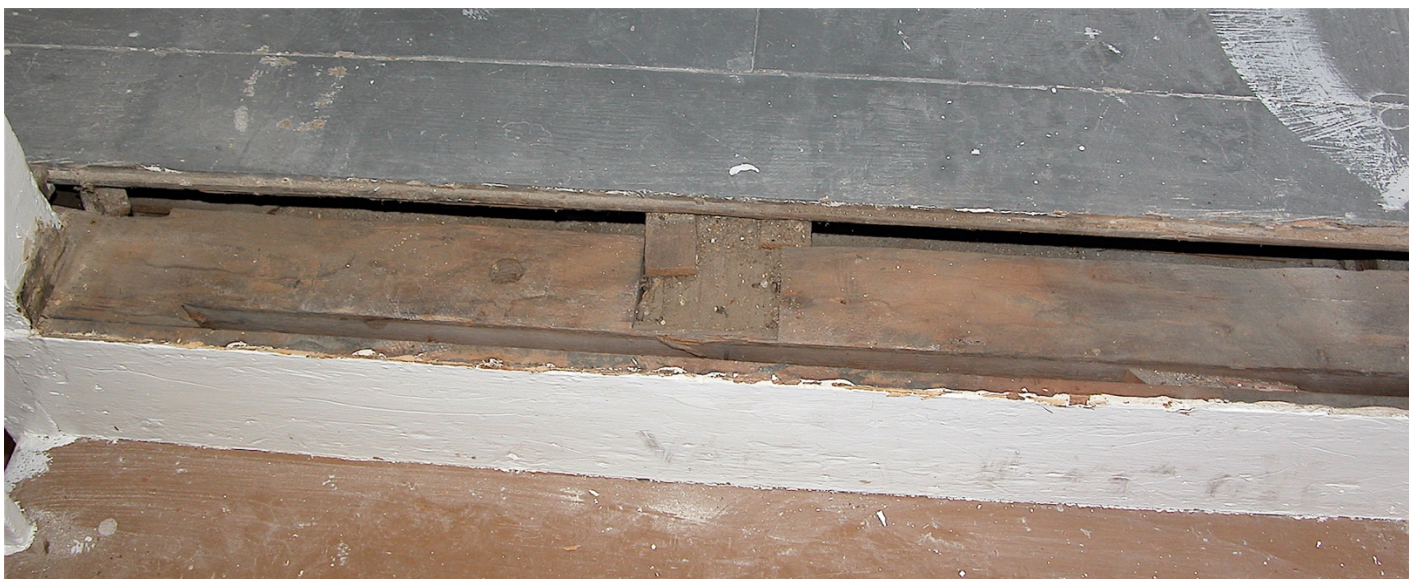
While replacing a flooring patch at the head of the stairs in the passage above, the first-period stairwell header was exposed. This timber is hewn on its top surface, and there is a drilled hole to facilitate tightening floorboards before nailing. Several similar drill holes were encountered in the tops of the joists under the original kitchen floorboards. The discovery of this first-period header provides further evidence that the second-floor flooring structure provided a firestop preventing the circa 1815 fire from consuming the first-floor woodwork.

Circa 1725-30 stairwell header (ascending stair)

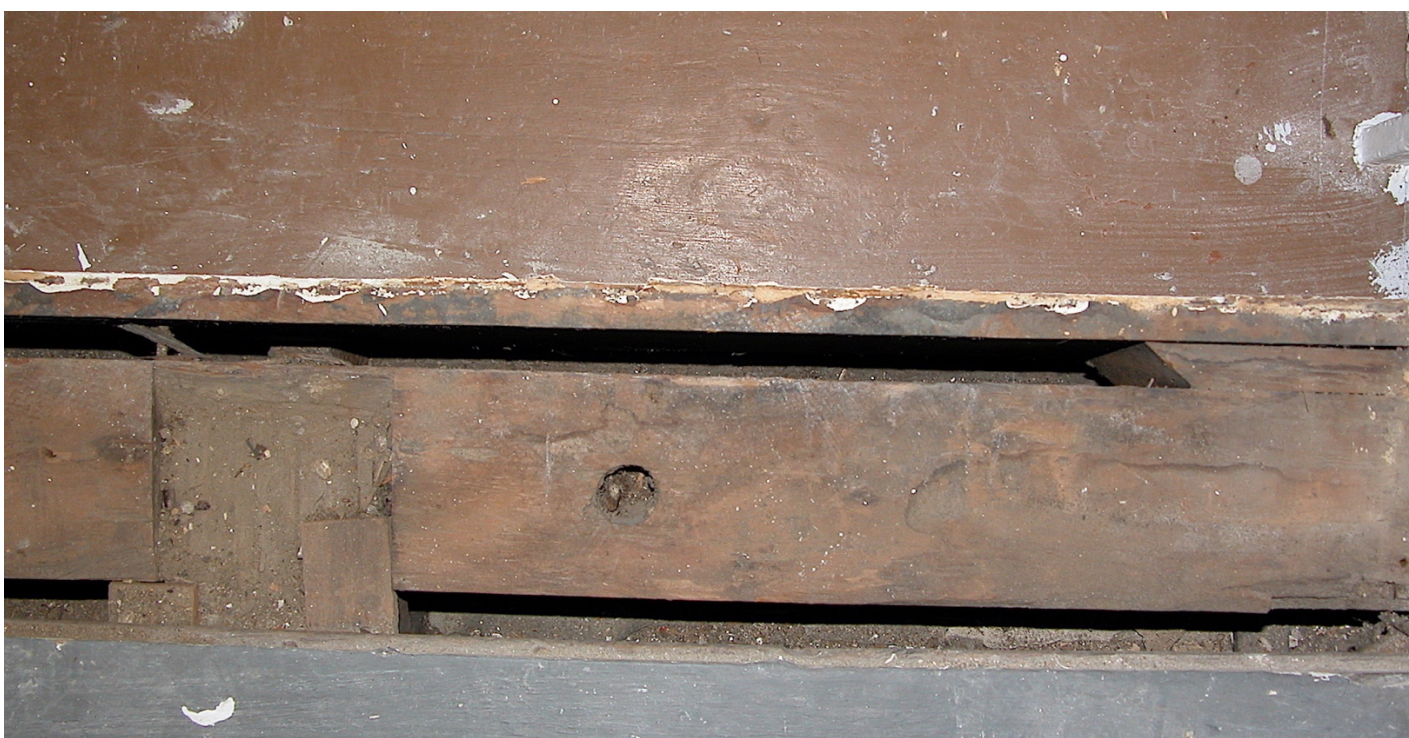
Note drilled hole for tightening floorboards (descending view)
