Fox Hall - *Part 19*, Front Porch Removal & Wrap-up

Jim Melchor, Dick Gresham, and Tom Newbern

As a reminder, the restoration of Fox Hall has been covered, thus far, in a series of 18 articles commencing in 2020 on www.ehcnc.org under Decorative Arts/Architecture. Fox Hall is a one-and-a-half-story brick house built circa 1725 for Ann Thelaball on the Elizabeth River in Norfolk County, VA. Figure 1 shows Fox Hall just prior to the beginning of the restoration project. This article is *Part 19* of the series.

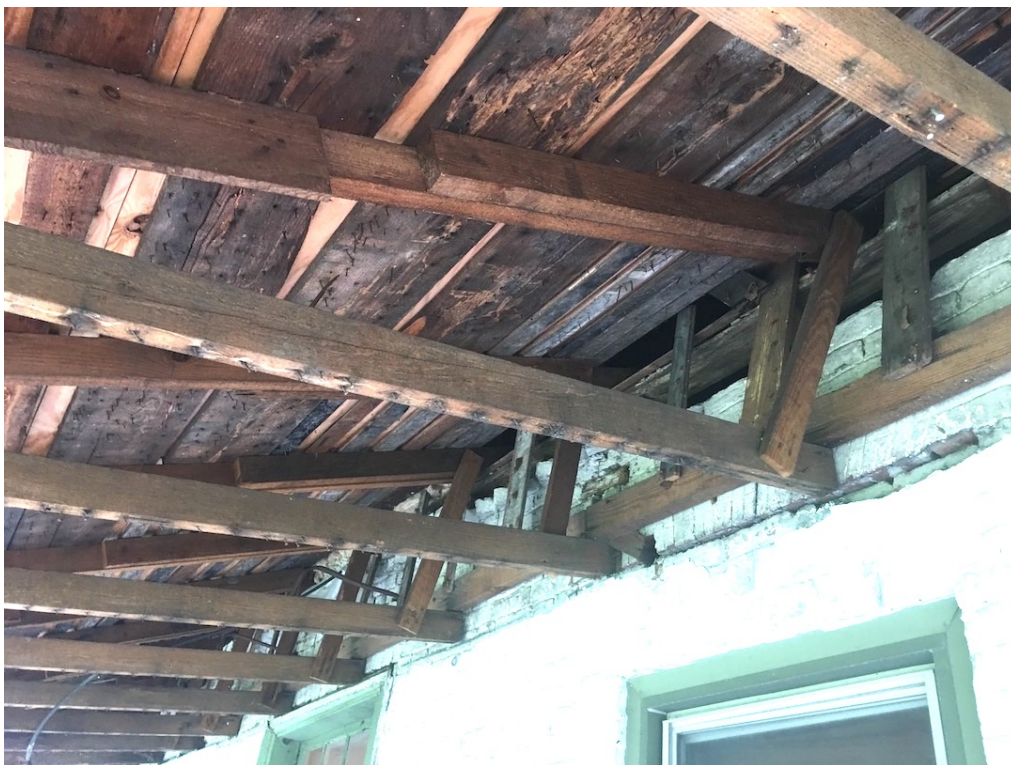
Figure 4 *Porch roof structure next to house.*

As can be seen in these two figures, much, but not all, of the porch roof structure dates from the Roper period of circa 1900. Removal of this structure was complicated by its rafters extending into the main house roof (See Fig. 4). Furthermore, there is decorative brickwork over the front door that had to be considered (Figs. 6 & 7). Beyond the decorative brickwork, extending to each end of the building, there was a circa 2016, flat, fascia-type board covering part of the roof structure of the house as well as areas of missing bricks at the top of the brick wall (Figure 8).

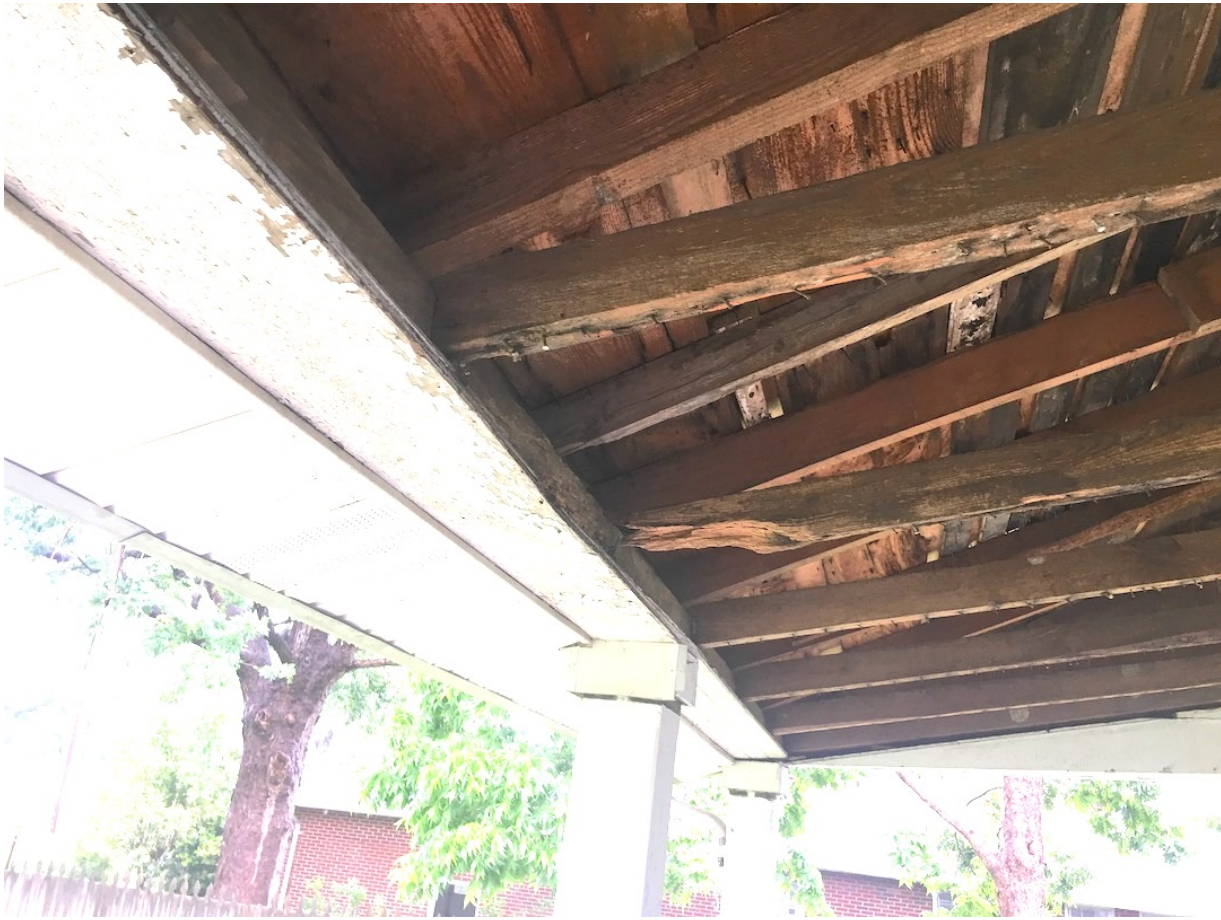
Figure 5 *Porch roof structure at edge of porch.*

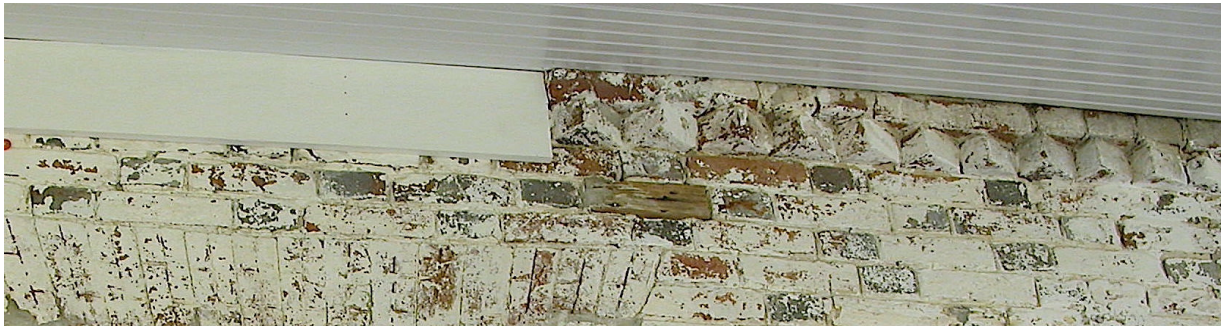
Figure 8 *Fascia-type board covering areas of missing brick.*

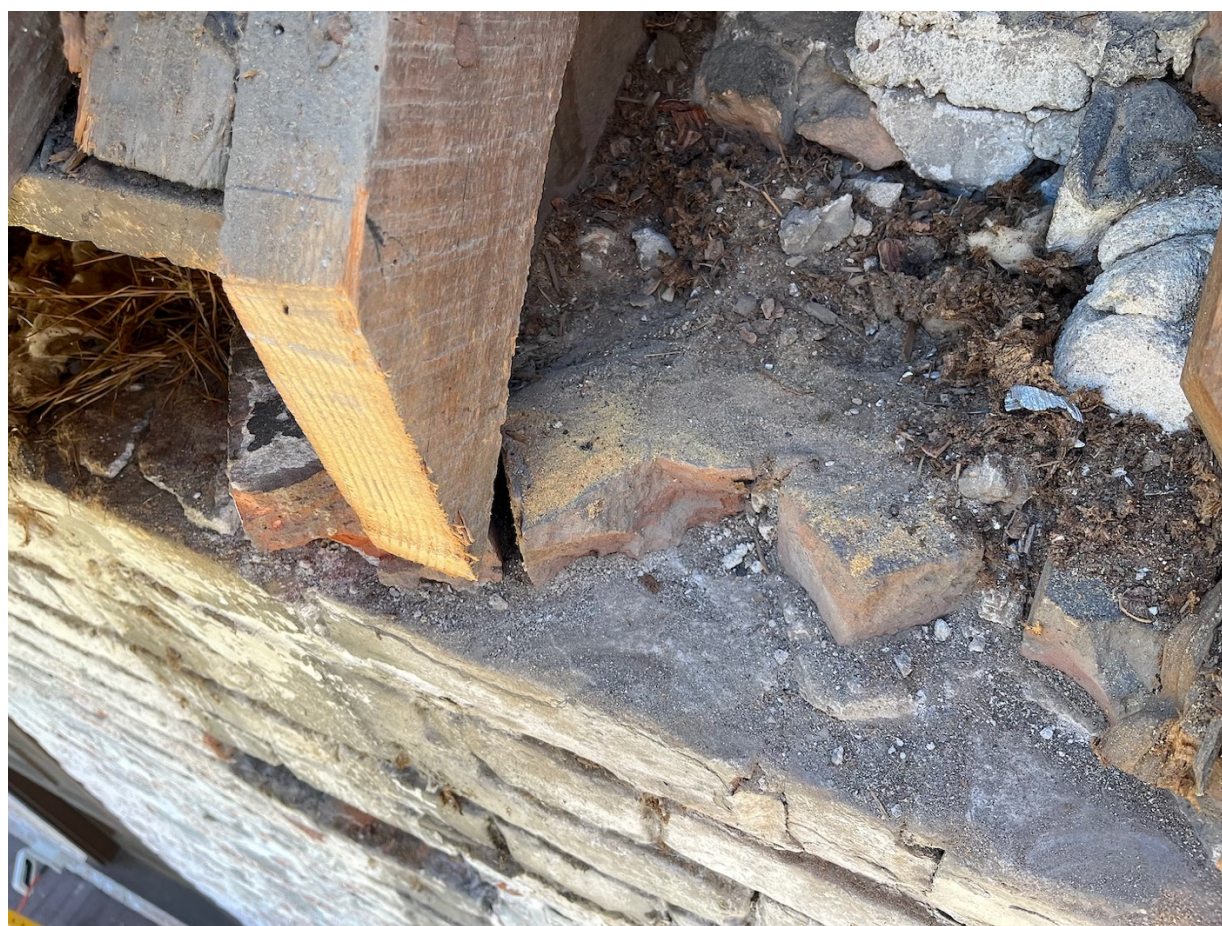
Across the front of the house on either side of the decorative work there were two courses of brick missing. As on the back of the house, there was no evidence of toothed brickwork until a short section of Roper trim was removed at the west end of the house. Here was found several mortar joints and angled bricks clearly proving that the toothed brickwork did, indeed, extend all the way across the front of the house (Fig. 14).

Figure 14 *Evidence of decorative, toothed brickwork across house front.*

This important discovery precipitated a call to our project mason, "Cheetah" Waller. As our mason and his crew began restoring the missing sections of toothed brickwork, our project carpenter, Tony Russell, finished enclosing the roof kick with a fascia and soffit (Figs. 15, 16, & 17).

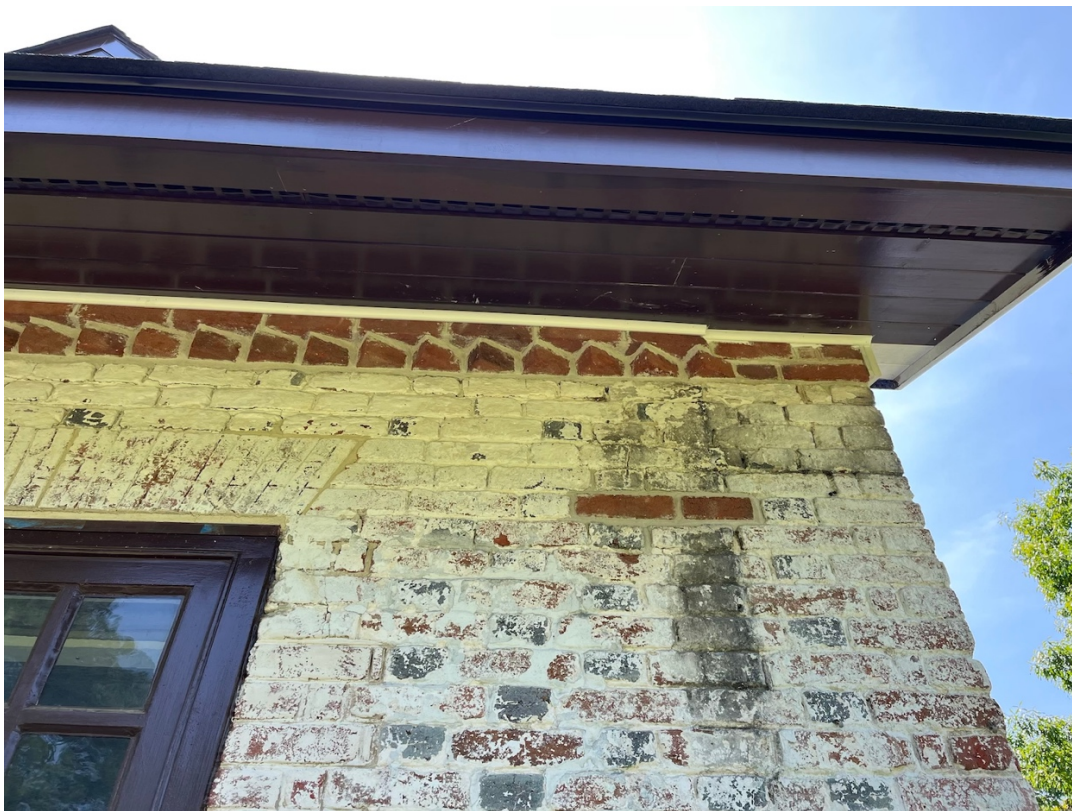
Note in Fig. 18 that the toothed brickwork stopped just short of the end of the building. Here, on both ends, the corbeled brickwork, removed after the circa 1815 fire, originally covered the ends of the tilt-plate eave. This was discussed in *Fox Hall - Part 11, Second-Floor Assessment*. Similar corbeling is in place on the Mason House (See Fig. 9) and on the Lynnhaven House in Virginia Beach, VA (Fig. 19). Lynnhaven House is discussed in *Fox Hall - Norfolk's Oldest House, Part 1*.

Figure 18 *Area of missing corbel.*

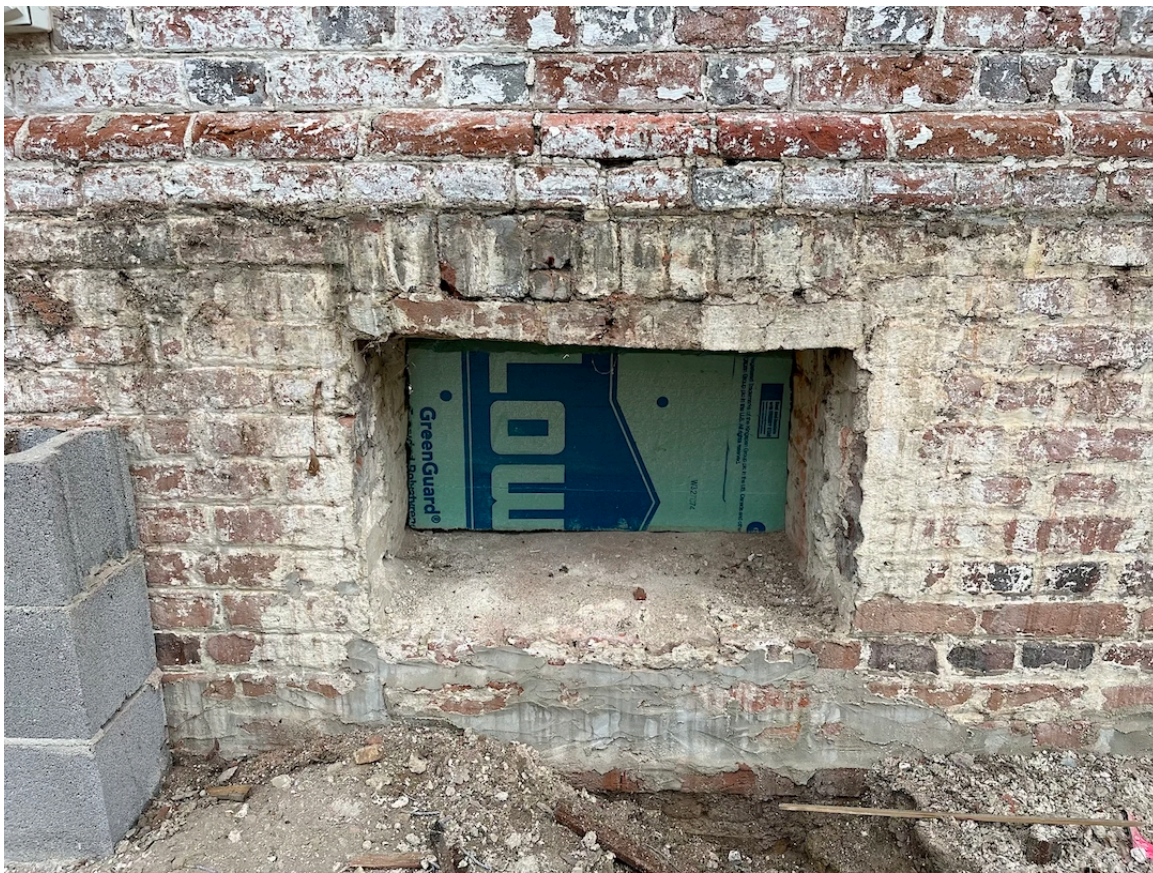
south side of the house, the top of the opening is one header course below the watertable (Fig. 22). At some point, the tops of the front openings were reduced a rowlock and stretcher course to accommodate a smaller vent (Figs. 23 & 24). Subsequently, these replaced vents were removed, likely by Roper before construction of his porch. The bottom of the east opening was lowered two courses of brick, while the west opening was lowered five courses. While it cannot be proven, Roper probably removed the barred vents and enlarged the openings to allow access for timbers he used in structural repairs under the house.

Figure 23 *East front vent opening.*

Considerable brickwork by project mason, "Cheetah" Waller and his crew, "Smoke" Haskett and Shakir Bullock, was required to repair damage to the vent openings and to restore them to original dimensions prior to installing the new barred vents (Figs. 25 & 26).

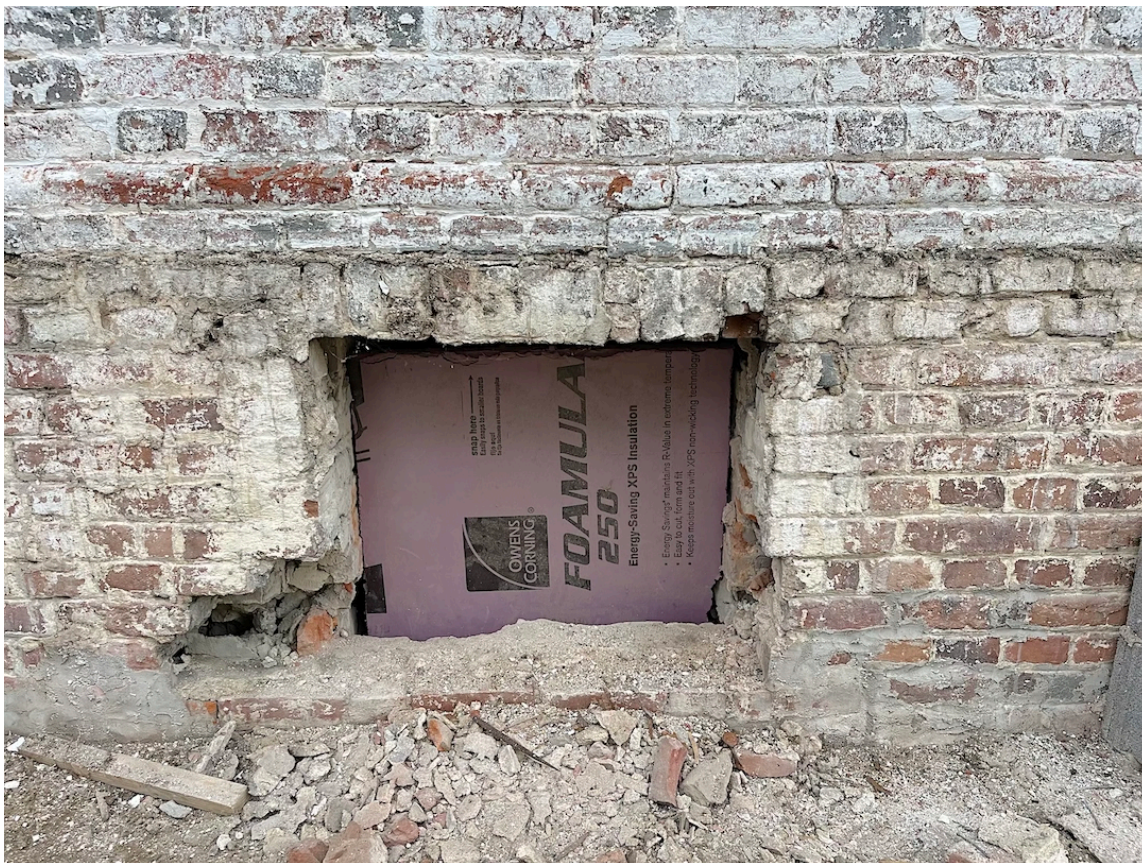
Figure 24 *West front vent opening.*

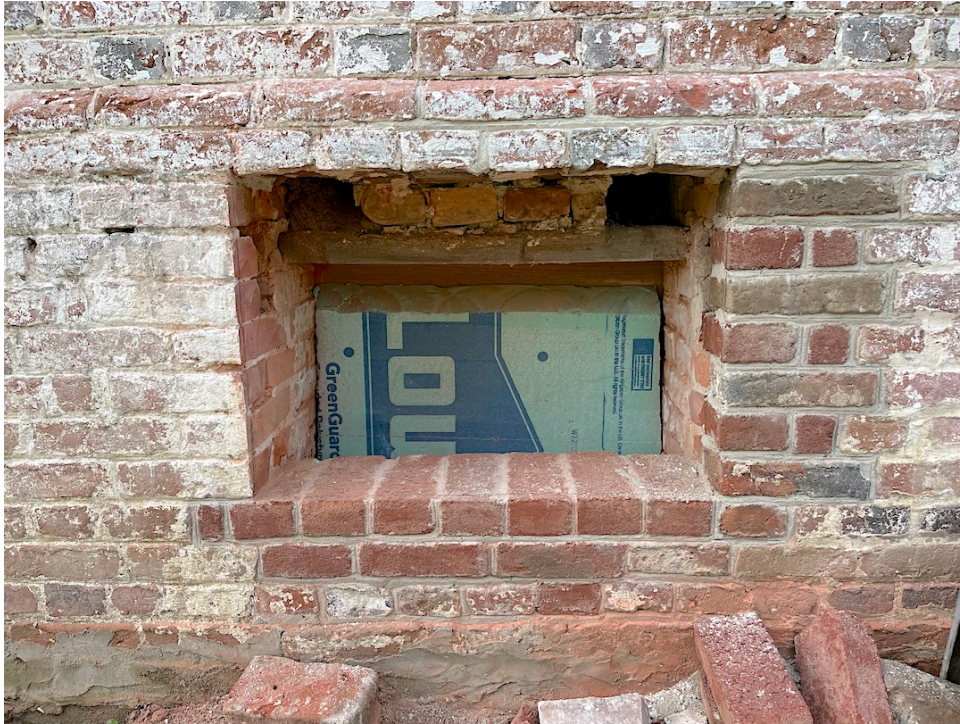
Figure 25 *East opening ready for vent installation.*

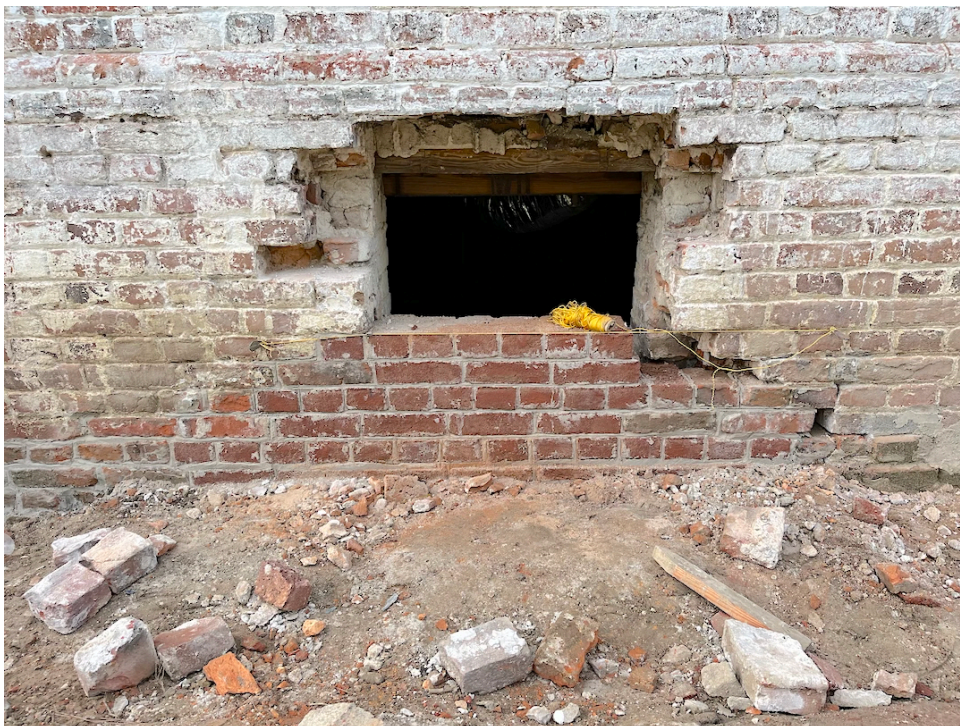
Figure 26 *West opening under repair.*

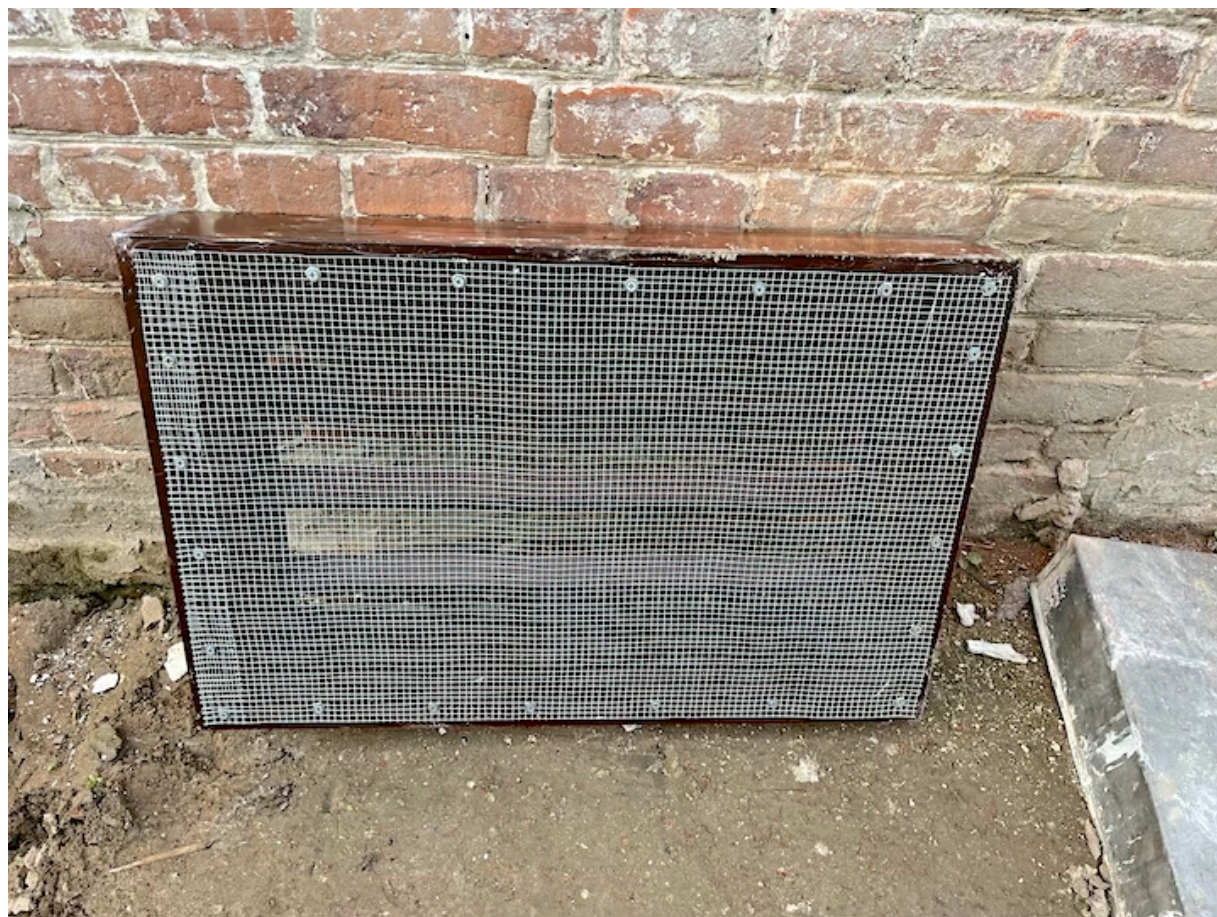
Figure 27 *New vent with copper enclosed edges and rat wire.*

Prior to installing the new barred vents, all four edges of each were fully enclosed with copper and sealed with construction adhesive by coppersmith, Carl Matthews. This was done to reduce the chance of rot and/or insect damage. In addition, hardware cloth or rat wire was installed on the inside of the vents (Fig. 27).

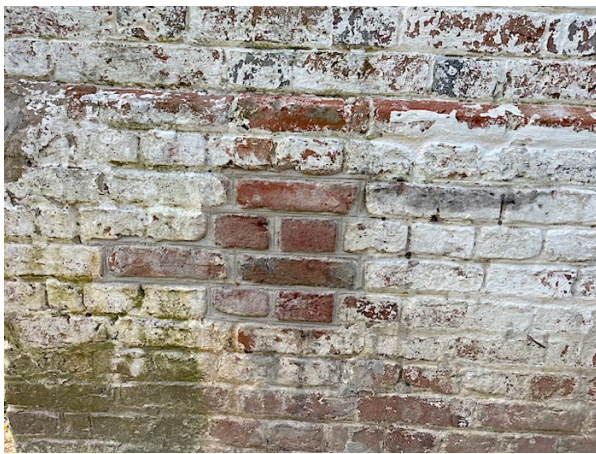
There were a number of areas of damaged brickwork associated with Roper's porch. Four in particular were joist pockets cut by him for his porch. These required relatively minor masonry repairs as did several repairs of broken bricks, a small settlement crack, and the removal of nailer blocks (Figs. 31 & 32) (See Figs. 16, 17, & 18).

Figure 31 *Joist pocket repair.*

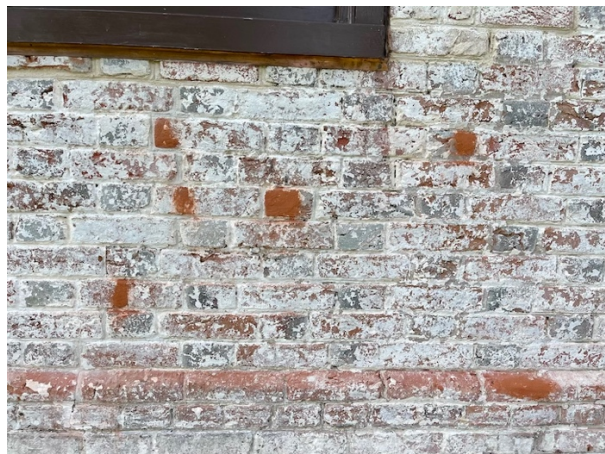
Figure 32 *Brick repairs.*

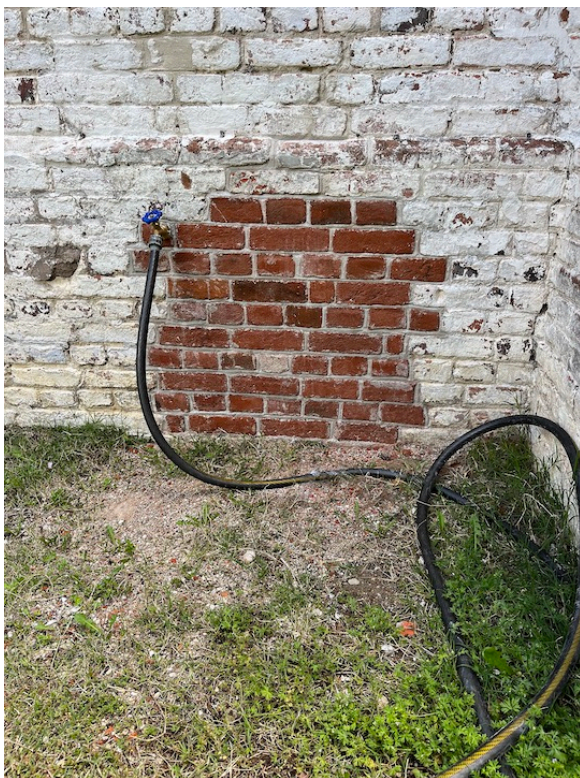
Figure 33 *West endwall north vent.*

There were four foundation vents of various sizes, two in each endwall on either side of the chimneys. Based on materials used, they were likely cut at different times during the Roper period. These have now been closed by the project mason and his crew (Figs. 33, 34, 35, & 36).

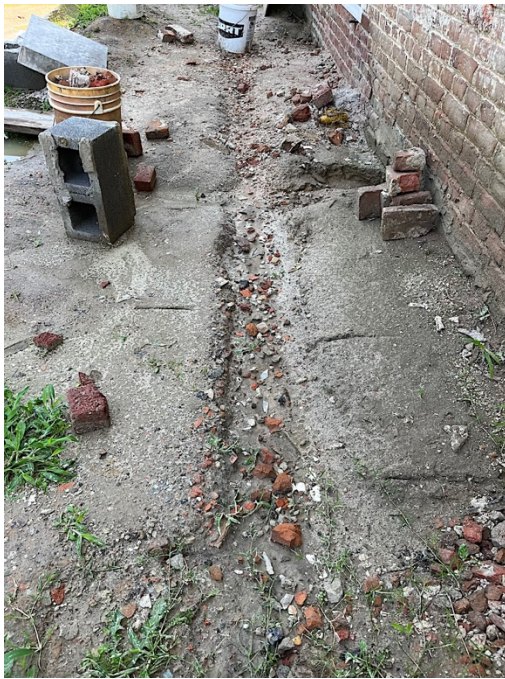
Figure 37 *Dripline of kick roof.*

Rainwater flowing off the front roof had to be addressed. Installation of a conventional gutter across the front edge of the kick roof, along with downspouts and splash boxes, was not considered appropriate to the period of the house and would detract from the view of its restored north elevation. In this case, an unobtrusive solution to rainwater management was a French-drain ground gutter installed along the dripline of the kick roof. The centerline of the dripline is 27 inches in front of the house wall (Fig. 37). The ground gutter consists of filter cloth, a four-inch, perforated drain tile, pea gravel, and brick pavers. The drain tile slopes both east and west from its high point centerline of the front door and terminates roughly ten feet from each end of the house in gravel filled dry wells (Figs. 38 & 39). A copper rainfall diverter will be installed on the roof above the front door and entry platform.

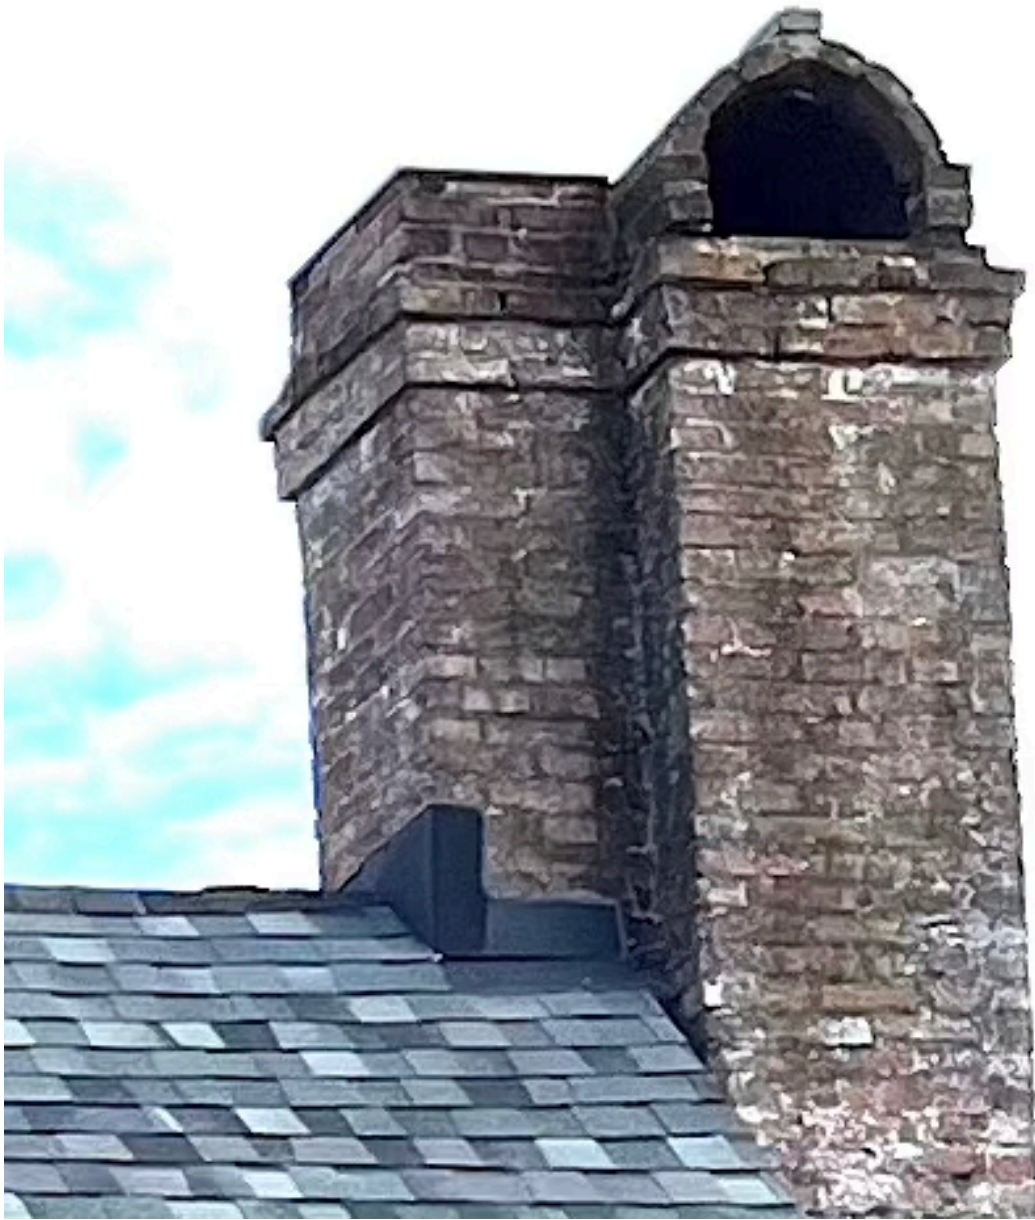
Figure 47 *Chimney cap before removal.*

The final structural task in the Fox Hall restoration project was the removal of the circa 1900, Roper-period chimney cap on the west chimney (Fig. 47, Fig. 48, and Fig. 49). Once removed, several of the original mortar joints on the inside of the main flue, near the top of the chimney, required tuck pointing. Since the fireplaces will no longer be used for fire safety reasons, the two flues were covered with heavy slate pavers cut to size. A gap of roughly a half inch was left under the slate covers to allow the flues to breathe or draw, thus preventing condensation that could damage the chimneys from the inside. While the east chimney did not have a Roper chimney cap, the same flue-covering treatment was applied earlier during the restoration project.
