# Fox Hall - Part 11, Second-Floor Assessment

#### Introduction:

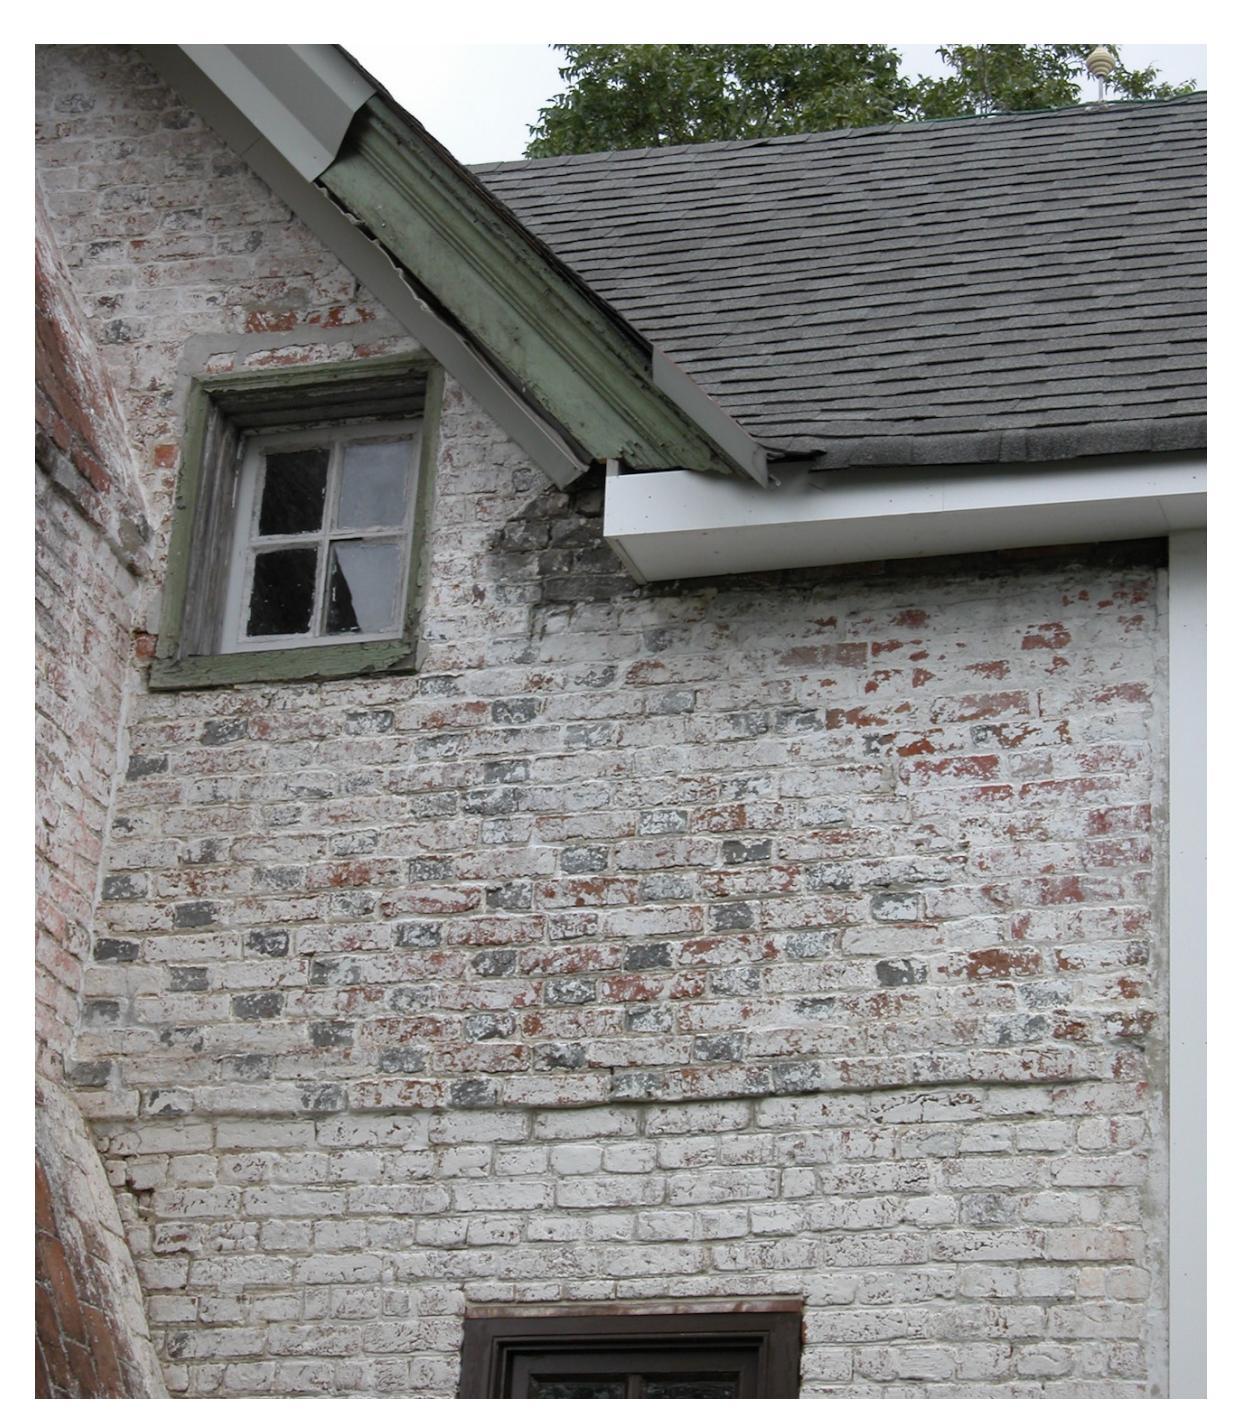
Figure 2

The original roof was the same pitch as the current roof. This is based on a rake-board ghost on the west endwall (Fig. 2, Rake-board ghost).

The original roof was the same pitch as the current roof line.

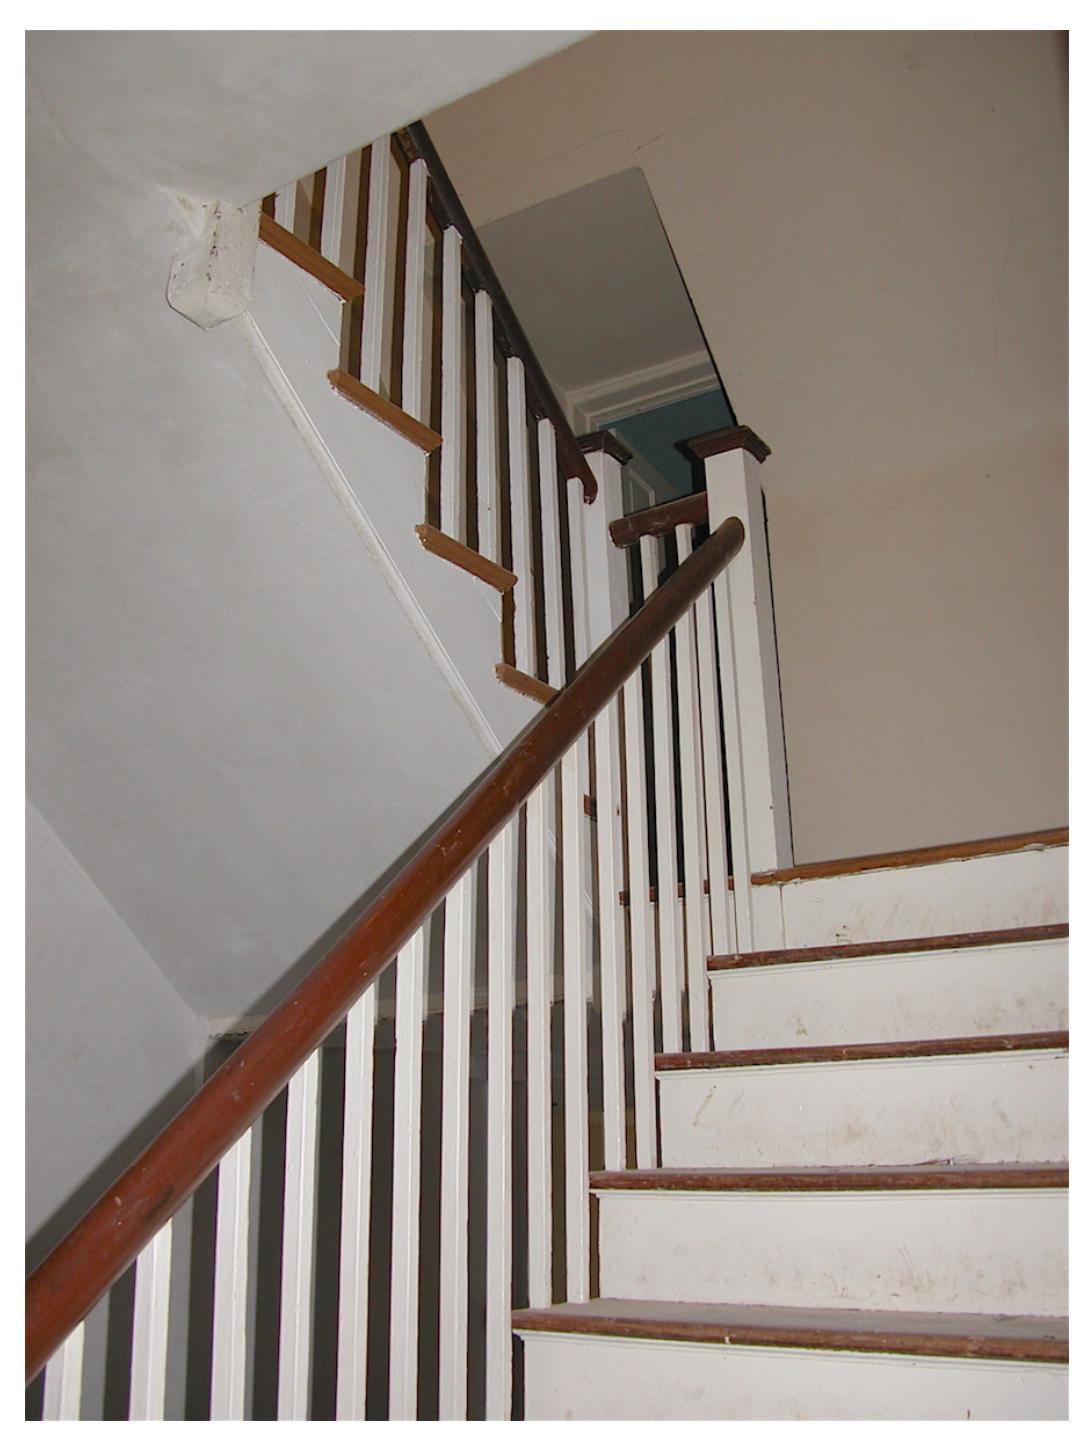
Figure 3

The stair was completely replaced circa 1790-1820, based on its local, ubiquitous style (Fig. 3, Replaced stair). All stair framing is sash sawn and fastened with cut nails (Fig. 4, Framing of replaced stair).

Fire destroyed the entire second floor above the second-floor floor joists. Based on sash-sawn stock and the style and construction of the replaced stair and balustrade, this fire and subsequent in-kind rebuilding of the second floor, attic, and roof took place somewhere between 1790 and 1820.

The late-eighteenth-early-nineteenth-century stair was installed at this time replacing the fire-damaged or destroyed original stair and balustrade. As discussed in *Part 1* of this series, the original stair likely would have been similar to the closed-string, board and batten stair at Lynnhaven House (Fig. 19, Lynnhaven House stair) or the closed-string stair at Linden Farm in Richmond County, Virginia (Fig. 20, Linden Farm stair).

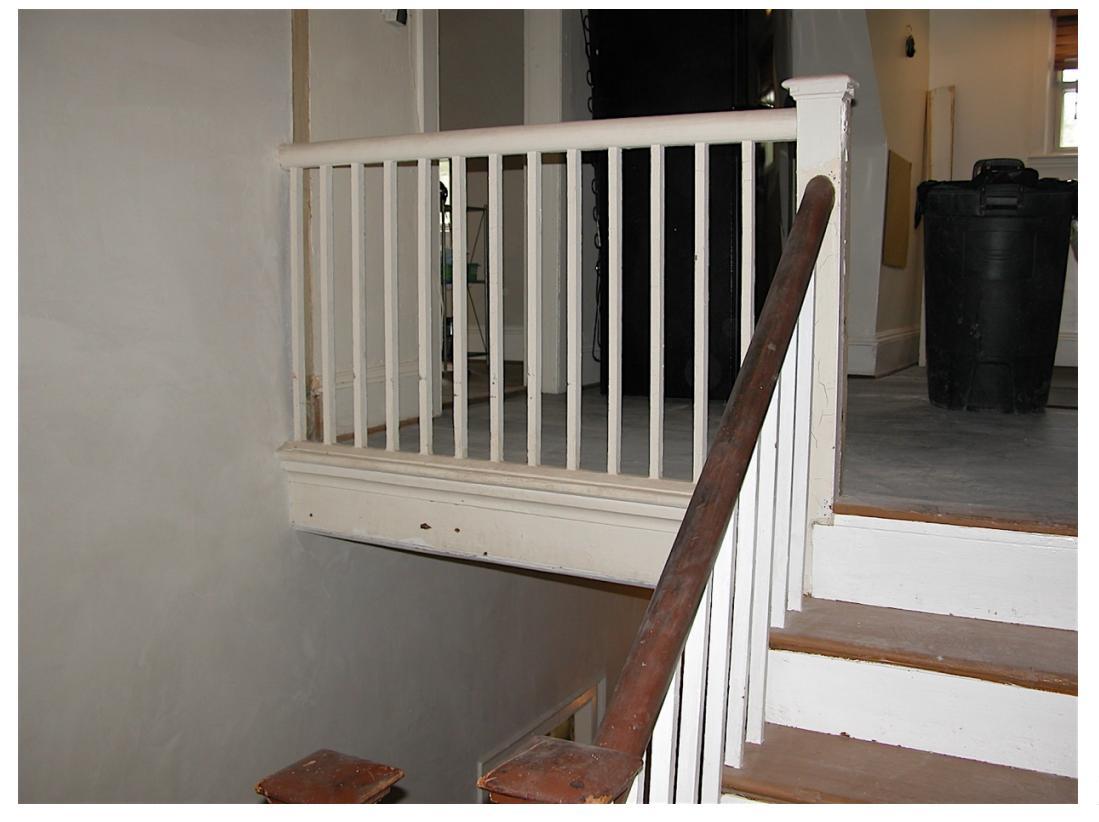
Upper-passage balustrade - The banister ends in the west wall (Fig. 5, Upper-passage balustrade).

Roper built or rebuilt the west-chamber wall and truncated the upperpassage banister in this wall. Likely, the original first-period balustrade and possibly the second-period balustrade extended into an open west chamber. The east-chamber/upper-passage wall also was constructed or reconstructed by Roper and has circa 1900 lath attached with wire nails as can be seen in the south eave/knee wall. We do not know if there were walls in either of these locations in the first or second periods. We do not know if the large annex was added to Fox Hall by Roper at this time or if it already existed. The current owner reported that there was a third fire in this annex. However, this fire was minor and has no bearing on the restoration of Fox Hall.

\* Upper-passage banister - A view window will be fabricated to cover the truncated banister.

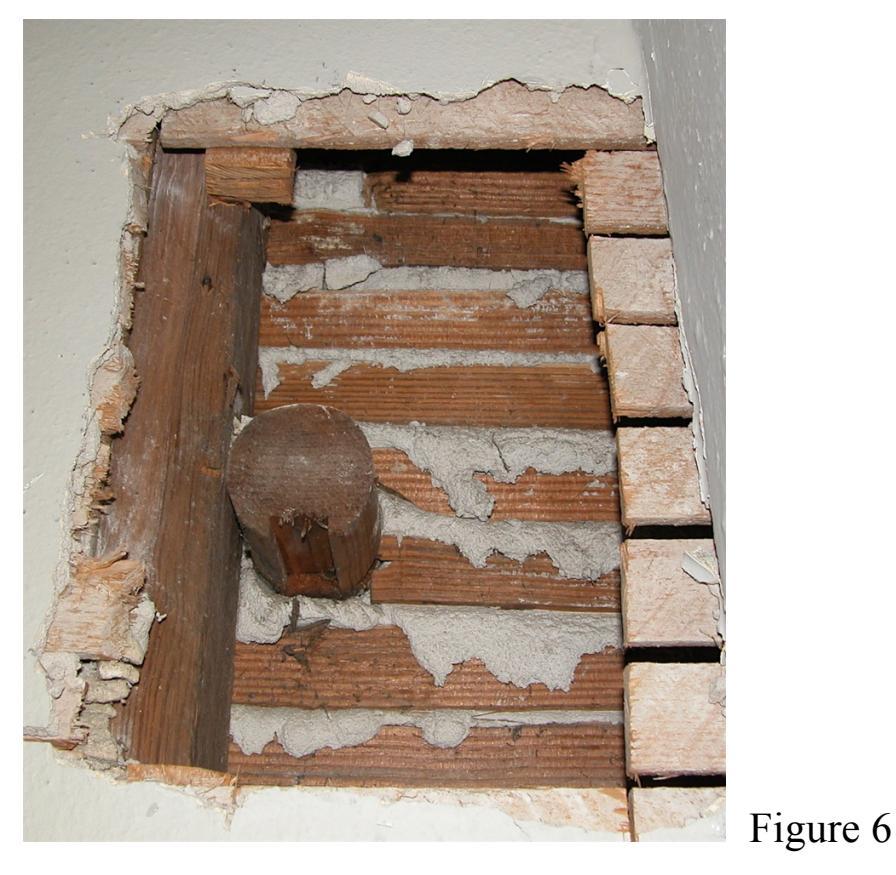
The banister was sawn, toe nailed to a stud, and is supported in the wall by circa 1900 plaster lath secured to studs with wire nails (Fig. 6, Sawn banister). The west newel post was cut below floor level, and its bottom section can be seen from the kitchen ceiling (Fig. 7, Bottom of newel post).

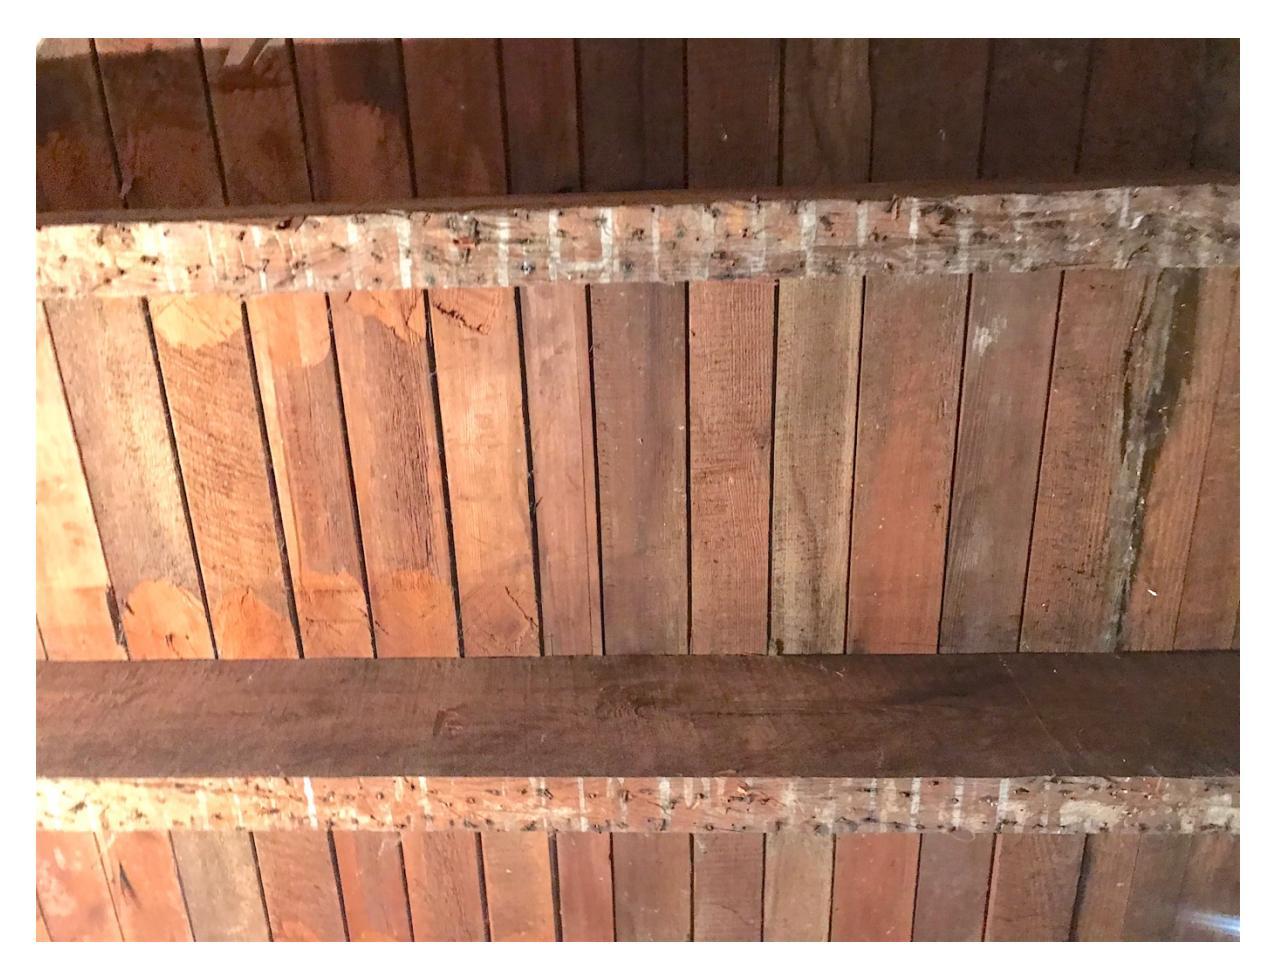
Figure 8

The west-chamber flooring, as seen from the kitchen, was replaced during the Roper period. This narrow-board flooring has circular-saw kerfs. The floorboards are chamfered over original second-floor joists. These joists have hewn edges and pit-sawn sides (Fig. 8, Flooring as seen from kitchen).

Late in the nineteenth century or early in the twentieth century, subsequent to the extensive second-floor fire, a second fire damaged portions of the attic and the west chamber. This is evidenced by the charred and sistered, sash-sawn rafters in the attic and the circular-sawn flooring in the west chamber. Roper apparently repaired this damage by sistering the charred rafters, replacing three dormers (one on the back and two on the front), adding the north gable on the front of the house where the third front dormer was, replacing the second-floor flooring, closing the west-chamber fireplace, and adding the fireplace surround to it.

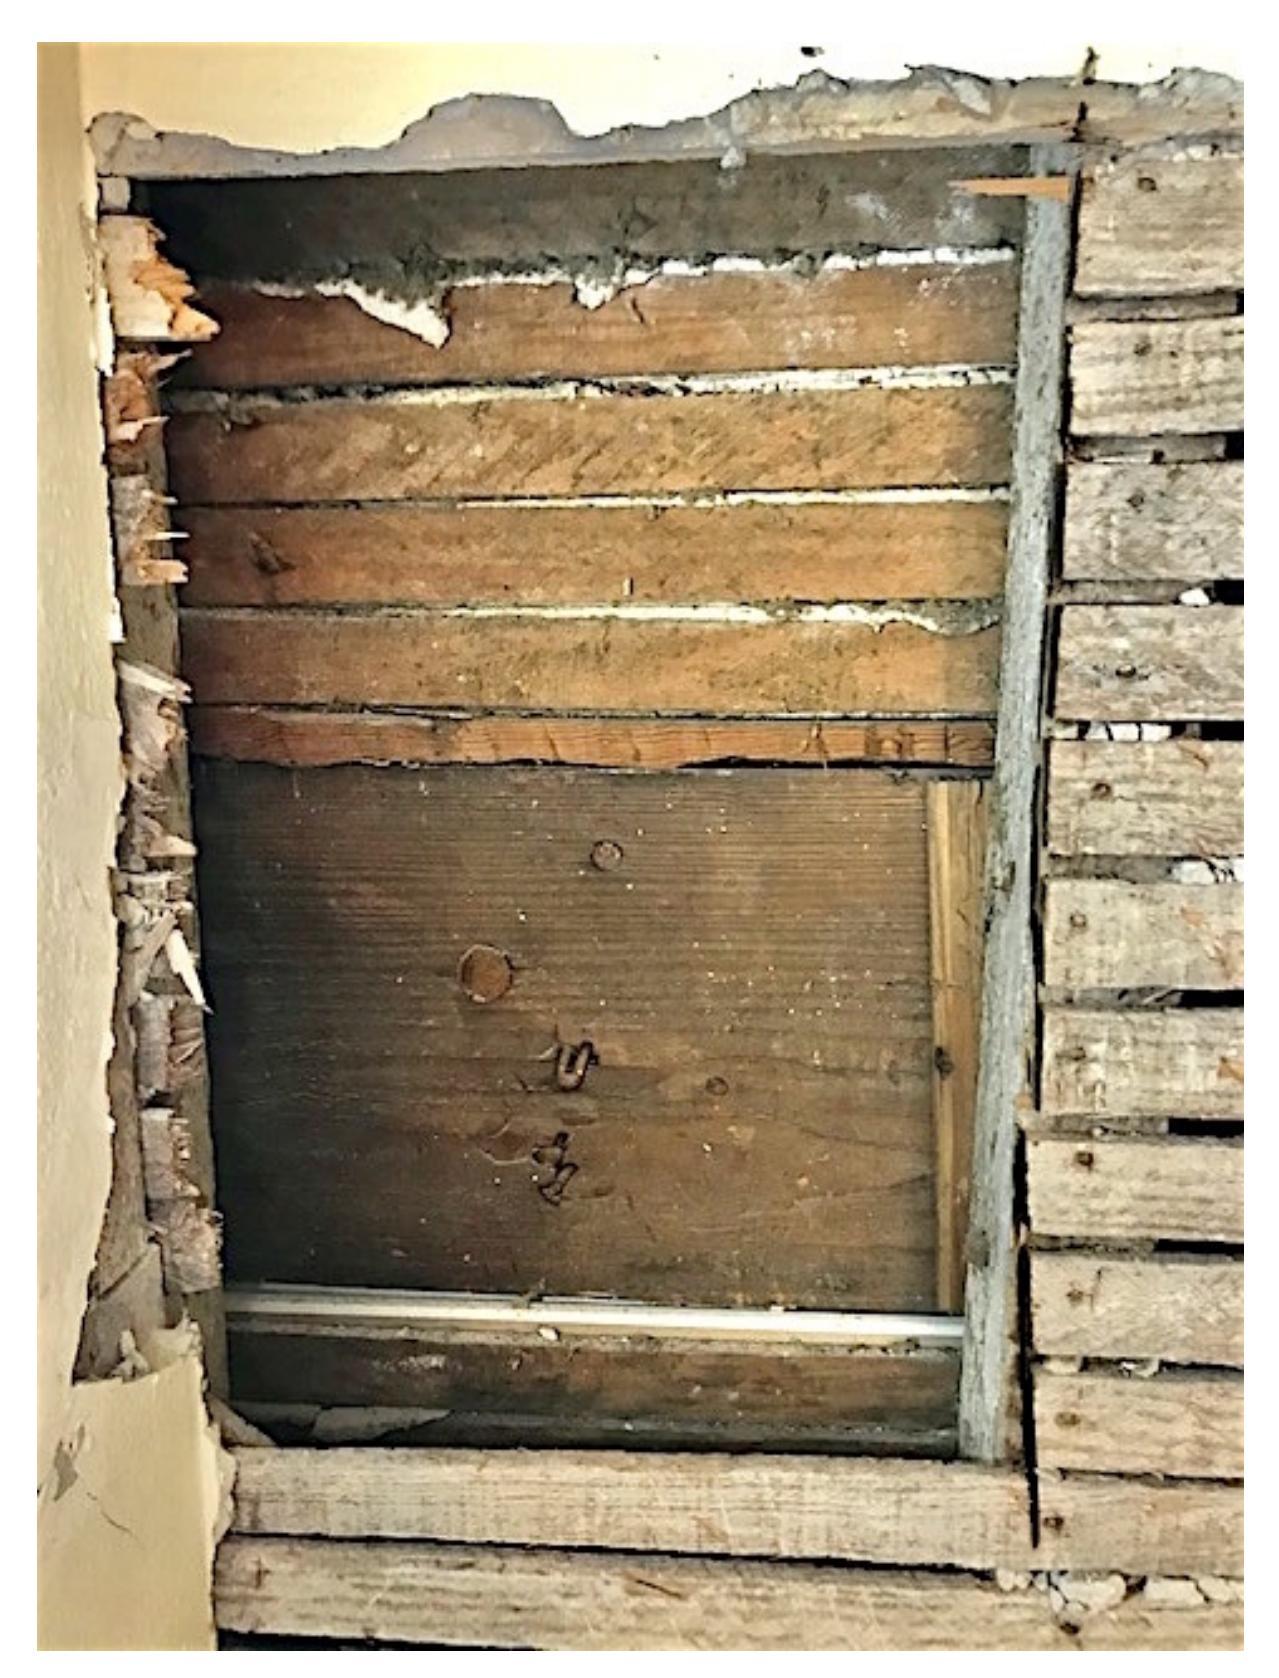
Figure 9

The joist between the west chamber and upper passage was headered off to accommodate the landing extension for the large Roper-period annex. This can be seen in the landing wall (Fig. 9, Headered joist).

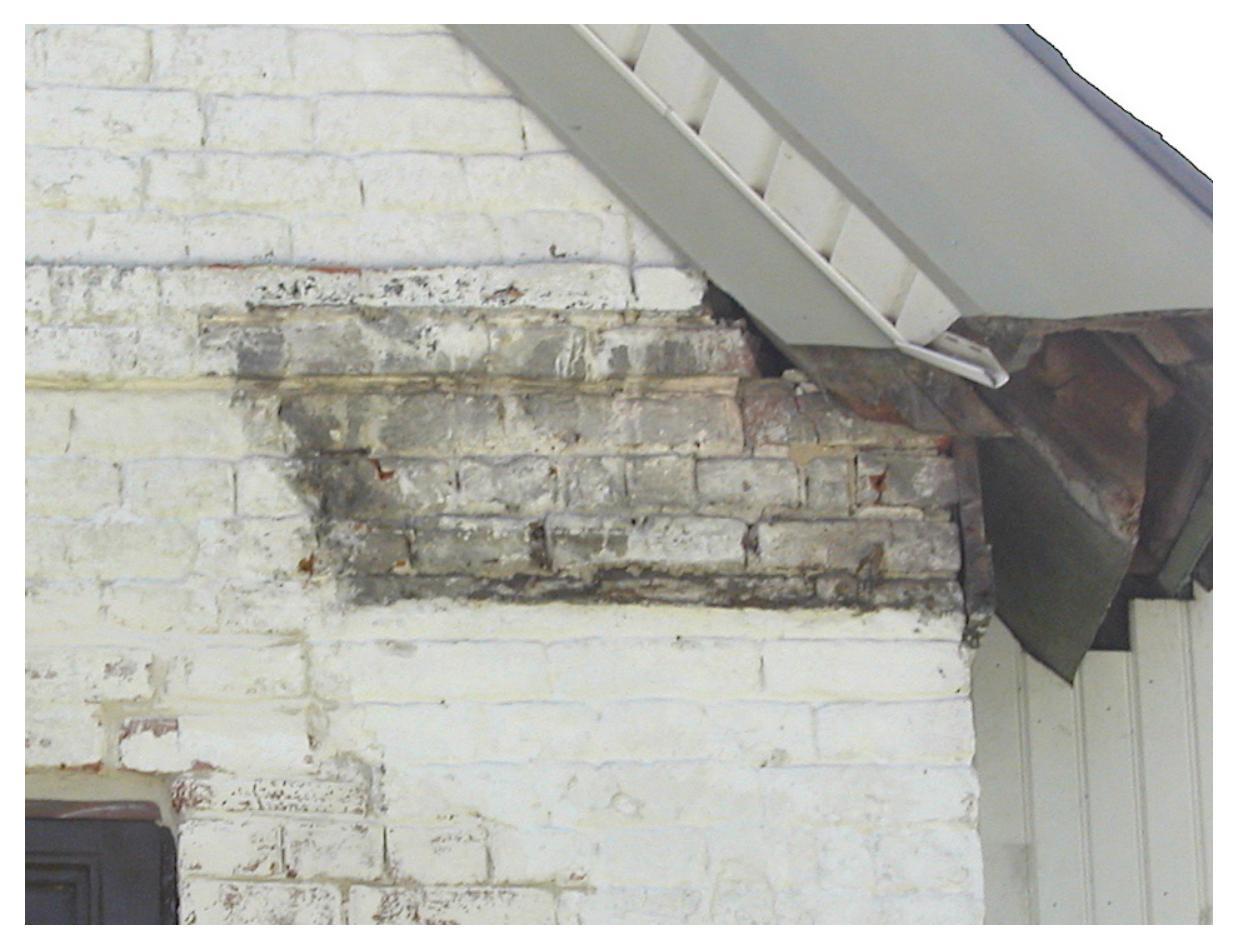
Figure 10

East endwall at intersections with south and north walls - There is evidence of minor brickwork repair in these locations, likely removing corbelling originally associated with tilted false plates (Fig. 10, Brickwork repair, north side of endwall).

The original eave structure was likely tilted false plates. This is based on the extension of the clipped joist tails, brickwork repair, and brick nogging evidence.

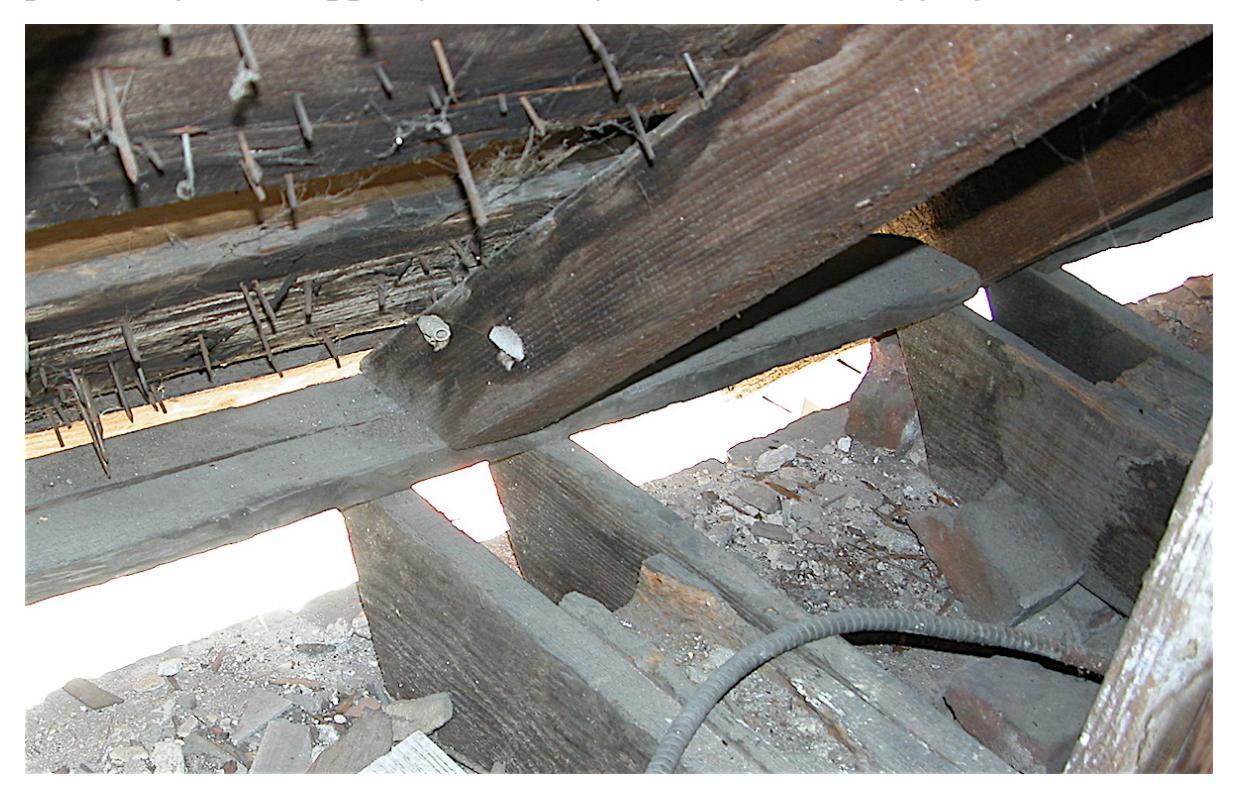
### Figure 11

South eave/knee wall - Pit-sawn joist tails are cut back about half of the wall thickness. Several of these clipped joist tails exhibit rotting, and a few show charring. All of these clipped joists are sistered on both sides

with sash-sawn 2x stock to support a sash-sawn, flat, 5/4" x 5" false plate (Fig. 11, Clipped joist tails, joist rot, brick nogging remains).

South eave/knee wall - Sash-sawn rafter tails are cut to land on the sashsawn, flat, false plate. The rafters are toe-nailed with cut nails into the false plate. The false plate is interrupted in places (See Fig. 11).

South eave/knee wall - Much roof sheathing is sash sawn and has cut nails penetrating inside of the knee wall, evidence from 19th century shingles (See Fig. 11).

As part of this rebuilding, the original second-floor joist tails were cut back, likely due to rot and/or the desire to update the eave to a box cornice. The original joists were sistered to the wall edge, a flat false plate was added to the top of the sistering timbers, and the rafter tails were toe-nailed to this false plate.

\* Eaves - No effort will be made to restore tilted false plates, if, indeed, they existed originally. The present eave construction dates to after the

first fire. We will repair this structure as needed and will install simple box cornices.

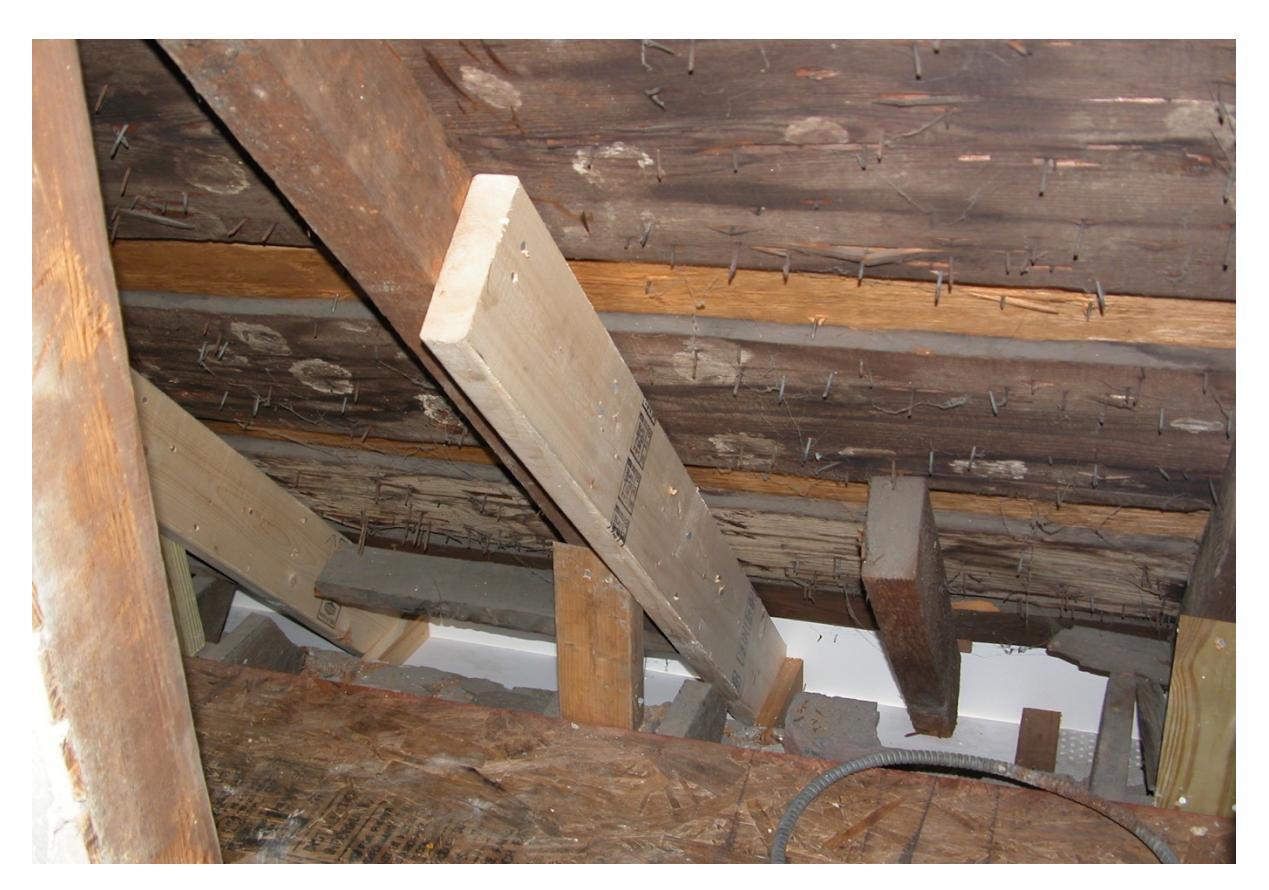
Figure 12

South eave/knee wall - There are several sections of short, circularsawn, 2x stock nailed to the roof sheathing. These served as false rafter extensions to support a late-nineteenth or early-twentieth century box cornice. Our team carpenter replaced the need for these by sistering rafter extensions to the actual rafters. He then rebuilt the box cornice on these. Short modern blocking has been placed by the team carpenter to shift rafter load from the false plate onto the joists (Fig. 12, Rebuilding of roof framing).

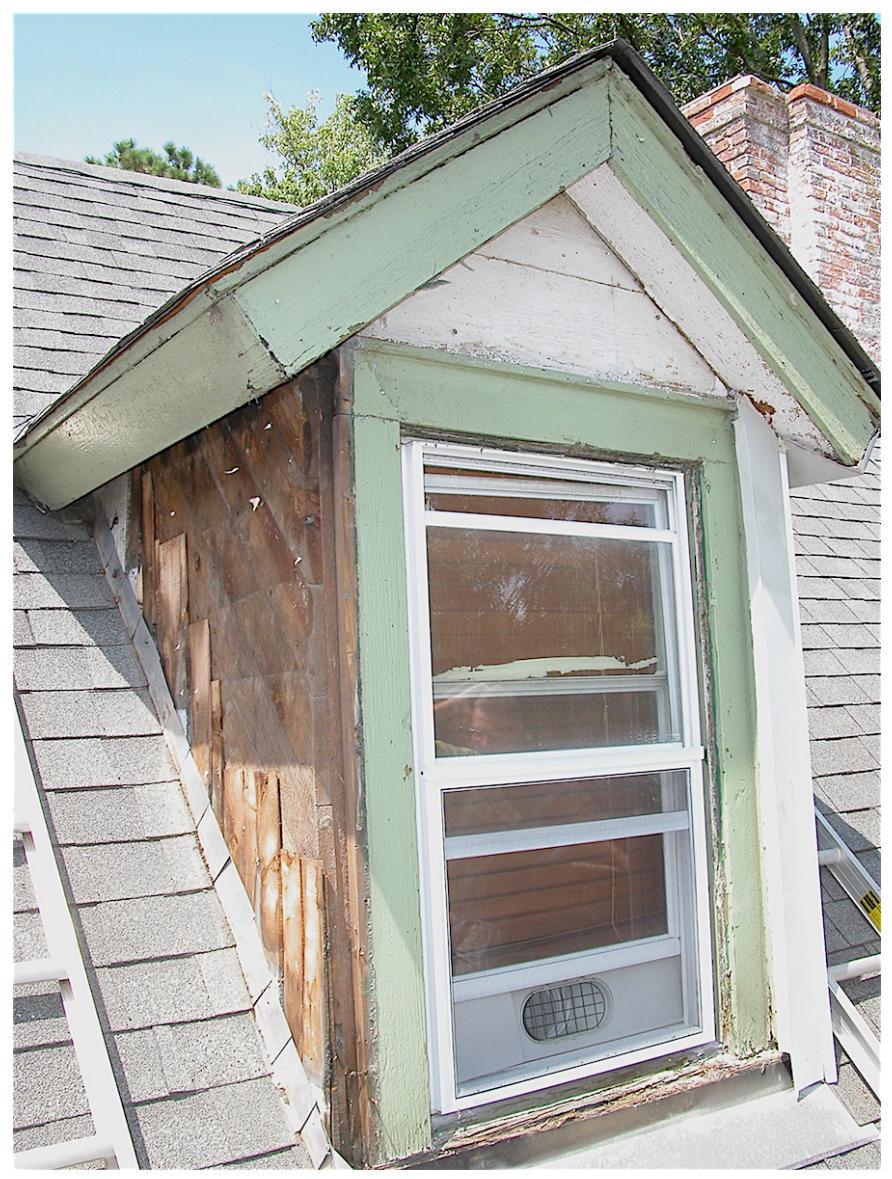
Figure 13

The three remaining dormers are entirely Roper period, complete with a Roper-labeled shingle (Fig. 13, South dormer) (Fig. 14, 6" cedar Roper shingle).

The three Roper dormers appear to be structurally sound, and the owner would like to retain them if possible, even though the pitch of their roofs does not match that of the main roof. If retained, the trim on these dormers would be redone to lighten their appearances. The restoration manager and team architect prefer to rebuild these dormers in the proper form to match the house roof. A final decision will be made after the dormers are stripped of their siding, trim, and roofing, and they are examined in detail.

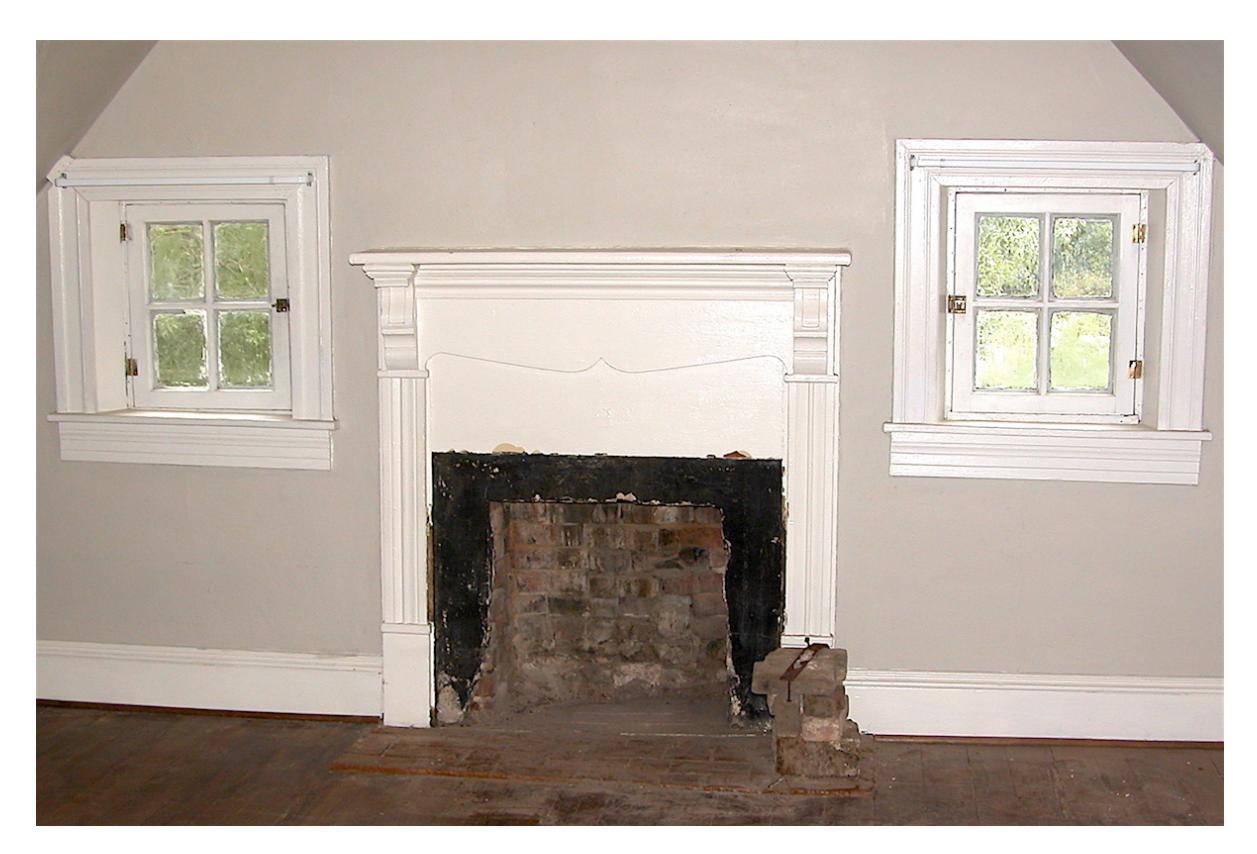
The west-chamber fireplace was boarded over with cut nails fastening the tongue and groove cover boards. This fireplace is now open. The firebox needs tuck pointing. The fireplace surround is Roper era (Fig. 15, West-chamber fireplace).

\* West-chamber fireplace - Stabilize the firebox by tuck pointing bricks.

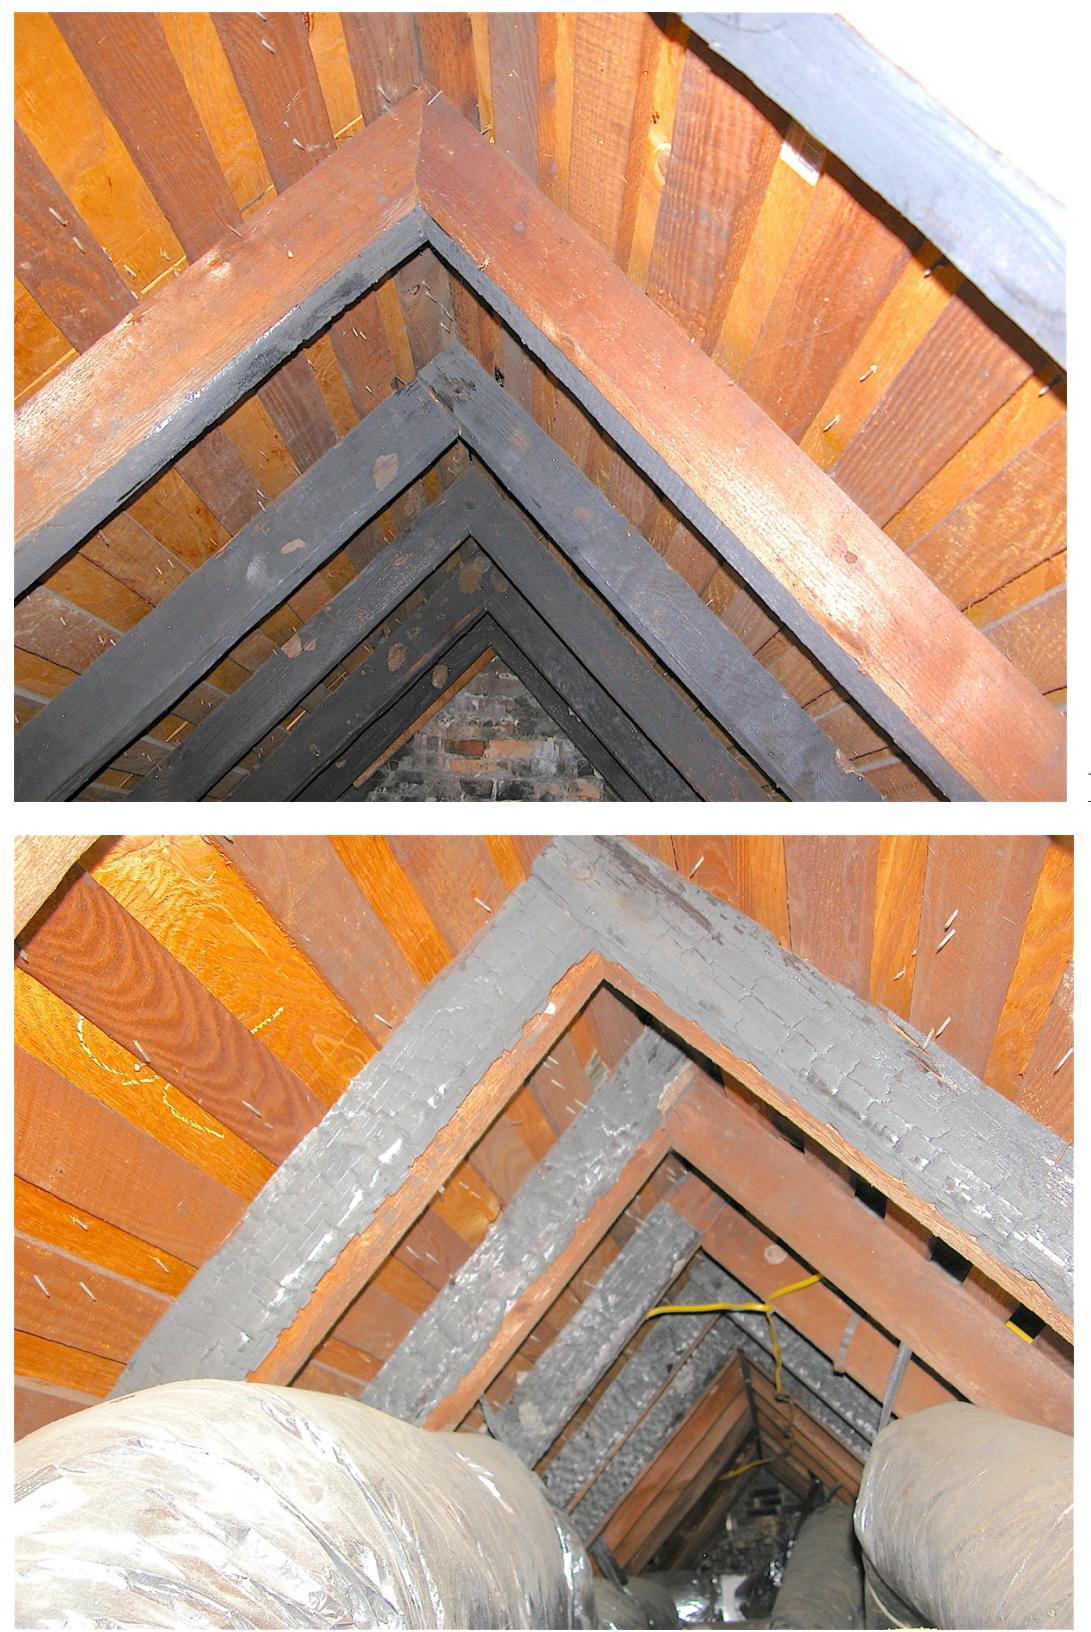
Figure 16

Attic - Extending from the west upper-passage wall to the east end of house, the sash-sawn, mortise and tenon-joined and pegged rafters are charred and sistered with 2x circular-sawn stock (Fig. 16, East chamber looking east). Beyond the west upper-passage wall to the west end of the building, there are no charred rafters, only newer 2x circular-sawn stock rafters (Fig. 17, East chamber looking west).

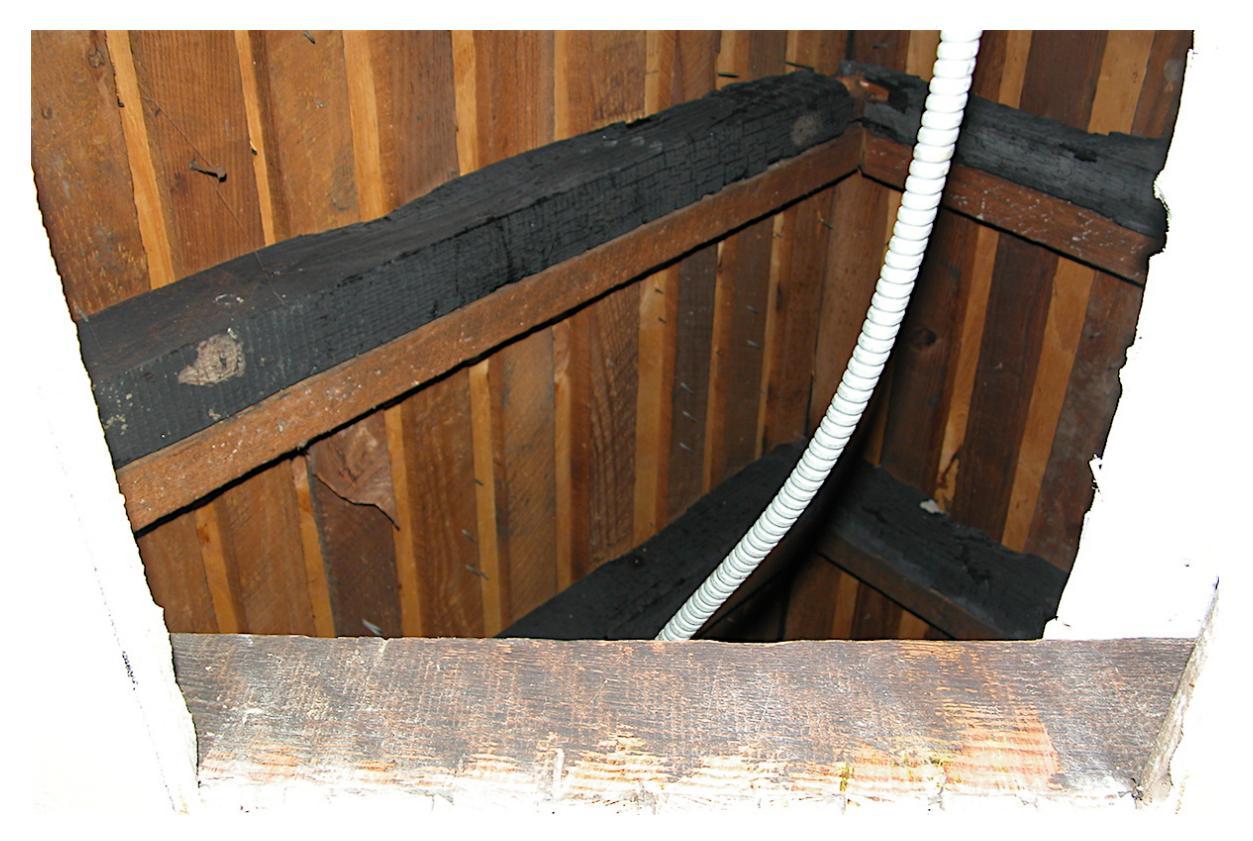
Figure 18

The attic joists and rafters are sash sawn (Fig. 18, Sash-sawn attic joists and rafters).

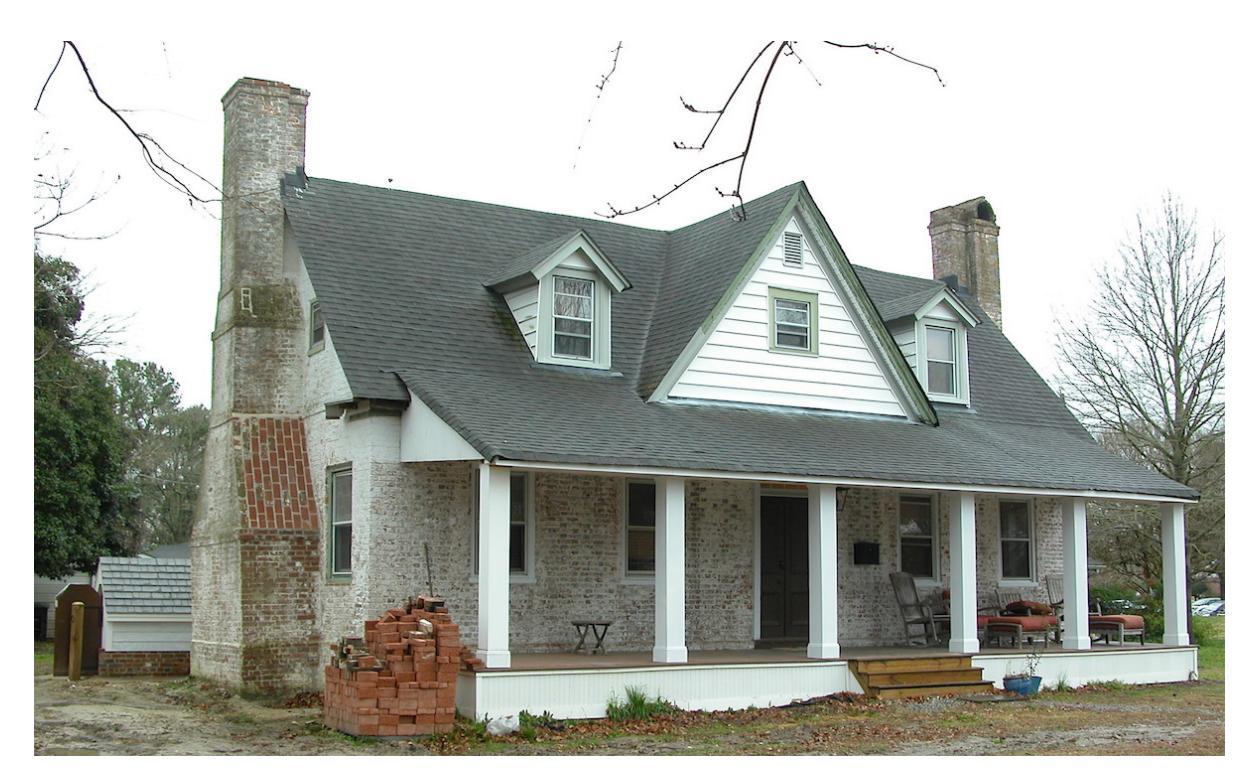
Figure 21

\* Roof - As can be seen in Fig. 21, Fox Hall presently has two dormers and a large gable across the front of the house and a third dormer on the back, all Roper period. It also has a front porch constructed by the current owner, replacing a similar Roper porch. The roof has been extended about one foot over both endwalls and fitted with heavy rake trim, again by Roper.

The major change to the roof will be the removal of the gable and the attached front porch. Once these excrescences are demolished, the roof will be reframed in the gable location with a new dormer, and the front eave will be repaired as noted in the above section.

When the current asphalt roofing material requires replacing, the excessive roof overhangs at the endwalls will be cut back, the heavy Roper trim will be removed, and new rake boards will be installed. No decision has yet been made on the roofing material. Possible choices are: riven and treated cypress or cedar shingles, composite shingles resembling riven ones, standing-seam metal, or textured asphalt/fiberglass shingles.

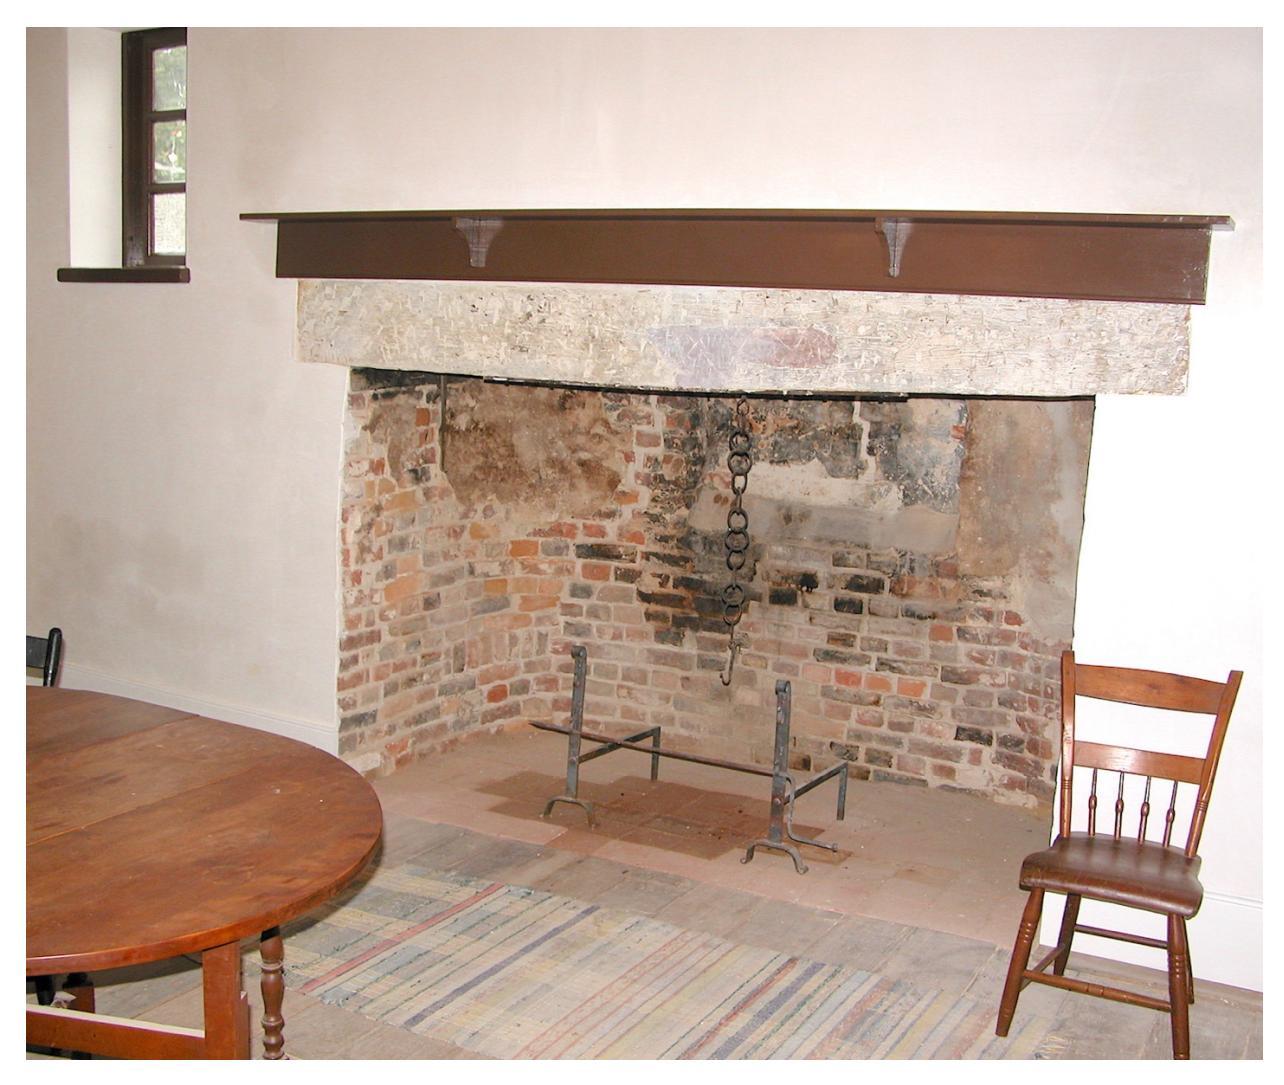
In Fox Hall - *Part 4*, Chimneys and Fireplaces, the decision was made to leave the interior brickwork of the west fireplace wall exposed and to plaster the original mantel tree. This decision has since been reversed. The wall has now been plastered, and the original mantel tree with its hatching for plaster is now exposed for study purposes.

Plastered west wall and exposed original mantel tree

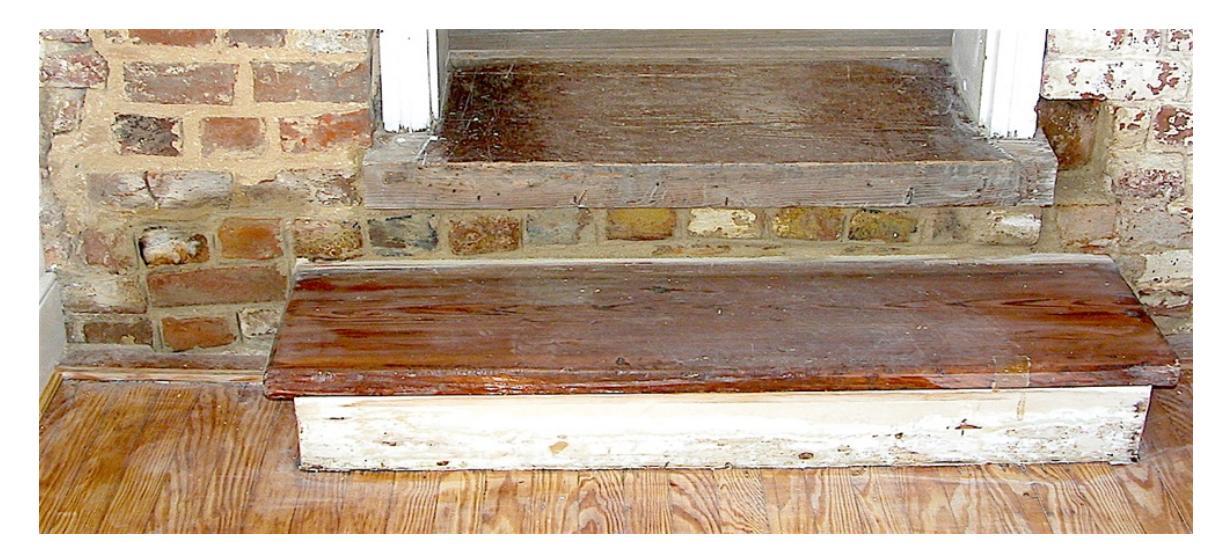
In Fox Hall - *Part 10*, Jack Arch Segment "8L" on page 25, we indicated that masonry repair was needed to stabilize the free-standing column of brick to the left of the doorway into the kitchen (See Figure 20 in *Part 10*). The loose bricks under the doorway and column have been reset.

Completed masonry repair
