# **Fox Hall - *Part 2*, Barred Vent**

Tony Russell

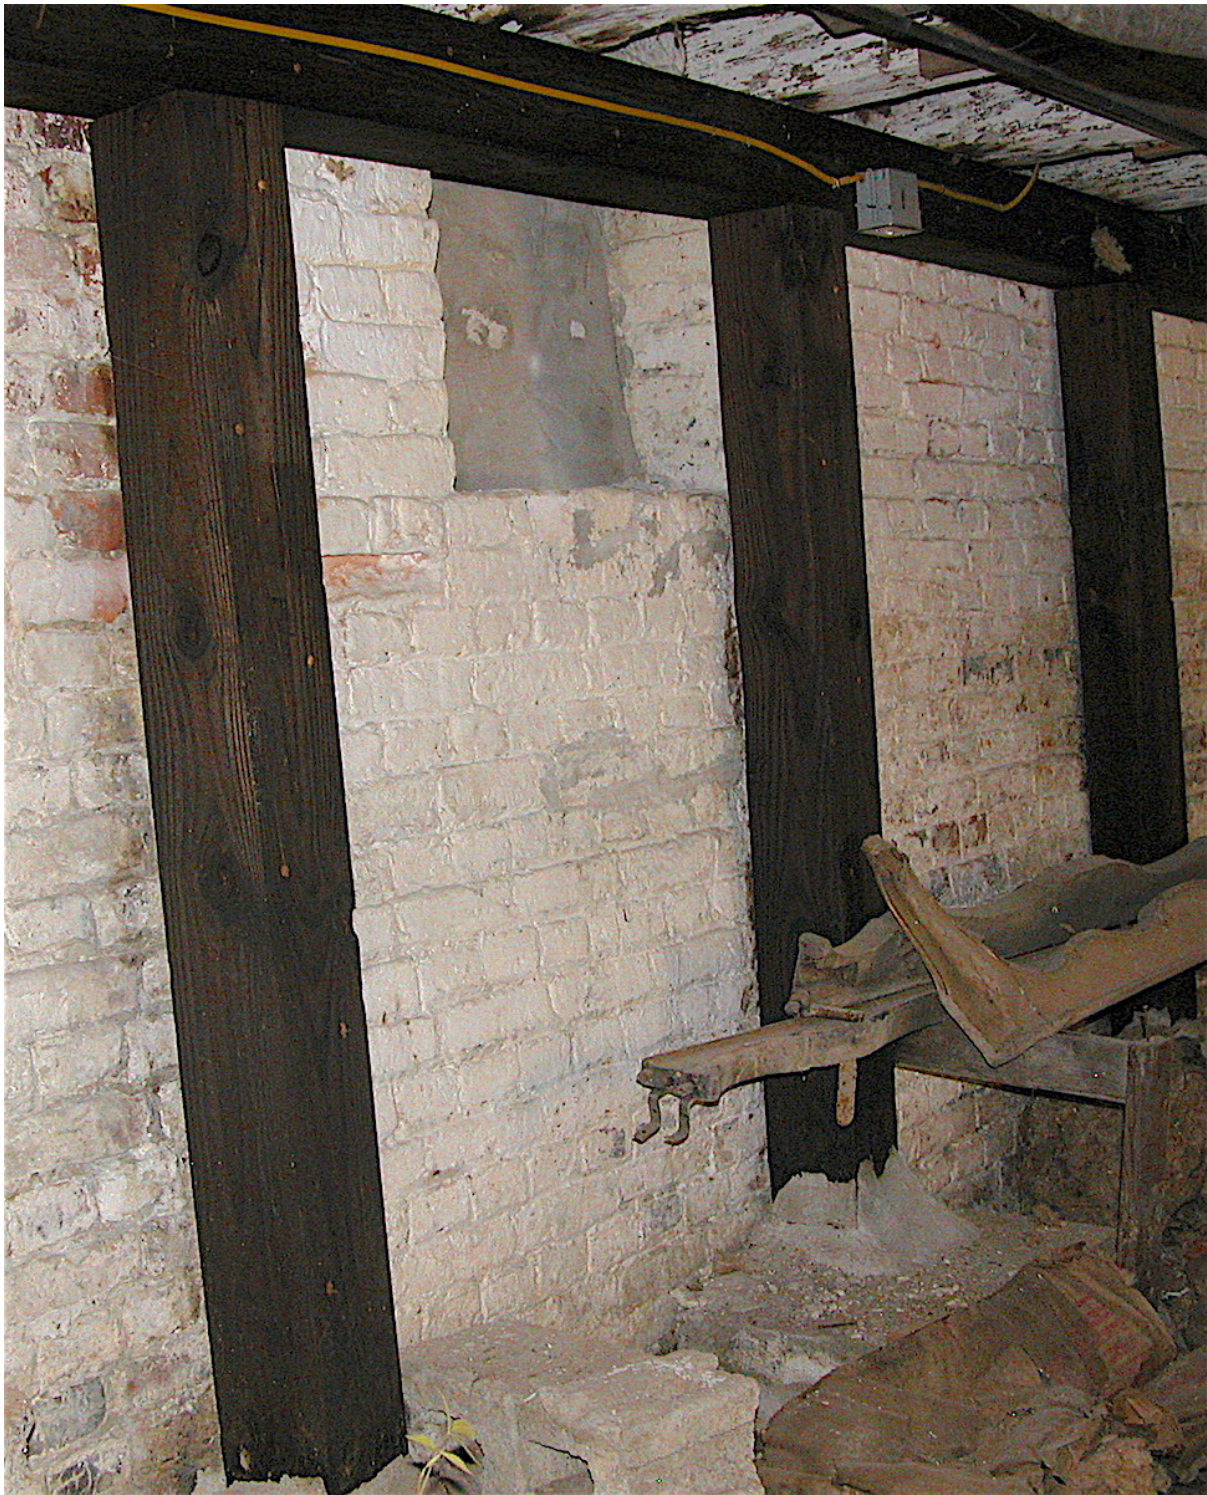
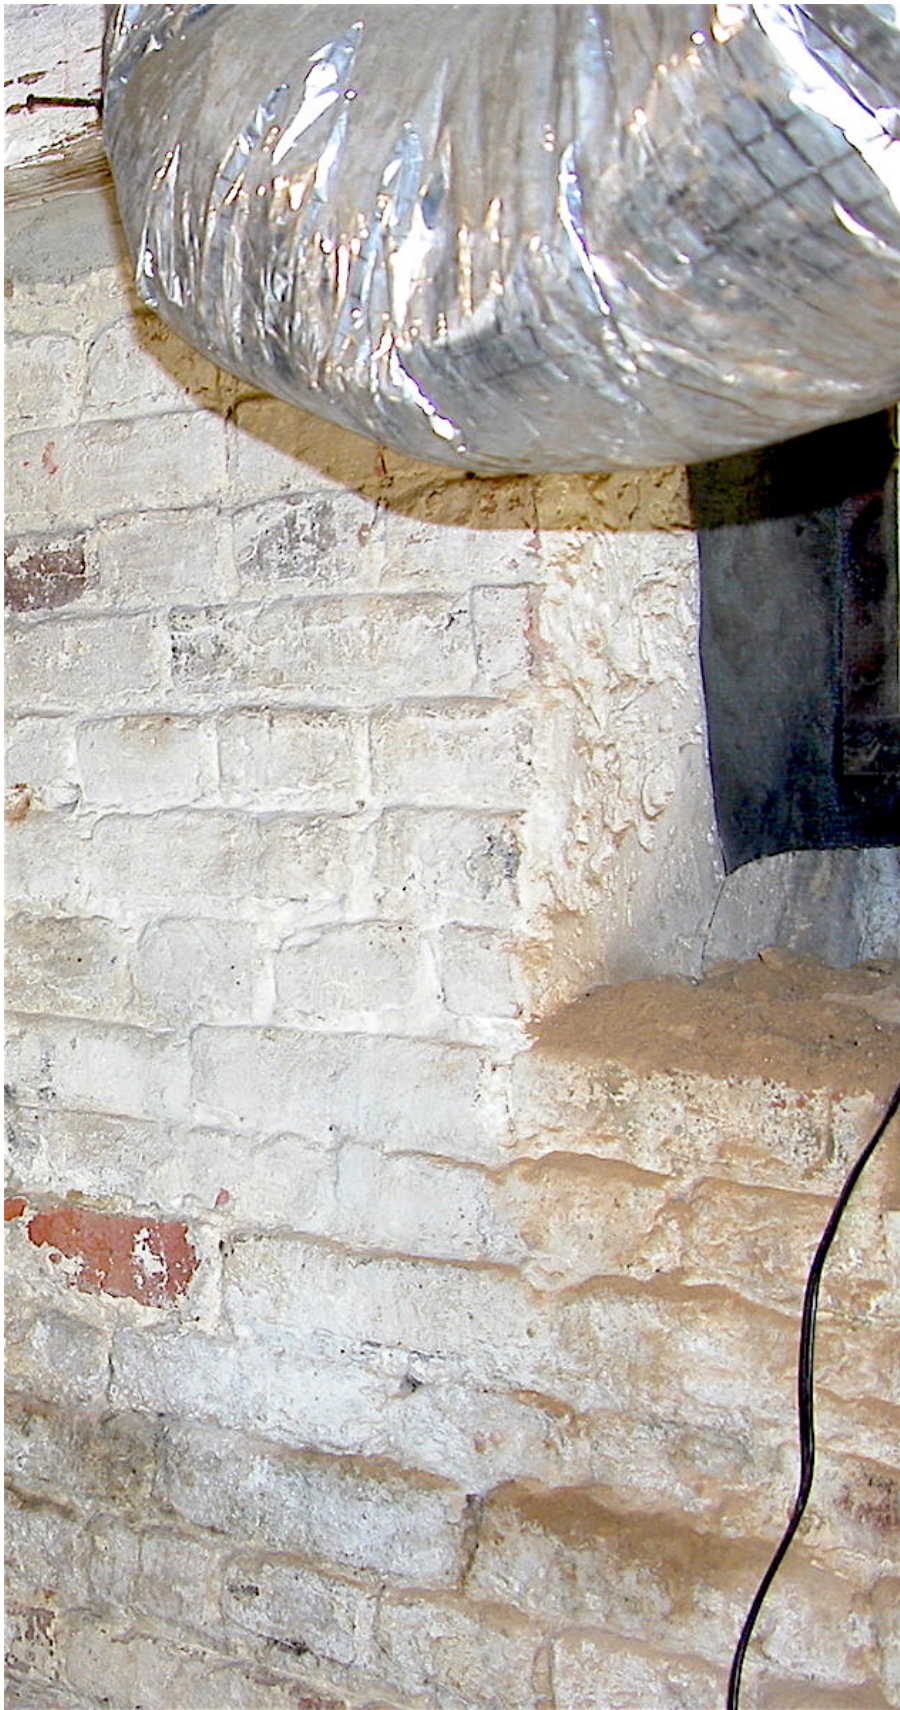
Figure 1

Fox Hall originally had three such barred vents, two on the front of the house and one on the back. The two vents on the front of the house were removed sometime in the past and lost (Figs. 1 & 2, Openings for barred vents on the front of the house, viewed from basement). Outside, these openings are now obscured by the front porch.

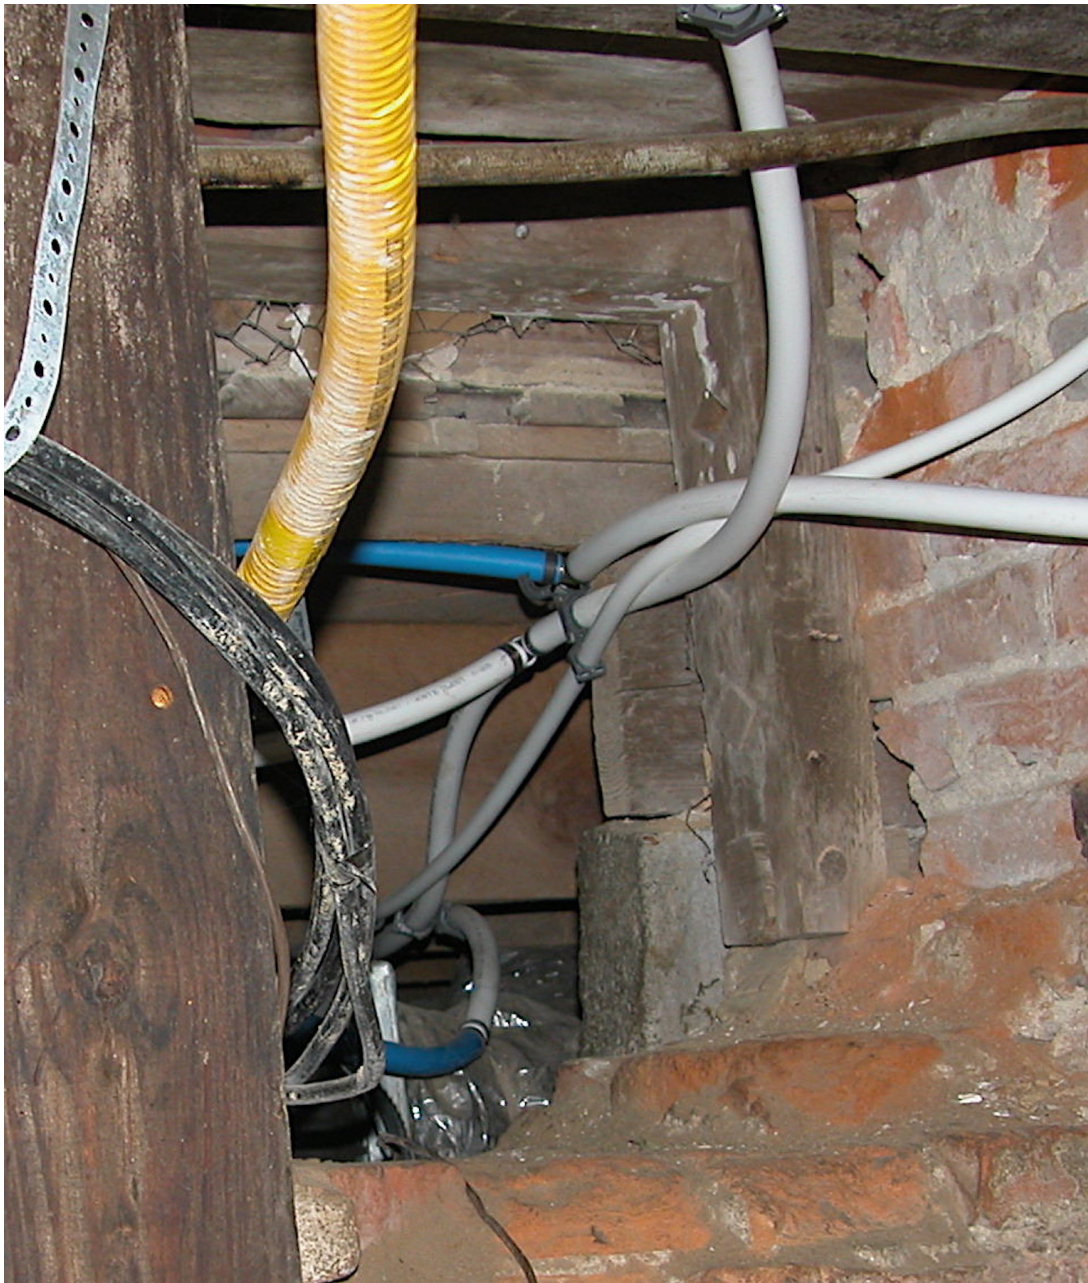
Figure 3

Fortunately, the barred vent on the back of the house remained partially intact. However, it was seriously damaged when parts of it were cut and broken away to allow for access for air-conditioning ducts and plumbing, gas, and electrical lines to pass between the original basement under Fox Hall and the crawl space under the twentieth-century addition. (Fig 3, Original barred vent).

This was a heavy-handed alteration that not only damaged the barred vent, but also the original brick basement wall, and the foundation and sill plate of the addition.

Since the upper part of this barred vent could be seen from the addition, the restoration manager decided that the vent would be partially restored to show another feature of the original house.

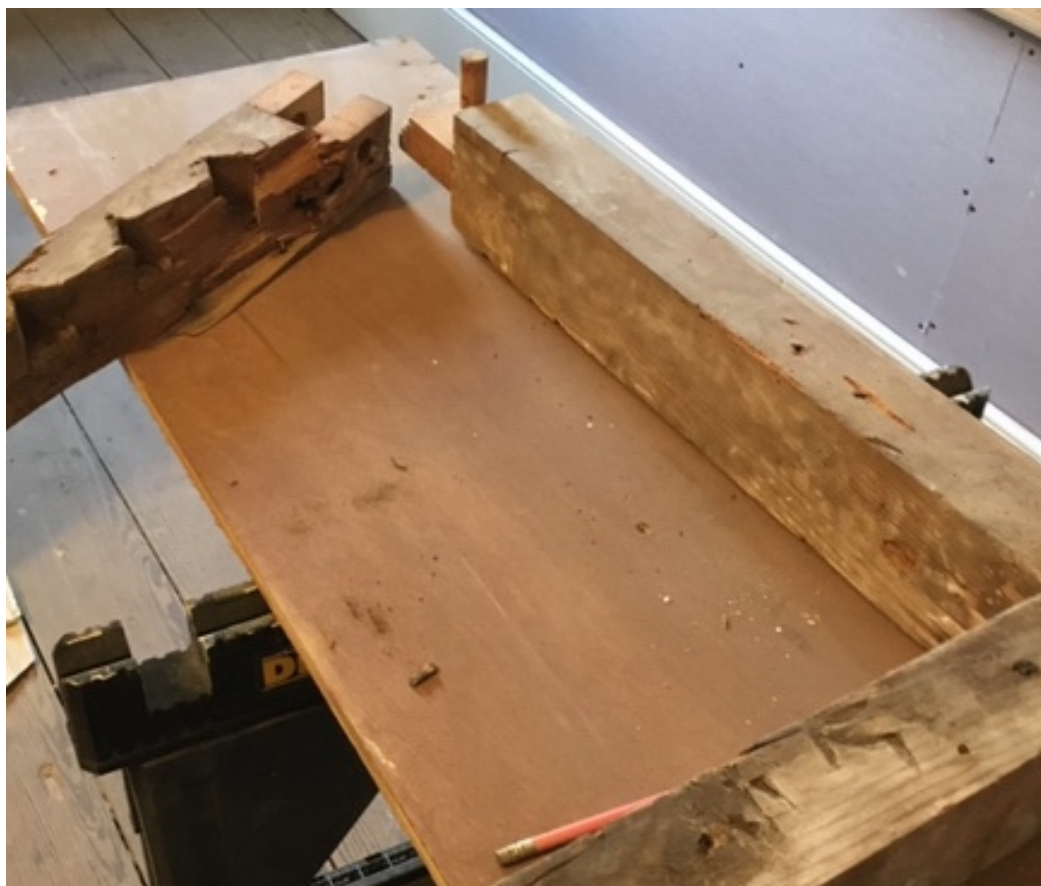
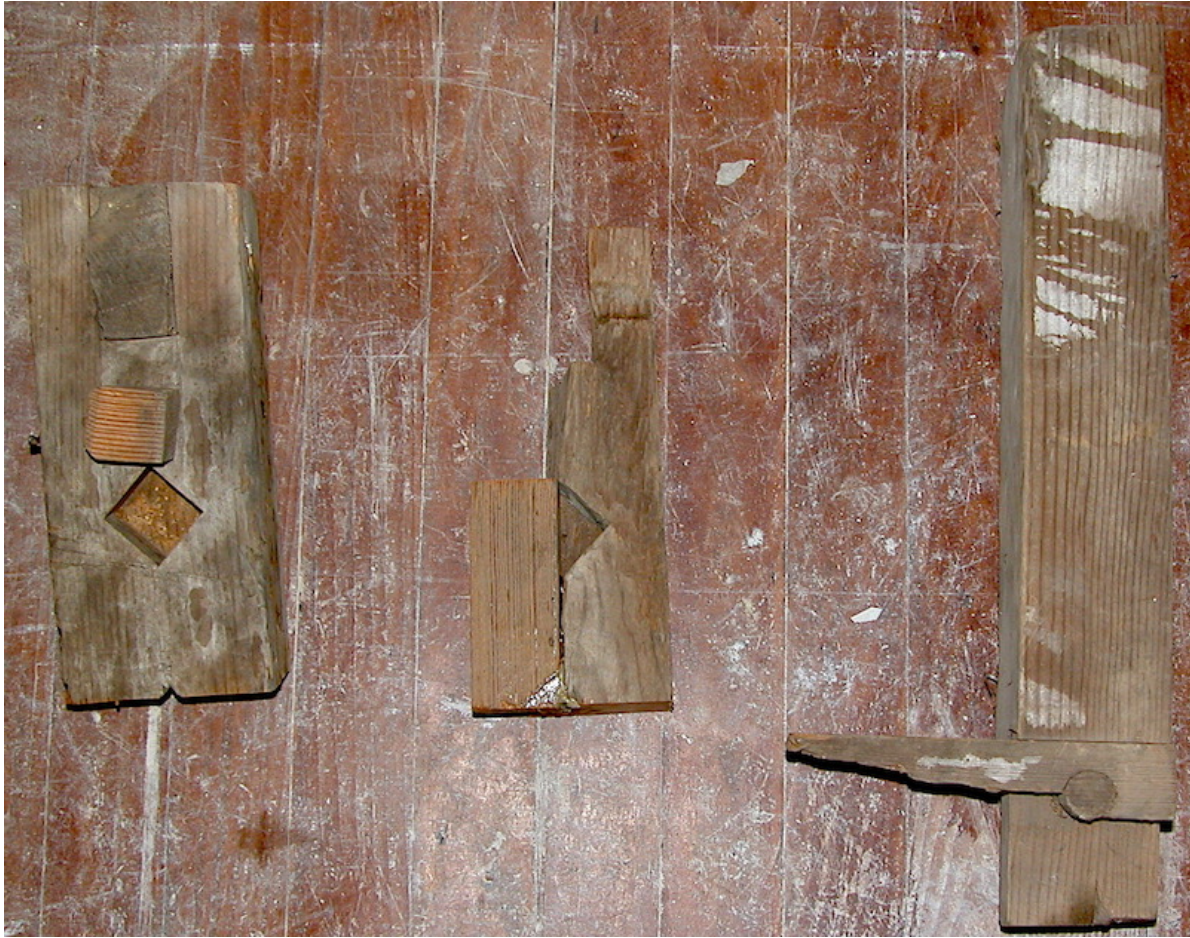
Figure 4

To do this, I had to remove the remains of the barred vent and trim off some of the damaged parts (Fig. 4, Disassembled vent frame) (Fig 5. Removed parts of barred vent).

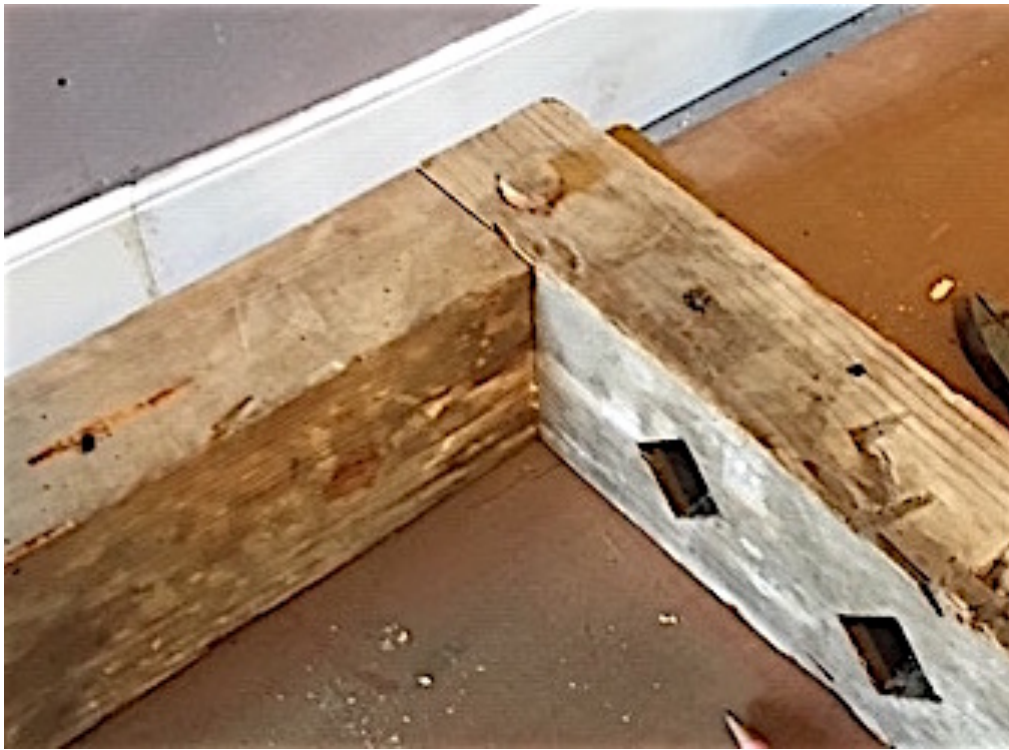
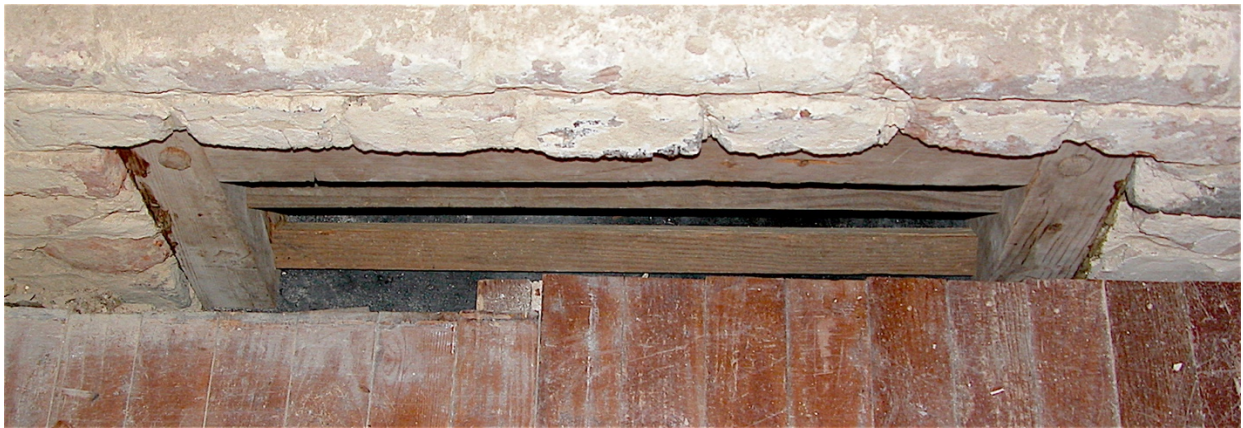
Figure 6

The original three bars were all missing. Space for two bars could be seen from the addition. So, I had to make two replacement bars and fit them into the vent frame (Fig. 6, Trimmed vent frame ready for reassembly) (Fig. 7, Barred vent with two replacement bars). The vent frame is made of yellow pine, and I used old pieces of yellow pine for the replacement bars.

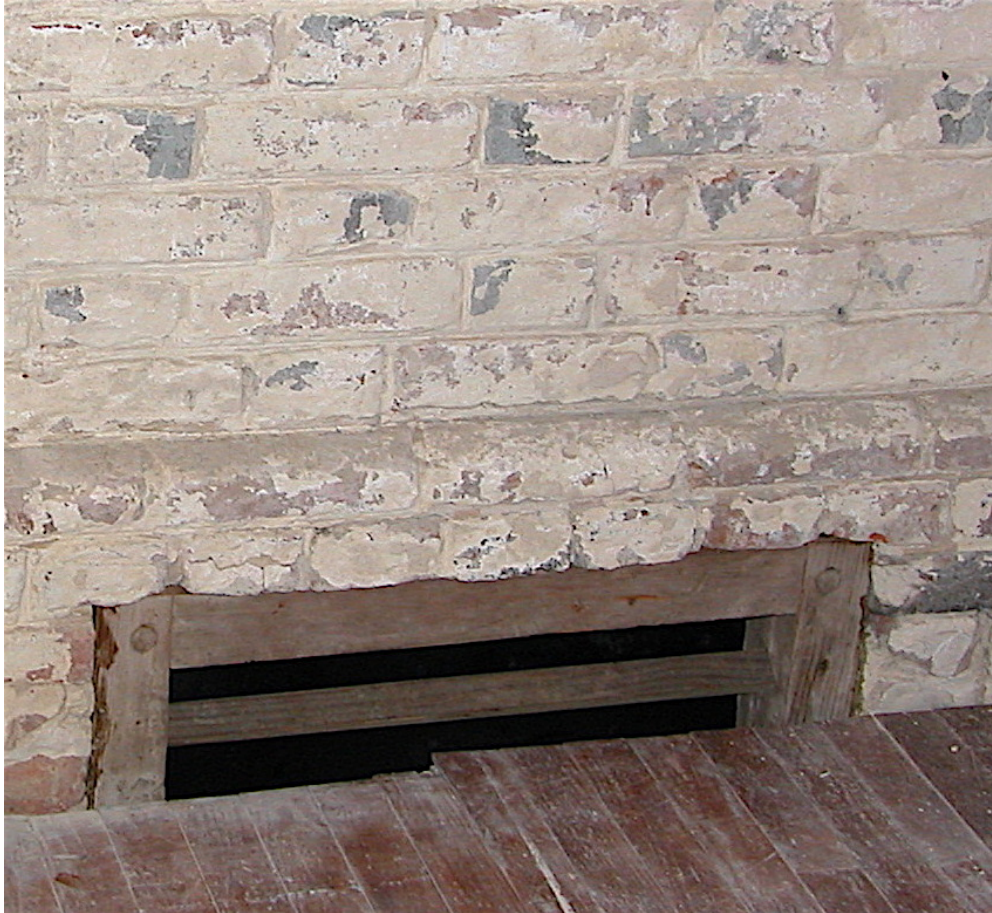
Figure 8

Due to the placement of the barred vent in the house wall and the intersection of the addition floor with this wall, one could see directly into the basement. To close off this view and to block the direct opening into the basement, I had to box off the bottom and back of the trimmed barred vent. This was done with wood painted black (Fig. 8, Restored

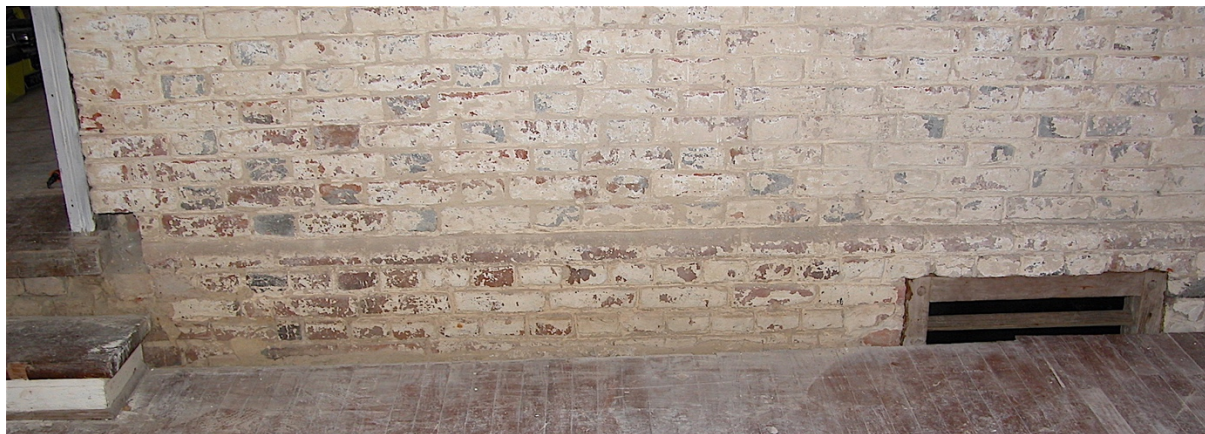
barred vent). Figure 9 shows the location of the barred vent in relation to the kitchen-chamber door (Fig. 9, Barred vent & kitchen-chamber door).
