Fox Hall - *Part 7*, First-Floor Plan

By Dick Gresham

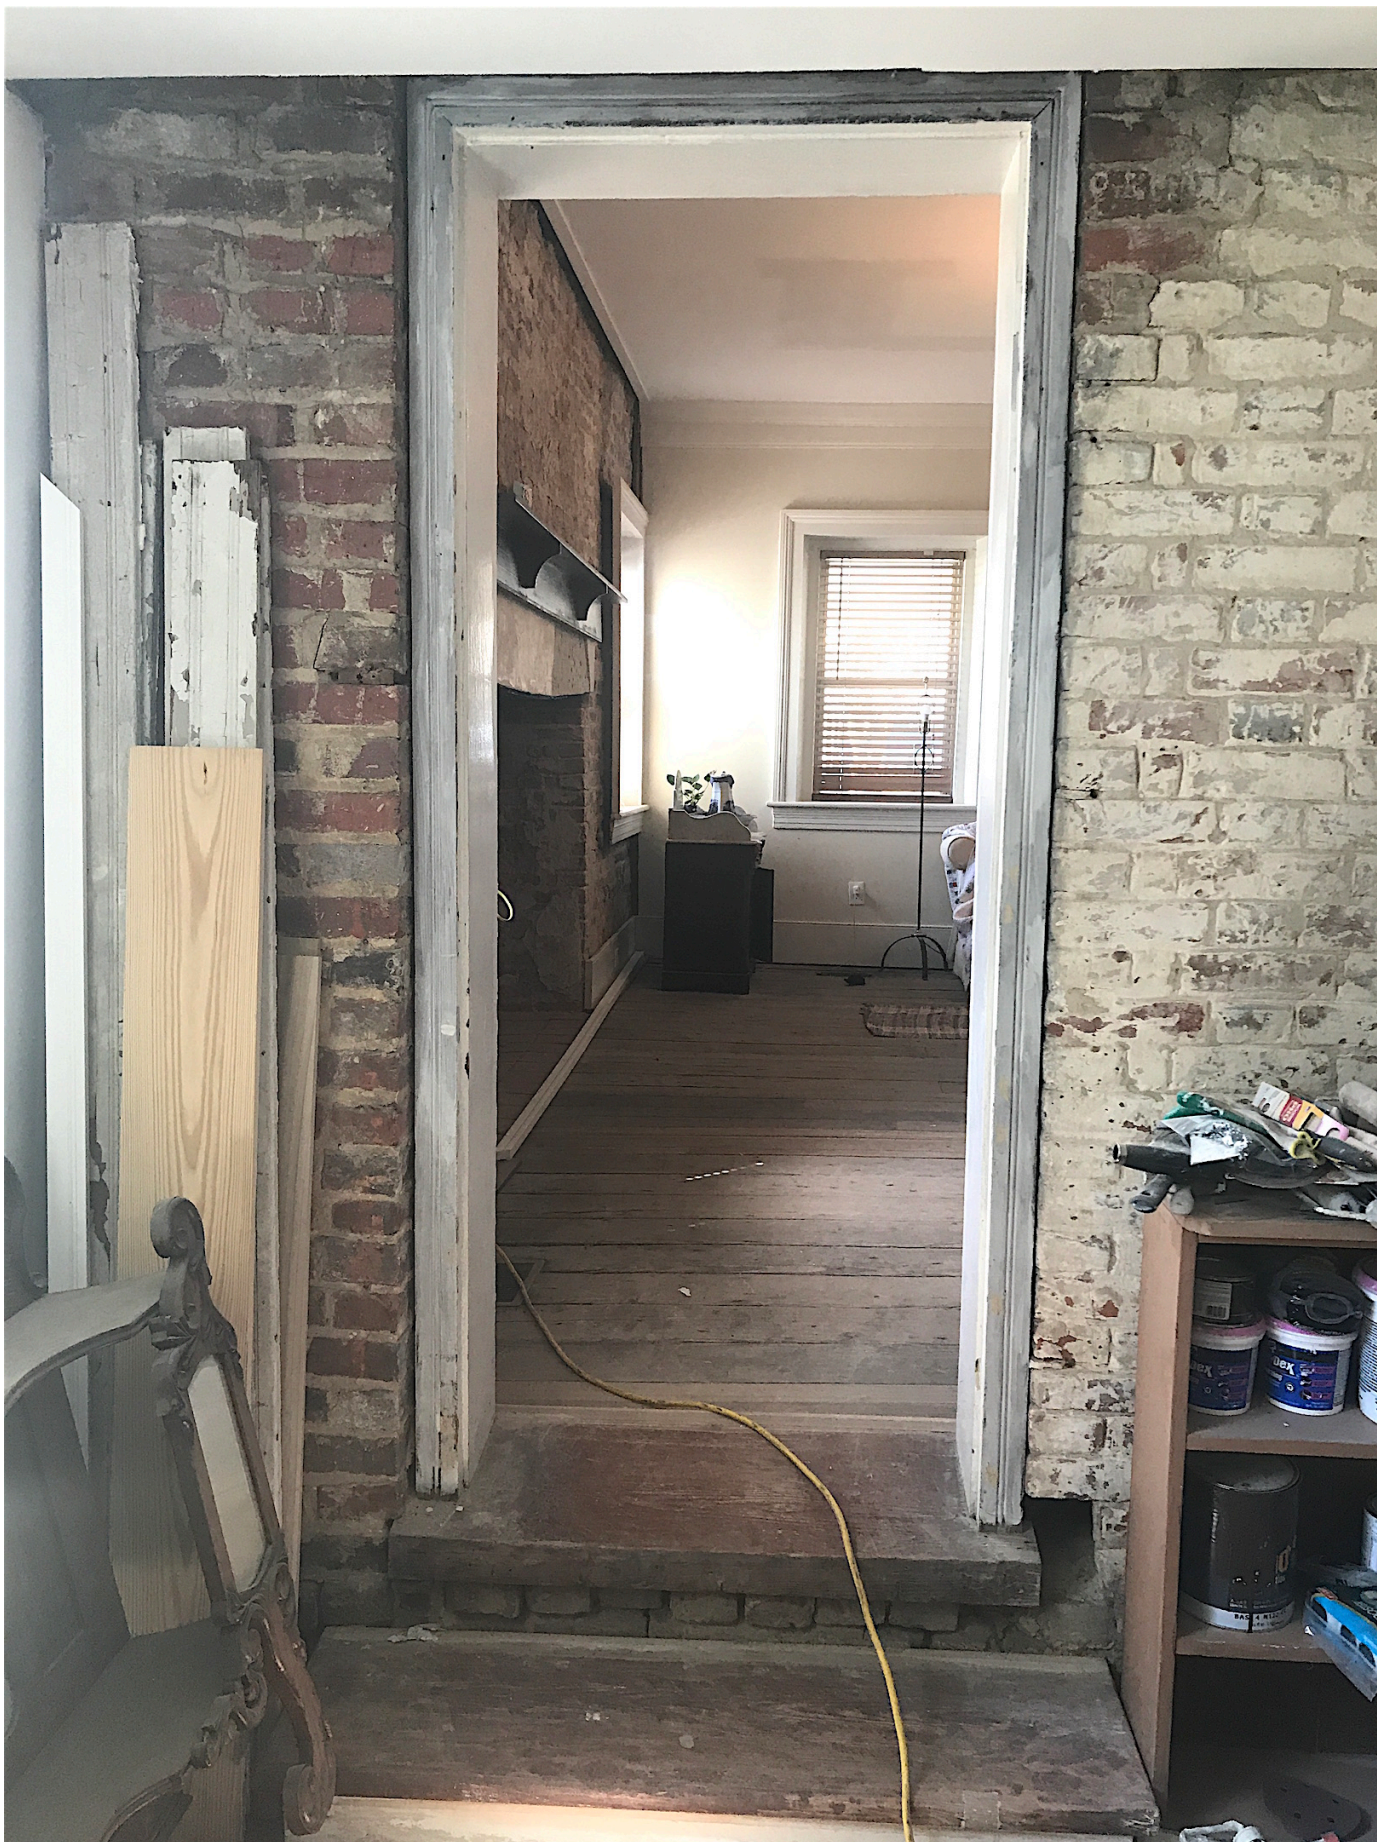
Figure 2

In the lower right of Fig. 2, there is a pocket in the brickwork initially thought to have been the location of the original passageway sill. However, we now believe that this pocket was the puthole for a 5" x 6" east sill of the kitchen chamber. There is no evidence of a brick foundation for the kitchen chamber, so it probably was supported on brick piers and was of frame construction. The damaged brickwork above the original passageway provides no indication of the roofline.

While excavating along the outside wall of the early twentieth-century addition, only modern concrete was encountered. Furthermore, the owner reported that there are remains of a small concrete pad in front of the passageway under the addition. Based on this evidence, the kitchen chamber probably was removed during the earlier construction of the late nineteenth-century addition and before construction of the present early twentieth-century addition, converting the area into a small exterior entrance.
