Fox Hall - *Part 9*, Brickwork Finish

By Jim Melchor and Tom Newbern

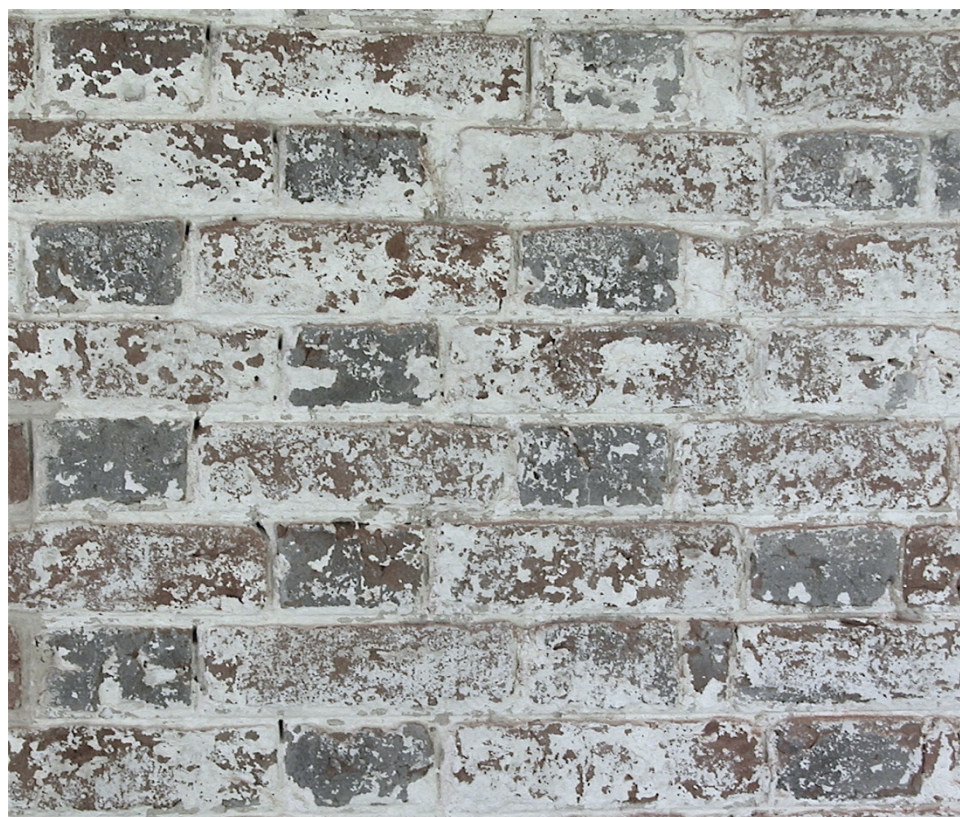
Figure 1

As discussed in previous parts of the Fox Hall series, the brickwork on the front and back of Fox Hall is laid in Flemish bond with glazed headers (Fig. 1, Fox Hall front and back walls, Flemish bond with glazed headers). The endwalls are Flemish bond below the water table and above the belt course, and English bond between the water table and belt course and in the chimneys (Fig. 2, Mixed brickwork on endwalls). There are extant jack arches over the five large first-floor windows and the front door as well as decorative hound-tooth brickwork over the front-door jack arch (Fig. 3, Jack arch over a large front window) (Fig. 4, Hound-tooth brickwork over door and portion of door jack arch). This brickwork was meant to impress!

Unfortunately, the exterior brickwork of Fox Hall, over the years, has been subjected to numerous campaigns of whitewash and white paint. Some of this has been removed with gentle pressure washing by the owner, but much remains (See Figs. 1-4). It is unlikely that all can be completely removed without risking damage to the original bricks and mortar. In repairing the chimneys, restoring the original window openings, and closing several modern penetrations in the original brickwork, the masons have had to use custom-made restoration bricks that closely match the natural color and texture of the originals. Obviously, these clean, unpainted bricks stand out and draw attention to the repairs (Fig. 5, Largest repair area, closure of a twentieth-century window).

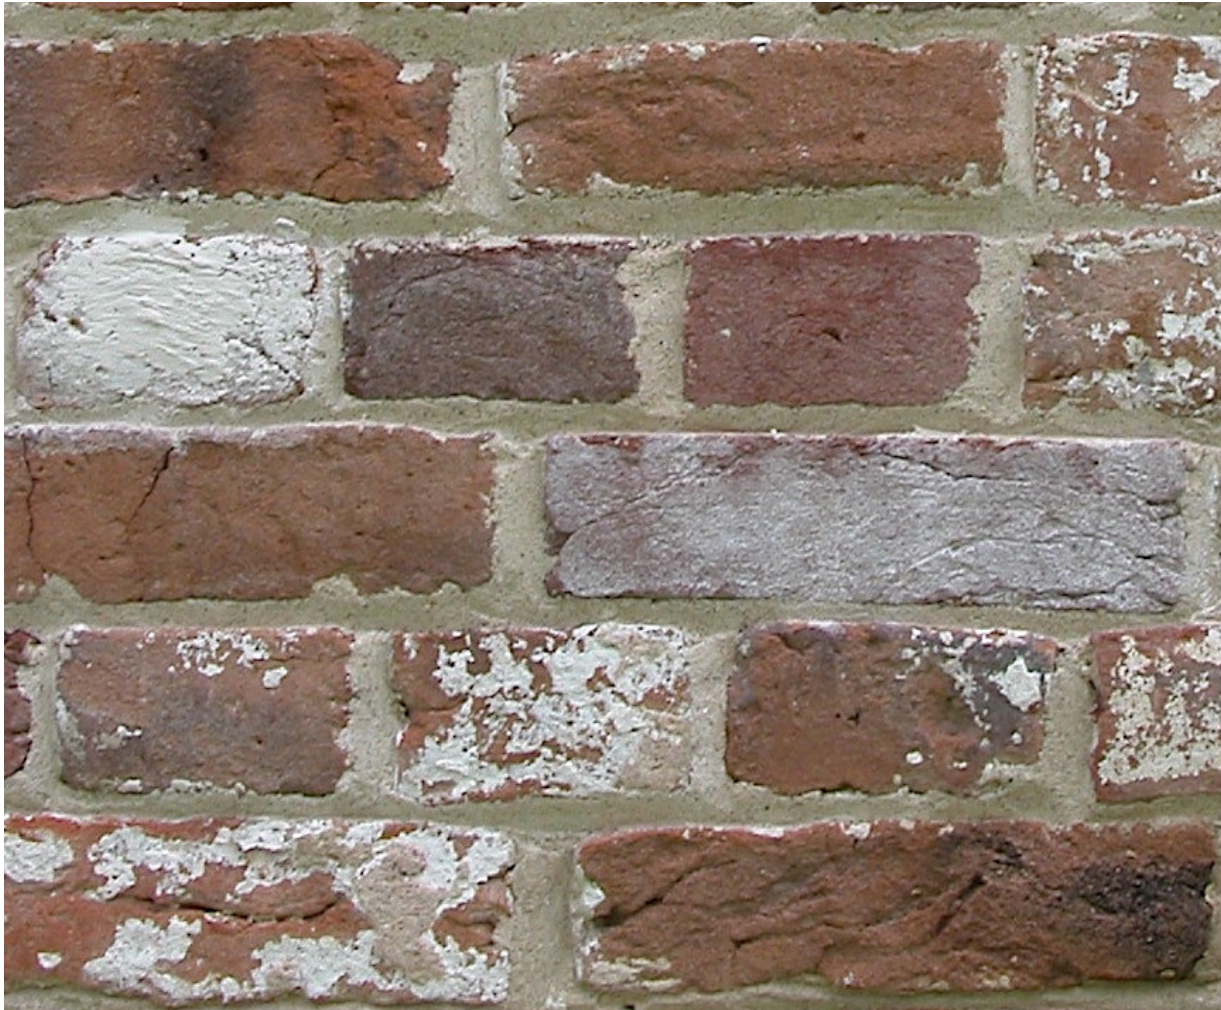
Figure 6

not matching the remnants of white paint/whitewash on the old brickwork. However, after the hydraulic lime has set for an hour or so, it turns white and is a close match (Fig. 6, Unsatisfactory lime wash on stretcher [center right], successful lime mix on headers [left above and left immediately below lime-washed stretcher]).

The wash used in this unsuccessful attempt was hydraulic lime 2.0 mixed to a thin, watery consistency. This wash was based on a suggestion from the team mason who thought hydraulic lime would provide a more stable finish than common masons lime. The manager then decided to try the same hydraulic lime mixed to mortar consistency, but without any sand aggregate. Mixed this way, the hydraulic lime can be judiciously applied with a brush in splotches on the restoration bricks or brushed on to cover the bricks completely. Before applying, the bricks must first be wet with water. Otherwise, the hydraulic lime will set too quickly thus preventing working it to the desired thickness and appearance with a brush. Once applied, the lime initially appears gray,

After allowing this second test application of hydraulic lime to cure for two days, its stability was tested with a garden hose and city water. None of this lime washed off the bricks.
