Fox Hall - *Part 12*, Second-Floor Plan

By Dick Gresham

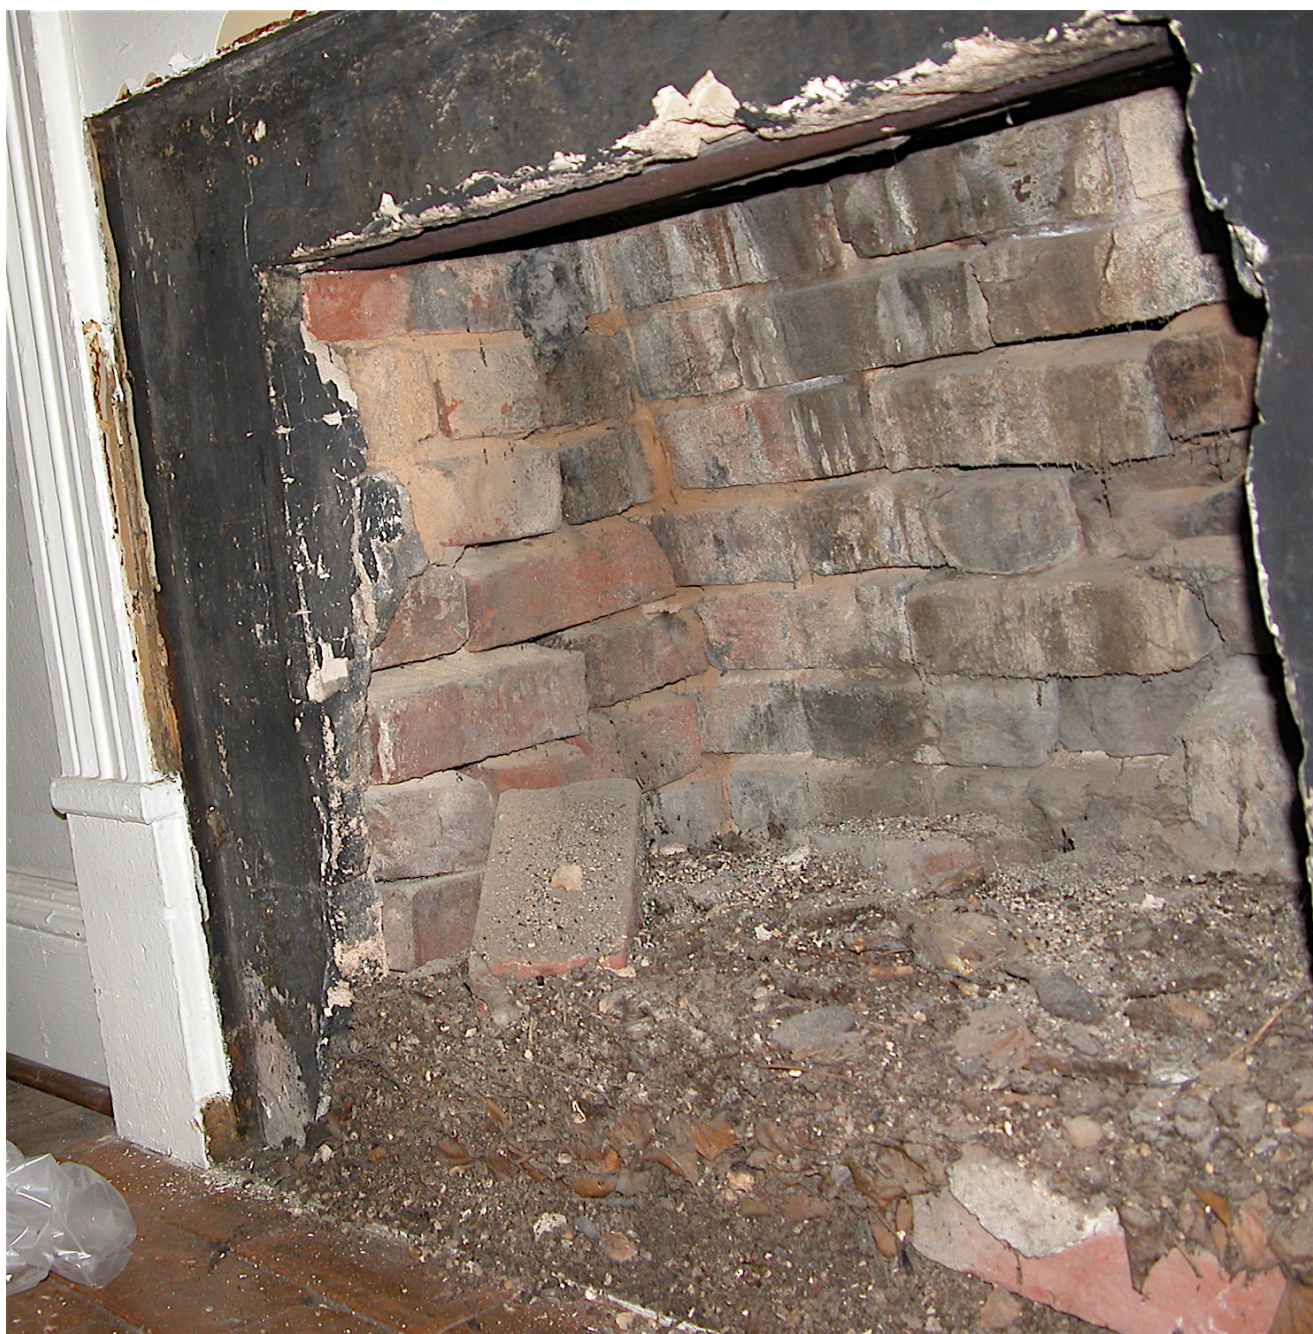
Needed tuck pointing in the fireplace in the west chamber, as noted in Fox Hall - *Part 11*, Second-Floor Assessment, has been completed. Hydraulic lime mortar and local sand was used in this repair work.

Fireplace before repair
