Fox Hall - *Part 13*, Dormer Construction

A detailed assessment of the second floor of Fox Hall has been made and is discussed in *Part 11*, recently published on this website. You are encouraged to read Fox Hall - *Part 11*, Second-Floor Assessment for more information on the current and previous dormers on Fox Hall.

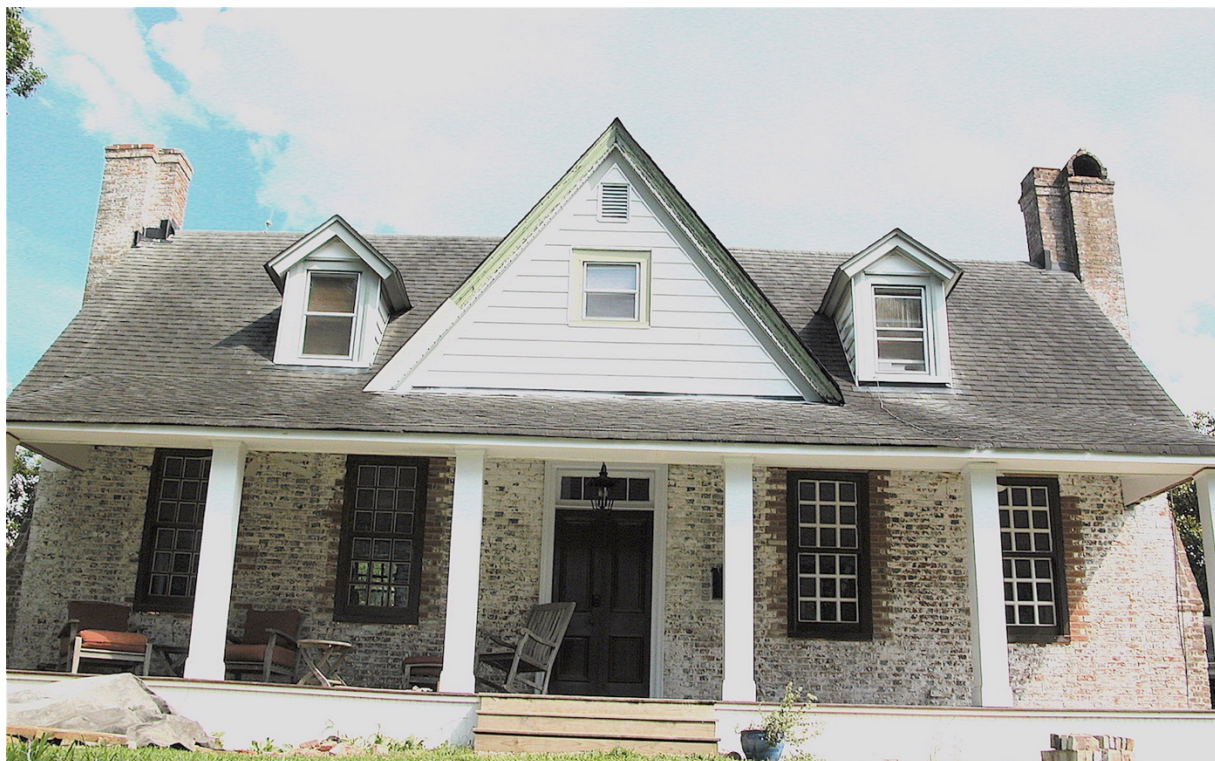
Figure 1

As can be seen in Fig. 1, Fox Hall presently has two dormers and a large gable across the front of the house, and there is a third dormer on the back (Fig. 1, Front dormers and gable) (Fig. 2, Back dormer). All are post second fire, circa 1900.

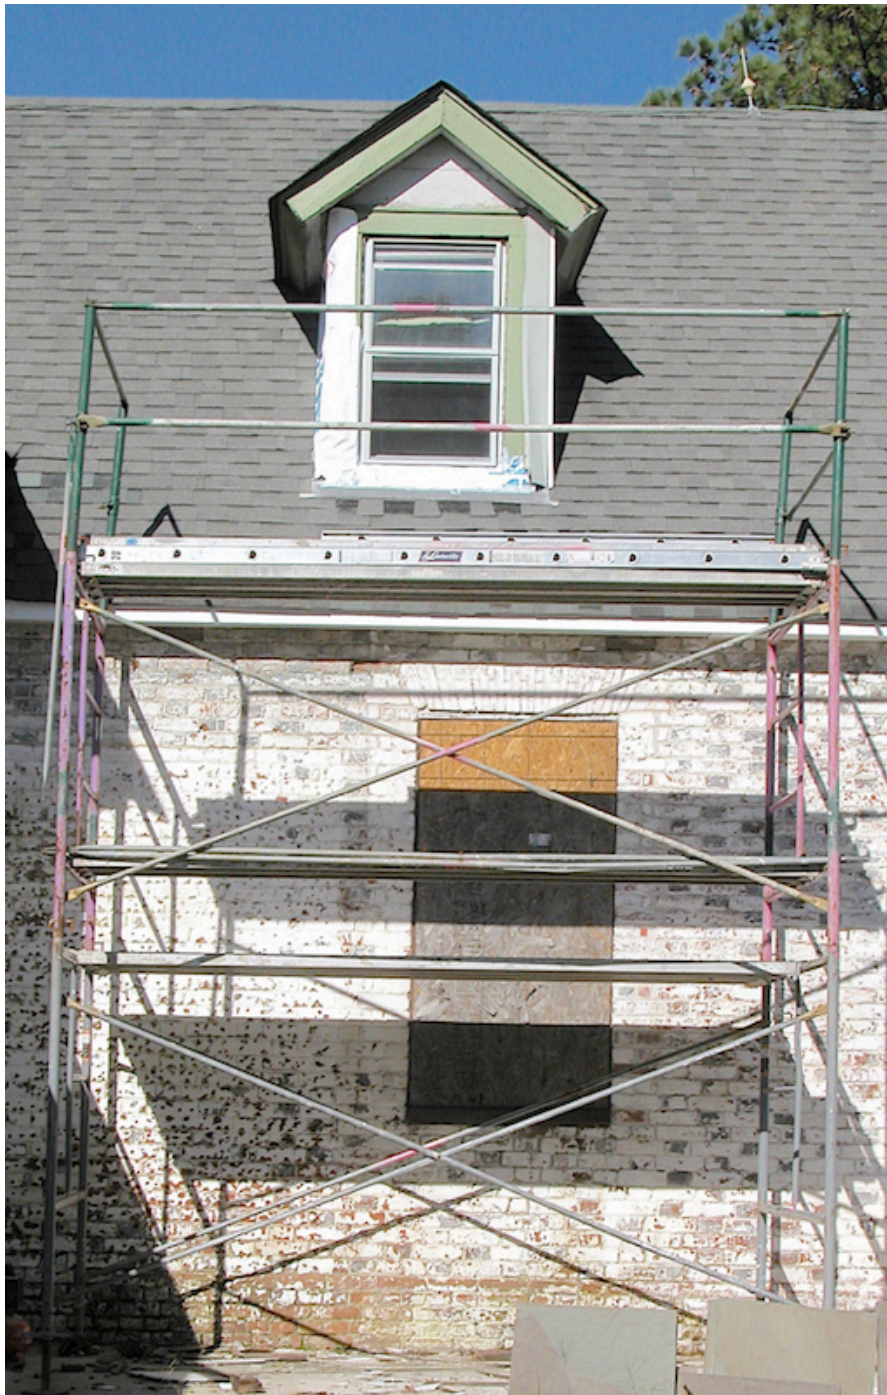
Figure 2

It is clear from Fig. 3 and Fig. 4 (Fig. 3, East dormer) (Fig. 4, West dormer) that the two front dormers do not align with the brick wall piers below. Furthermore, the dormer on the back does not align with the window below or with the east dormer on the front of the house (See Fig. 2). Apparently, during the circa 1900 rebuild after the second fire, little consideration was given to the location of the original dormers or

The restoration team has decided to rebuild these four dormers in the proper form to match the house roof. The east and west dormers on the front of the house will be more closely centered on the wall piers. The one on the back will be installed in the same location as the existing dormer (See Fig. 2). The fourth dormer will be placed in the location of the front gable once it is removed, centered over the front door of the house.

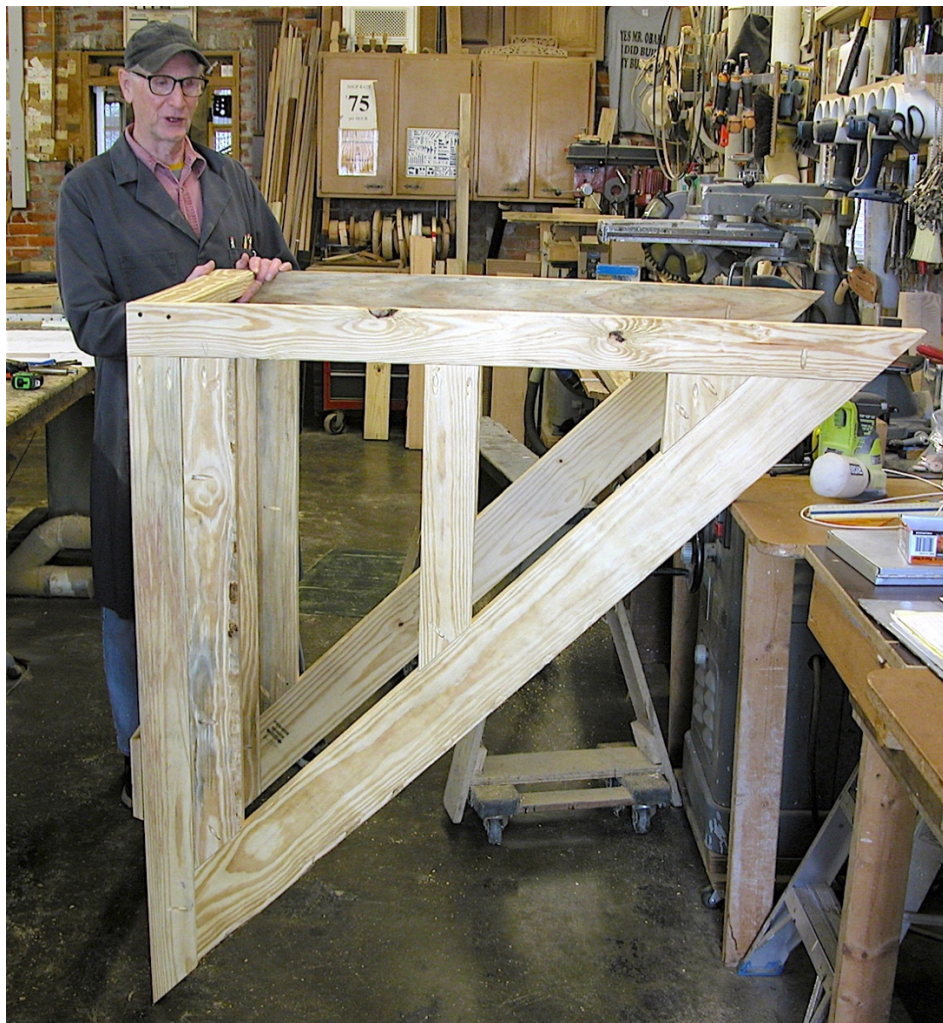
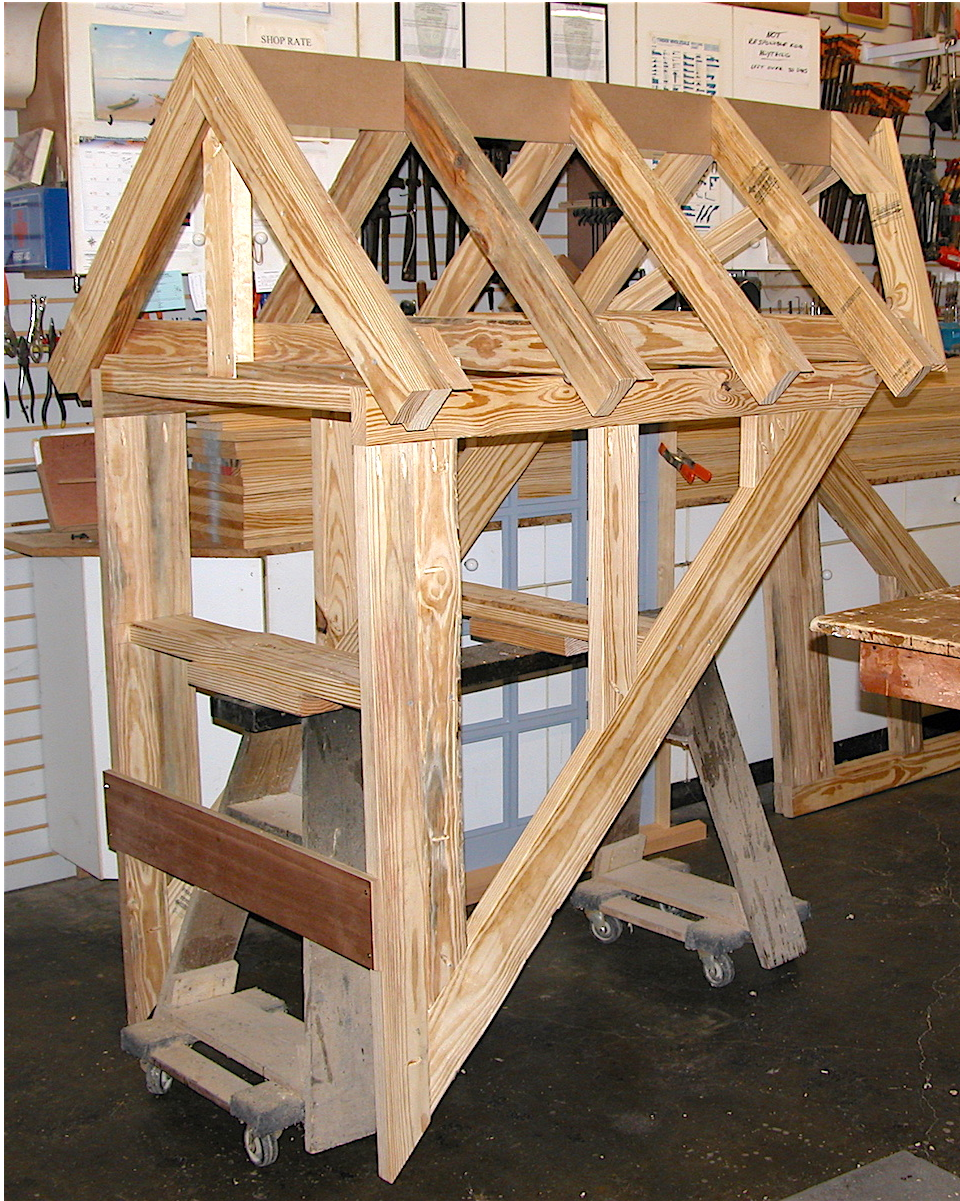
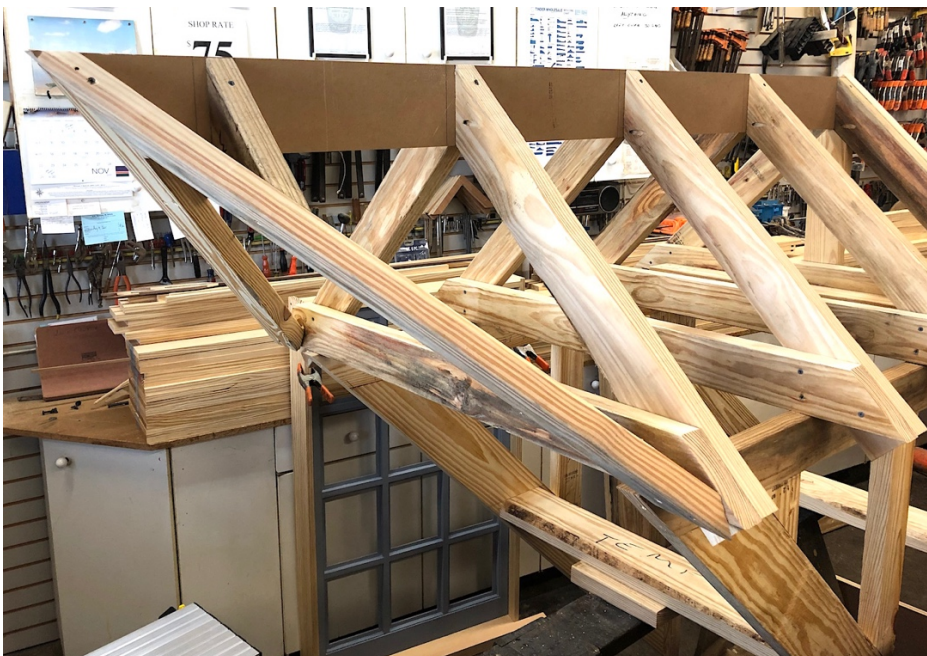
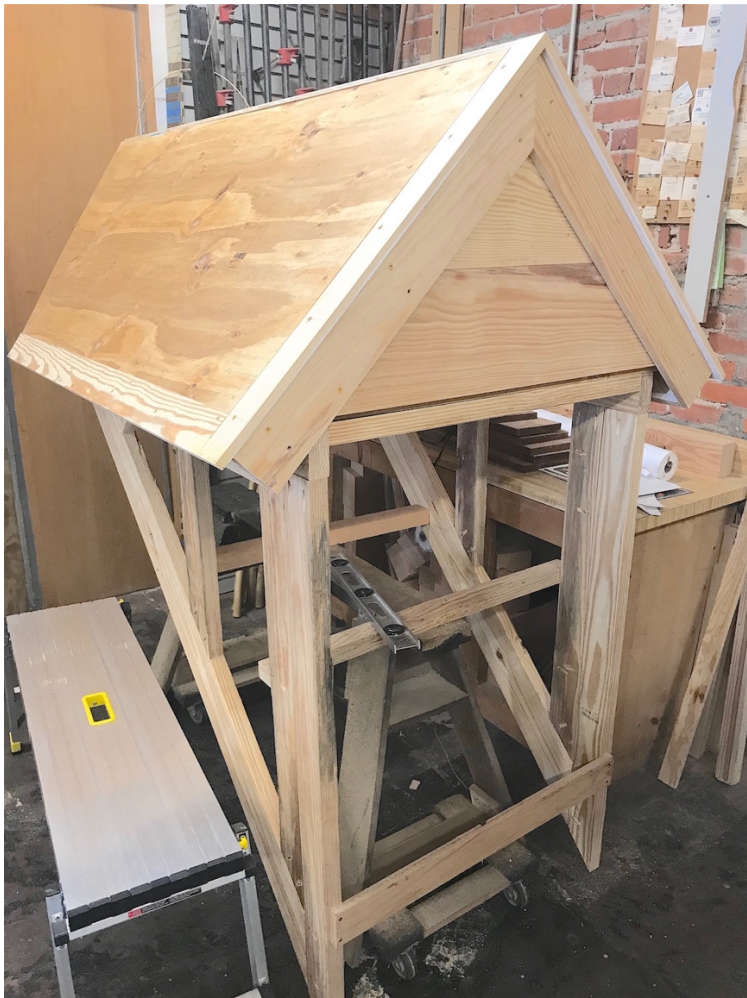
The dormers have been shop made rather than constructed in place. Once the improper dormers are removed, the new dormers will be lifted and attached to the roof over their newly sized openings. This is in keeping with early eighteenth-century practice in Virginia. Architectural historian, Marcus Whiffen, stated "Dormers...by the eighteenth century had acquired distinctively Virginian forms. Dormers are not...an integral part of the roof structure, but are framed separately. ... They could therefore be added to or removed from a house at will, and they often were."¹

Figures 8 through 12 show the construction sequence of the dormers.

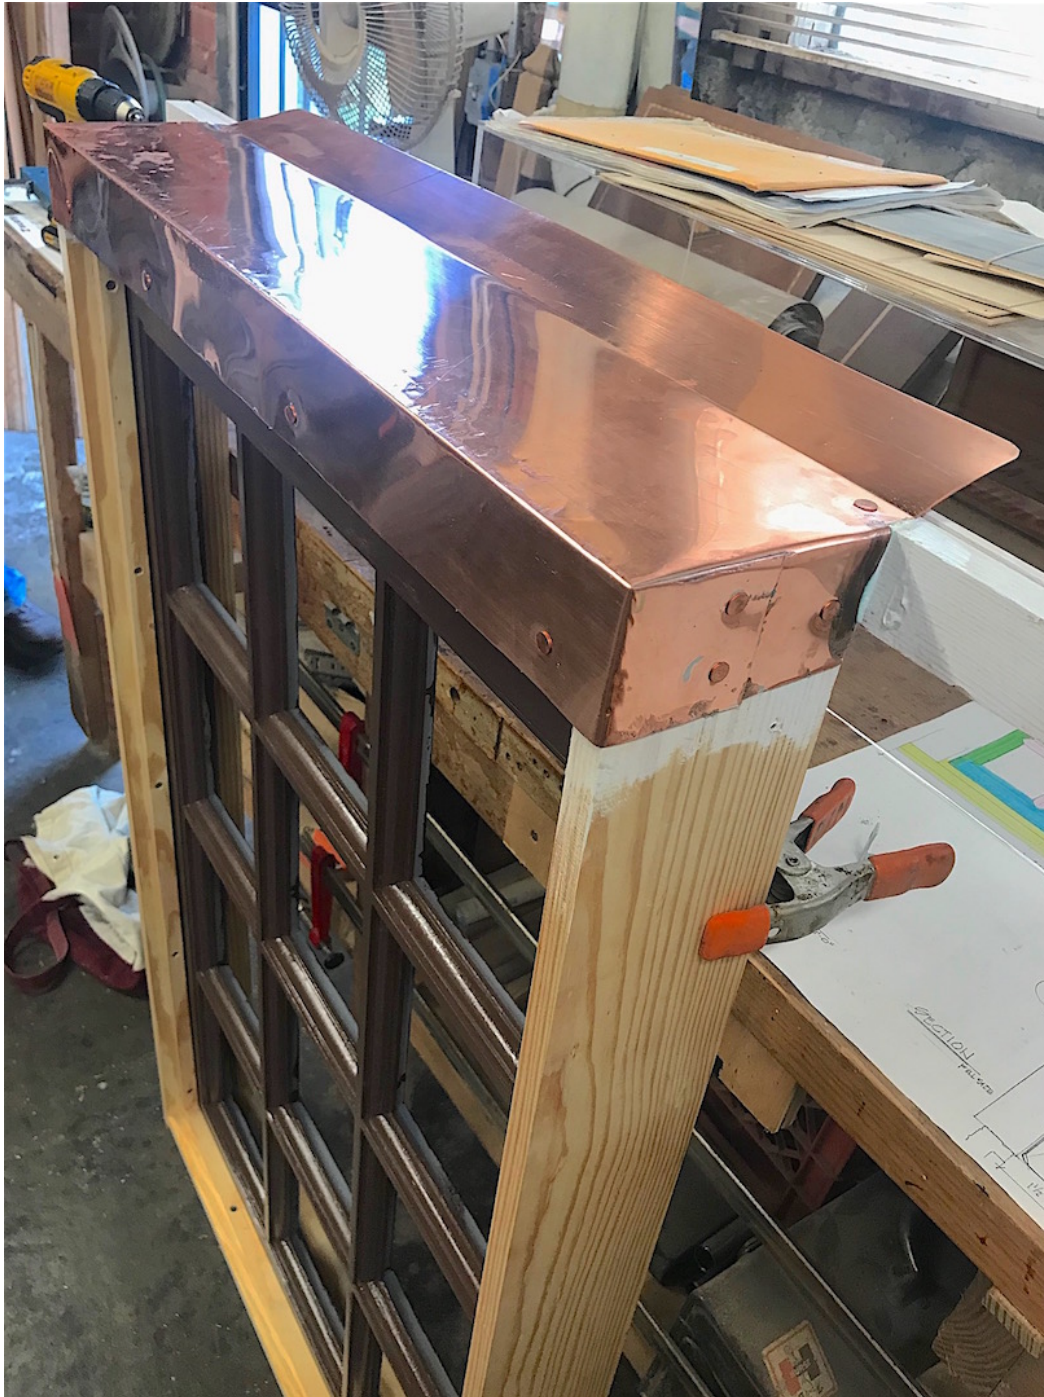
Figure 13

In Figure 13, copper pans, fabricated by the restoration manager, have been installed on the bottoms of the dormer window frames to protect them from water damage. Figure 14 shows the completed four window frames with sash installed.

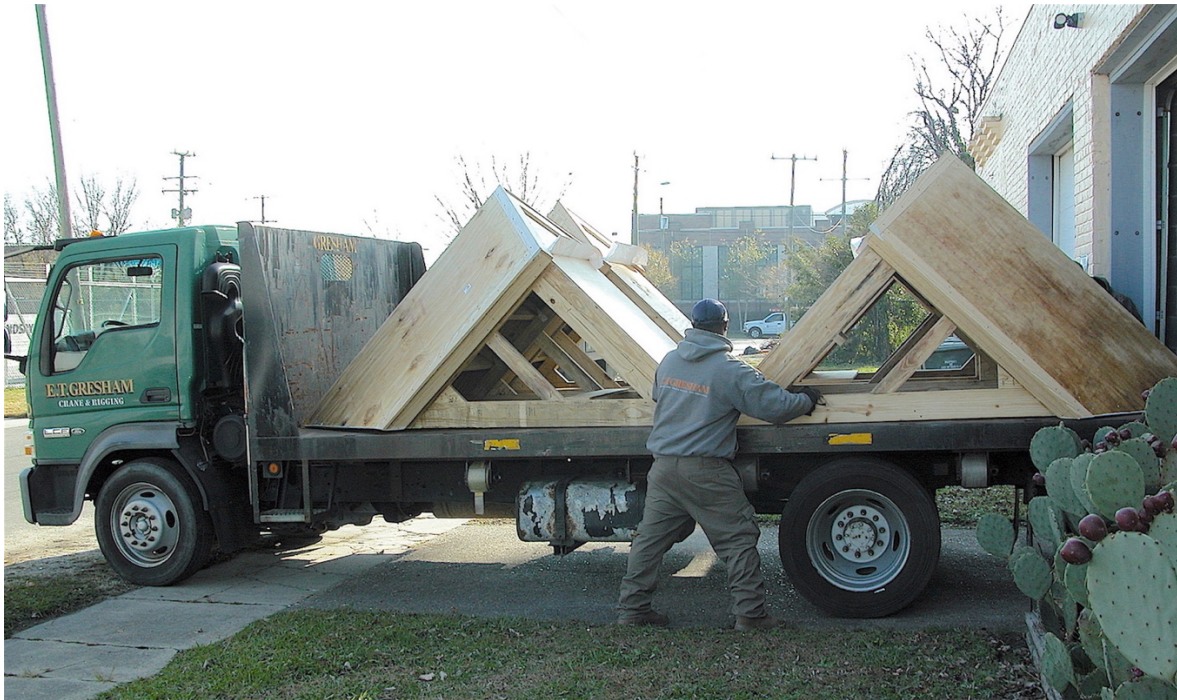
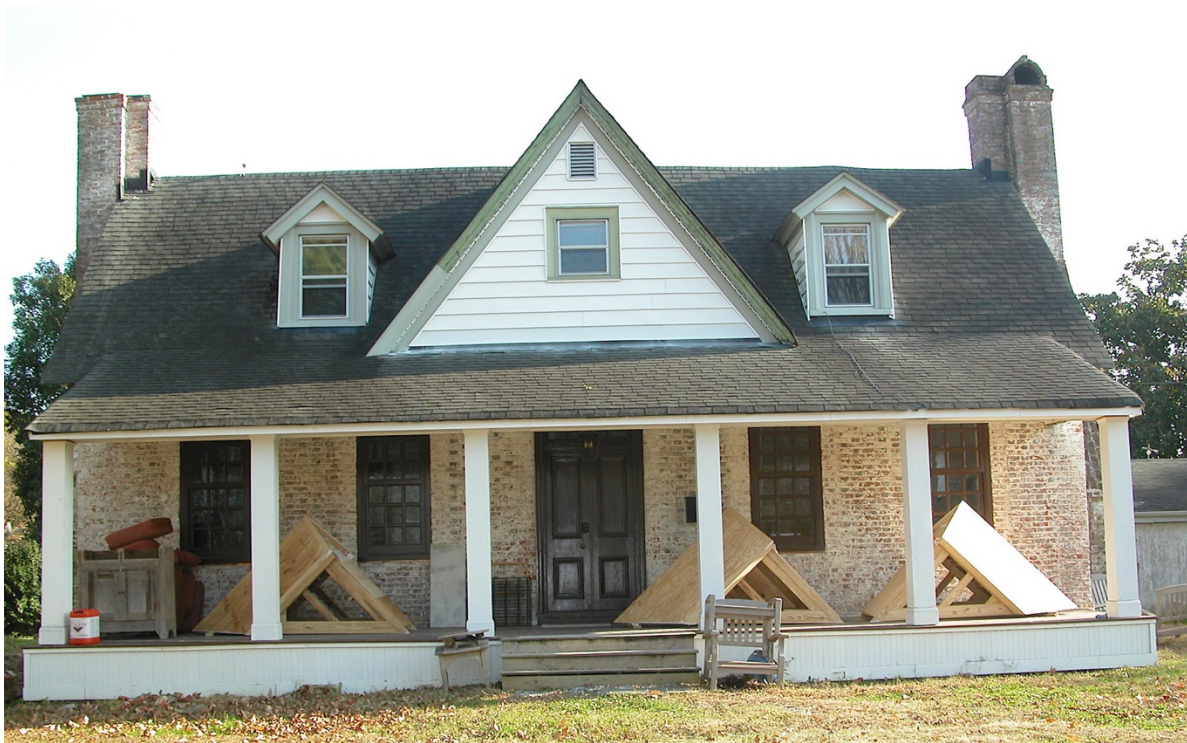
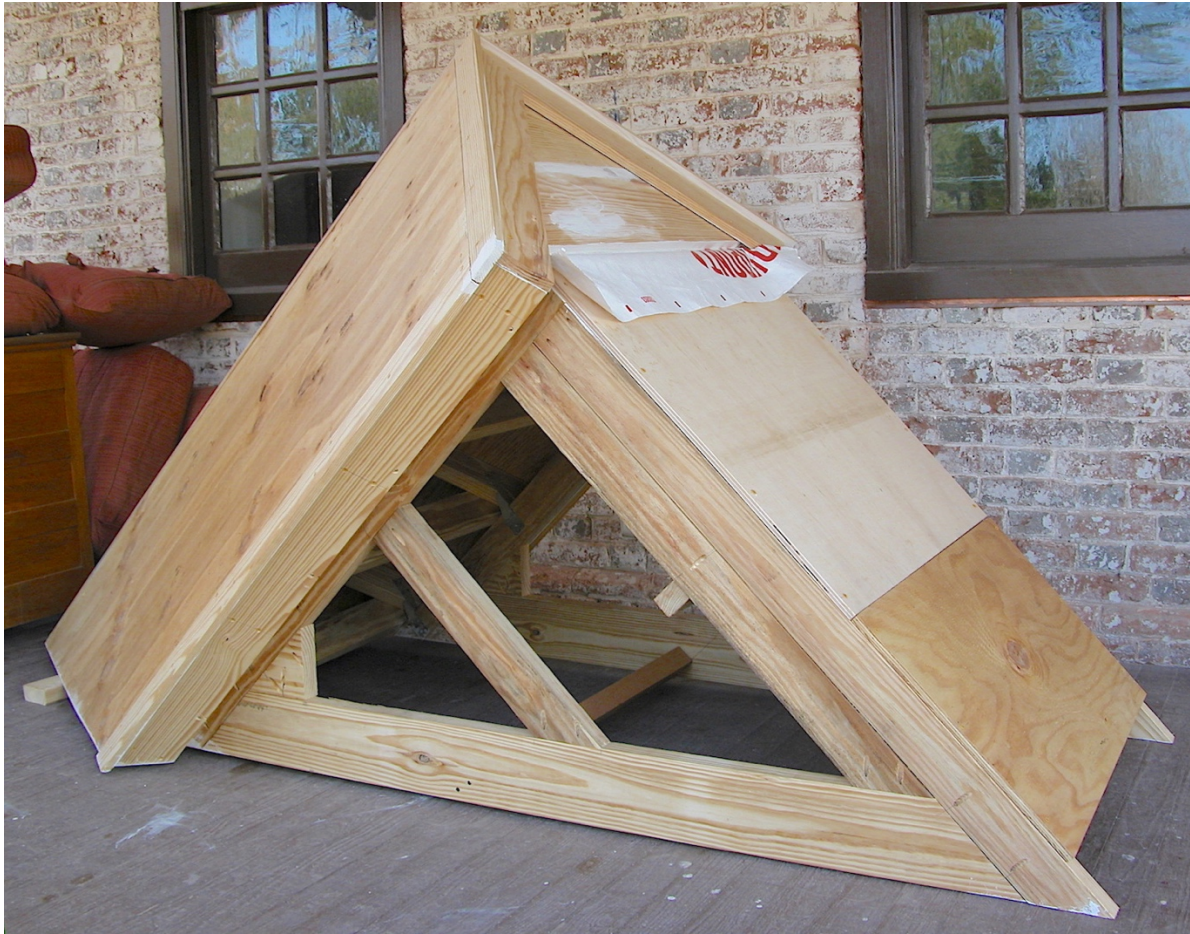
The four, completed, shop-made dormers were loaded onto a flatbed truck and transported to Fox Hall for staging until they can be installed on the house (Figs. 15 through 17, Transport of dormers from cabinet shop to Fox Hall).

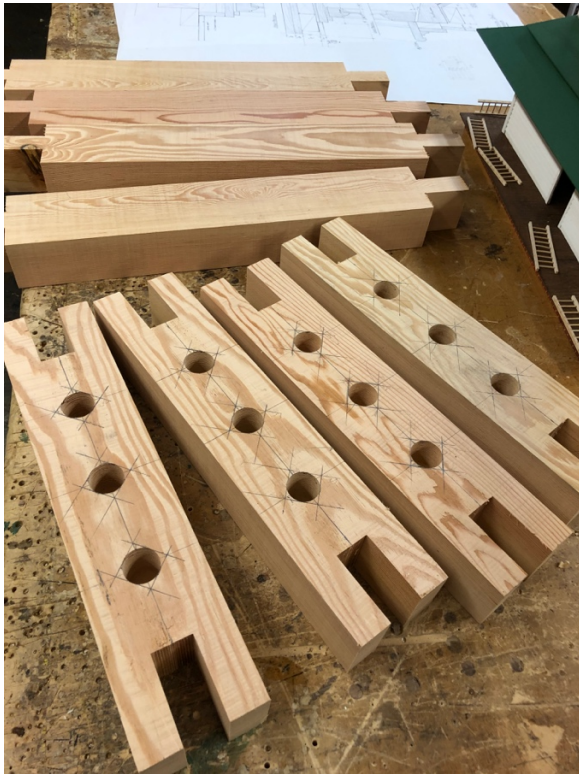
In Fox Hall - *Part 2*, Barred Vents, on this website, basement ventilation was discussed. Author, Tony Russell, stated "Fox Hall originally had three barred vents [for ventilation], two on the front of the house and one on the back. The two vents on the front of the house were removed sometime in the past and lost". Russell restored and re-installed the remains of the third original barred vent. This work is documented in *Part 2*. The team cabinetmaker has reproduced the two missing barred vents for future installation on the front of Fox Hall. The following four figures document the construction sequence of these two barred vents.

Initial layout & cuts

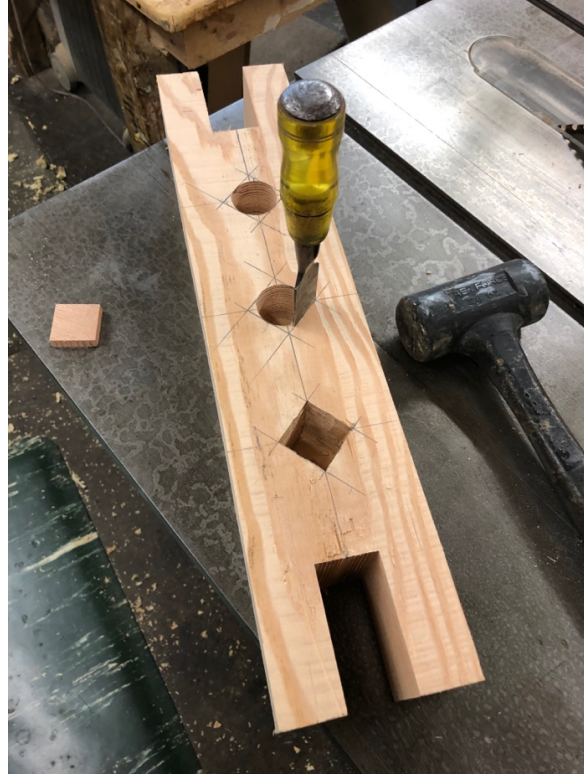
Cutting square mortises for bars

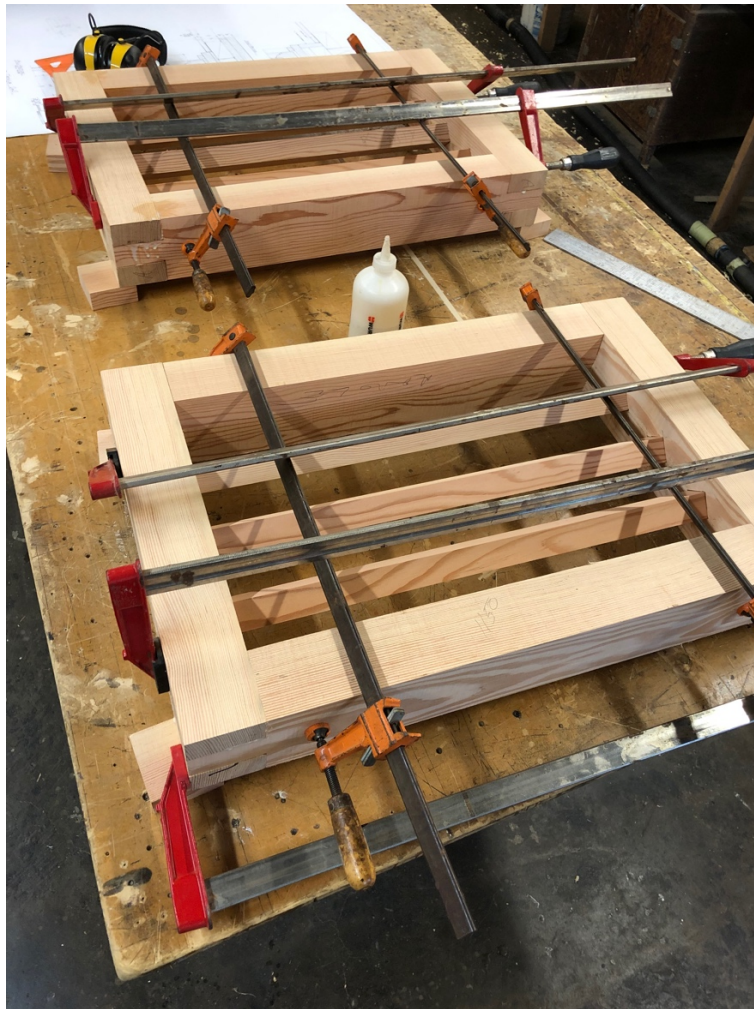
Assembly

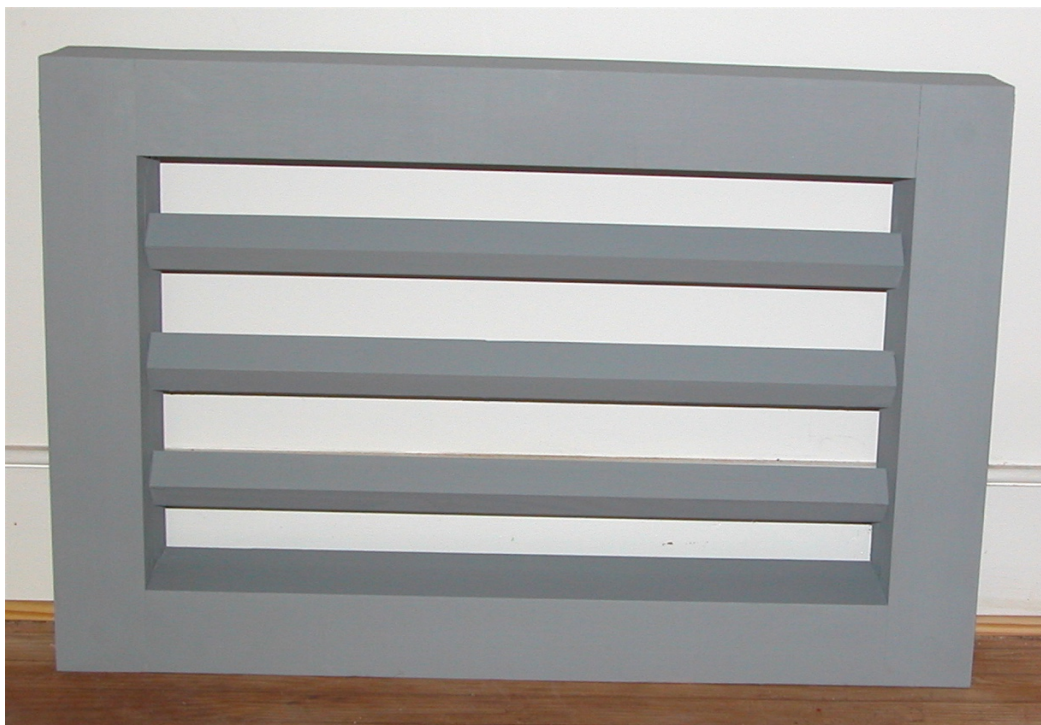
Construction complete

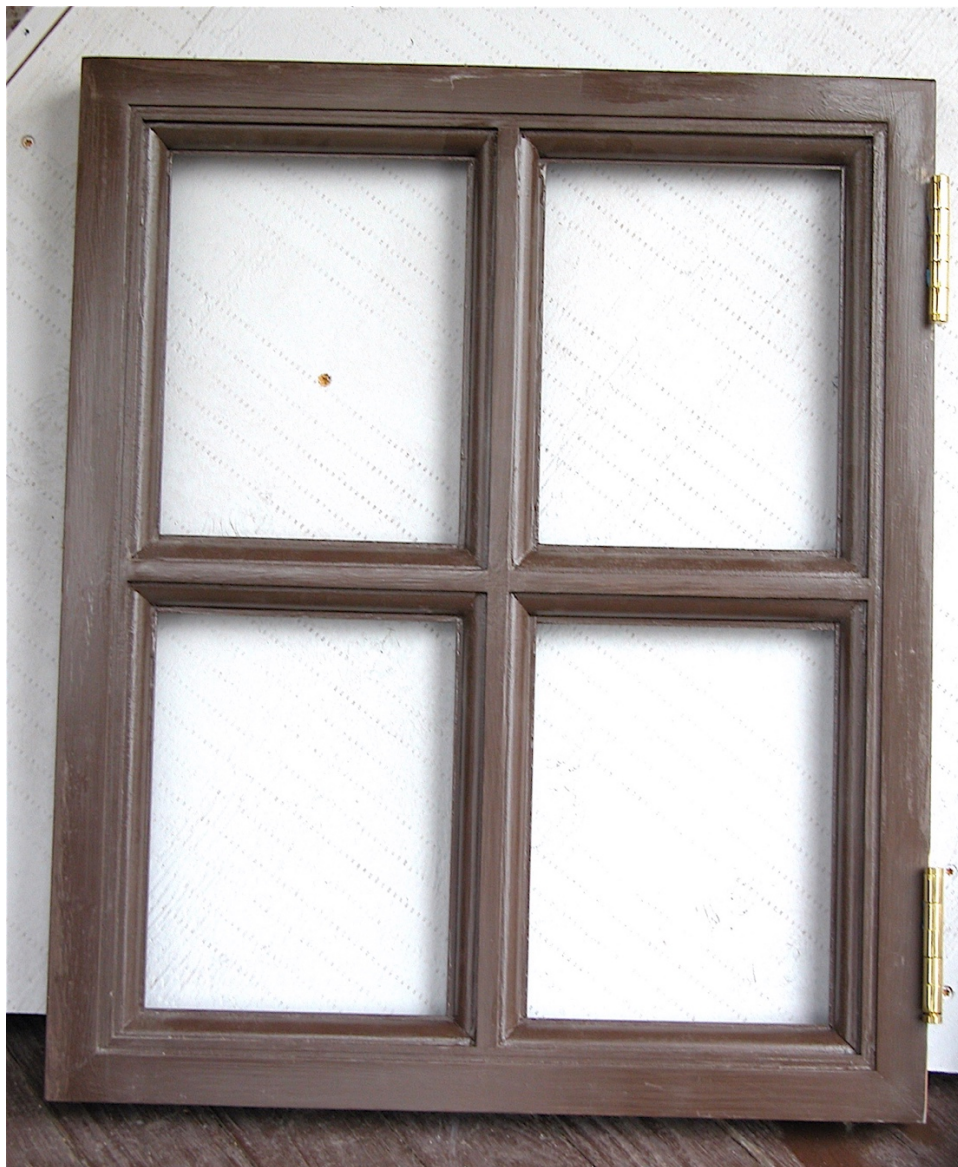
In Fox Hall - *Part 11*, Second-Floor Assessment, under the heading, *Additional Restoration Projects...*, it is noted that there are four small windows, two in each endwall. These windows date to the circa 1900 rebuild after the second fire, and the casement sash in each has been replaced with sash and restoration glass matching the restored first-floor windows. Likewise, a new transom window for over the front door has been fabricated, matching the restored first-floor windows.

Small endwall window

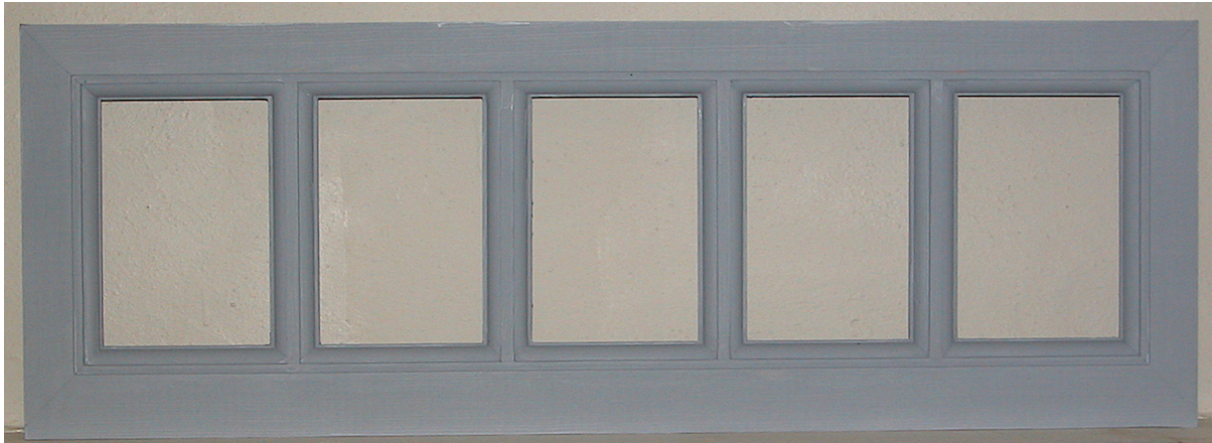
Transom window
