# Surprising Discoveries From the Analysis of the Exterior Paints of “Bel-Mede” in Williamsburg, Virginia

Front Facade

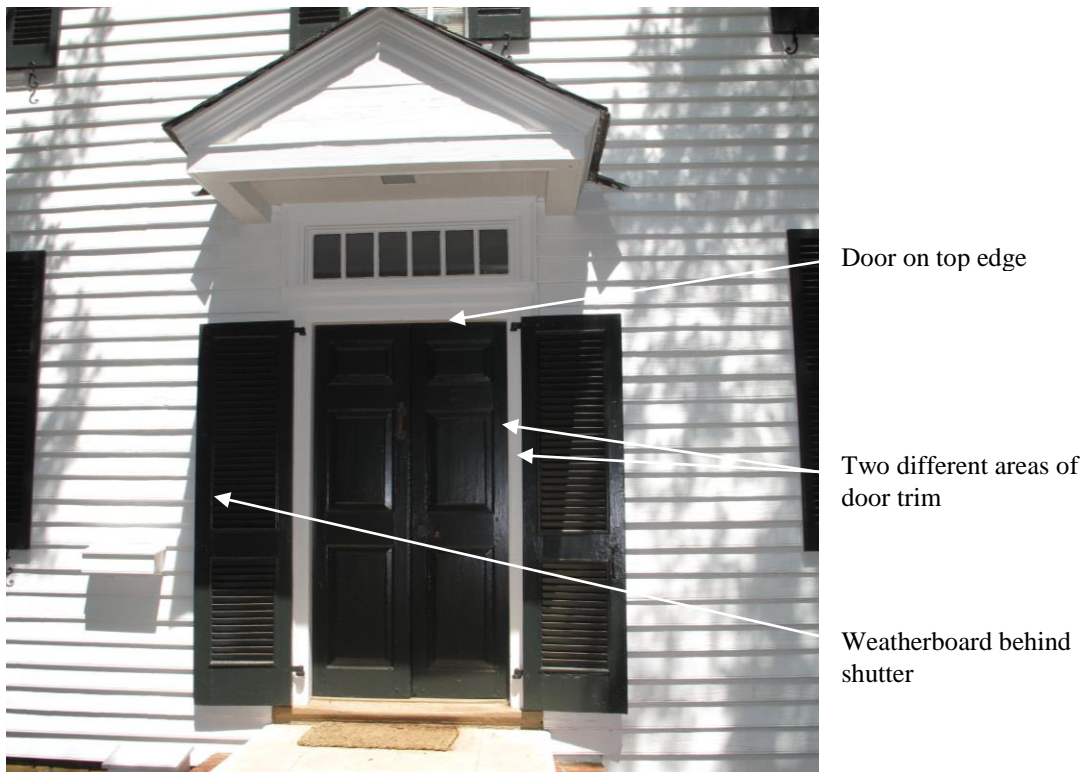
#### Sample Locations

1. Front façade, top edge of right door leaf.
2. Front façade, door trim, right side at bead molding, about 5-feet up.
3. Front façade, weatherboard just left of door, about 5-feet up, under lip of bottom edge.
4. Front façade, door architrave, right side, at joint of backband.

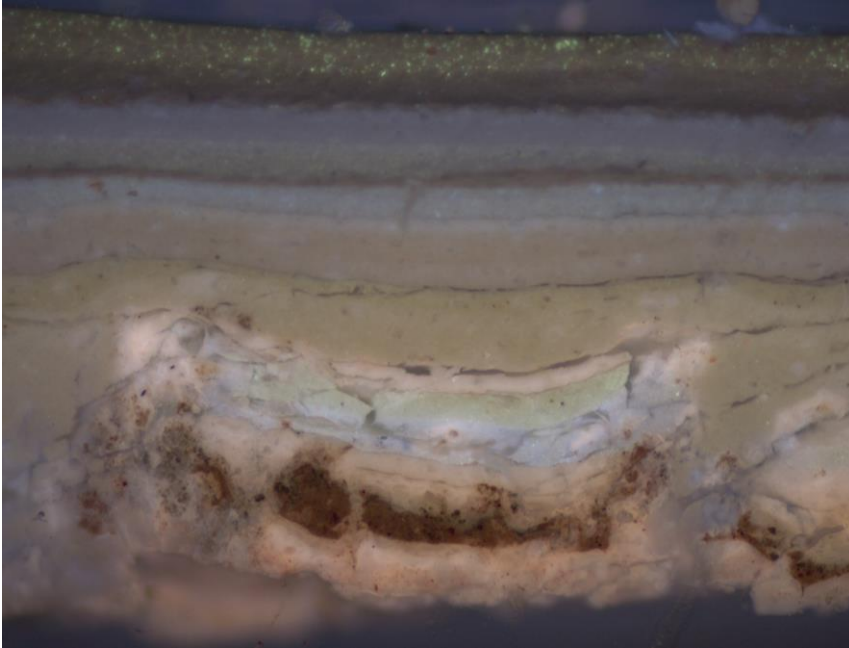
Sample 2. Front façade, door trim, right side at bead molding, about 5-feet up.  
Ultraviolet Light 100X

The most remarkable discovery was that the first layer of paint on the weatherboards and door trim was a disrupted, weathered, distinctly pink layer of oil-bound paint. In sample 2 from the door trim this first pink layer was followed by an off-white paint. In sample 3 from a weatherboard the second generation was a slightly darker pink. It was difficult to discretely separate pigments from the first pink layer for pigment identification because

Approximately 16 generations of paint remaining in the area sampled

Original dull pink paint

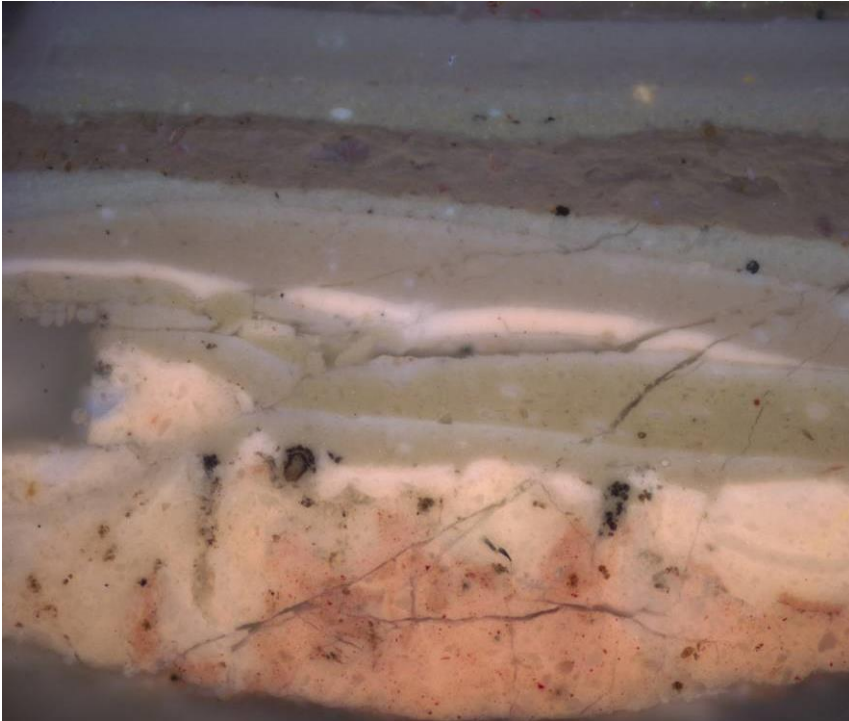
Sample 3. Front façade, weatherboard just left of door, about 5-feet up, under lip of bottom edge.

this paint was so degraded and disturbed, but in cross-section the first and second paint generations in sample 3 appear to be composed of red ochre, white lead, calcium carbonate, and a few red lead particles.

First pinkish paint found on the weatherboards and door trim

Second generation of darker dull pink paint

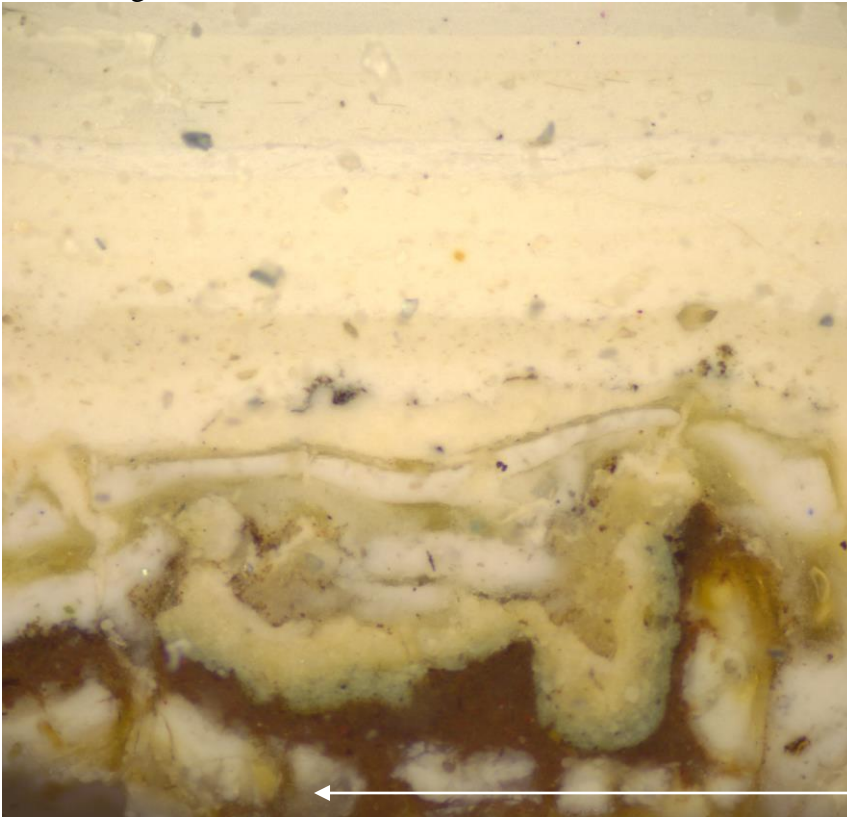
Sample 4. Front façade, door architrave, right side, at joint of backband.  
Visible Light 100X

First fragmentary off-white layer resembles the first paint found on the front door in sample 1

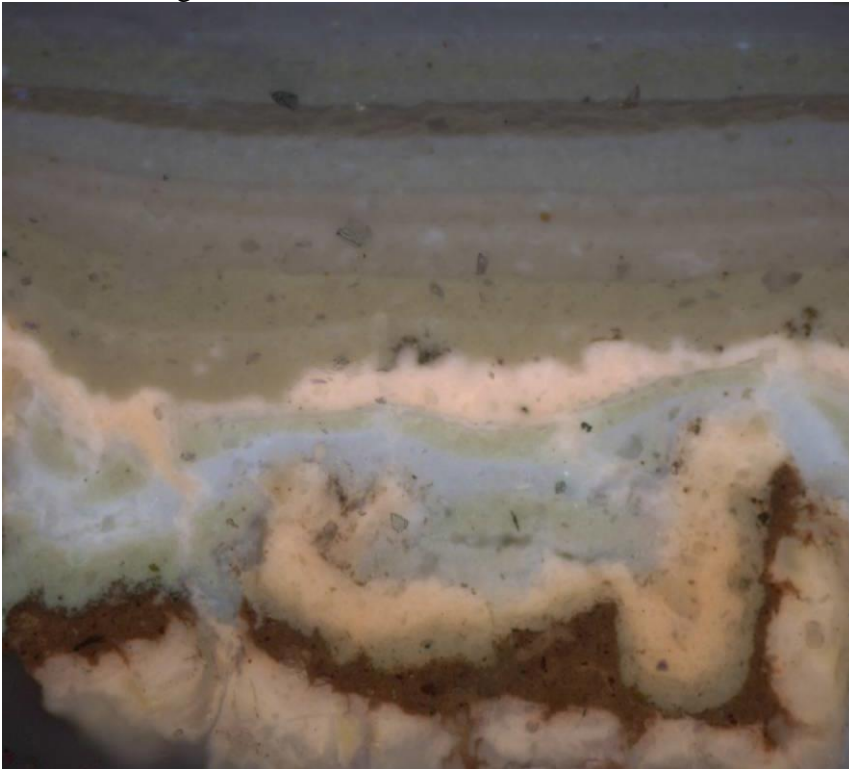
Sample 4. Front façade, door architrave, right side, at joint of backband.  
Ultraviolet Light 100X

UV Light & DCF for the presence of saturated and unsaturated lipids 100X  
All layers reacted positive for saturated (cross-linked) lipids to varying degrees
