## **Cross-section Paint Microscopy Report Exterior Paints**

### **Cupola House The Cupola House Association Edenton, North Carolina**

Date: October 6, 2018

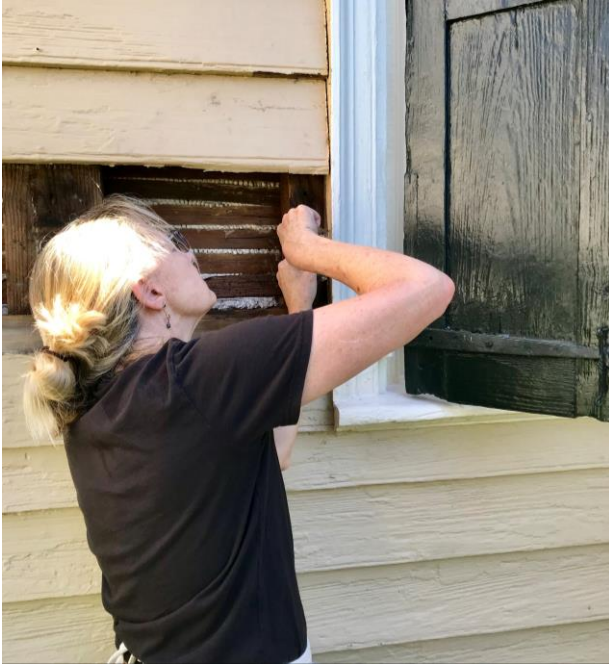
South Elevation Sampling Overlap of Siding Paints onto Window Architrave  
Reid Thomas Photograph

The samples taken from the thick paint overlaps from the rusticated siding onto the sides of the window architraves were not analyzed in cross-section as examination at low magnification indicated that these accumulations are primarily degraded putty fill material, not early paints. Photographs of all nine sample locations are included for reference.

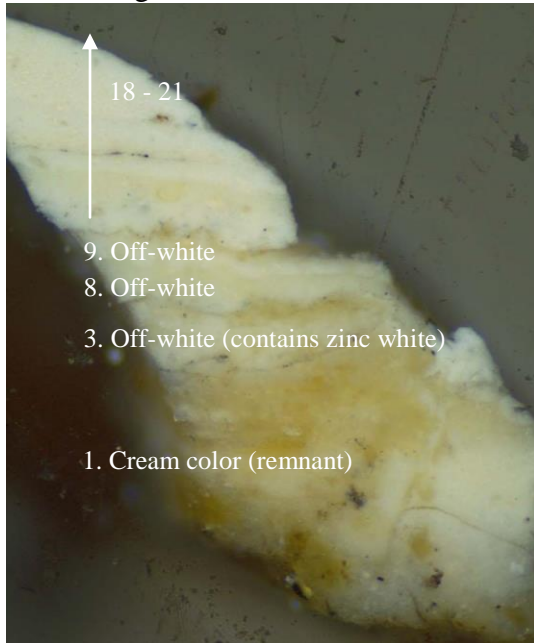
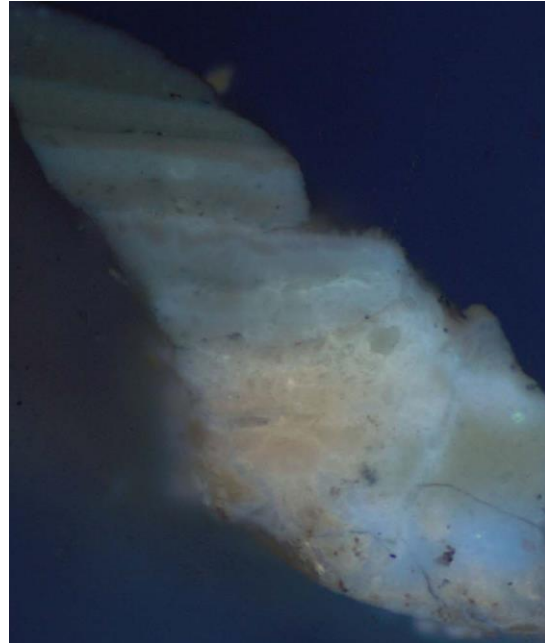
S-1. South elevation, west side, soffit of overhang.

The paint histories are less complete in sample S-1 from the soffit of the overhang on the south elevation and in S-4 from the 1810-20 weatherboard. But, the paint histories can be aligned for comparison in the chart below. This comparative table suggests that most of the earliest paint evidence was lost from weathering, and then perhaps from later paint stripping. The first generation on the early nineteenth-century weatherboard seems to align with the second generation of cream-colored paint found on the bracket. This suggests that almost no eighteenth-century paint remains on the bracket or the soffit. Further research into the exterior paints on other protected original elements, like the roof soffit and the soffit of the cupola, might help to clarify and expand the layering sequence for the eighteenth-century exterior coatings.

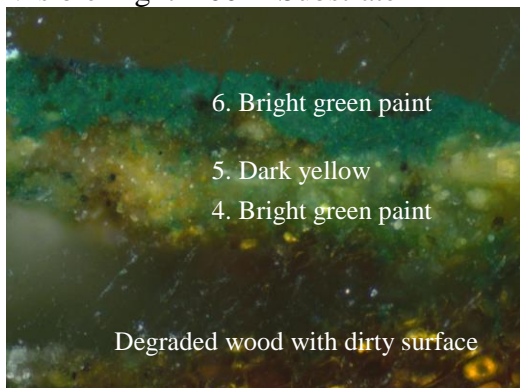
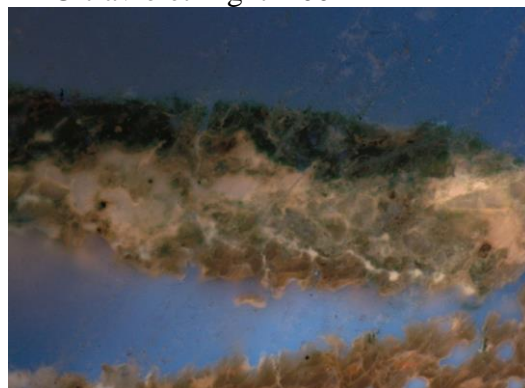
Shutter 8. Exterior shutter. There are at least fifteen generations of paint remaining on the shutter, but the wood substrate in this cross-section, and in the other uncast portions of the shutter samples, is extremely degraded. This suggests that virtually all the earliest paints completely weathered away before later repainting efforts. In sample “Shutter-8” there is clearly a long history of green paints which range from early bright greens to the most recent blackish green. The shutter was painted gray in generations 3 and 9, and deep red in generation 12. The earliest bright green paint in this cross-section can be aligned with the fourth generation of paint in sample 2 from the iron bar, so it has been labeled as generation 4 in this shutter sample. It is likely that the original paint on this shutter was green, but the earliest paints are too degraded and weathered to be confident about interpreting the original shutter color.

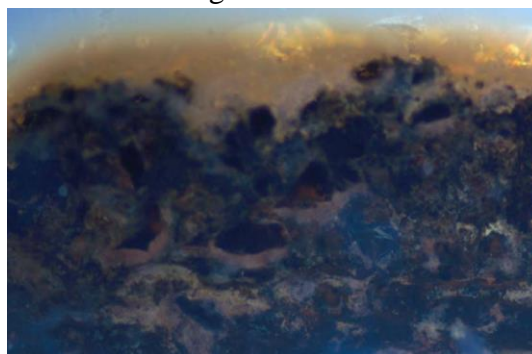
**Sample 1. Shingle.** The exposed end of this blackened shingle is fissured, charred and weathered, but there is an accumulation of slightly glossy, dark brownish material where two shingles overlapped at the top of the exposed end. This area was sampled for analysis and in cross-section the wood substrate is blackened and compressed, most likely from extreme heat exposure. There is an amorphous, translucent brownish coating on top of the wood surface which softened on exposure to the mineral spirits applied to the sample before cover slipping. Binding media analysis shows that there is oil in this brownish coating and in the wood. The appearance of the brownish coating in cross-section, and the presence of oils, is typical of an unpigmented, natural pine tar coatings which were traditionally heated with linseed oil or fish oil during preparation. So, optical microscopy analysis indicates that there is a natural tar coating on the shingle, but further organic materials analysis would be needed to confirm the presence of pine tar and other organic components.

Weak + reactions for oils in tar and in wood

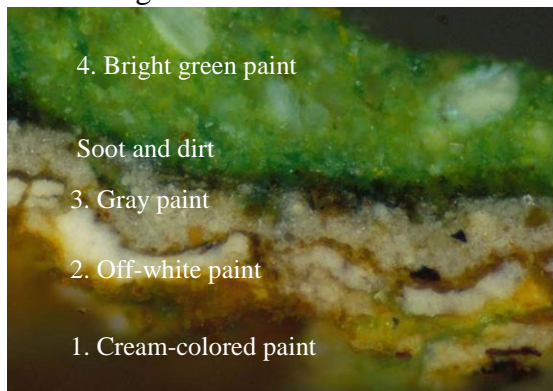
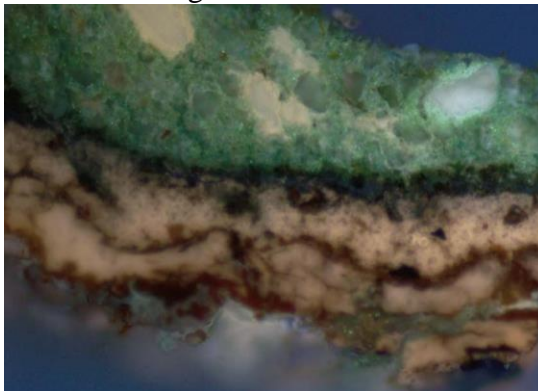
Sample 2. Iron bracing bar, possibly from cupola, greenish and whitish paints.

**Sample 2. Iron bracing bar.** The paints on an iron bar that might have been part of the original cupola balcony structure are fragmentary and degraded by rust, but there are still islands of paint clinging to the iron substrate. Cross-section microscopy analysis shows there are four generations of paint remaining on the iron bar, each with films of corrosion and dirt on their surfaces. The earliest surviving paint is a coarsely ground cream color (at the bottom of the cross-section), followed by an off-white paint in the second generation, and then a coarse gray paint in the third generation. There are films of grit and rust between each of these paints. The most recent paint in this cross-section is a thick, coarsely ground, green paint. The bright green paint in this cross-section can be aligned with an early green paint on the shutter, which has been labeled generation 4 in shutter sample 8. The original cream-colored paint is white lead-based, and may relate to the earliest cream-colored paint found on the exterior bracket (sample S-5), but the cream-colored and off-white paints in this sample are too degraded to make a confident connection.

Binding media analysis with biological fluorochrome stains shows that all the paints on the bracing bar are oil-bound, and the fourth generation bright green paint contains protein components as well. The shape, size and morphology of the green pigments in the bright green paint suggest the presence of chrome yellow and chrome green, which dates this green paint to after about 1825 when chrome green became readily available. There is a thick layer of soot and dirt on the top of the third-generation gray paint, which indicates it was exposed for decades before being repainted bright green.

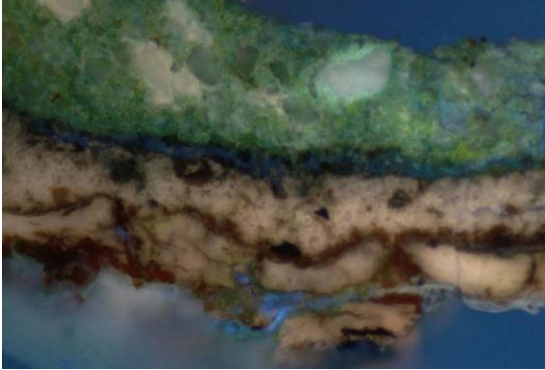
Sample 2. Iron bracing bar, possibly from cupola, greenish and whitish paints.

No reactions

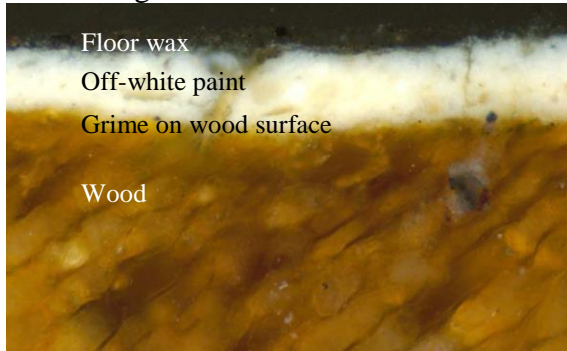
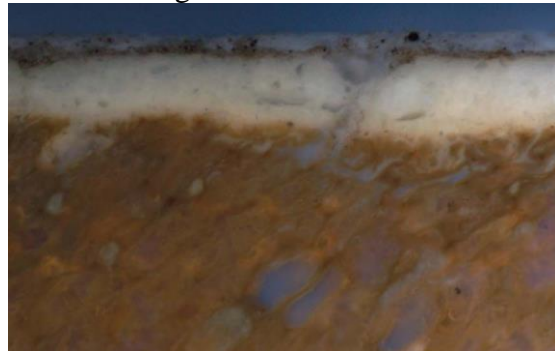
CP-1. Raised edge of paint on flooring, west side, southwest corner, possible overlap from baseboard.

Sample CP-1 Paint Overlap Onto Flooring. In cross-section it is apparent that the accumulated materials on the flooring consist of only one off-white paint layer which is cracked and grimy. There is a translucent layer of modern floor wax on the surface of the paint. This paint is likely not related to the earliest paint on the woodwork because the surface of the wood is oxidized and slightly grimy, indicating that the wood flooring was left unpainted for long enough for it to become degraded before the off-white paint was accidentally brushed or dripped onto the flooring.

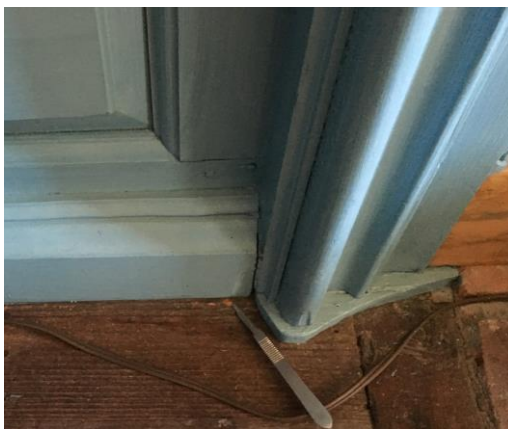
SE-1

In sample SE1-1 from the flooring there is a thick, uneven layer of blackish grit and soot on top of the wood. This is followed by a layer of finely ground gray-blue paint that seems to relate to the current paint on the replicated woodwork. This evidence suggests there is no eighteenth-century paint remaining on the raised ridges on the flooring in this room.

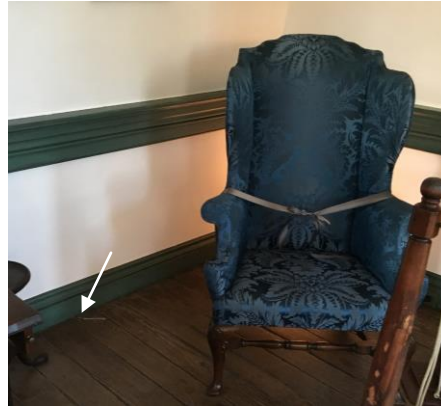
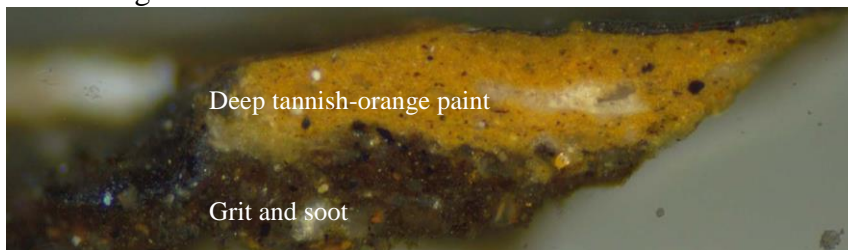
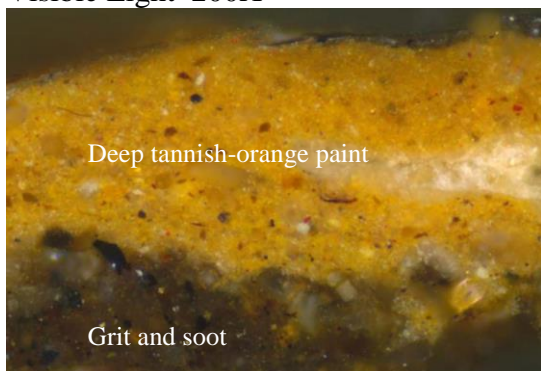
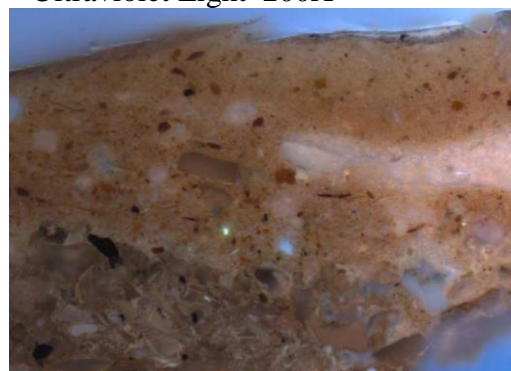
The evidence in SW1-1 consists of a coarsely ground tannish-orange paint that might date to the eighteenth or nineteenth century. But this paint is on top of a thick layer of grit and soot which means it cannot be the original woodwork paint.

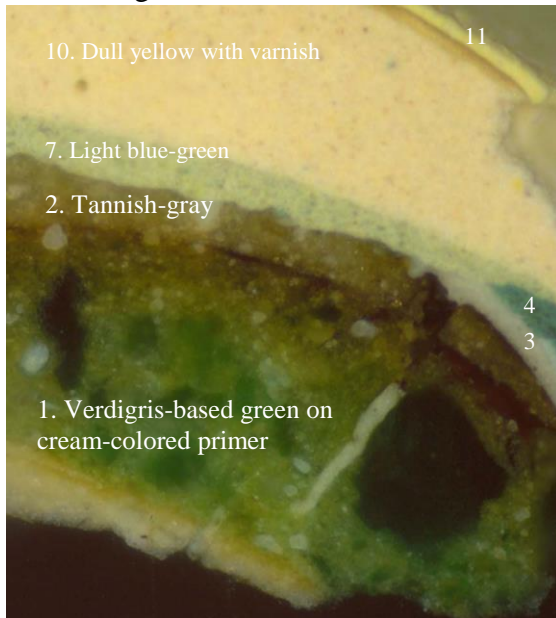
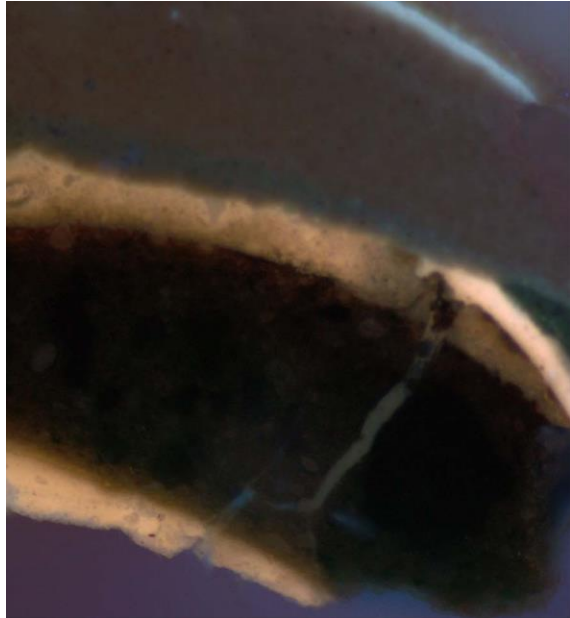
SE-2. East wall, south window, edge of left backband molding.

The evidence in samples SE-2 and SE-3 shows that the first layer above the wood is a cream-colored paint, followed by the distinctive, coarsely ground, bright emerald green-colored paint. There is no boundary or definite edge between the cream-colored paint and the bright green paint, indicating that the cream-colored paint was the original primer. This is a traditional craft approach because the copper-based green pigment verdigris is slightly translucent and does not have good covering power. In the cross-section the surface of the green paint is discolored and darkened, which is typical as verdigris is an unstable pigment which tends to darken over time when combined with linseed oil or varnish. However, when freshly applied this grainy green paint must have been brilliant and glossy, likely making this room the most stylish chamber in Edenton, North Carolina at the time.

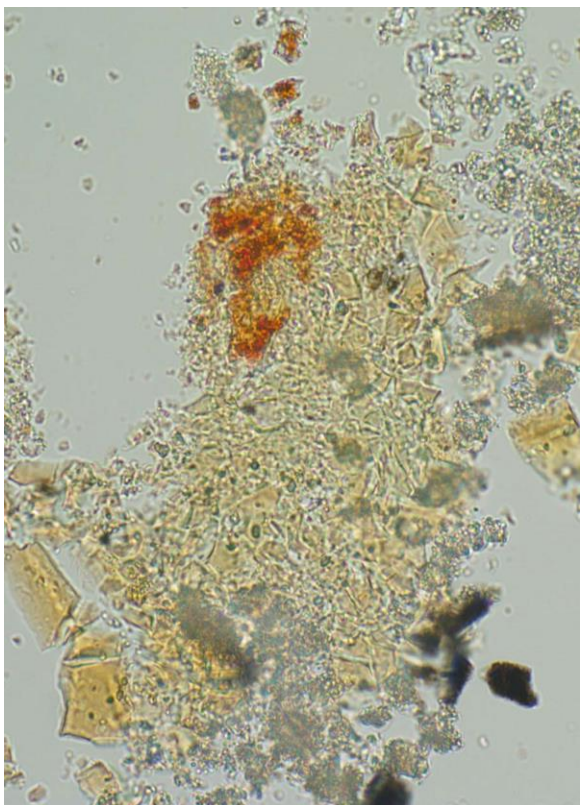
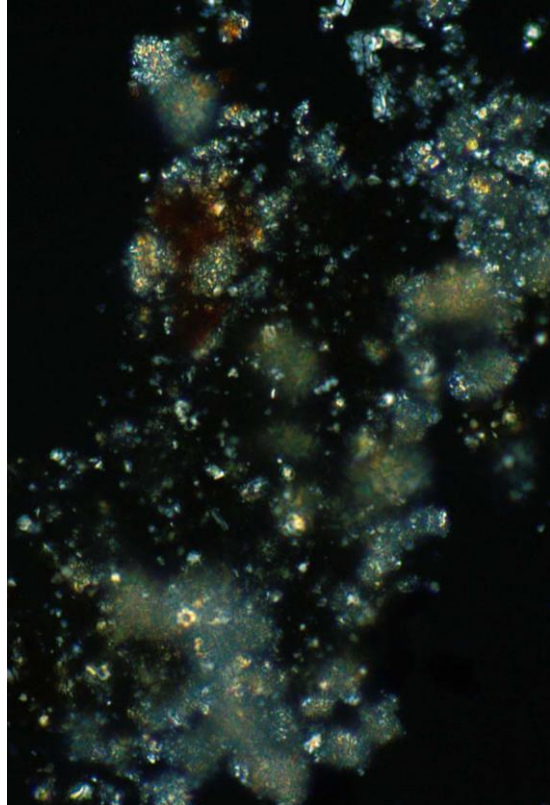
SE-4. West wall, baseboard cap left of door. Pigments in the original dark brown: charcoal black, red ochre, calcium carbonate and varnish.

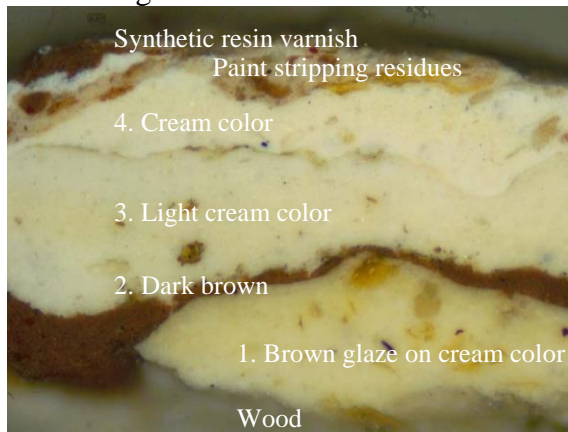
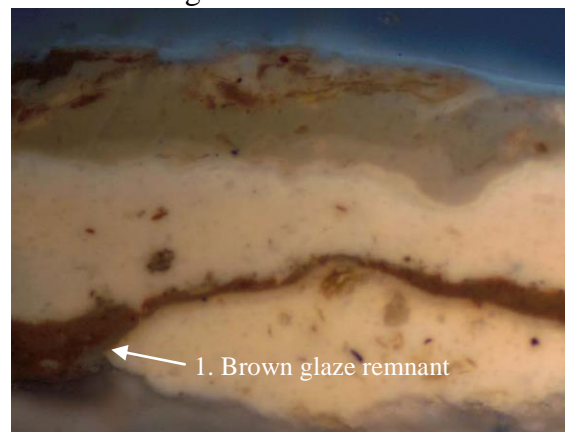
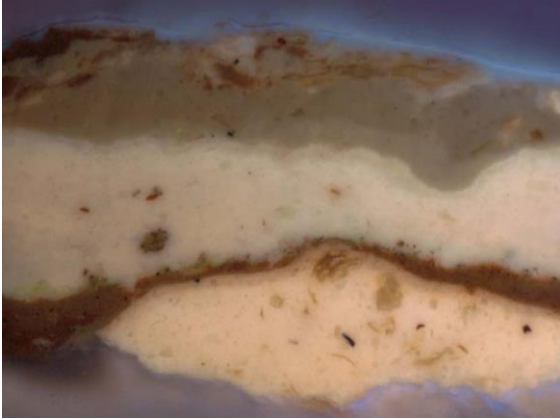
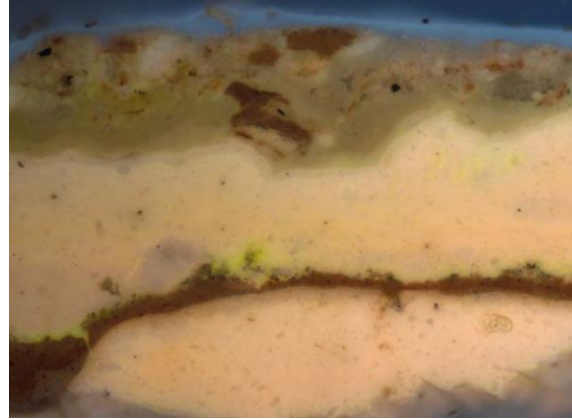
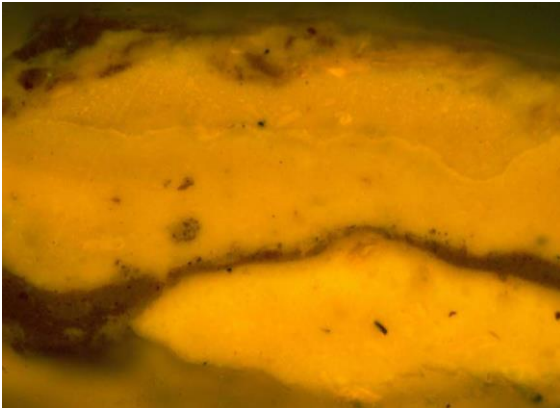
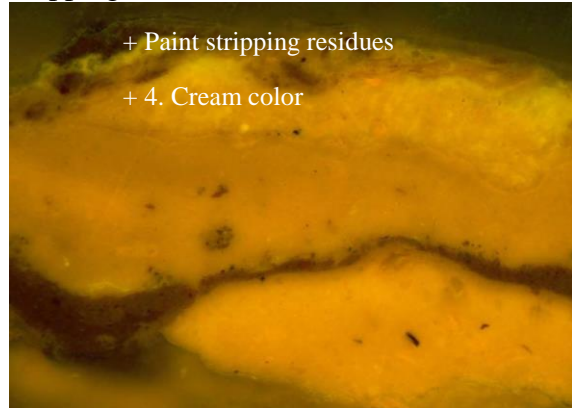
CH-1. Door leading to SE bedchamber, upper left corner, middle left panel.

**Sample CH-1. Door.** There are remnants of early door paints trapped in the corners of the joinery which provide surprising insights into the original appearance of this door, and likely all the doors in this second-floor passage. In sample CH-1 the first generation consists of a fragmentary brown glaze layer on top of a cream-colored base coat. This brown glaze survives only at the left side on top of the first cream-colored paint in the cross-section. The door was repainted dark brown in the second generation, and then two different shades of cream color in generations 3 and 4. There is a murky accumulation of cream-colored and red-brown paints on the surface of the cross-section which represent residues from the paint stripping process. There is thin synthetic resin varnish on top of the paints.

Binding media analysis with biological fluorochrome stains indicates that all the paints are oil-bound, and there are protein components in the fourth generation of paint and in the paint stripping residues.

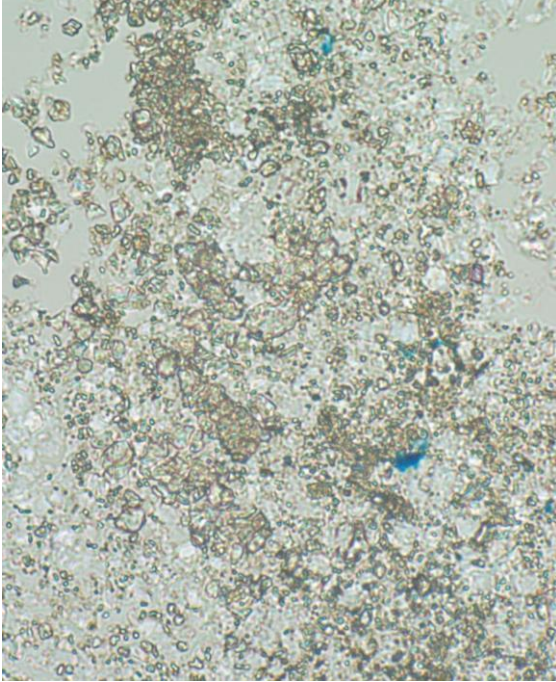
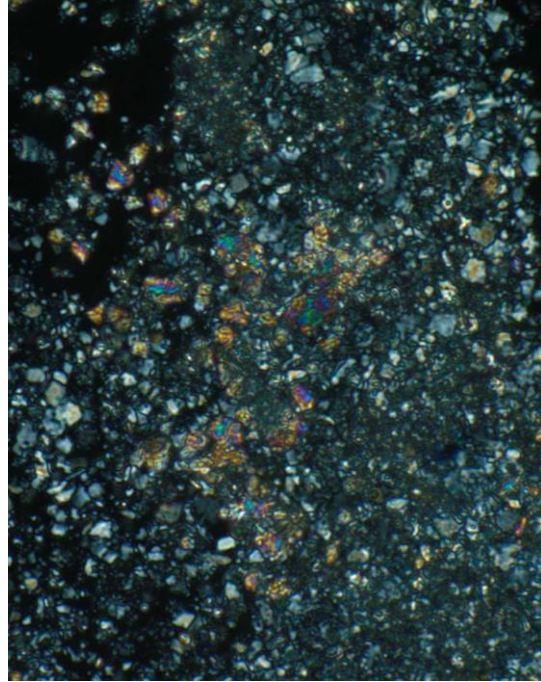
CH-2. East wall, right edge of architrave for north door. Pigments in the original gray paint: white lead, calcium carbonate, scattered Prussian blue and carbon black.

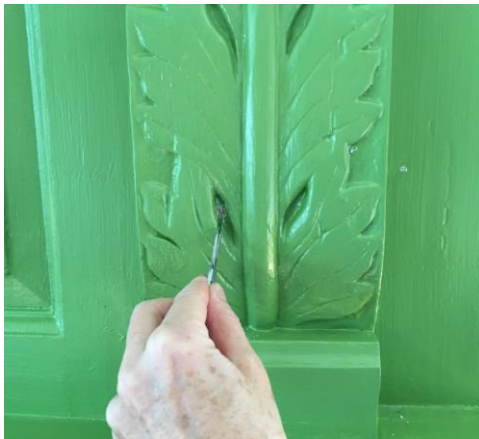
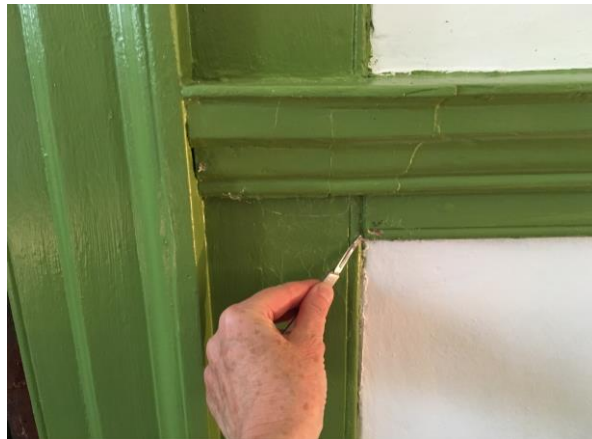
Samples SW-1 and SW-2 Woodwork Paint. Cross-section microscopy analysis shows that there are ten generations of paint in the most complete sample SW-1 from the overmantel. The evidence in this cross-section reveals that the yellow-green paint is actually the second paint generation. The original paint is a tan layer that collected a distinct layer of grime before it was painted over with the distinctive yellow-green paint. This yellow-green layer also became grimy and discolored before it was repainted in the third generation with a finely ground off-white paint. The same evidence was found in SW-2 from the chair rail, which cleaved apart during sampling.

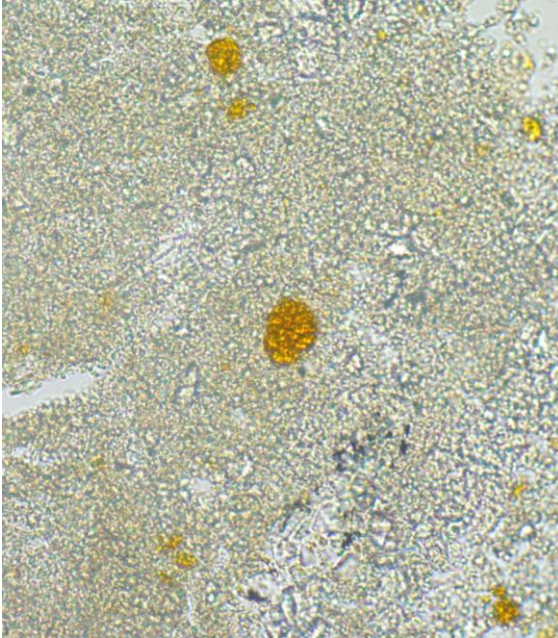
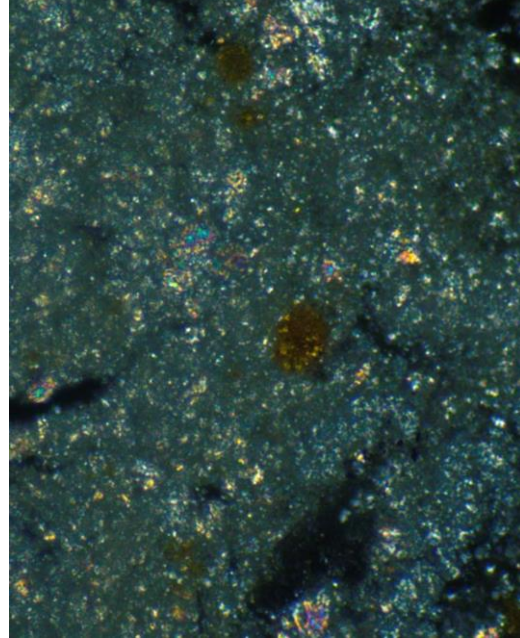
SW-1. West wall, in interstices of leaf carving on right side of overmantel panel.  
Pigments in the original tan paint: white lead, yellow ochre, calcium carbonate, scattered lampblack.

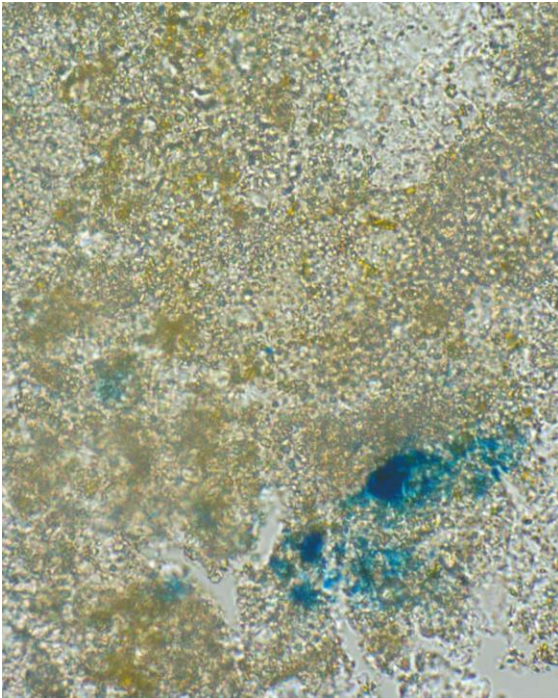
SW-1. West wall, in interstices of leaf carving on right side of overmantel panel.  
Pigments in the second-generation yellow-green paint: white lead, chrome yellow, Prussian blue, and calcium carbonate.

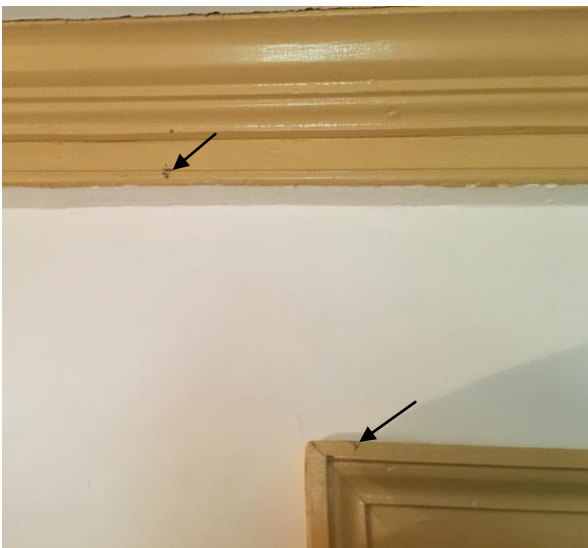
NW-1 and NW-2

There are eleven generations of paint in sample NW-1 from the cornice. The stratigraphy begins with an off-white paint which has a thin film of soot on its surface. The second generation is a thinly applied light blue paint, and it is followed by a cream-colored paint in the third generation. This third generation cream color is the first paint layer on the wood in sample NW-2 from the door architrave. The paints in the cross-sections and the uncast samples can be aligned on the cornice and the door architrave after generation 3. Generation 4 is a cream-colored paint with a grimy surface. This paint contains zinc white, so it must date to after about 1845 when zinc white was incorporated into architectural paints.

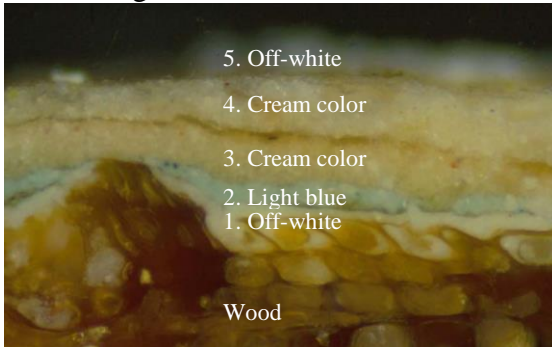
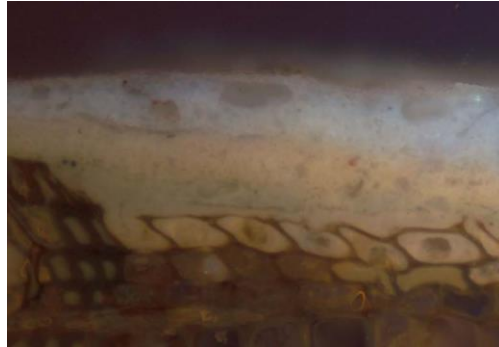
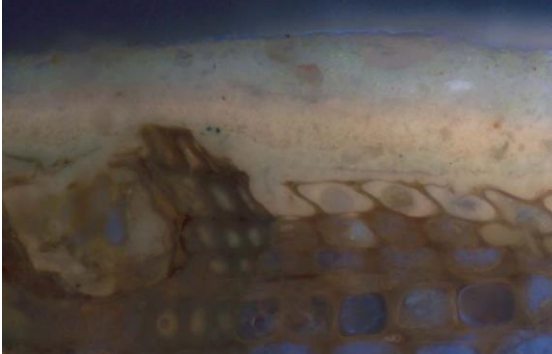
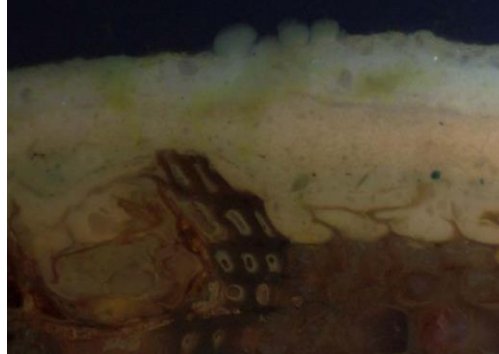
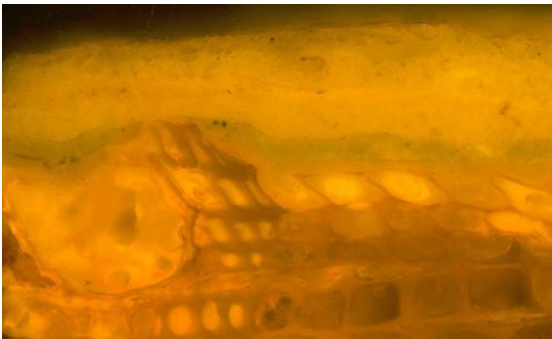
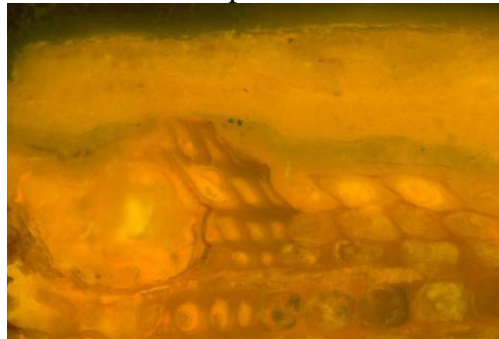
NW-1. South wall, bottom edge of cornice, above door.

Binding media analysis with biological fluorochromes shows that all the paints contain oil components, and there is a weak positive carbohydrate reaction in the off-white paint in generation 5.

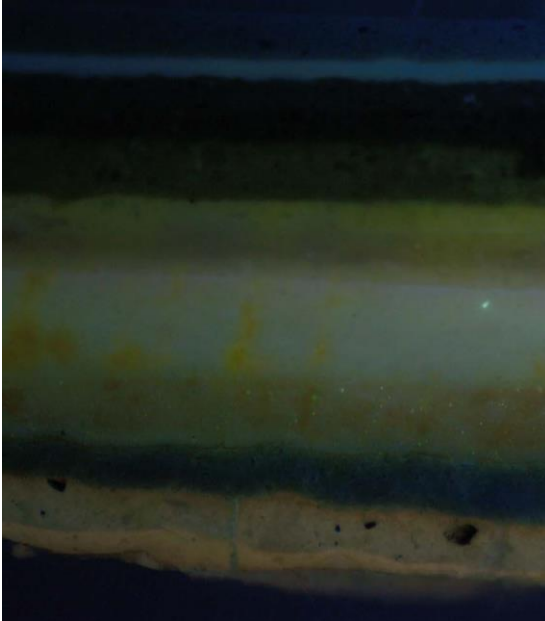
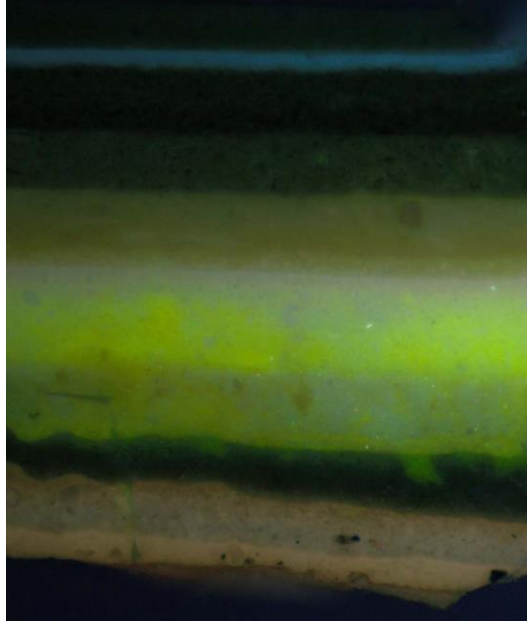
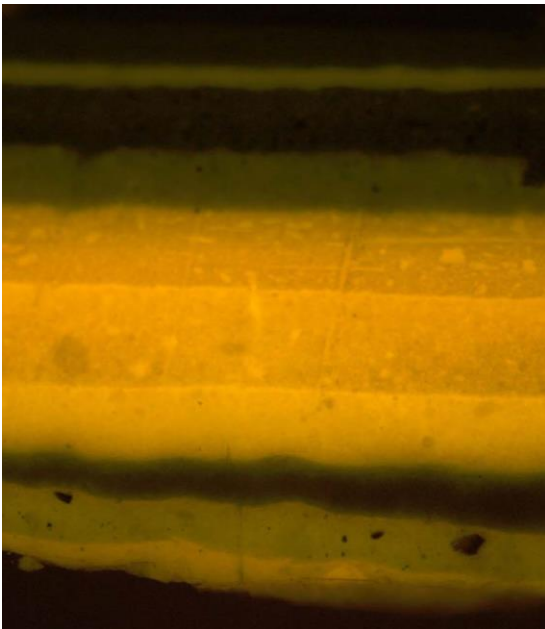
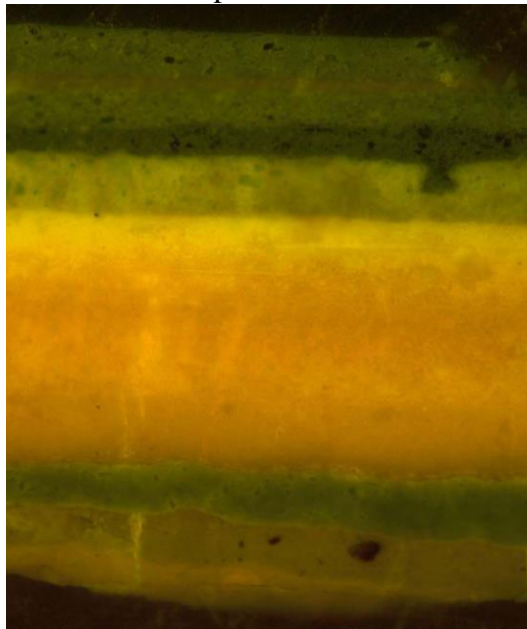
NE-1. South wall, southwest corner, surbase of chair rail.

Binding media characterization with biological fluorochrome stains shows that all the paints contain oil components, and generations 8 through 10 have weak carbohydrate additives. There were also positive reactions for proteins in generations 7 through 10. Polarized light microscopy analysis shows that the original gray-blue finish coat is composed of Prussian blue, white lead, calcium carbonate and widely distributed yellow ochre and lampblack. This type of blue paint is consistent with mid-to-late eighteenth-century composition and colors.

No reactions for carbohydrates

+ reactions for oils in all paints

+ reactions for proteins in 7 - 10

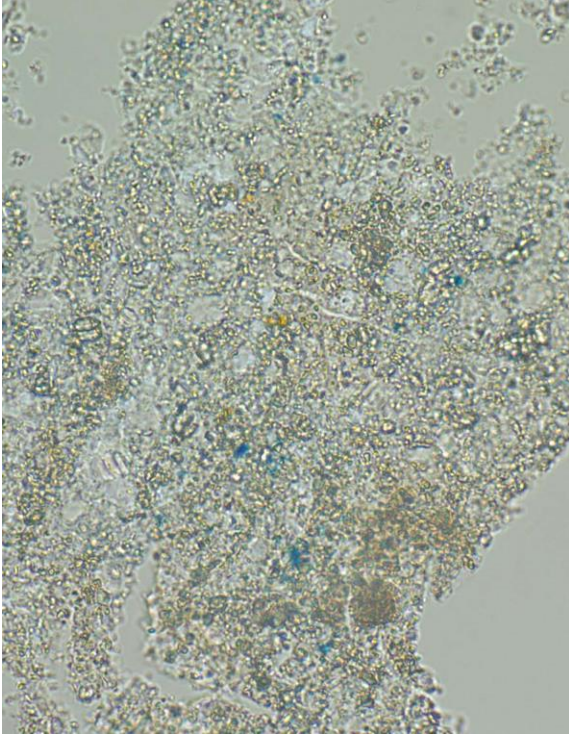
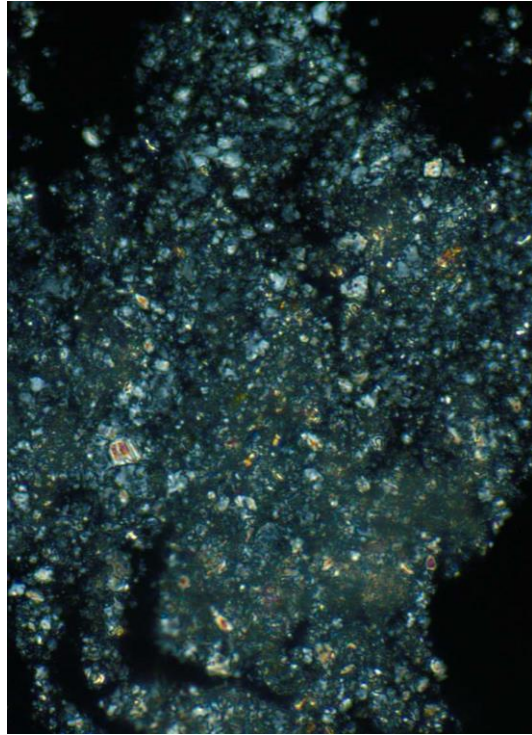
NE-1. South wall, southwest corner, surbase of chair rail. Pigments in the original blue-gray finish coat: white lead, Prussian blue, calcium carbonate, widely scattered yellow ochre and lampblack.

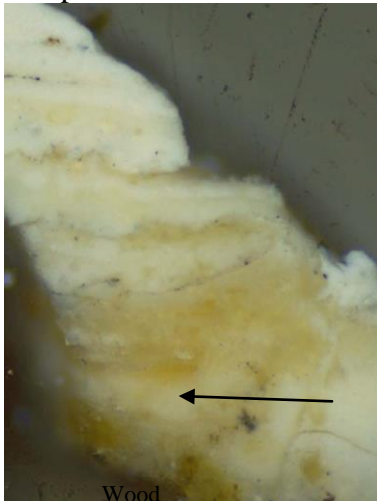
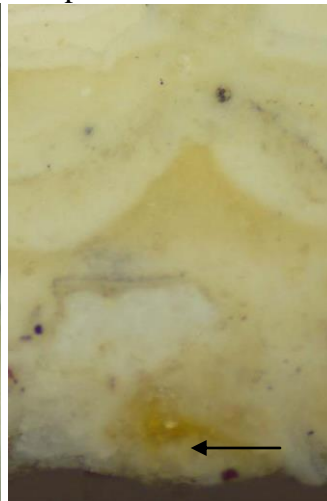
The original cream-colored trim paint was matched by eye at 30X under a color-corrected light source because it is too uneven and degraded to allow accurate color measurement. The commercial match #OC-36 is an excellent visual match to the best preserved areas of the cream-colored paint. Optical microscopy analysis suggests that this paint was originally moderately glossy and could be reproduced in a semi-gloss coating.

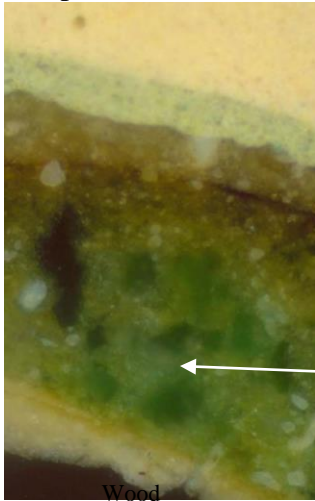
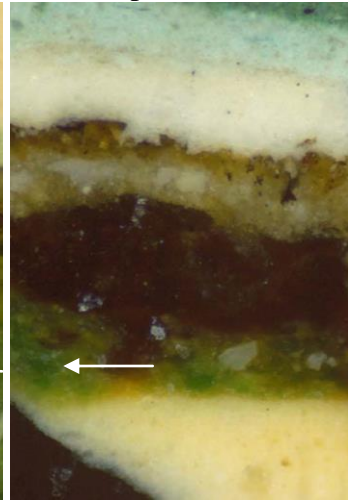
The original green finish coat paint was matched by eye at 30X under a color-corrected light source because it is too grainy, uneven and darkened to allow accurate color measurement. The commercial match #2035-10 is an excellent visual match to the best preserved areas of the coarsely ground green paint. Optical microscopy analysis suggests that this paint was originally moderately glossy, and quite grainy, and could be reproduced in a semi-gloss coating.

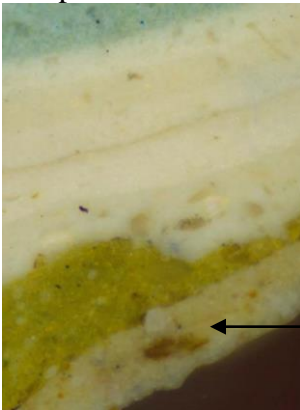
Sample SW-1

The original tan paint was matched by eye at 30X under a color-corrected light source because it is too uneven and degraded to allow accurate color measurement. The commercial match #HC-34 is an excellent visual match to the best preserved areas of the first-generation tan paint. Optical microscopy analysis suggests that this paint was originally slightly glossy and could be reproduced in a satin coating.

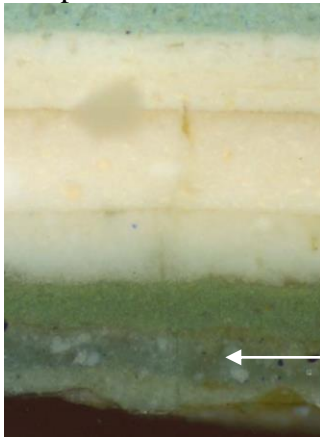
Sample NE-1

The original gray-blue paint was matched by eye at 30X under a color-corrected light source because it is too uneven and degraded to allow accurate color measurement. The commercial match #AC-24 is an excellent visual match to the best preserved areas of the first-generation gray-blue paint. Optical microscopy analysis suggests that this paint was originally slightly glossy and could be reproduced in a satin coating.

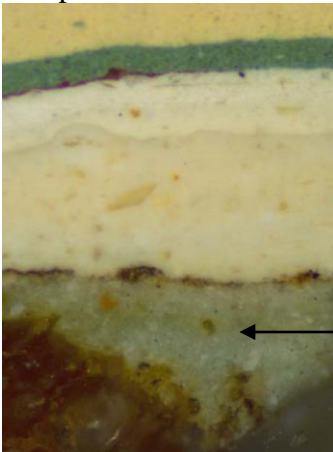
Sample CH-2

The original gray paint was matched by eye at 30X under a color-corrected light source because it is too uneven and degraded to allow accurate color measurement. The commercial match #AC-17 is an excellent visual match to the best preserved areas of the first-generation gray paint. Optical microscopy analysis suggests that this paint was originally slightly glossy and could be reproduced in a satin coating.
