Fox Hall - Part 4, Chimneys and Fireplaces

Jim Melchor and Tom Newbern

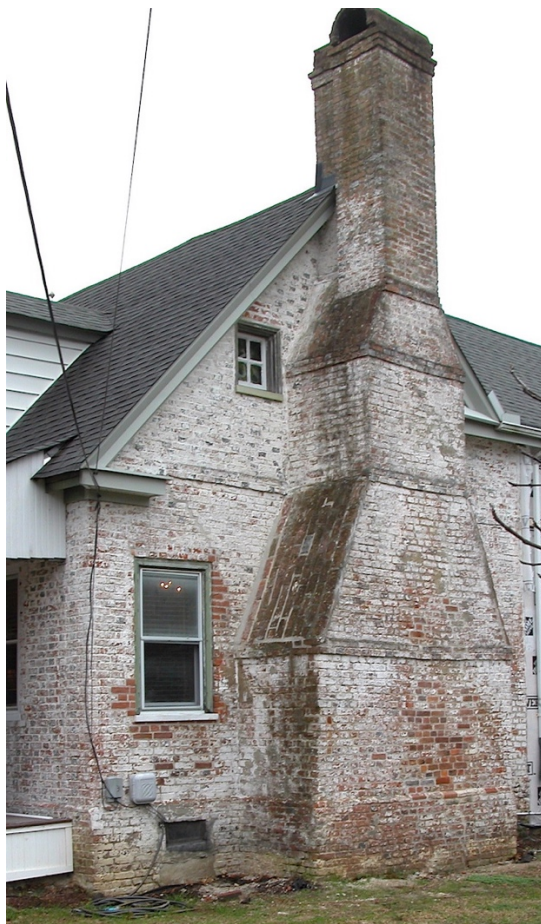
Figure 1

For reference, Fox Hall faces north. The west chimney is seen in Fig. 1, the east in Fig. 2. The west chimney serves the kitchen fireplace, while the east chimney serves the hall.

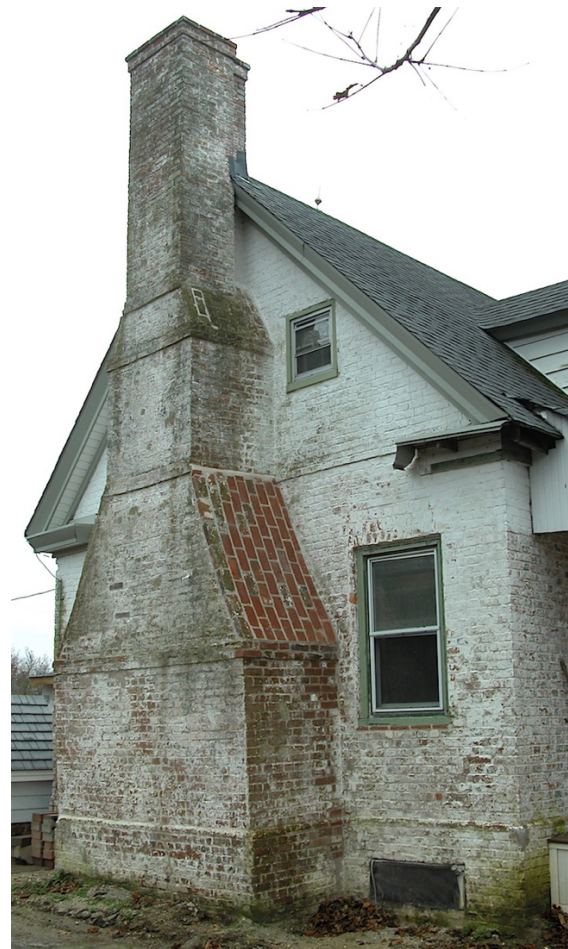
Figure 2

See Fig. 2 for a view of the east chimney as restored.

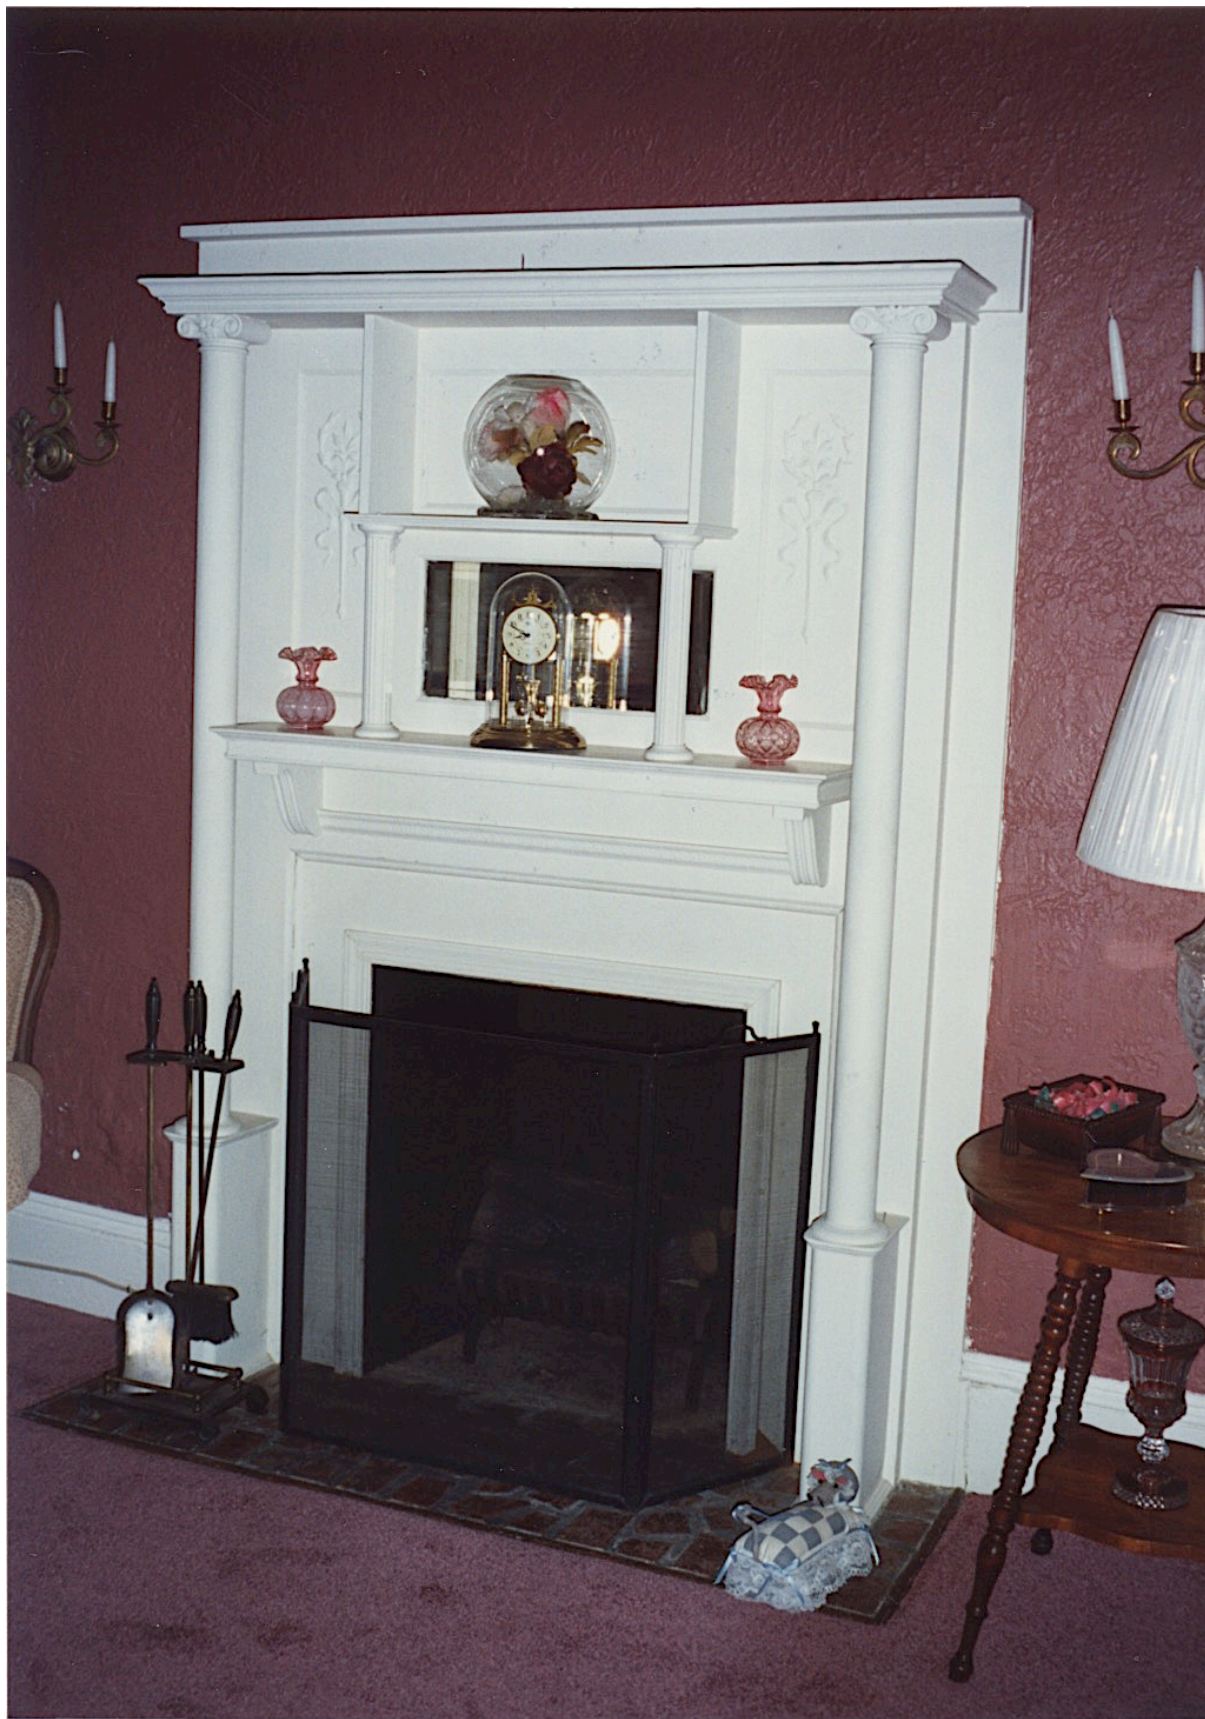
Figure 6

Kitchen Fireplace To begin discussing the restoration of the kitchen fireplace, first take a look at the starting point (Fig. 6, Twentieth-century evolution of kitchen fireplace). By this time, the kitchen had become a fashionable but comfortable parlor or living room. Cooking, dining, and other household activities were relegated to the addition. The hall was variously used as sleeping quarters for the owners and, at times, as rental space.

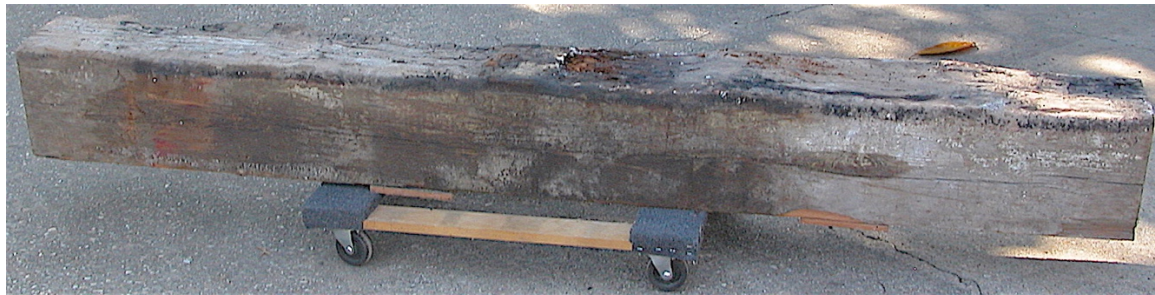
Figure 27

2) A much smaller and less structurally sound substitute manteltree replaced the original. A large timber, lightly charred on one side, likely was the original manteltree from the hall fireplace. It was discovered in the basement, but it unfortunately had been shortened several feet, possibly during its removal. This timber was reused from an earlier structure, as it has several stud notches on one edge (Figs. 27 & 28, Possible original hall manteltree).

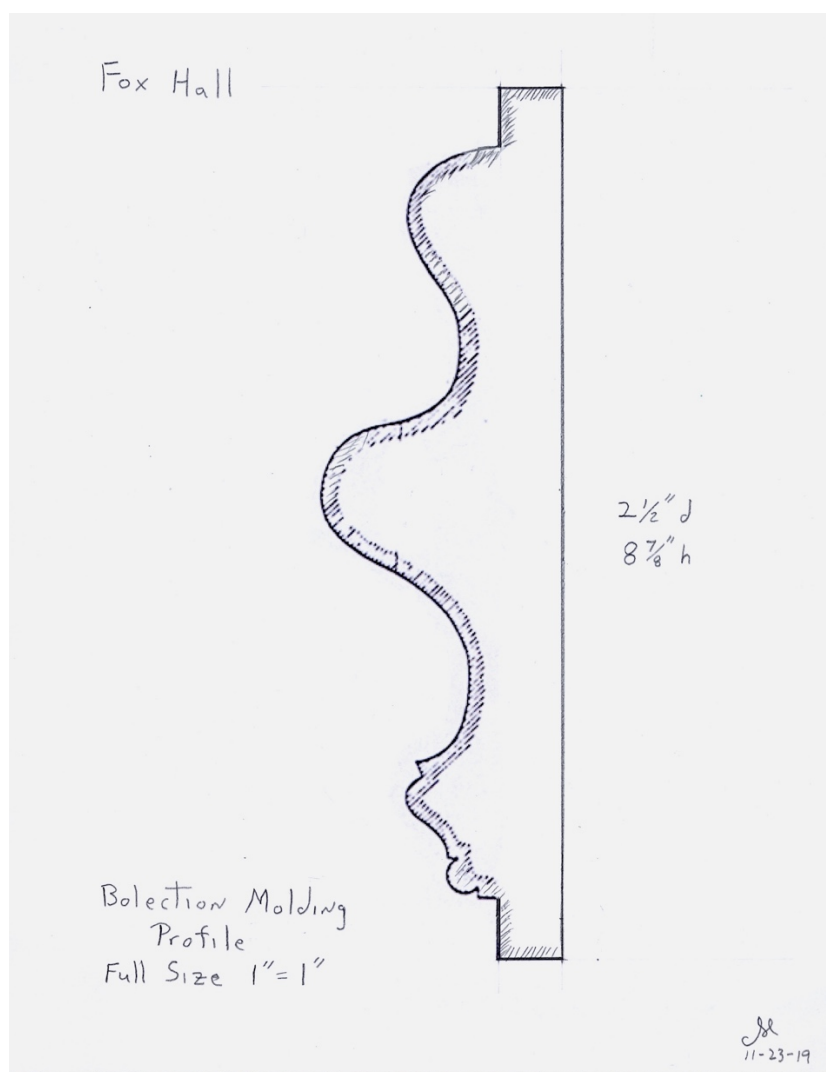
Figure 37

with a large bolection molding surrounding its hall fireplace. Unfortunately, this molding was damaged by fire, and it was discarded rather than being repaired during the restoration of the house. However, all was not lost. This bolection molding was documented in the HABS drawings of the house. Since the two houses are so closely related, it is not unreasonable to assume that Fox Hall also had a similar bolection molding surrounding its hall fireplace. An appropriate bolection was designed based on the one illustrated in the Lynnhaven House HABS drawings (Fig. 37, Design of Fox Hall bolection molding).
