Fox Hall - *Part 8*, Windows

By Jim Melchor, Tom Newbern, "Cheetah" Waller, and Dick Gresham

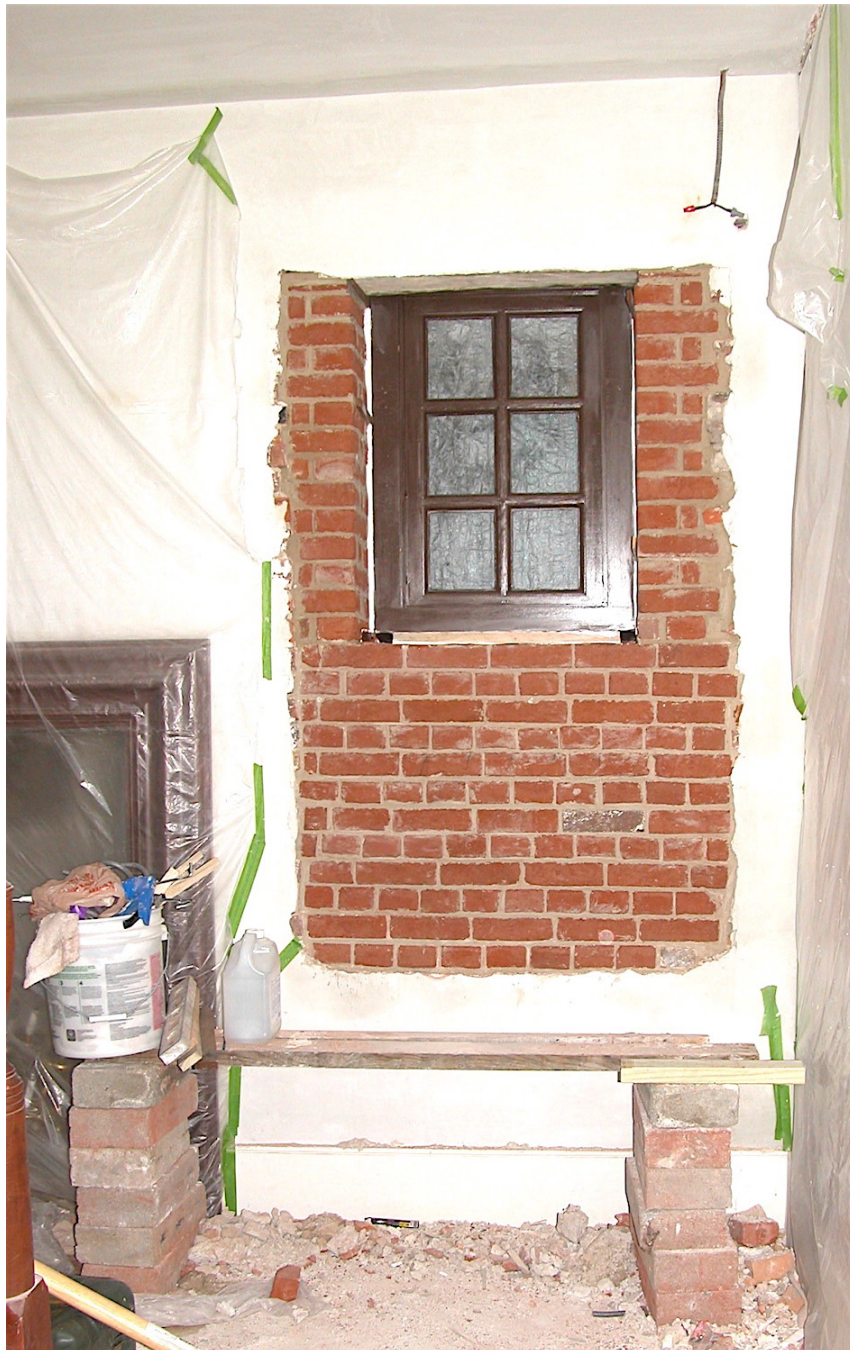
Note the tapered top mortar joint over the window. The bottom of the rough opening is level and both sides are plumb. The window frame is square and is set plumb and level in the opening. This mortar joint was the concession to the settled endwall without removing and resetting more original brick above. Figure 30 is the interior view of the set window before installation of trim.
