Fox Hall - *Part 10*, Jack Arch Segment "8L"

By Dick Gresham, Jim Melchor, and Tom Newbern

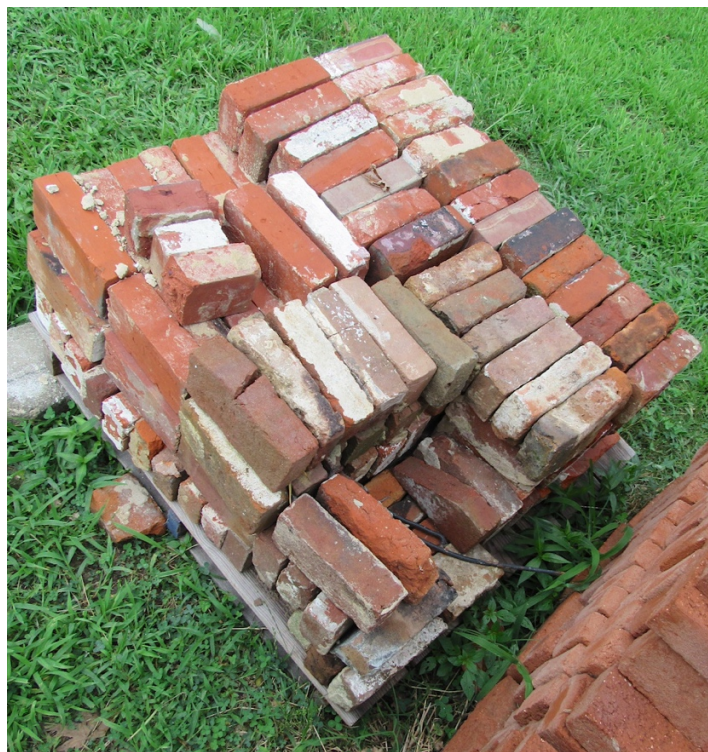
Figure 2

The first duty of the team architect was to design and construct the cellar entrance or "doghouse" (See Fox Hall - *Part 5*, Cellar Entrance). This led to an ongoing duty of culling through these piles of debris to find, collect, sort, clean, and stack bricks according to age, type, and degree of usefulness – initially for the doghouse's foundation and later for other restoration uses (Fig. 2, Culled and sorted bricks).

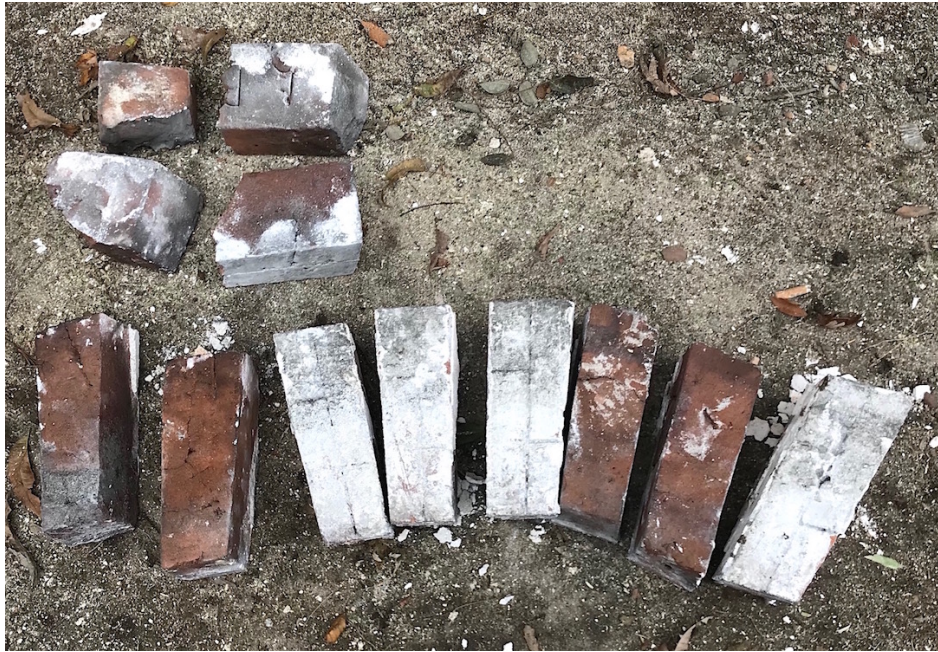
Partial Jack Arch Fox Hall Front Door

Update - As noted in Fox Hall - *Part 8*, Windows: "Earlier in the restoration project (*before the restoration team arrived onsite*) during repair to the jack arch over the front door, several marked bricks in the jack arch were encountered. These bricks ... were marked prior to firing. These marks are symbols rather than numbers". At the time of writing *Part 8*, only the photo of the segment in Fig. 39 in *Part 8* (Fig. 10 above) had been supplied to the restoration team. The additional information about the front-door jack arch was provided verbally by the owner. The team did not realize until recently, when the owner found and provided additional photos of the jack arch, that the first mark was not a symbol, but the numeral "5" and that the segments are lettered (Figs. below, Numbered and lettered segments from front-door jack arch). Finally, the markings on the segments make sense. Apparently, the brickmakers standing toolkit included a number of sets of molds for making an assortment of jack arches of different sizes. Thus, the number refers to the set of molds for a specific jack arch, and the letter is the location of that segment within the jack arch. These mold sets would not have been made for a job and then discarded. They would have remained in the brickmakers inventory to be utilized on subsequent jobs requiring a certain size jack arch. In the case of the brickmakers at Fox Hall, they had at least eight sets of molds and used set "5" for the front-door jack arch and set "8" for the jack arches over the five large windows and kitchen chamber doorway.
