# Fox Hall - Part 11, Second-Floor Assessment

#### Introduction:

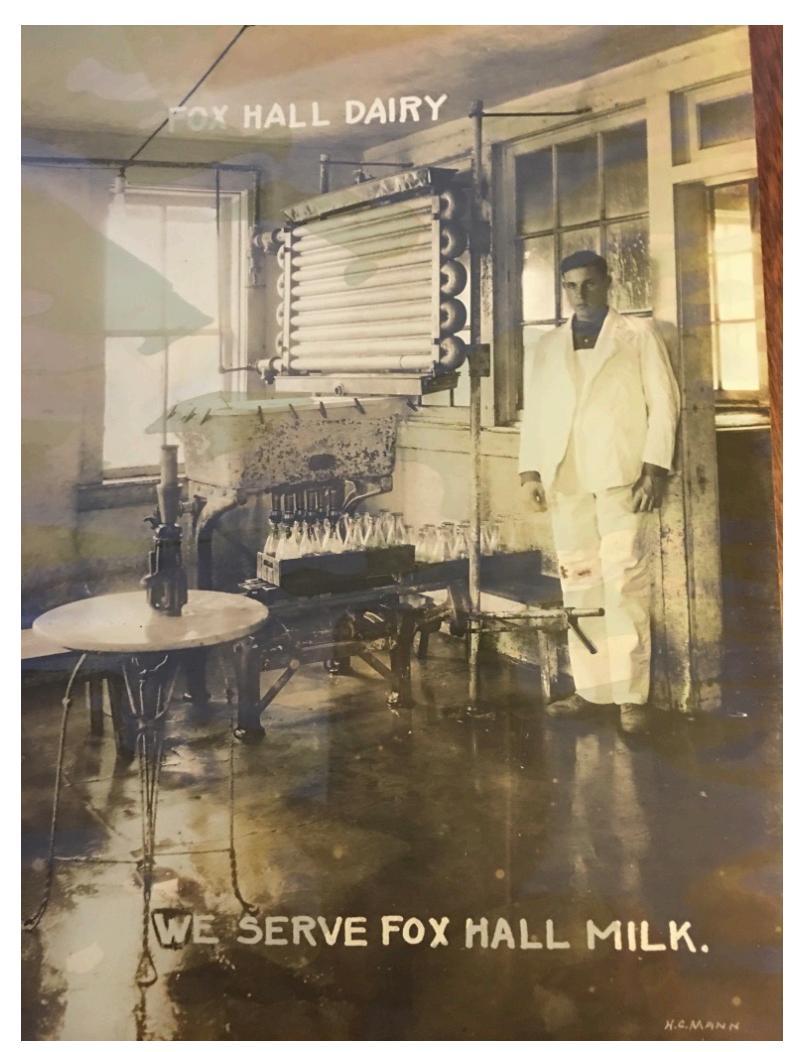
Around 1920, August Malmgren purchased Fox Hall and operated it as a dairy farm (Fig. 1, Son, Marius Malmgren, at Fox Hall Dairy). After World War II, the Malmgren family sold most of the Fox Hall property for a housing development. The present owner, Susan Sutherland, is a Malmgren descendant. She is responsible for the current major restoration project at Fox Hall.

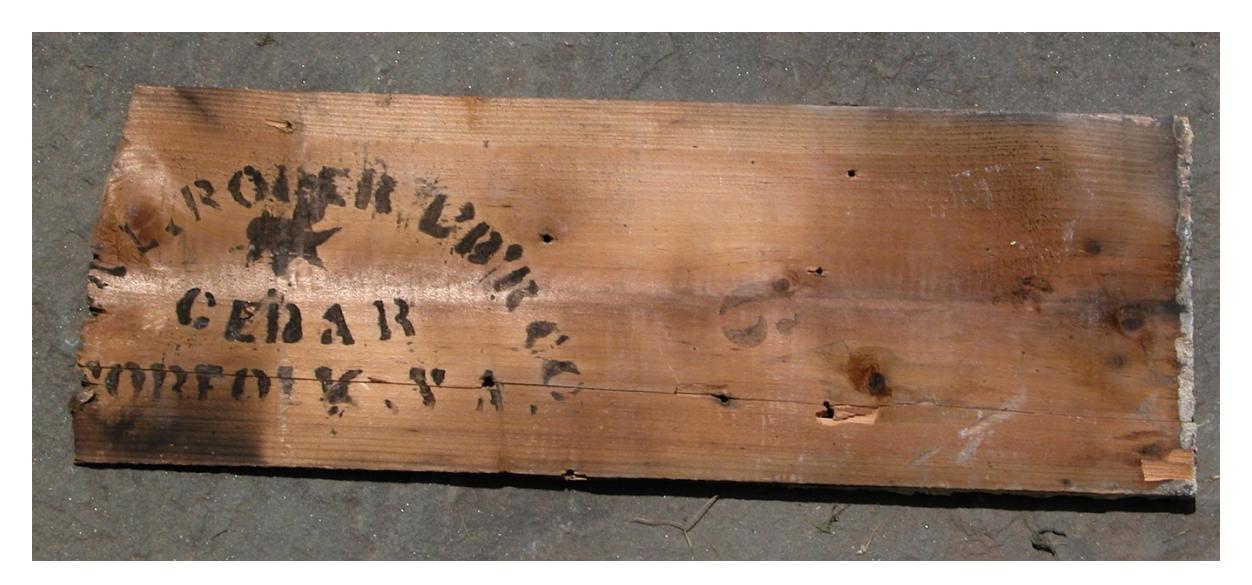
Figure 14

The three remaining dormers are entirely Roper period, complete with a Roper-labeled shingle (Fig. 13, South dormer) (Fig. 14, 6" cedar Roper shingle).

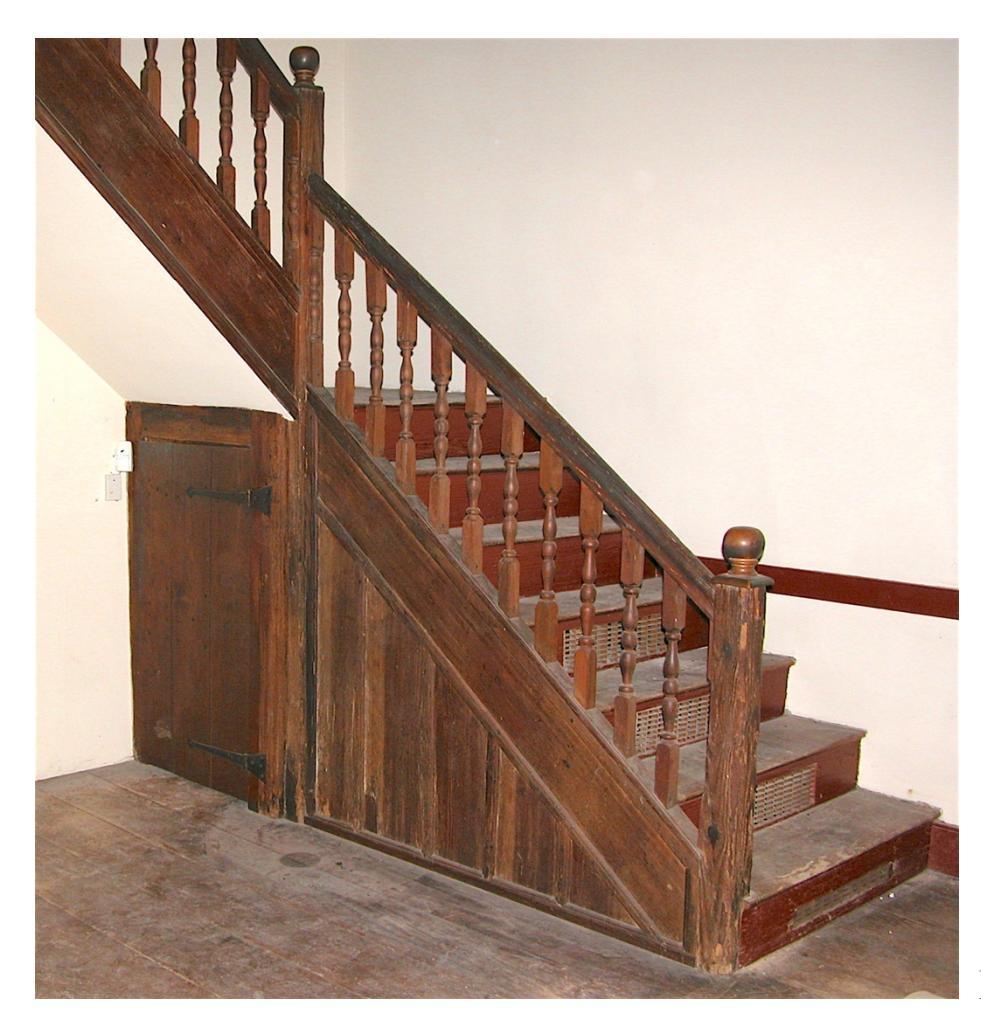
Figure 19

The late-eighteenth-early-nineteenth-century stair was installed at this time replacing the fire-damaged or destroyed original stair and balustrade. As discussed in *Part 1* of this series, the original stair likely would have been similar to the closed-string, board and batten stair at Lynnhaven House (Fig. 19, Lynnhaven House stair) or the closed-string stair at Linden Farm in Richmond County, Virginia (Fig. 20, Linden Farm stair).

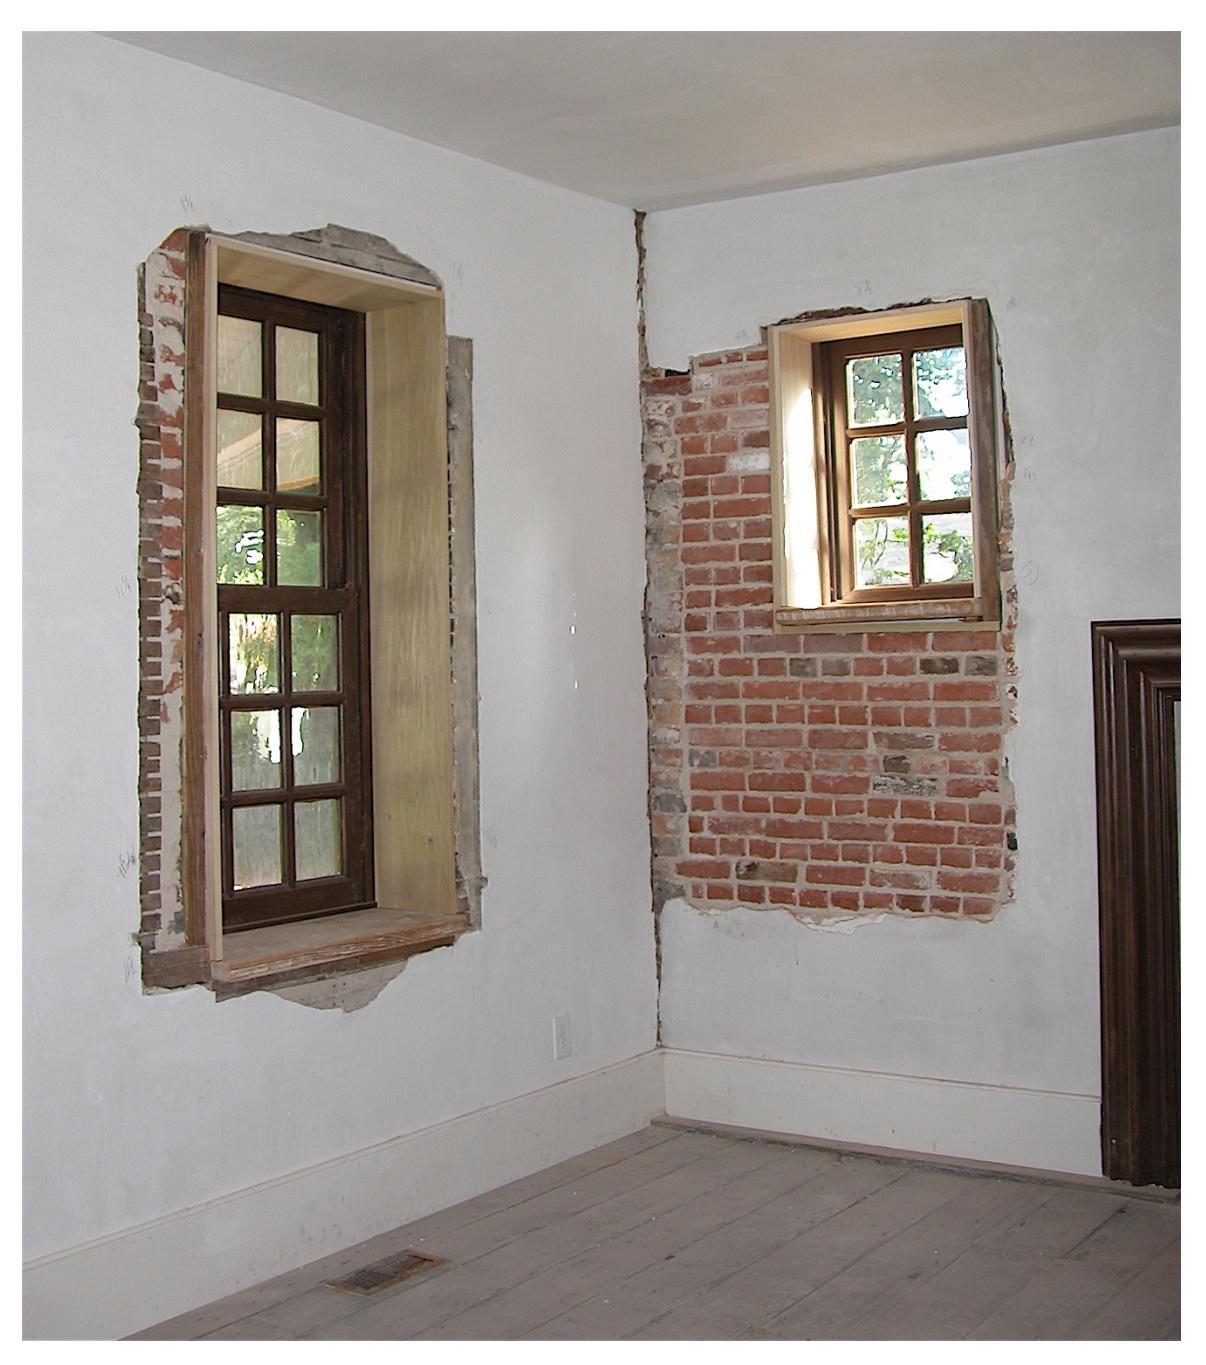
Sample of area in hall before finish plastering

In Fox Hall - *Part 8*, Windows, the restoration of the first-floor windows was discussed. This work required masonry repairs inside and out and trim work around the windows inside. The team plasterer and his crew, who did extensive plaster restoration in the hall and passage after the restoration of the fireplaces in the hall and kitchen, returned to finish plastering in these two rooms.

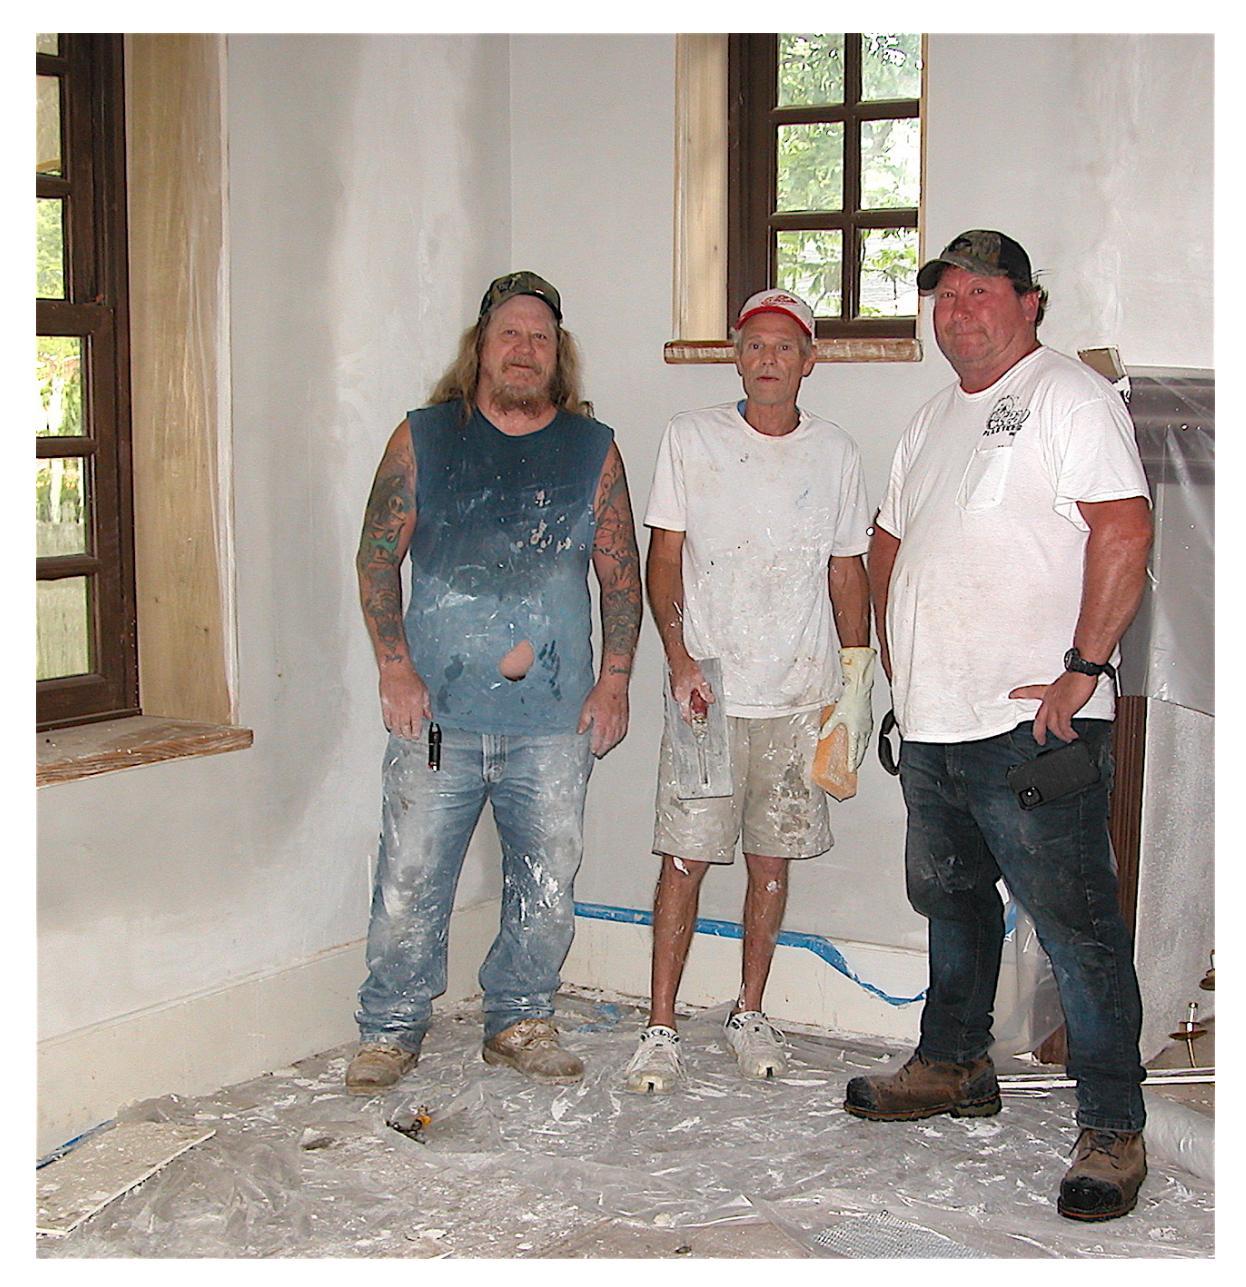
Team plasterer, Jesse Banks (right) & crew plasterers, Mark Harmon (center) & "Hotsy" Lloyd (left) in same area of hall as above after plastering

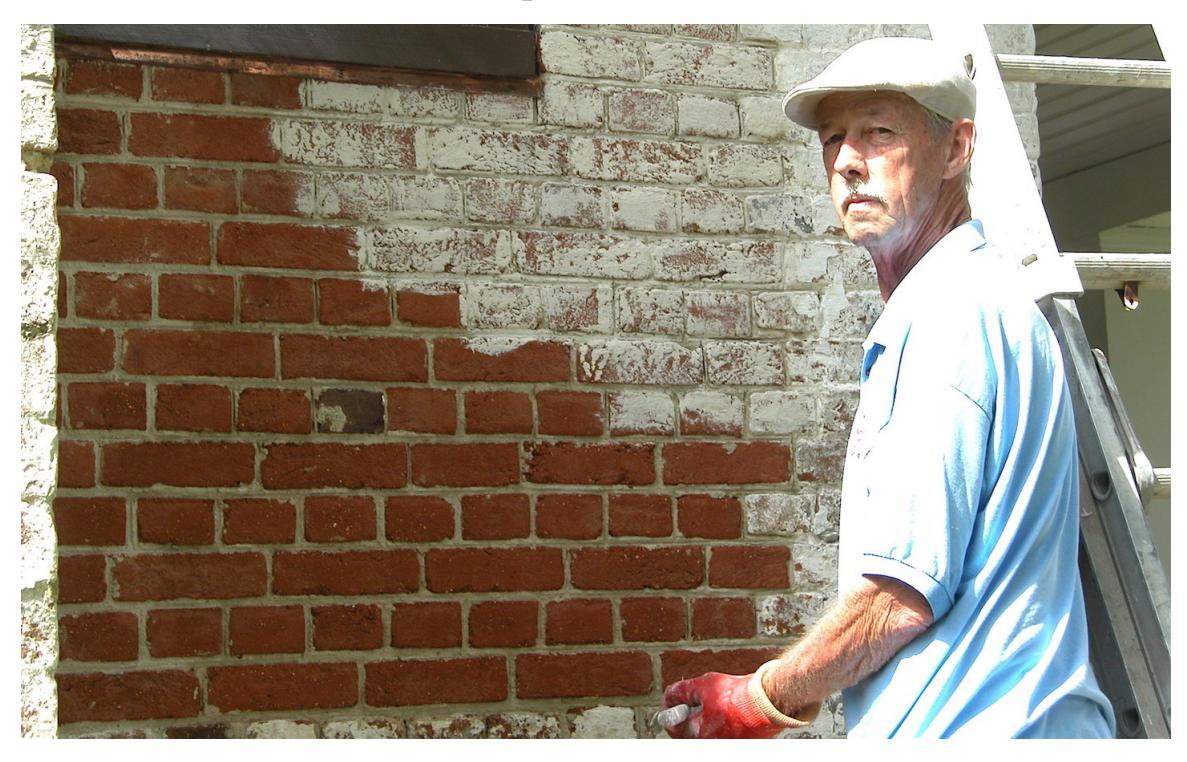
Team painter, Randy Creef, visually blending new with old

In Fox Hall - *Part 9*, Brickwork Finish, the procedure for visually blending in the restoration brickwork with the original was presented. This work has now been completed.

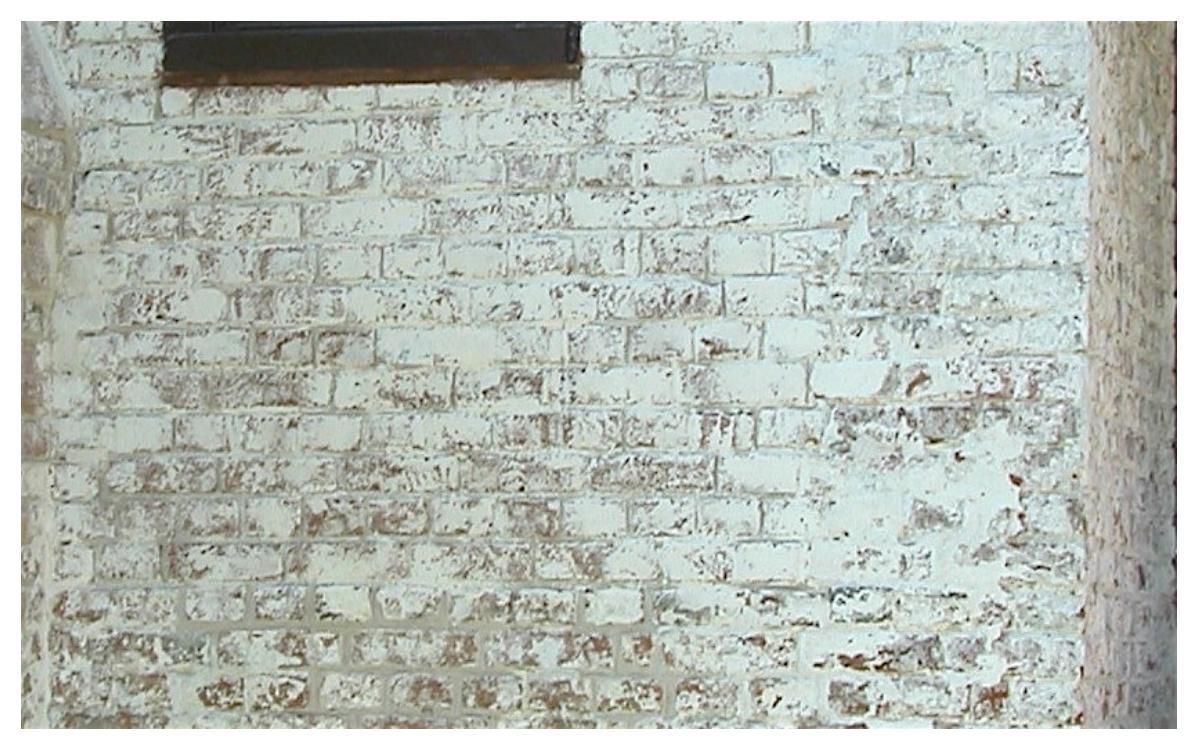
Blending done in above area

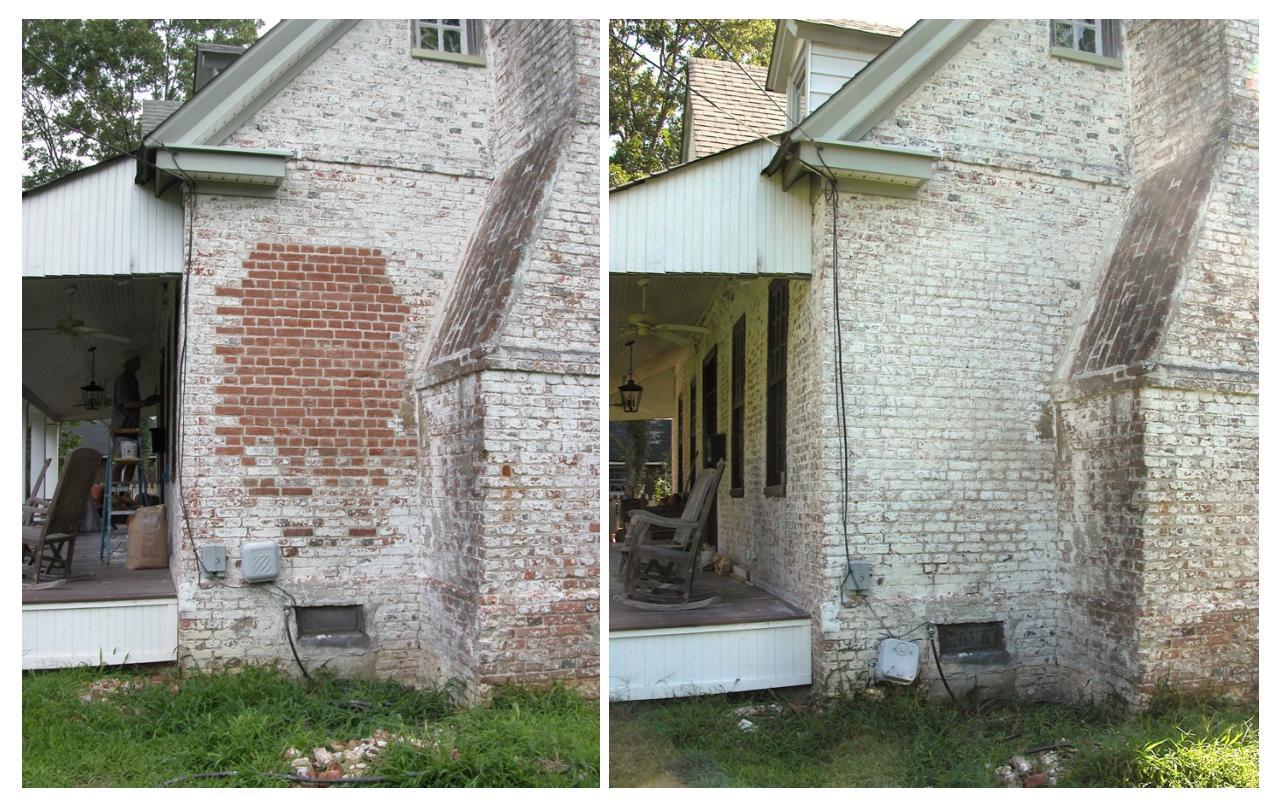
Before blending

After blending
