Linden Farm, An Overview

By Donald J. Orth

Editors' Note: In 1977 when Don and Martha Orth bought Linden Farm, they embarked on a journey to restore a small, eighteenth-century, vernacular farm house. This unimposing, but extremely rare, example of early Virginia architecture was in a poor state of repair and close to being lost. Through the Orth's dedication, hard work, and significant financial commitment, Linden Farm was saved. Today, it stands as a monument to Virginia's early farmers and how they lived. In this article, Don takes us on their Linden restoration journey. Throughout the article, we have supplemented Don's photographs, where appropriate, with photographs of our own. JM & TN

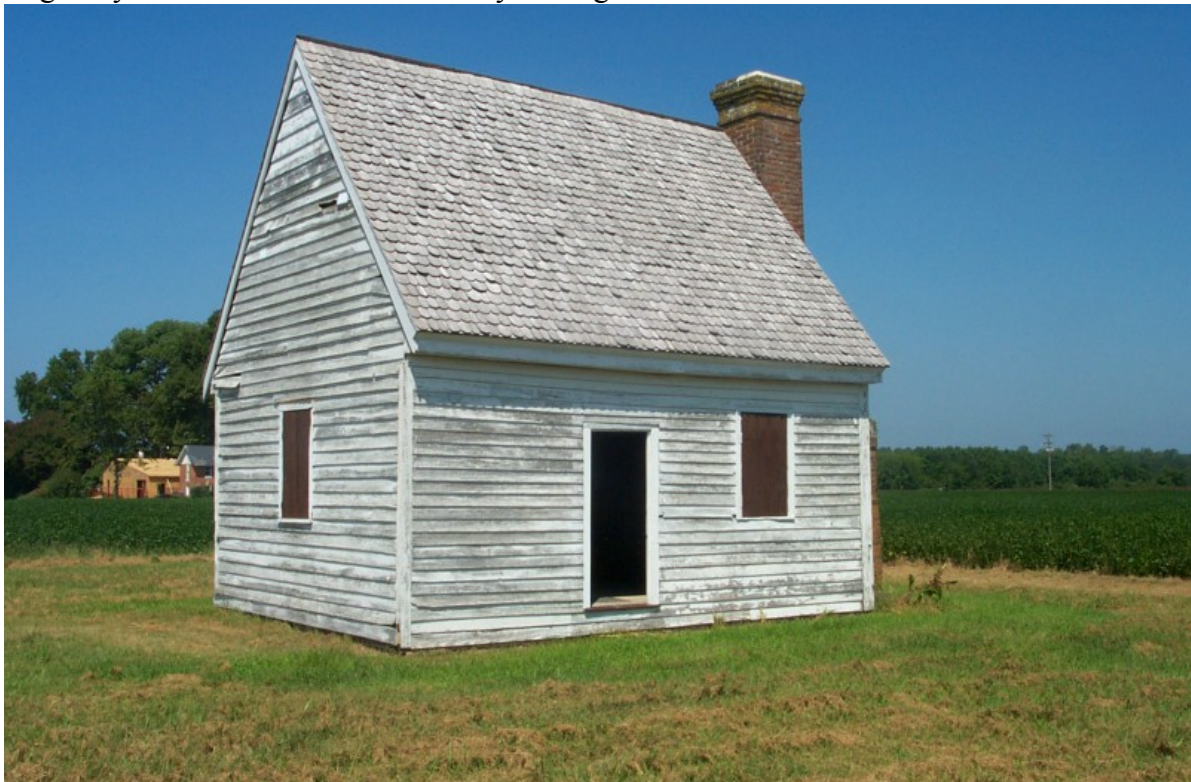
Figure 6

The earliest stage of Linden began as a one-room and loft house in 1761. William Dew, who owned the farm at that time, was evidently responsible for its erection. This little house was similar to many that once occupied the Tidewater area of Virginia. Unfortunately, almost all are now gone. Man finds old buildings a bother and has an inclination to tear down the old and build anew. Fortunately, Pear Valley (1740) in Northampton County, Virginia has been saved and is now on the Virginia and National Registers of Historic Places. It is carefully looked after by Preservation Virginia (formerly APVA) (Fig. 6, Pear Valley). Linden originally looked similar to Pear Valley in Stage I.

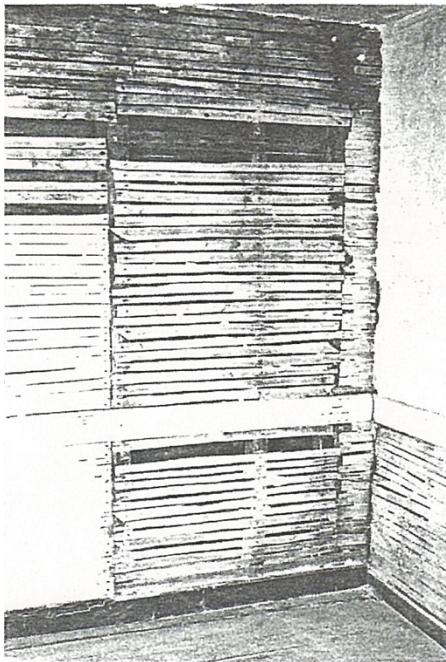
Figure 7

Details: When facing the front of Linden today, the oldest part is on the right (see Fig. 2). It is an early one-room plan building now encased within today's larger Linden. A partial wall of this early building still remains so we know much of what it once looked like. The one-room building's floor pattern was rectangular (15 by 21 feet) occupying what is today's dining room and front half of the passage (hallway). Its front door was located to the right (south) of today's main door. This can be seen by short lath spanning two doorposts along with a header on top (Fig. 7, Location of original door).

The chair rail and baseboards seen in Fig. 7 are later (Stage II?) additions. The wall to its right in the photograph was probably added during Stage II. The outside walls of this small building were covered with pine-pitch-covered, riven clapboards. We know this because part of the early wall on the north gable side still remains. Its siding was not removed when the Stage III south wall was built against it. A sliding window with trim, along with pitch-covered riven clapboards can be seen through a glass exhibit panel inserted on the last addition's inside parlor wall (Fig. 8, Looking through glass panel: pine-pitch, Stage I clapboards in center, Stage III vertical stud and brace on right, and Stage I sliding window and trim on left).

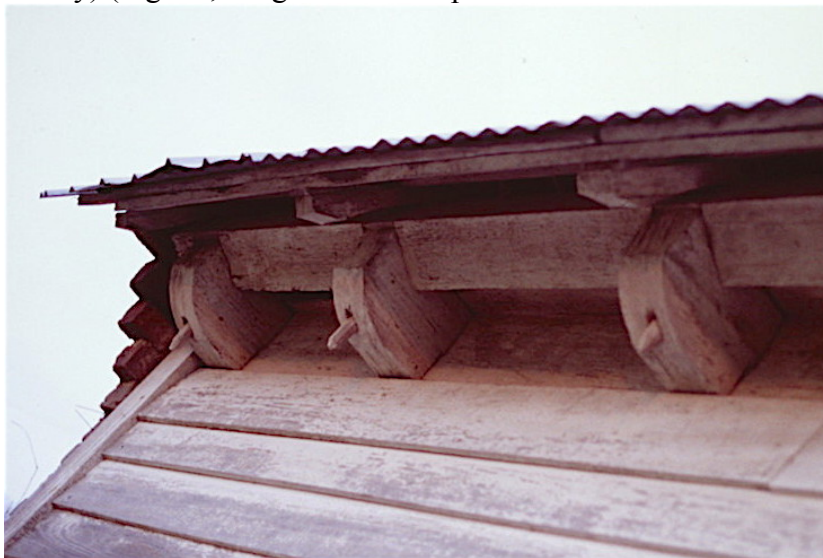
Figure 9

Early Linden had tilted-false-plate eaves. This early false plate still can be seen on the building's front side. The tilted-false-plate on the back (east) side of the building was removed when the lean-to structure was added to the early house during Stage II. Evidently, builders found the tilted-false plate useful when lining up rafters along the length of the eave. This was an easy way to square-up rafter ends separate from joists. Perhaps later, the extra work to construct a tilted-false plate, made their use obsolete (Fig. 9, False plate eave at Pear Valley) (Fig. 10, Diagram of false-plate eave construction at Linden).

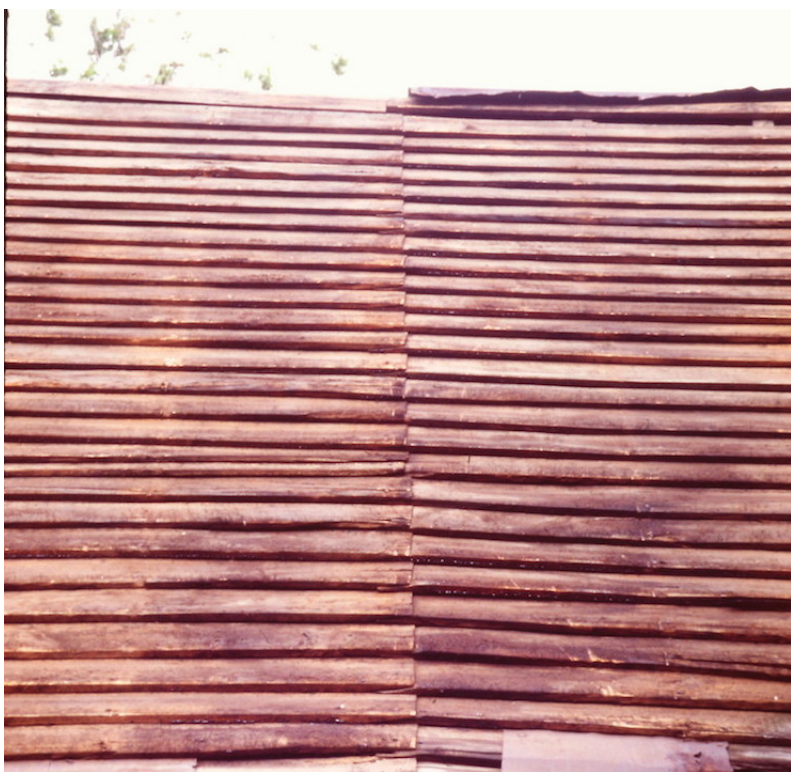
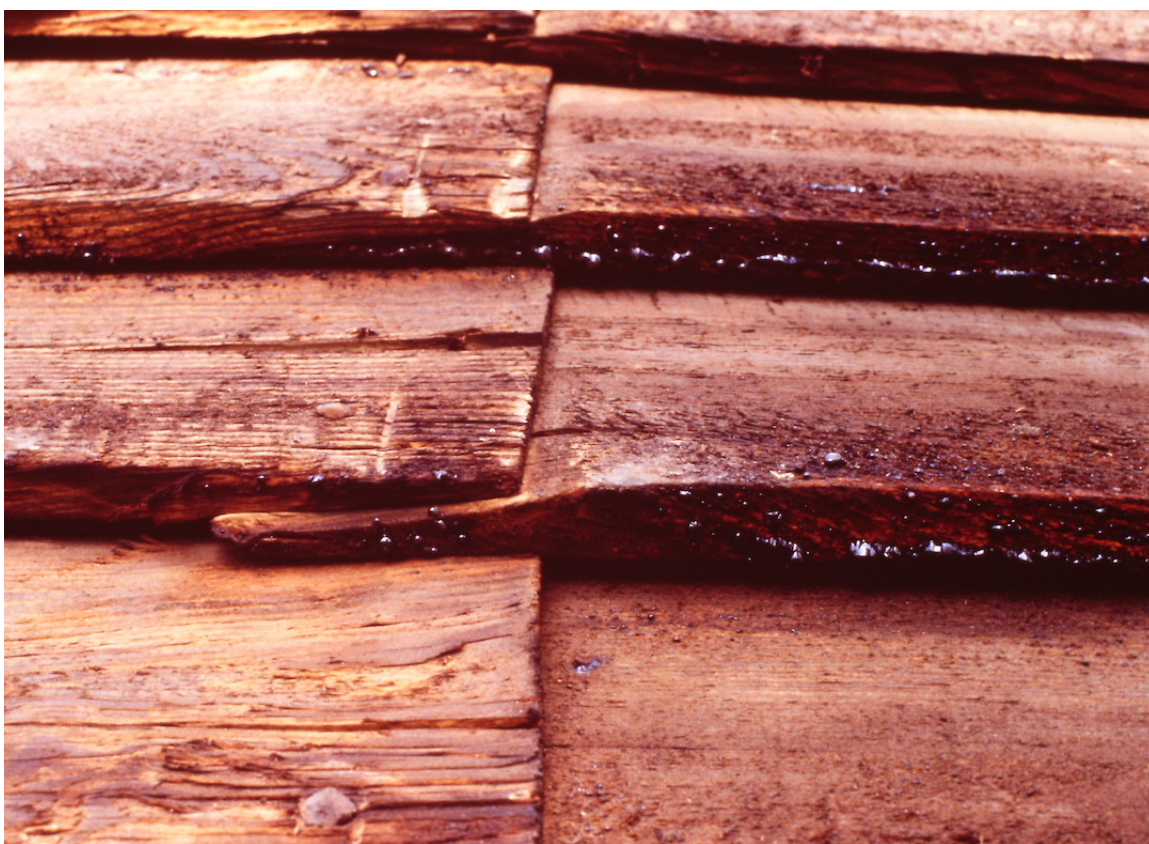
There was found beneath the building's floor, half covered in dirt, a 4-foot long pine-pitch-covered riven board. It is tapered at both ends, suggesting the building's first roof likely had pitch-covered clapboards (Figs 11 & 12, Pitch-covered roof clapboards on Rochester House just over the Richmond County line in Westmorland County) (see Rochester House at: http://www.milaminvirginia.com/Links/HOUSES/rochester_house.html). Also found beneath the original flooring were round-butt shingles suggesting the roof later was covered with newer and more weatherproof shingles.

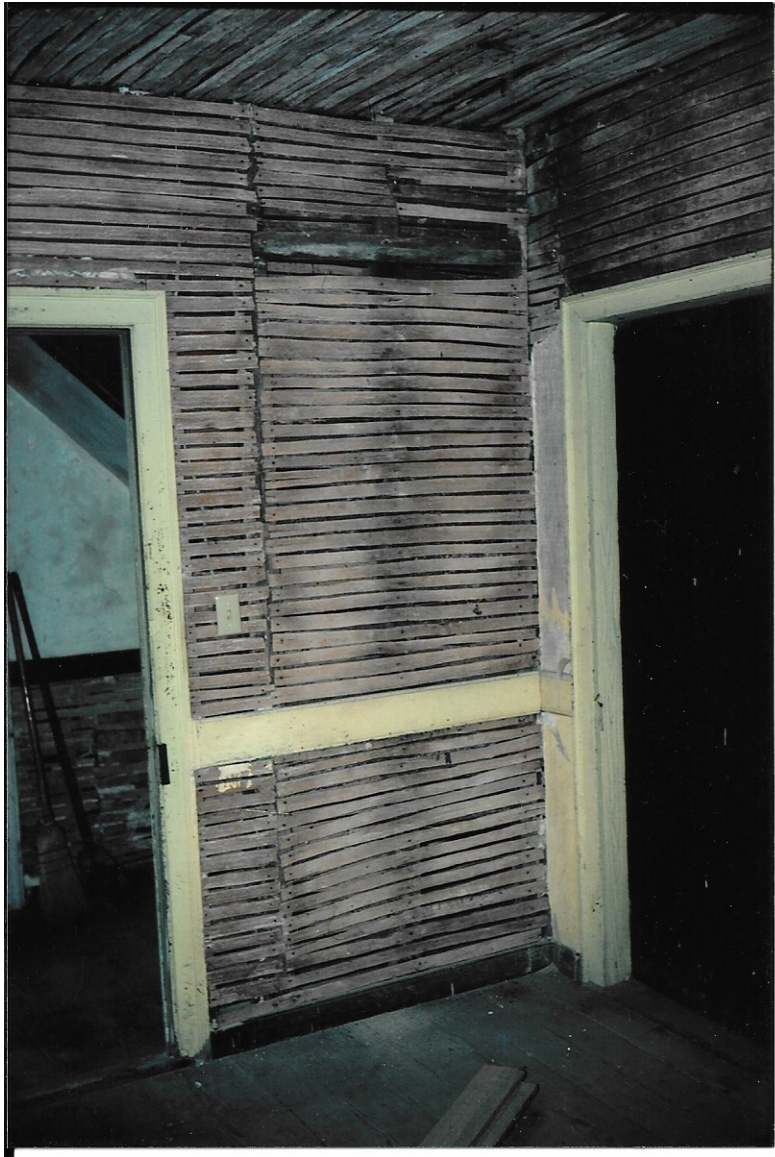
The stairs, in the northeast corner, were put in sometime during Stage I (Fig. 13, Evidence of early, Stage I stairs). They were slightly wider than the stairs in the house today and also might have been steeper, being restricted by a back door at its base. The stairs ascended toward the gable-end north wall and then turned left along the gable wall to the loft. This was within the width of what is today, the passage (hallway). There is a wide board on the second floor (loft) parallel to the existing stairs that may cover up the width of the early stairs. The left door in the Stage II wall in Figure 13 is nineteenth century; an earlier door in the same location was smaller. The door on the right is in its original location to the outside of Stage I or into the lean-to of Stage II. The early stairs evidence in the photograph is revealed by the header and short lath. It extended further into the loft floor than the later closed string stairs. The first, early stairs also may have been boxed-in from the beginning. The photograph also shows the lath before modern plastering.

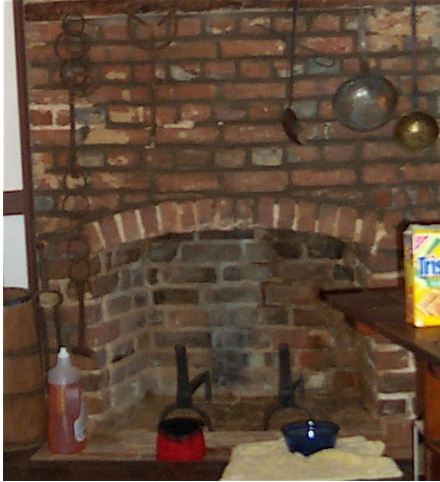
Figure 17

At this time, brick, double-corner fireplaces with a massive, two-flue chimney were added, each facing into the rooms to provide heat (maybe cooking) on both sides of the two rooms (Stages I and II). The arched opening in the lean-to is original (Fig. 17, Lean-to fireplace opening). It is the only arched fireplace intact in the house. That on the other side in Stage I originally had an arched opening that was later modified during Stage III into a square opening in order to accommodate a large Greek mantel.

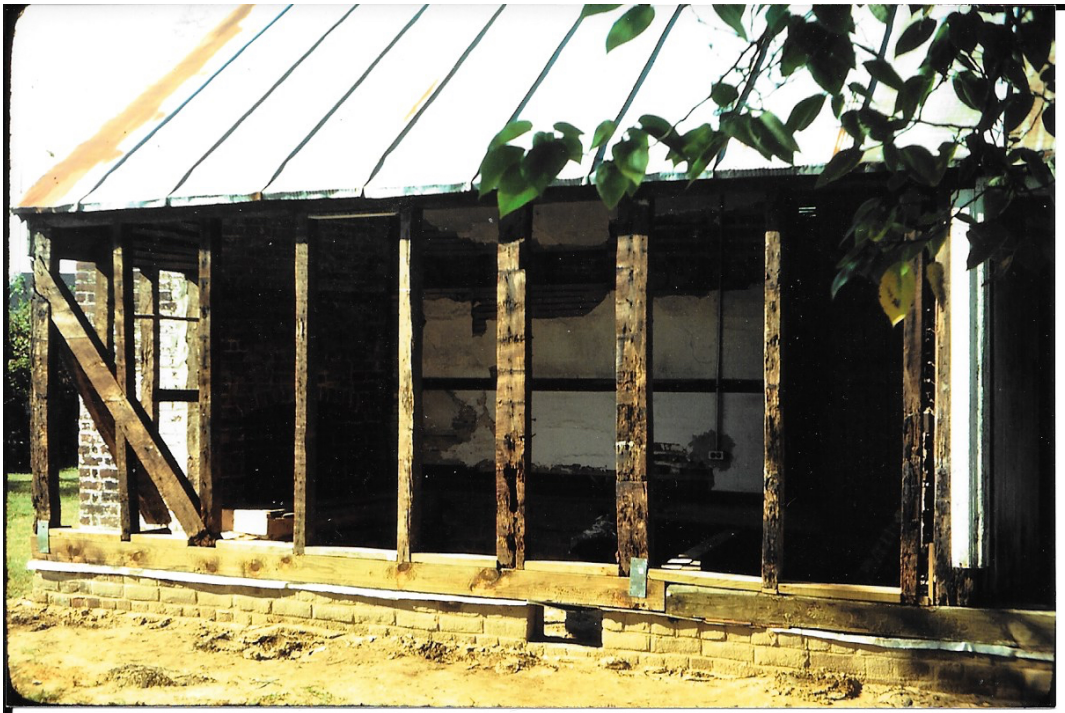
Figure 18

Figure 18, Stage II lean-to showing new sill and part of the old one on the right. Also shown is a corner post and brace, studs, and two window posts. Lath and plaster have been applied on the inside as has new siding been applied to the outside.

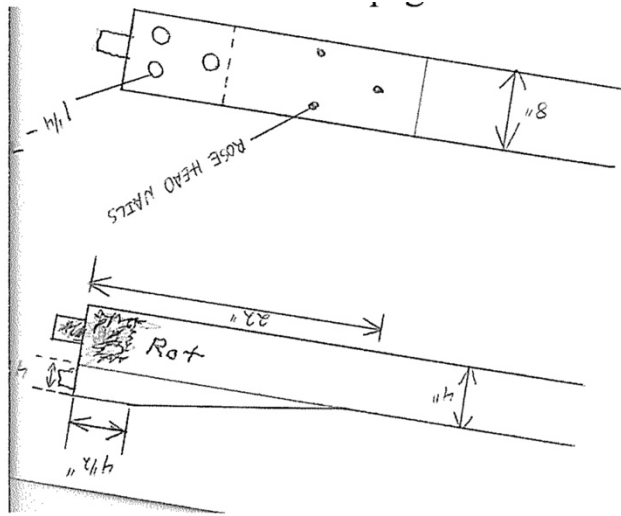
Figure 20

The area near the back doors was in bad condition having a great deal of rot. Evidently there was considerable leakage around the sill and the end of the joists. This apparently was an ongoing problem, as the joist ends near the doors were given extensions (Fig. 20, Sketch of joist extensions). Three wooden pegs holding each extension were missing. Why, when the wood extensions were solid and intact?

This is a poor sketch, partly up-side-down, but hopefully it gets the idea across. The wood extension attached to the original joist, held by three pegs and three rose headed nails. The extension would attach into the replaced sill.

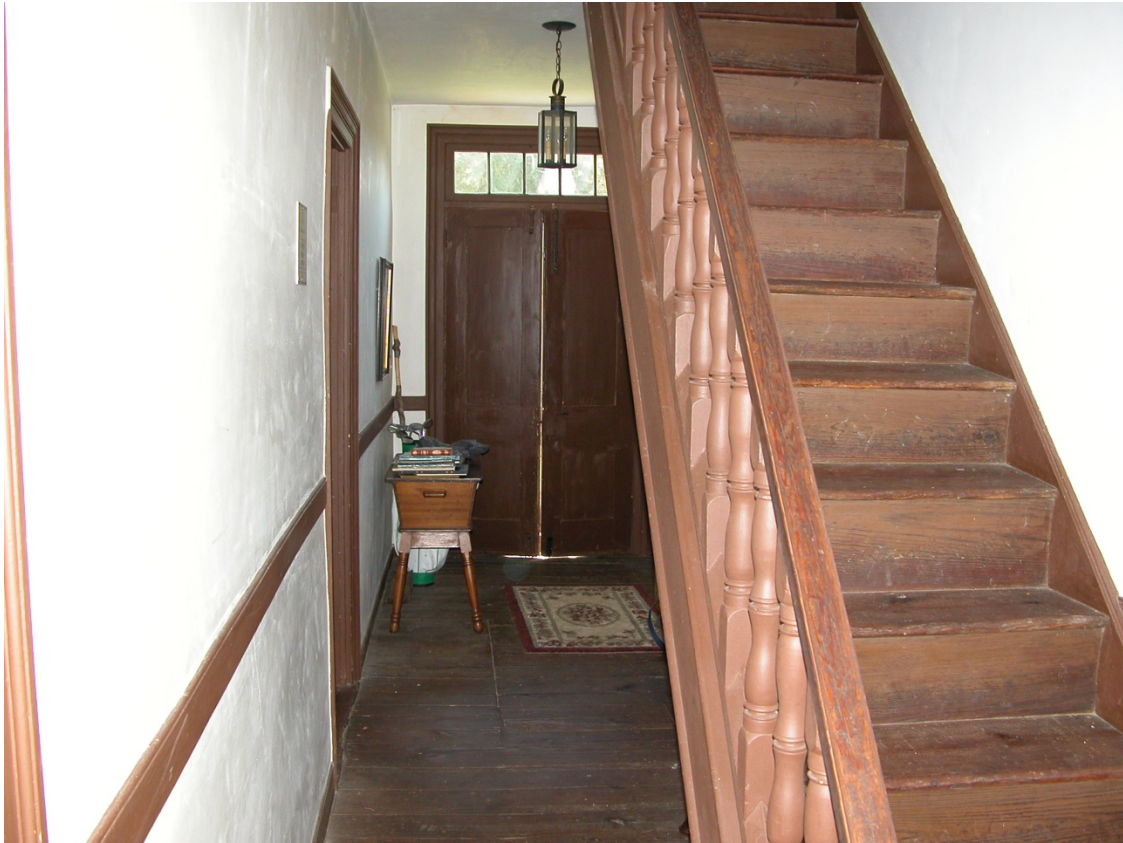
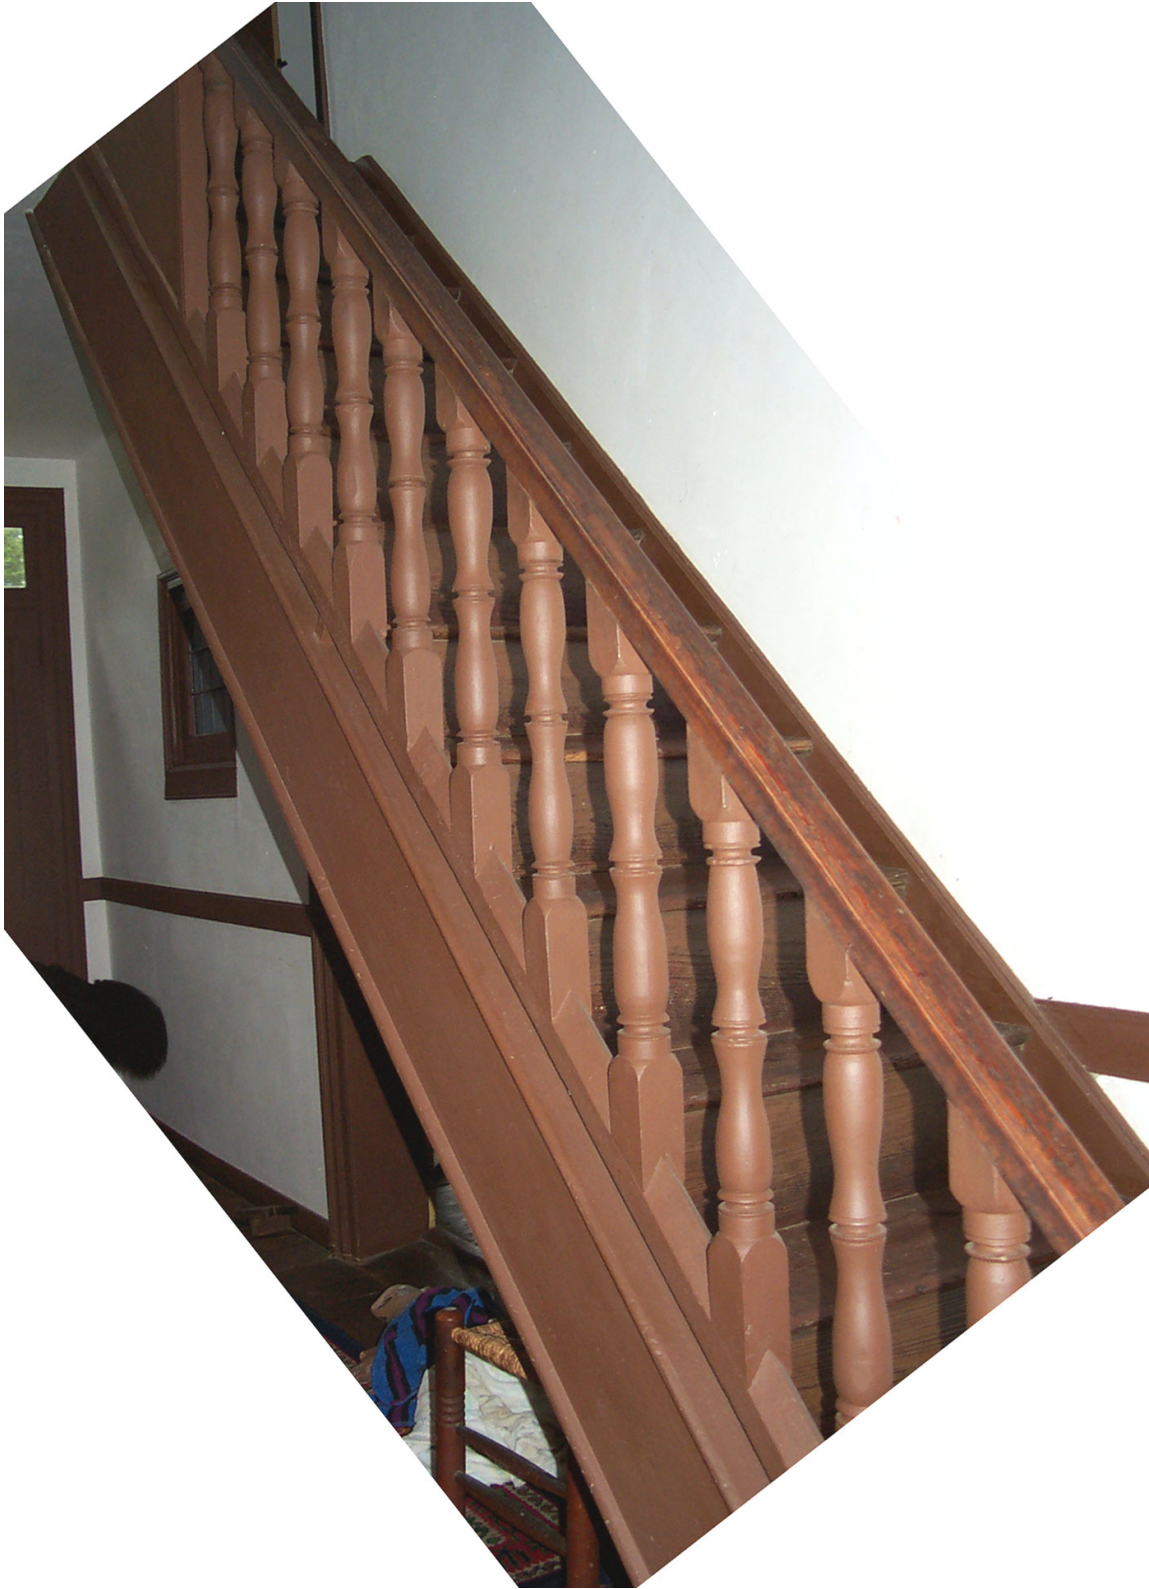
Summary: Retaining the room and lean-to shape, a larger structure was built directly against the older two. Like the earlier two stages, there is a large room in front and two smaller rooms in the lean-to addition. There are two iron hooks on the larger front room wall, three windows (two in front and one on the north side), two doors, one to the passage and one to the north back room (with H-L hinges). Four dormers were placed equally across the front of the completed building giving light to the hall and the large and small second-story chambers. The north, small lean-to room has an outside door and one leading to the large front room. There is no evidence of a door connecting the two small lean-to rooms. The south lean-to room's door leads to the (passage) just at the bottom end of the new stairs. New stairs replaced the old with closed string and early turned balusters (Figs. 21 & 22, Closed-string stairs with turned balusters).

installed against the north wall of the narrow passageway taking about half the walkway space. The new closed string stairs have early turned balusters and railing, a feature much earlier than the Stage I building. It appears that they may have been from a seventeenth or early eighteenth century building. In the 100 years that the Dew family owned and lived on the farm, they had a home on their land, but where was it? Late seventeenth century records often comment "at" or "on" the Dew place." Did the Dews live in an early (earthfast) house that had these stairs which were saved and later used in the Stage III renovation? Just a thought.

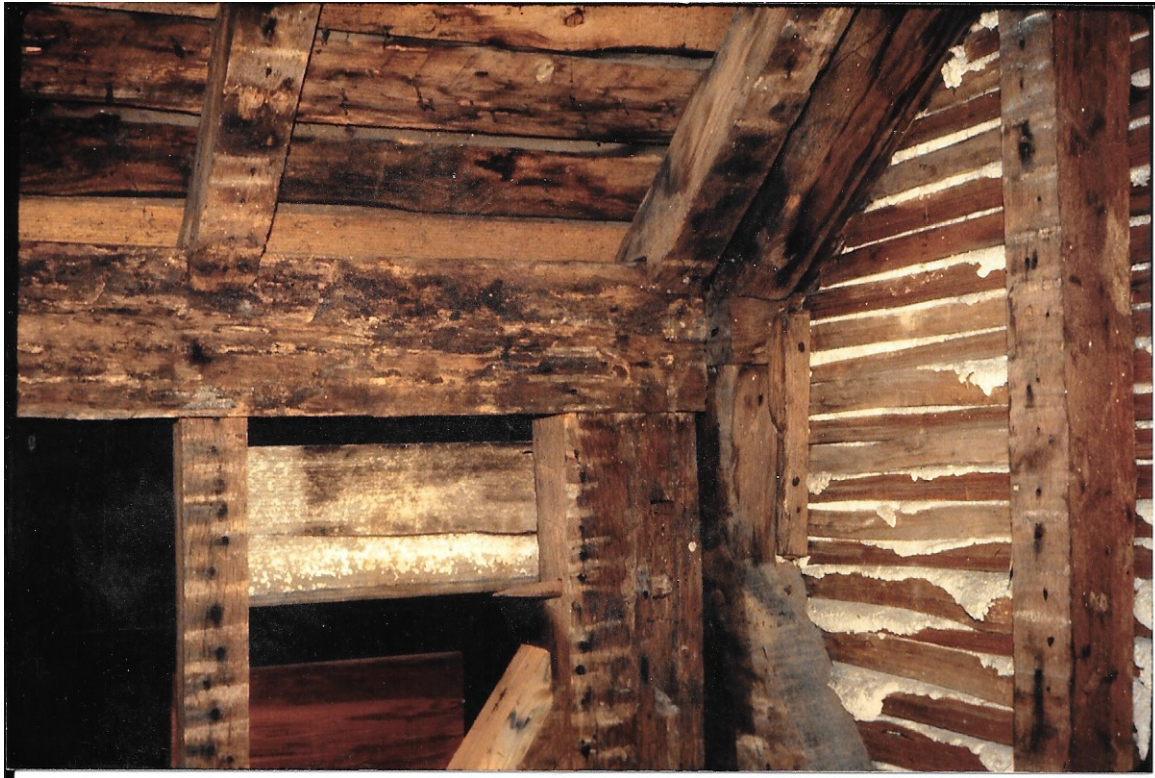
Figure 23

Details: Stage III addition completes Linden as it appears today. It was built directly and physically against the Stage I and II structures (Fig. 23, Joining of lean-to corner posts of Stages II and III).

Note the rafter plate and corner post of Stage III, on left, are larger timbers than those of Stage II (back side of plastered lath.)

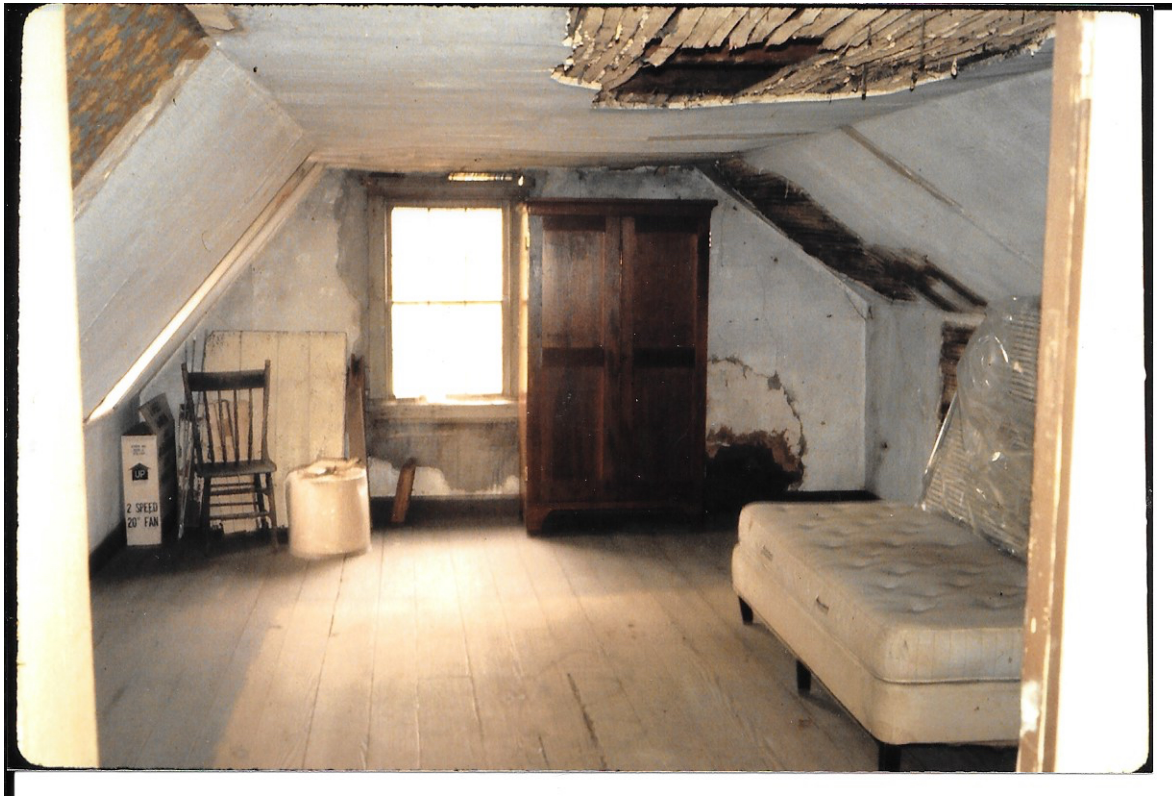
Figure 24

The large, Stage III chamber upstairs has a large window in the north, gable wall (Fig. 24, Large Stage III chamber).

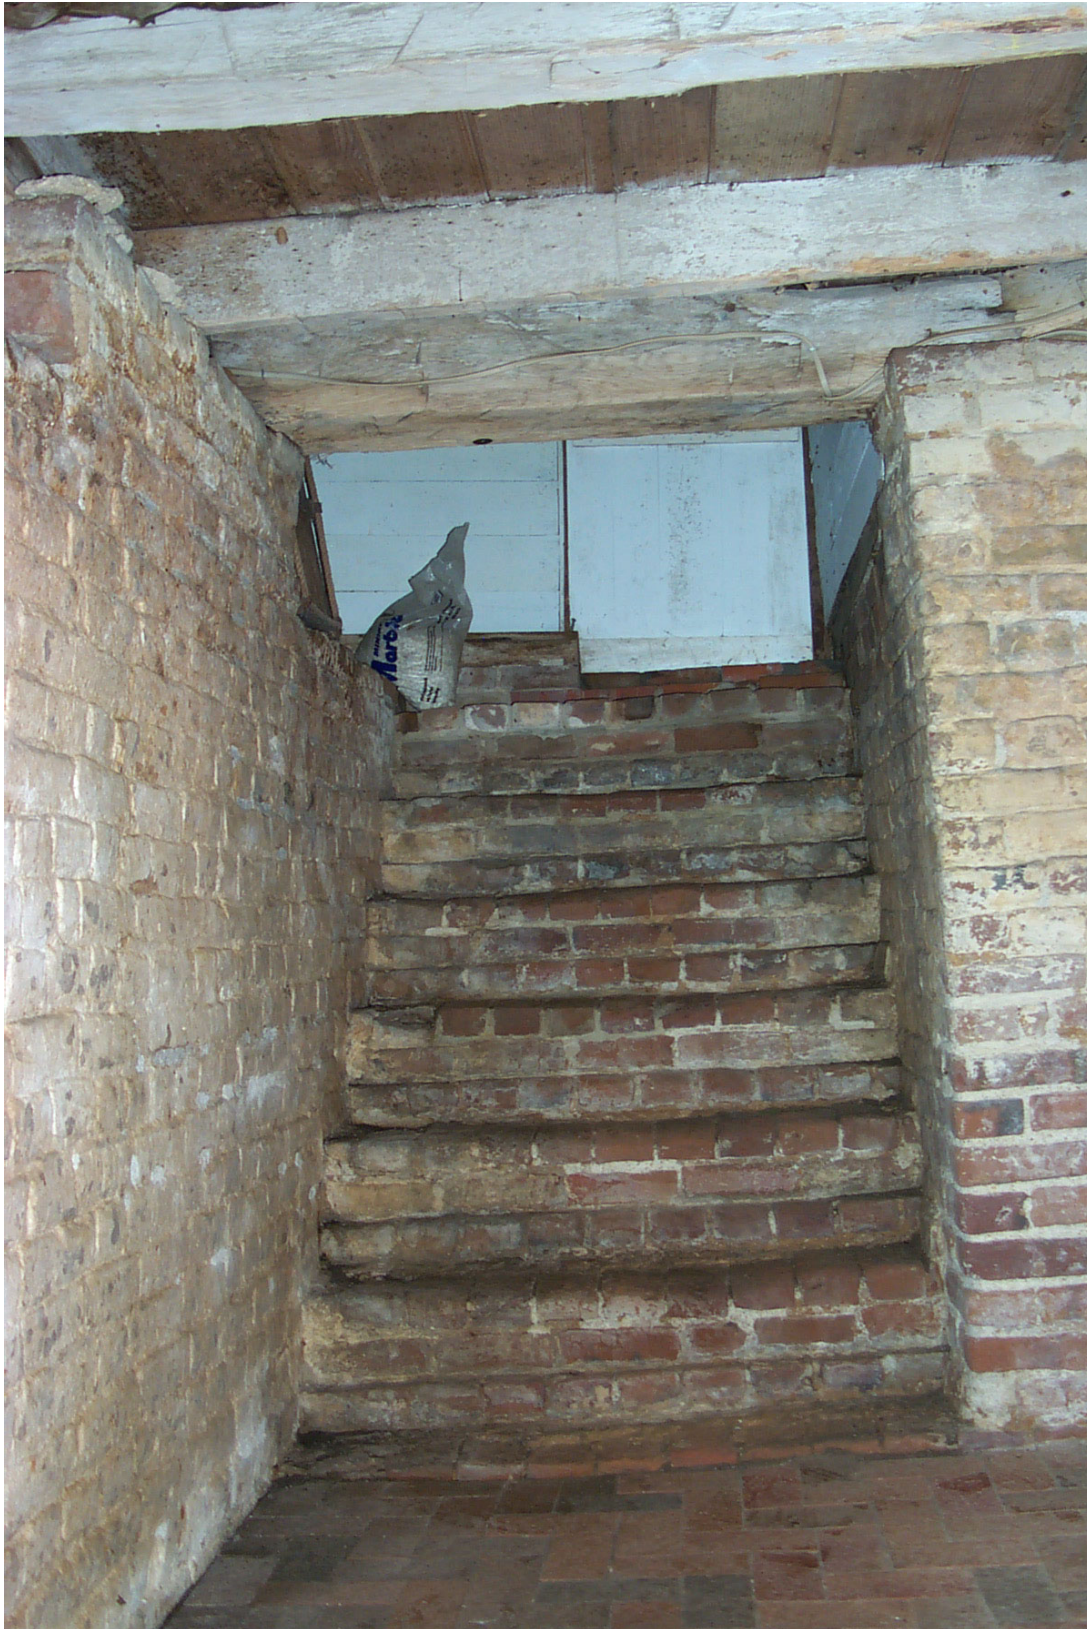
Figure 25

A cellar lies beneath the large room with an entrance originally to the outside by means of a slanting outside cellar door or bulkhead. Later the cellar door was replaced with a small addition in order better to cover the steps (Fig. 25, Cellar steps). The cellar had a dirt floor that we paved with brick. The cellar replicates the above room except for the large chimney foundation across it's northeast corner. Its headroom is about six plus feet high. The cellar has two, narrow, outside windows through the house's brick foundation on the east side. These windows once had wood framed vertical bars.

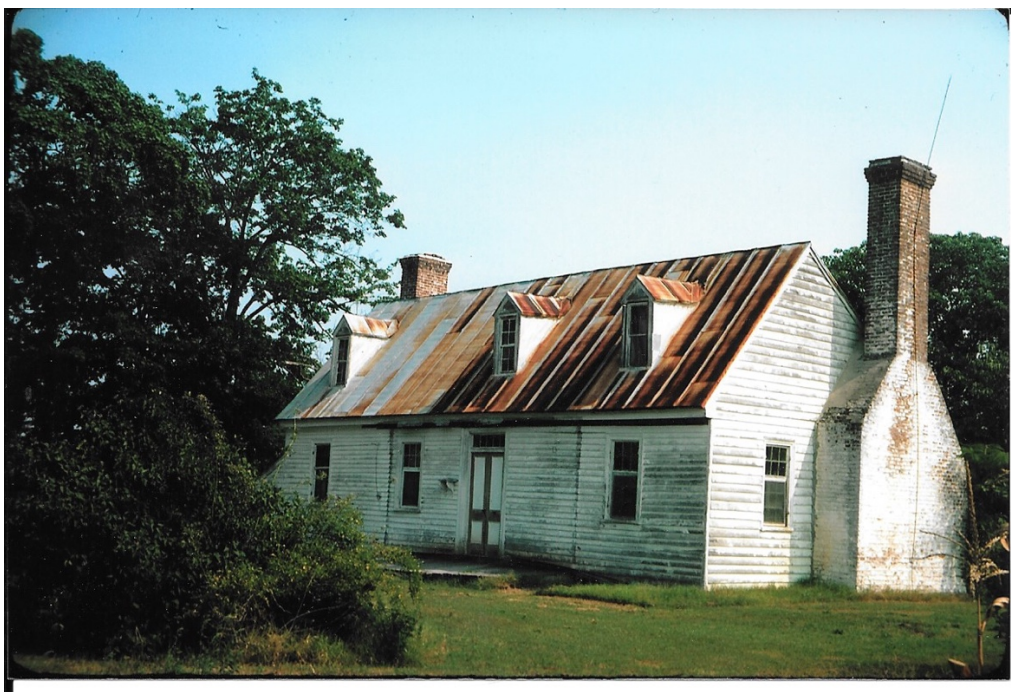
Figure 30

In 1977, my wife, Martha Orth, and I purchased Linden Farm and house from Virginia Sanders, and we soon began a program of restoration. Also, in 1977, Linden Farm was placed on the Virginia and National Registers of Historic Places. The house and properties were in a bad state (Fig. 30, Linden at time of Orth purchase). Unfortunately, we lived in Arlington, Virginia, and we both had jobs with the Federal Government. Each weekend we would drive 125 miles, one way, to do restoration work on the old house.

The missing dormer in the large, upstairs room (see Fig. 30) was rebuilt by Bill Duncanson and attached in place. This was done by cutting through the ceiling that covered the hole in the roof when the dormer was removed. Again, there are four dormers across the roof as originally placed by Edward Saunders in 1803. Joe Gaines and his helper applied modern plaster to all rooms of the house.

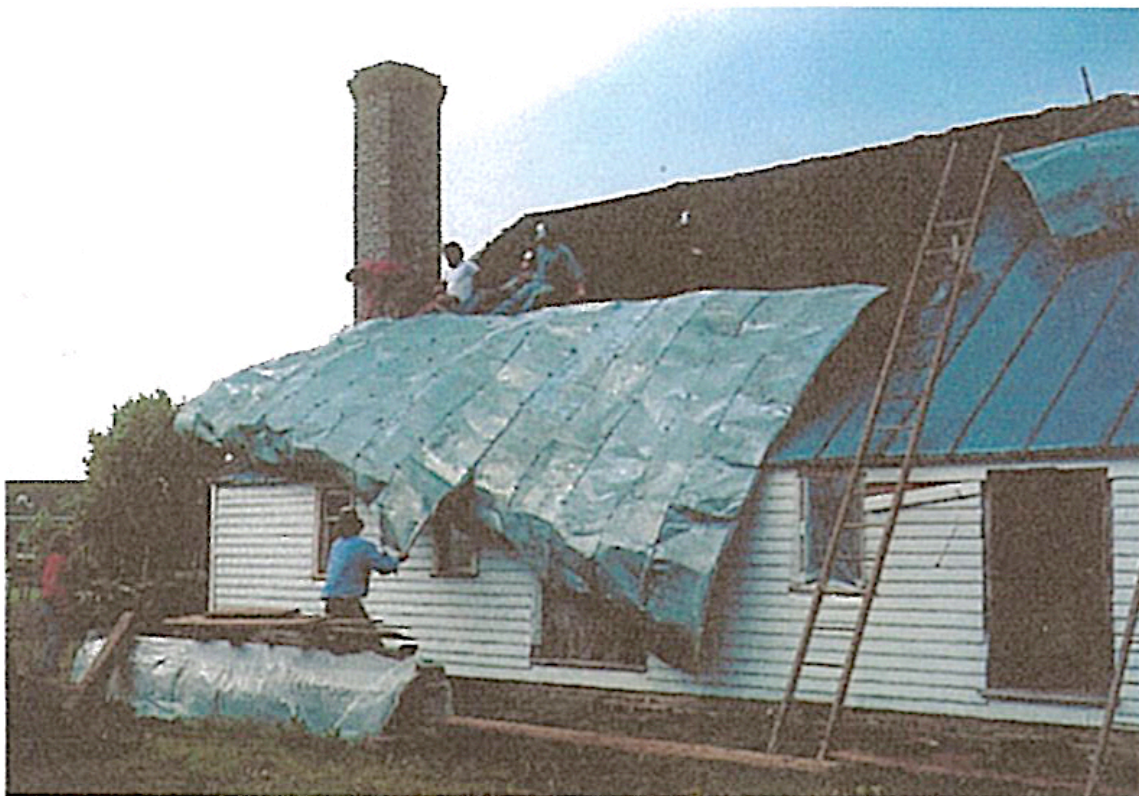
Figure 31

The standing-seam, metal roof was removed (Fig. 31, Removal of metal roof).

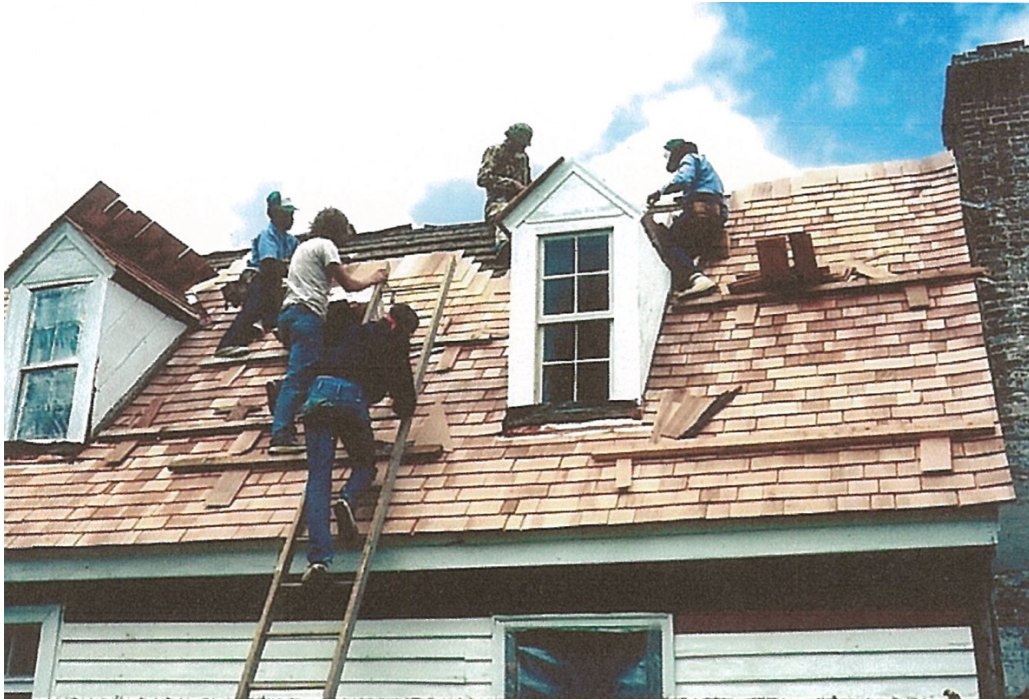
Figure 33

The original one-room house had a riven-clapboard roof, apparently followed by a round-butted shingle roof, followed by a square-butted shingle roof, followed by a metal roof, followed by our modern square-butted shingle roof. Bill Duncanson and I worked on the roof removing rotted, lath boards and replacing them with new ones while the roofers applied new roofing shingles (Fig. 33, Linden restoration roof work) (Fig. 34, Shows masons repairing the south chimney cap.

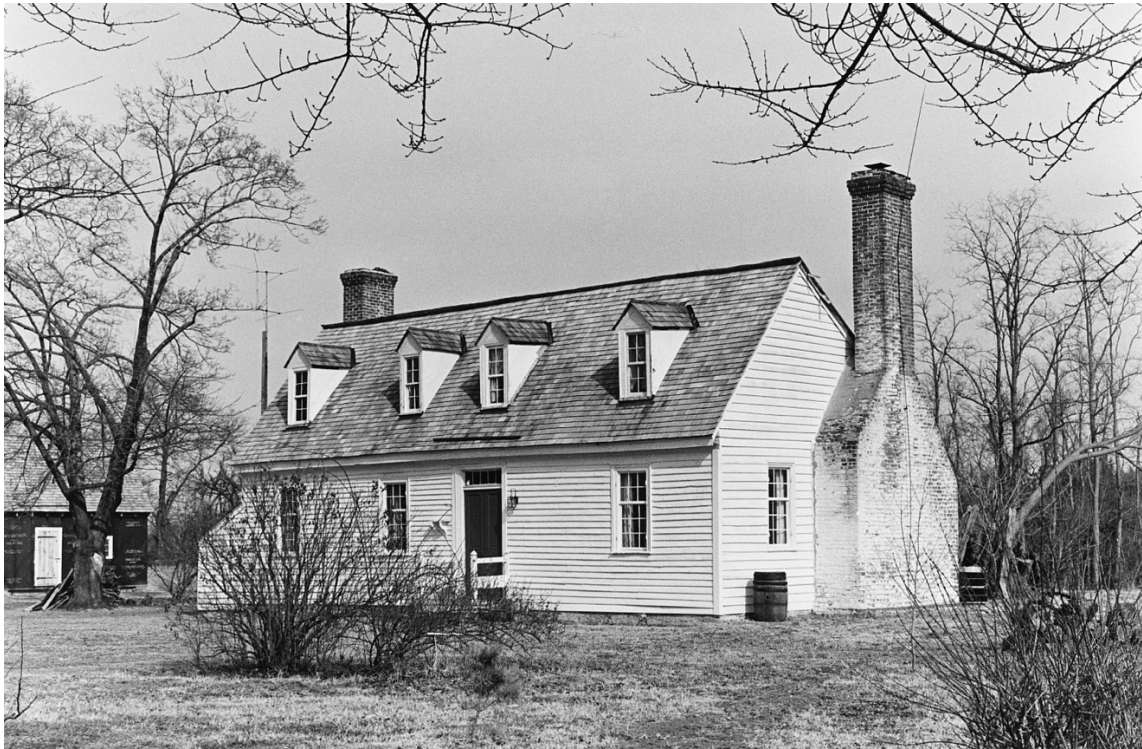
Figure 37

By 1982, the restoration of Linden was essentially complete (Fig. 37, Linden in 1982 after restoration).

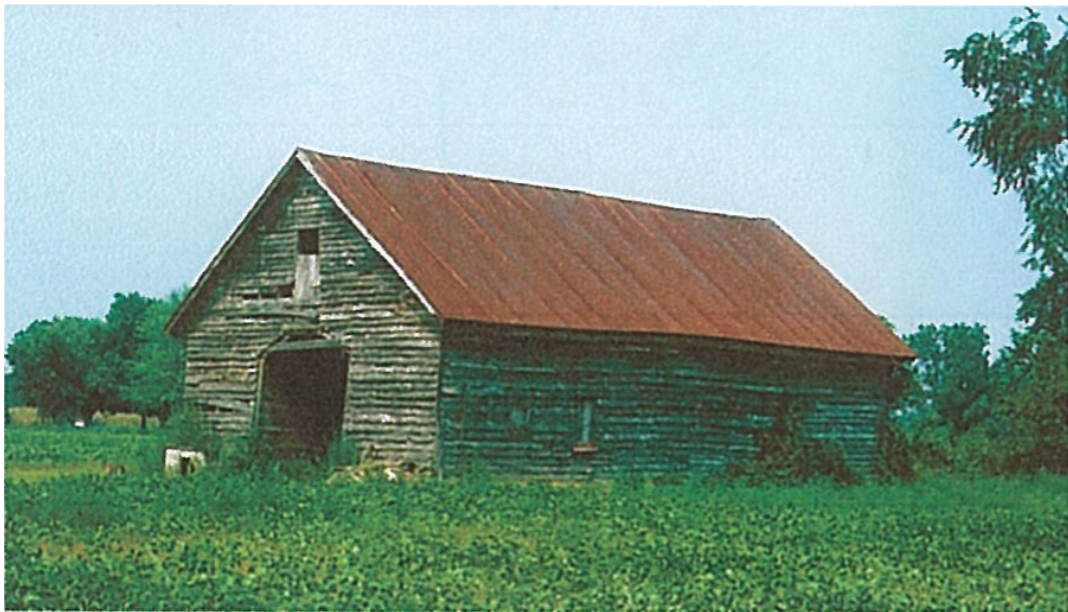
Figure 38

The nineteenth-century barn on Linden Farm north of house was severely deteriorated, could not be saved, and was subsequently destroyed in a windstorm (Fig. 38, Linden Farm barn).
