# Fox Hall - Norfolk's Oldest House, *Part 1*

Fox Hall is an eastern-Virginia, brick, vernacular house located on the northeast side of Norfolk. It is sited on land formerly in Norfolk County but later annexed by the City of Norfolk. Fox Hall dates circa 1725-30 (Figs. 1-3, Fox Hall as of January 2020). The house faces north.

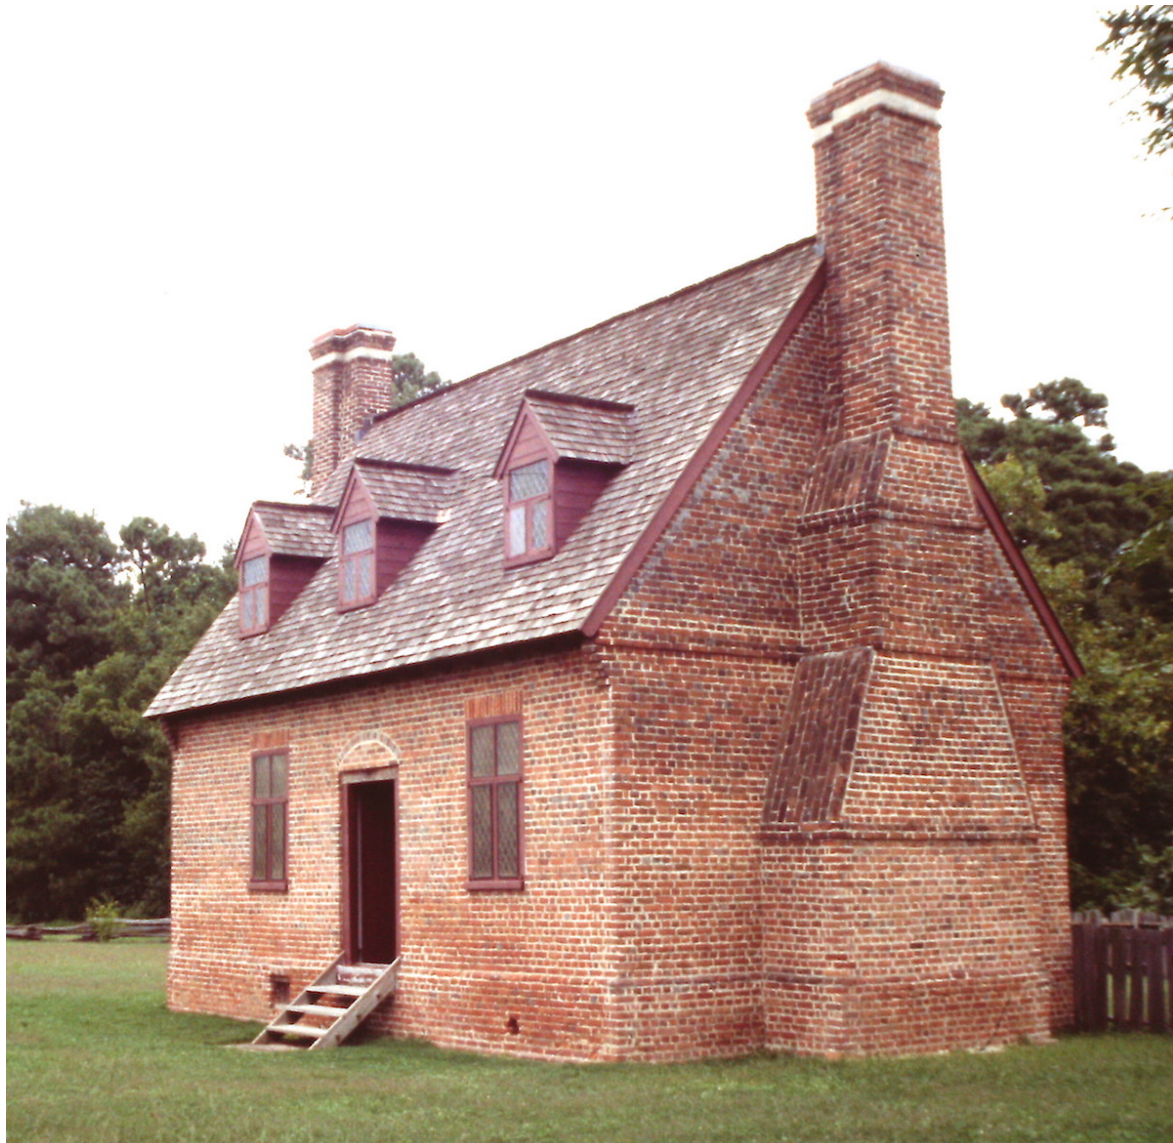
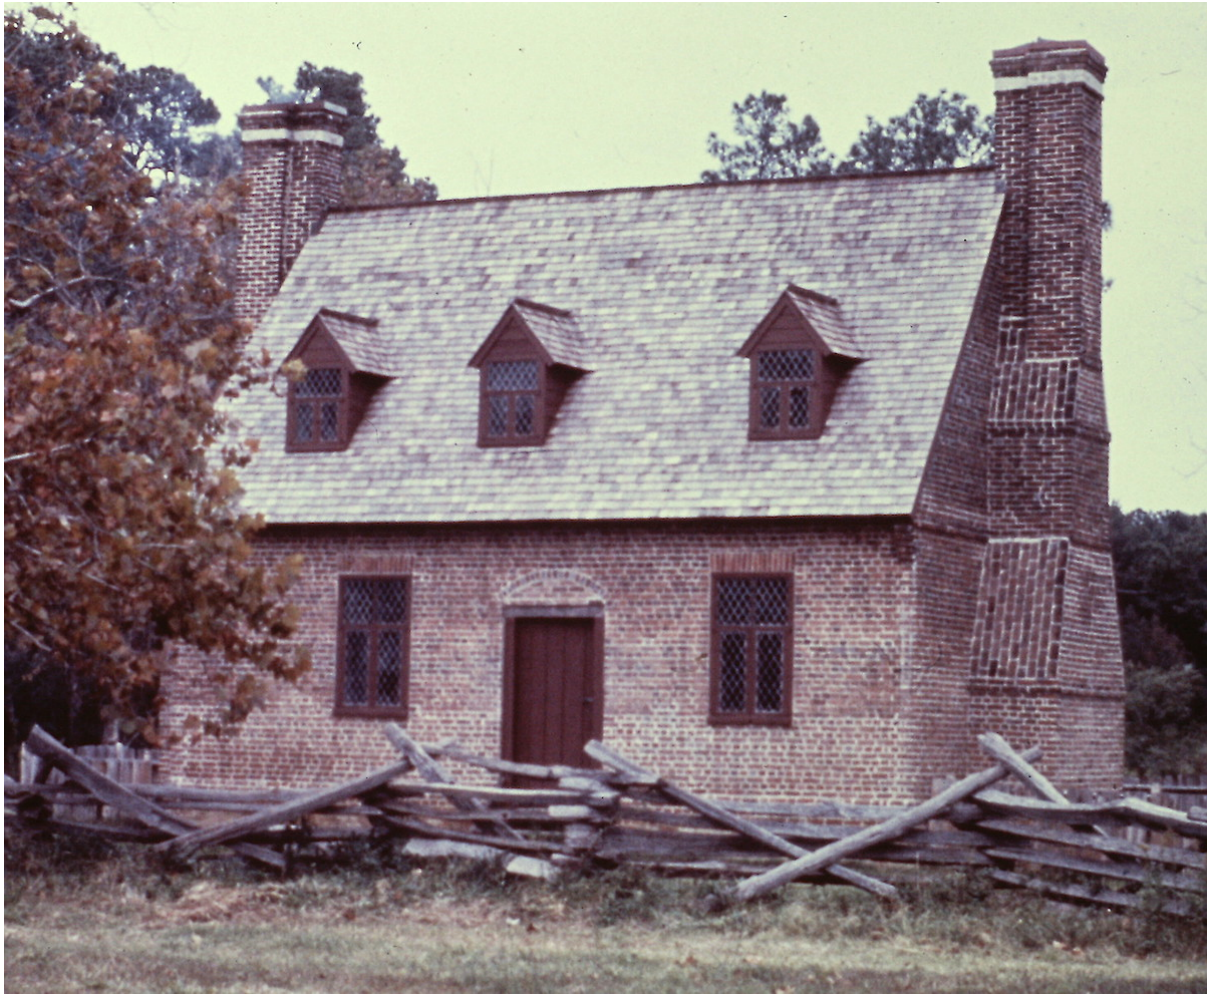
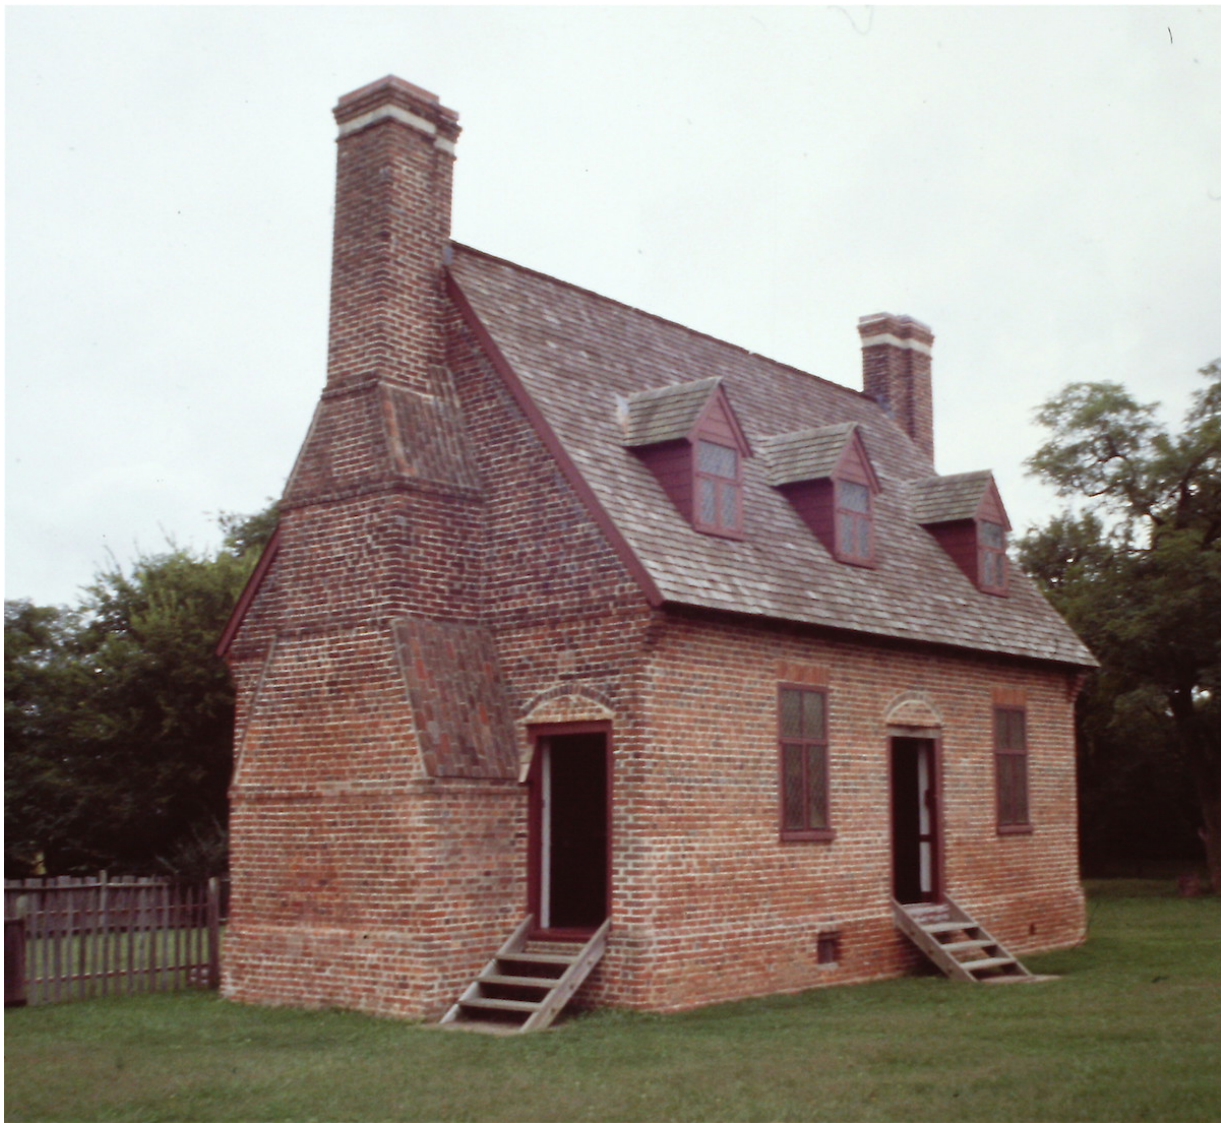
Fox Hall is close in design to, but considerably larger than, the Lynnhaven House, another vernacular brick house, located nearby in the City of Virginia Beach (Figs. 4, 5, & 6, Lynnhaven House). The door next to the chimney in Fig. 6 was originally a window.

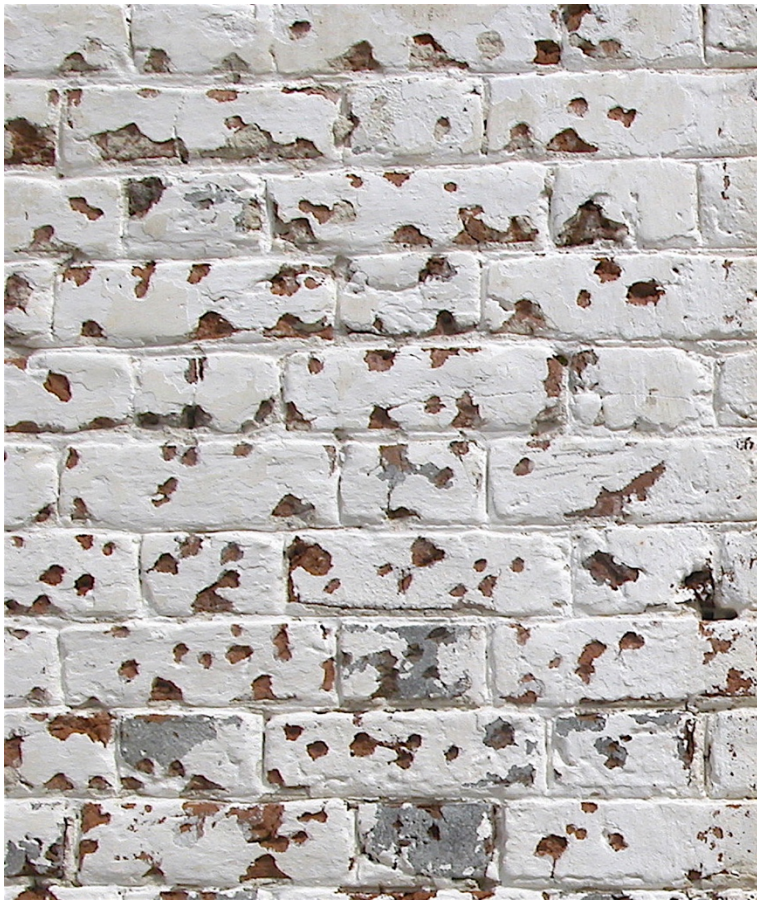
Figure 7

While the brick bonding is different, Fox Hall is Flemish bond (Fig. 7, Fox Hall bonding) and Lynnhaven House is English bond (Fig. 8, Lynnhaven House bonding), the overall design of the two houses is so similar, it is probable that the same undertaker built both of them. *Note: In the context of period architecture, undertaker is a builder.*

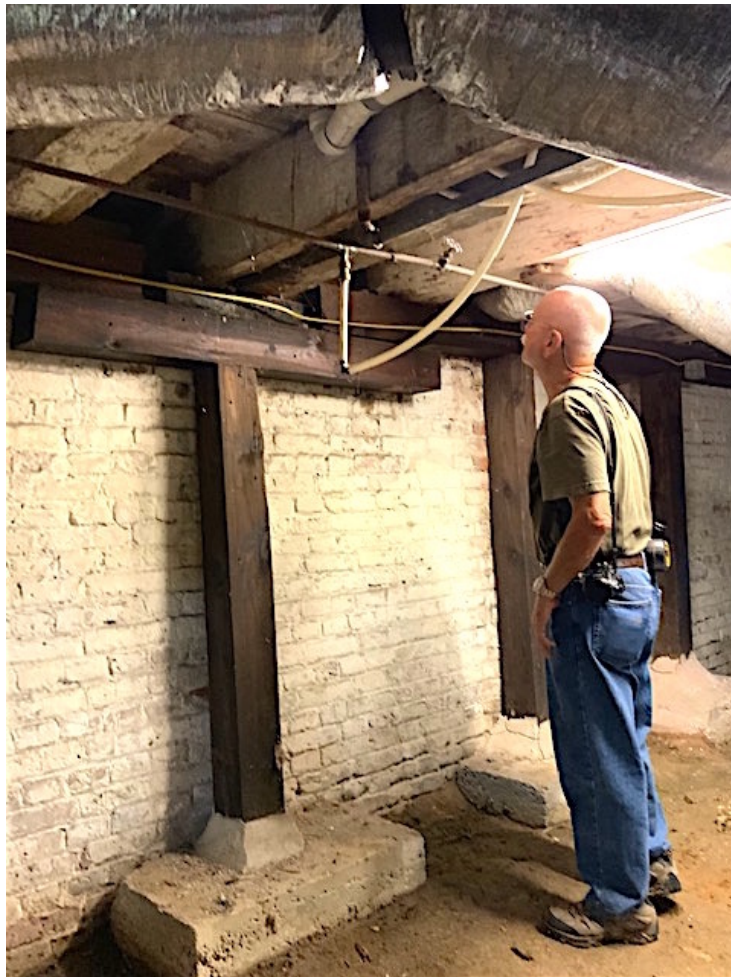
Figure 13

Apparently, all the first-floor floor joists were cut, seasoned, and installed prior to the change order. These are approximately five by six inches in cross-section and are roughly evenly spaced. The joist needed

to support the new wall delineating the central passage from the hall in the change order is different. It consists of two timbers roughly three by ten inches set side-by-side about two inches apart and inserted between two other joists (Fig. 13, Change-order joists).

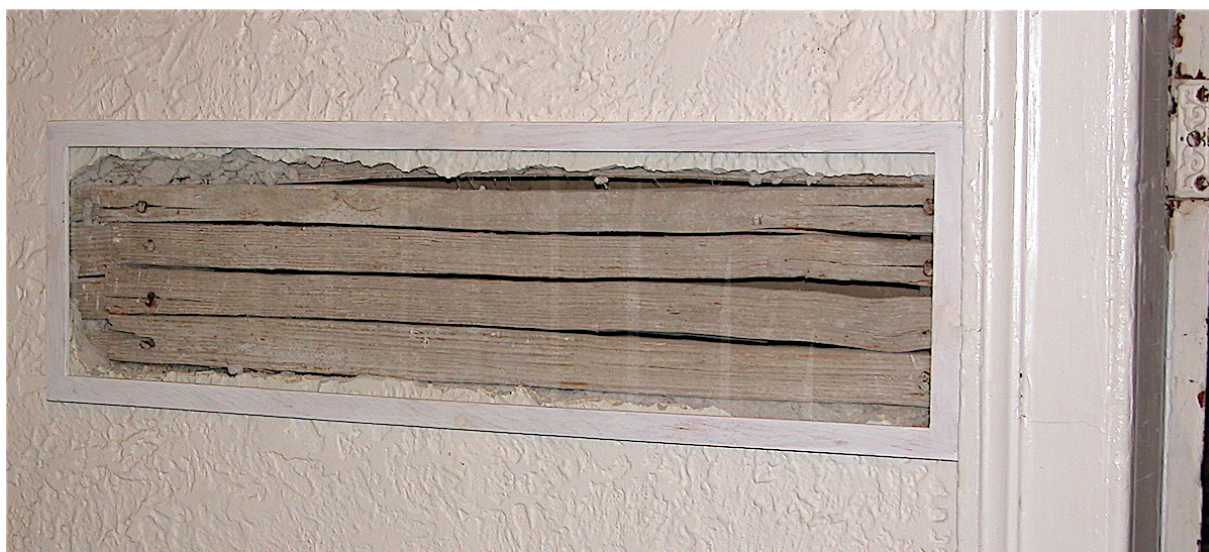
Figure 14

Another bit of evidence is the plaster lath in the walls on both sides of the central passage. It is riven, tapered on the ends, overlapped, and secured with a single wrought nail at the joints, exactly the same in both original walls (Fig. 14, Plaster lath in passage).

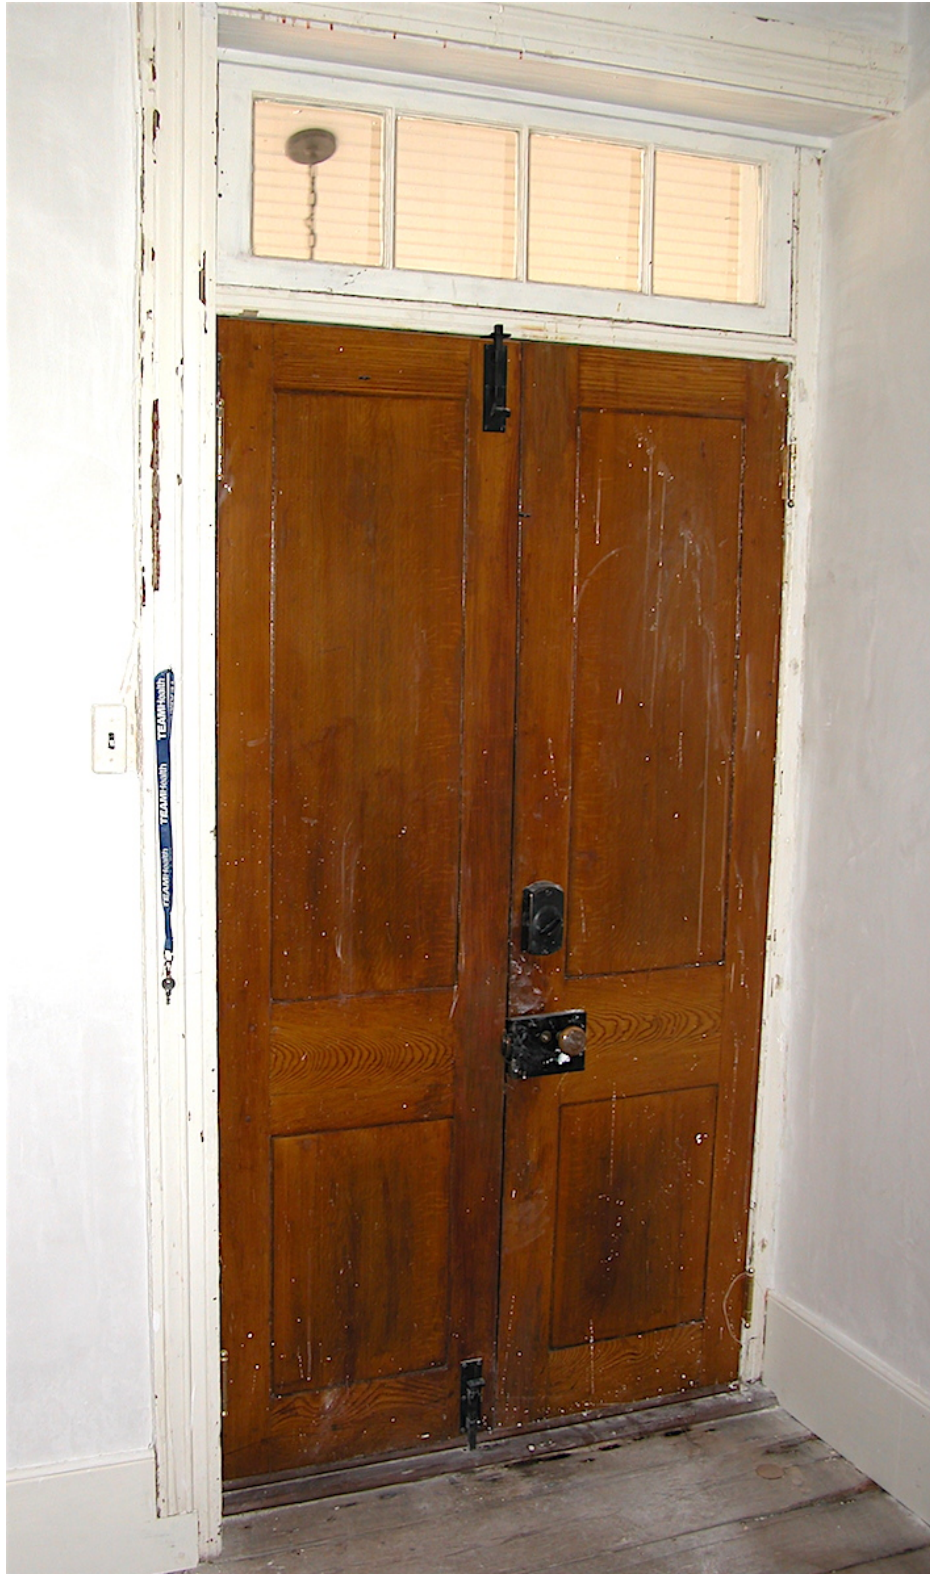
Figure 15

The front door of Fox Hall is centered on the front elevation of the house (See Fig. 2). However, as viewed from inside of the house, the front door is not centered on the central passage but opens hard against the passage-hall wall. If Fox Hall were built as initially conceived on a hall-kitchen floorplan, the front door would have fully opened into a spacious hall. The back door is aligned with the front door at the end of the

central passage (Fig. 15, Front door, inside view) (Fig. 16, Reconstructed back door, inside view).

Based on the width and height of the original front-door jamb with its transom lights, Fox Hall would have been fitted with a double door. This door was lost sometime in the past and replaced with what appeared to be a large office door glazed with opaque glass (Figs. 23 & 24, Incorrect office door). Fortunately, the owner was able to find a double door from a salvage company. This door has been fitted to the door jamb (Fig. 25, Salvaged double door) (See Fig. 15).

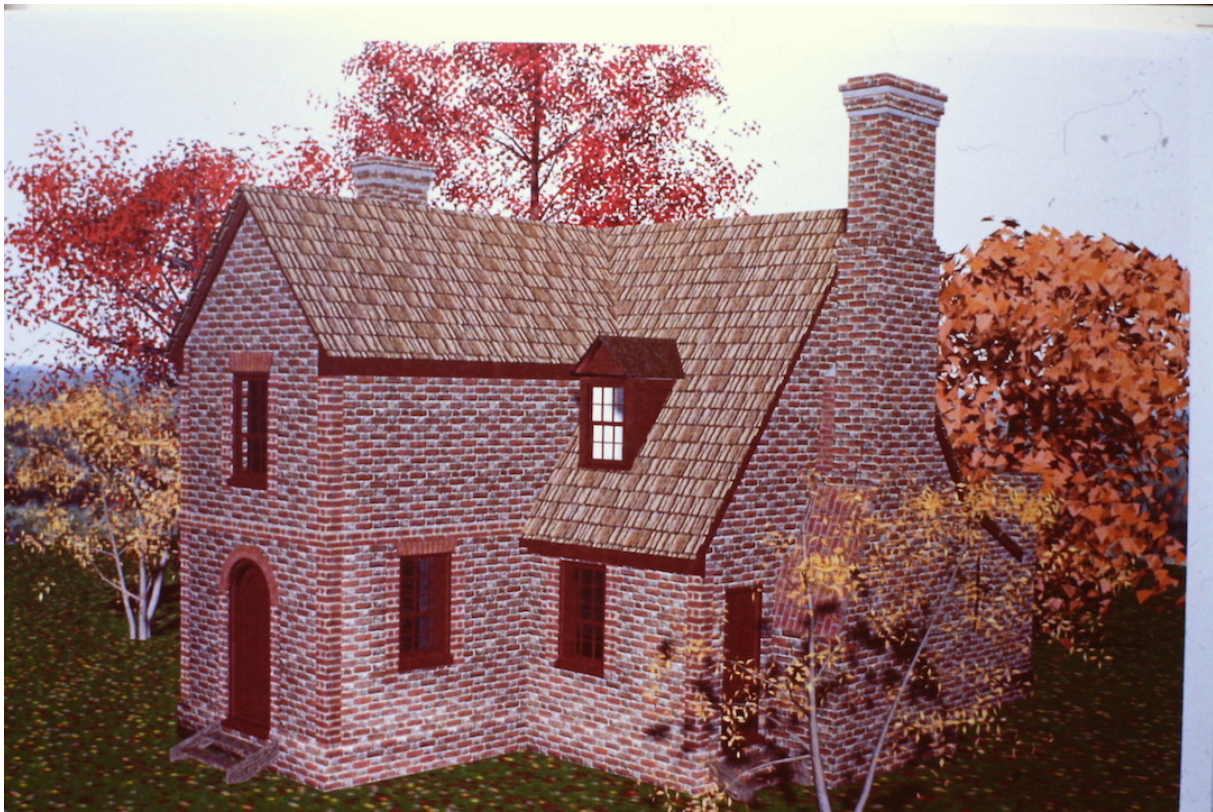
Figure 17

Since the original frame house between the two chimneys was too small to accommodate a central passage, Jones solved the access problem by constructing an attached brick porch tower. The first-floor vestibule in the porch tower served the function of a central passage in controlling access of visitors to his home. Matthew Jones died before construction was complete, and his son and son's guardian were left to finish the job (Fig. 17, Computer rendering of Matthew Jones House circa 1730).

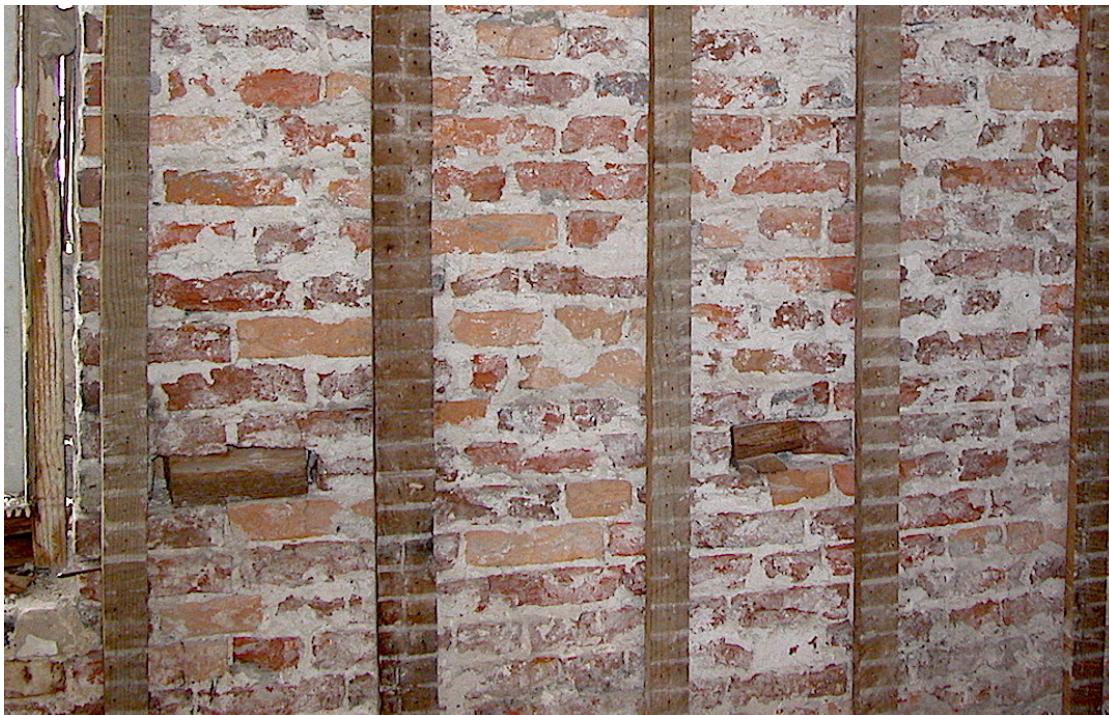
Figure 18

Sometime in the eighteenth century, the hall was decoratively upgraded with a baseboard, chair board, and crown molding. Wooden nailer blocks, cut into the brickwork of the south wall at appropriate elevations, are clear evidence of these upgrades (Fig. 18, Wooden nailer blocks for chair board). Late-nineteenth-century plaster and lath have been removed from this wall. Original plaster here was damaged by moisture, thus necessitating the late nineteenth-century plaster and lath (Fig. 19, Remnant of original plaster, above & to right of nailer). All four walls in the hall have now been re-plastered. On this wall, ventilation space was left at the top, behind, and bottom of the plaster for air circulation to prevent moisture buildup. Also, a baseboard, patterned on a later eighteenth-century example along the stair in the central passage, has been installed. An appropriate chair board and a cove crown molding have been milled and will be installed in the hall.

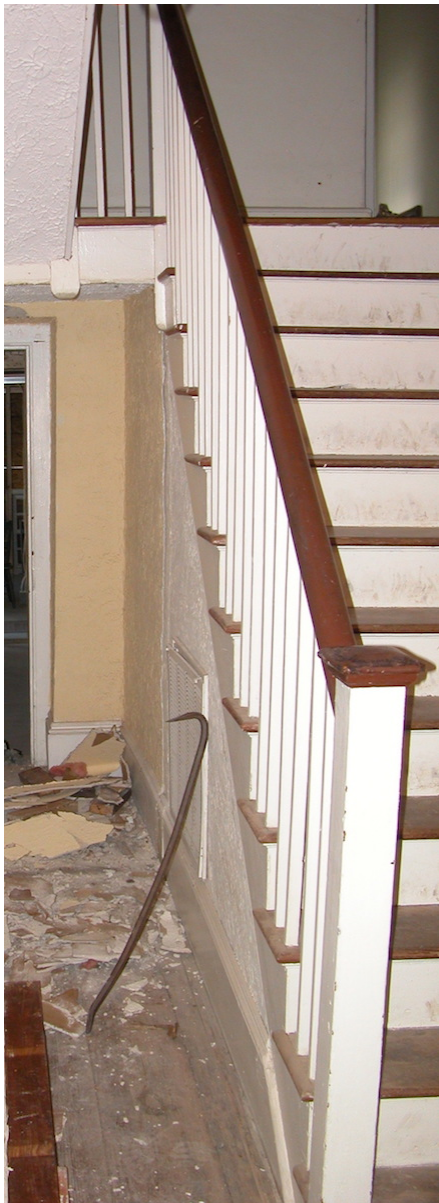
Figure 20

The central-passage stair was replaced in the late-eighteenth- or early-nineteenth century. It is typical of ubiquitous, open-string stairs found in turn-of-the- nineteenth-century houses all over eastern Virginia (Fig. 20, Fox Hall stair). Evidence of the original stair remains in the form of two small rectangular mortises cut in the floor next to the present stair (Fig. 21, Mortise of earlier stair to left of newel of existing stair).

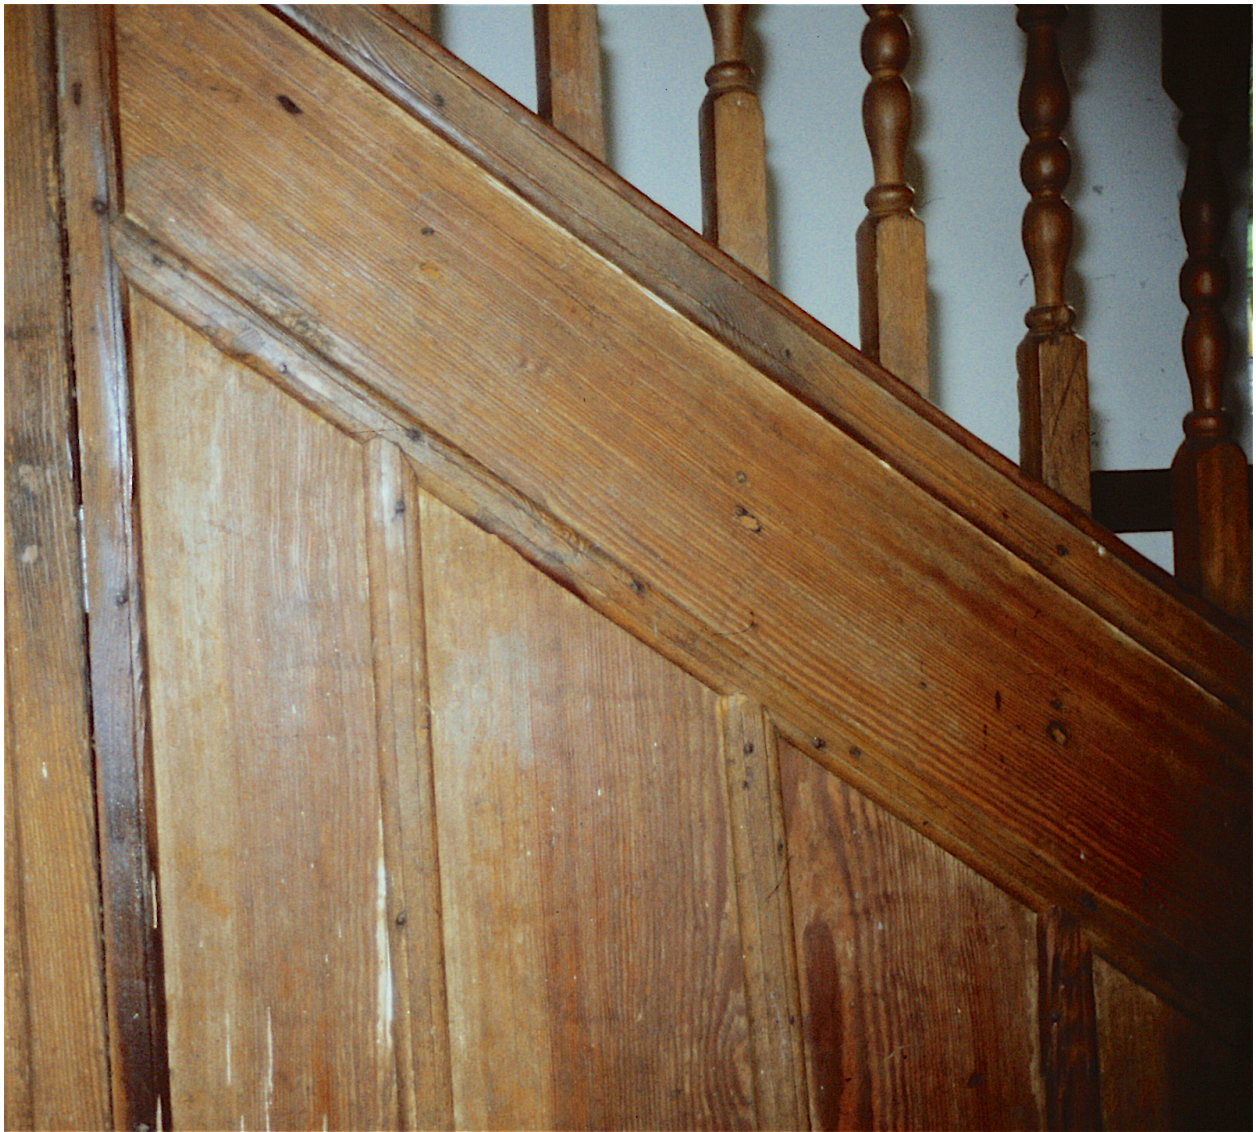
Figure 22

The original stair likely would have resembled the original closed-string stair with cubby in the Lynnhaven House, but it is doubtful that we will ever know (Fig. 22, Lynnhaven House stair).

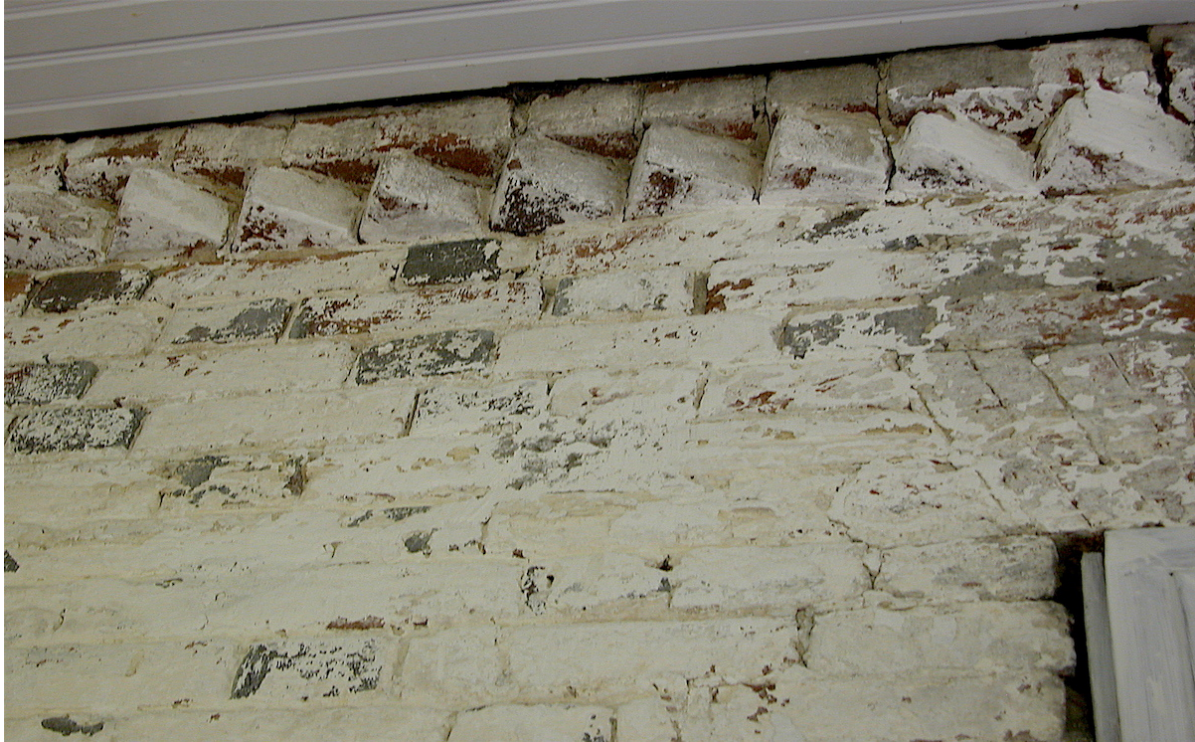
Figure 26

The decorative, hounds-tooth brickwork above the front door is of special note (Fig. 26, Decorative brickwork).

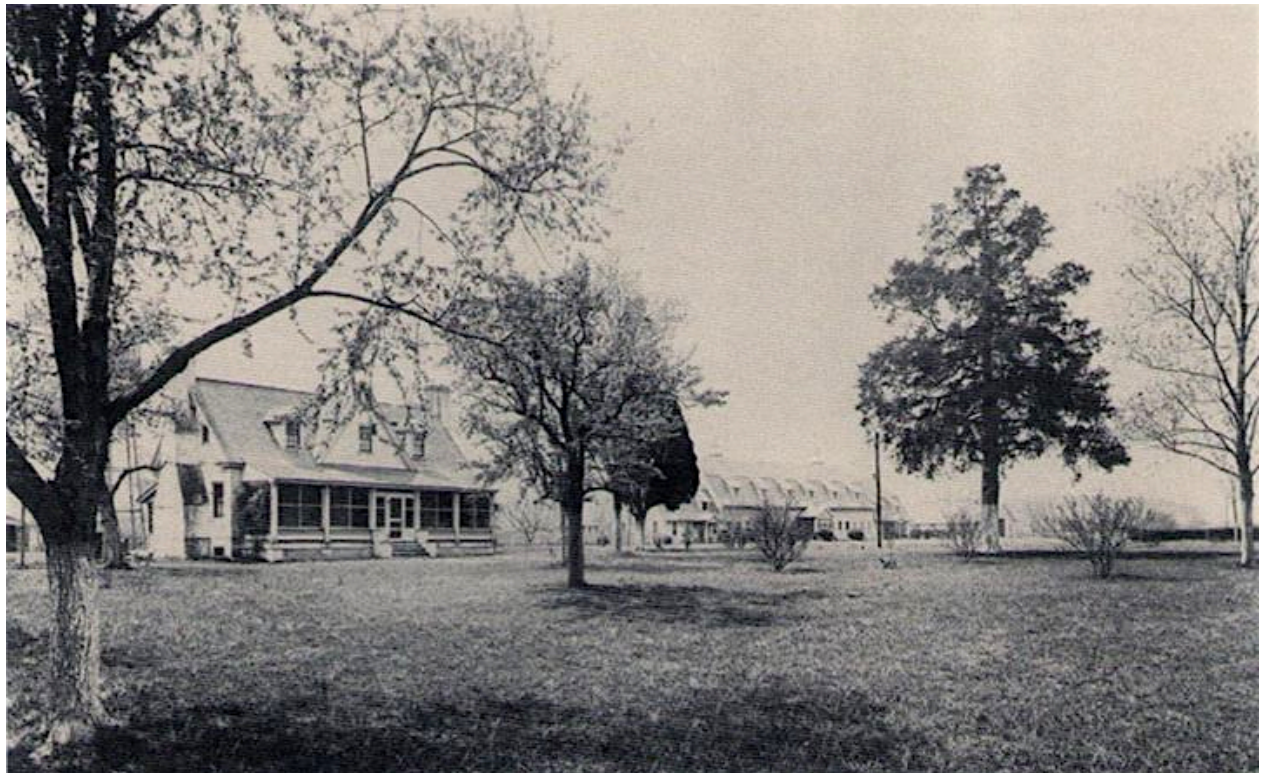
Figure 27

The most obvious change to the original house was the addition of the large gable and porch on the front (See Figs. 1, 2, & 3). These likely were added sometime in the 1920s and can be seen in a photo thought to be of that timeframe (Fig. 27, Fox Hall circa 1920s?).
